# Evaluation of Support and Ground Response as Longwall Face Advances into and Widens Pre-Driven Recovery Room

*Thomas M. Barczak*, Senior Research Engineer  
*Stephen C. Tadolini*, Chief, Rock Safety Engineering Branch  
NIOSH-Pittsburgh Research Laboratory  
Pittsburgh, PA

## ABSTRACT

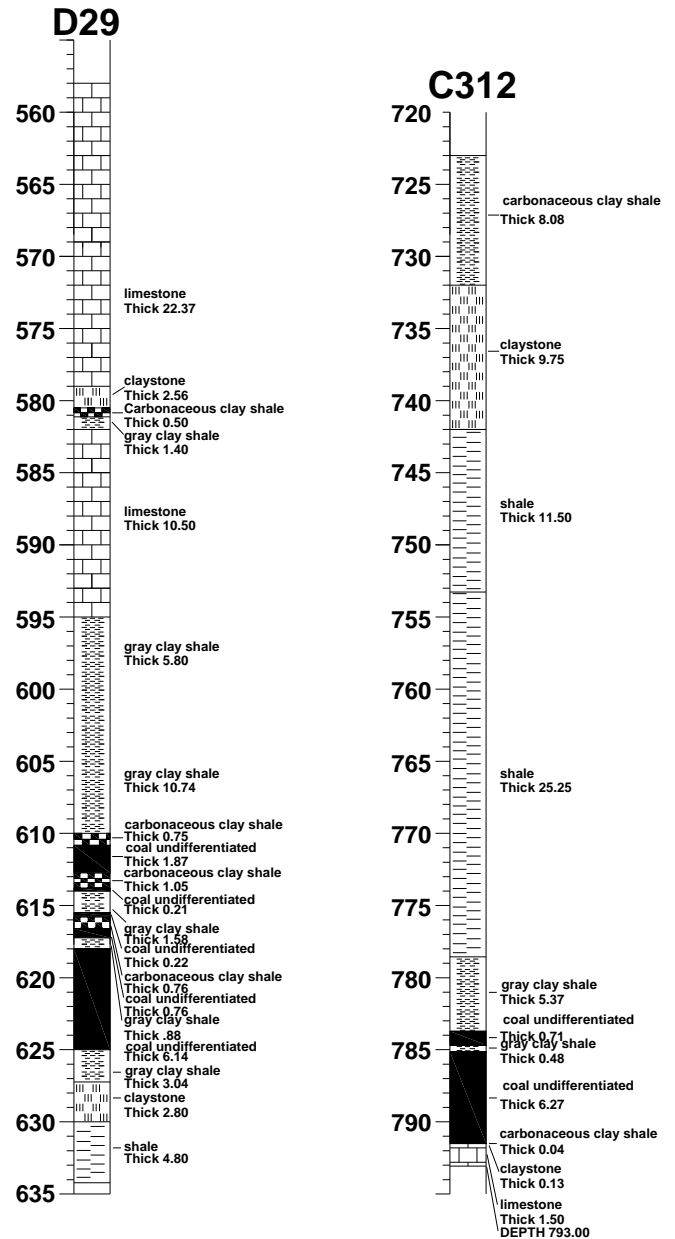
Figure 1. Geological columns in the longwall recovery area.

The B4 longwall panel was 1,450 ft wide. The depth of cover averaged 600 ft. Figure 1 shows the roof lithology from two coreholes near the B4 recovery area. The immediate roof consists of clay shale, silty shale and rider coal, which is common to the Pittsburgh seam providing a relatively weak immediate roof structure. The area is overlain by 10 and 22-ft thick limestone members and 11 and 25-ft thick shale layers as shown in figure 1.

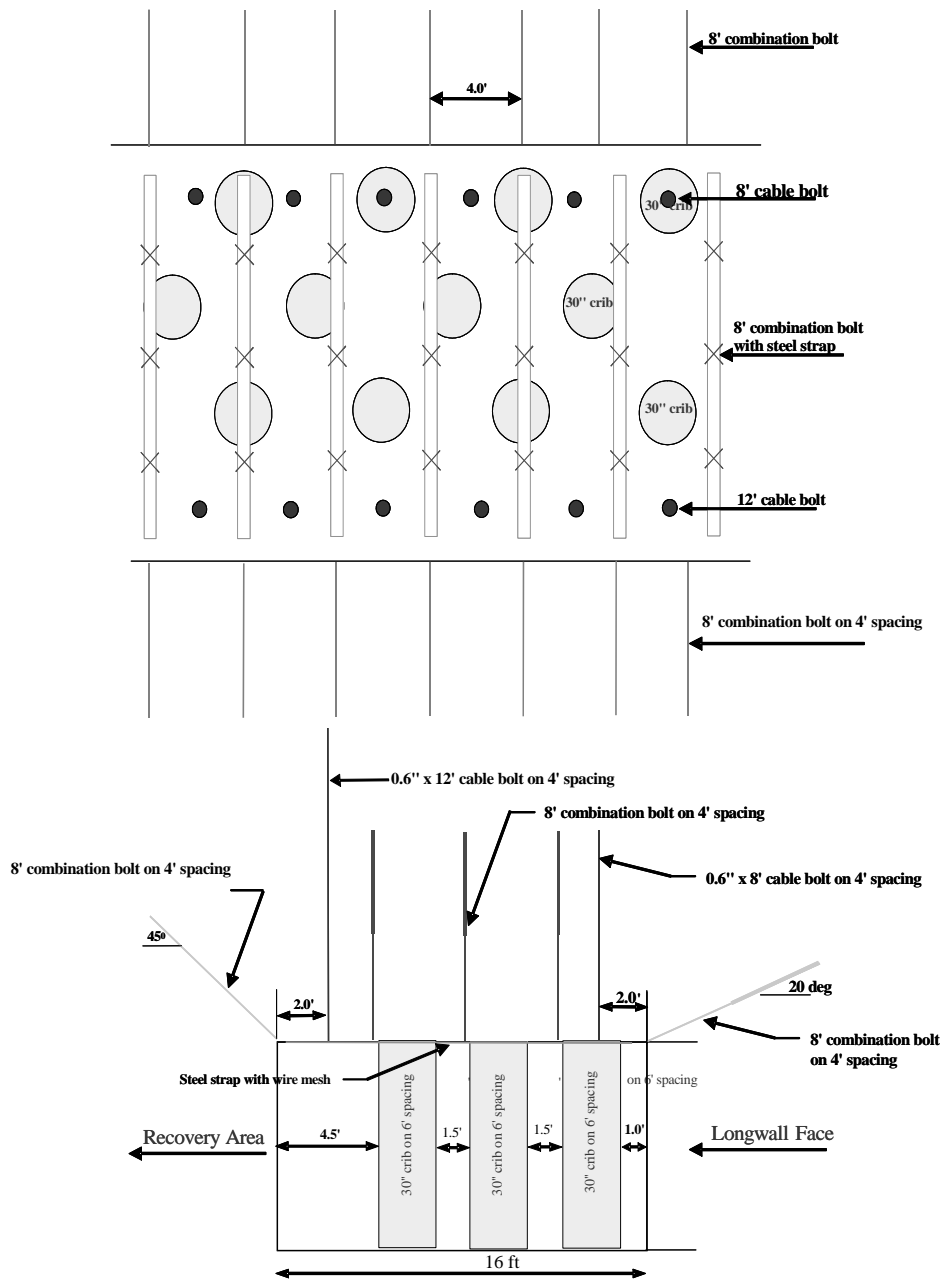
Figure 2. Support design for the longwall recovery room.

Figure 2 shows the support design for the recovery room. The recovery room was supported with 8-ft, grade 75, combination bolts. Combination bolts were also angled over the longwall panel and the outby pillar ribs to provide additional support as the face cuts into and then widens the recovery room. Eight-ft cable bolts on 4-ft spacing were installed 2 ft from the panel rib to help support the roof when the first row of cribs were cut out, and 12-ft cable bolts on 4-ft spacing were installed 2 ft from the pillar rib to reinforce the roof from possible shear/tension fractures. The roof was glued with polyurethane resin (PUR) on the outby (pillar) side to strengthen the roof in the area adjacent to the pumpable cribs. The mine chose not to use PUR on the inby side, as was done on the previous panel, to facilitate caving of the immediate roof once the shields entered the room.

Three rows of 30-in-diameter pumpable roof supports were utilized in the recovery room as shown in figure 2. These were Calcium-Sulfo-Aluminate (CSA) grout filled supports that are identical to the supports used for the longwall tailgate except the spiral metal wire in the bag was replaced with a fiberglass wire that could be more easily cut by the longwall shearer. The performance characteristics of this support, as measured in the laboratory through full-scale testing in the NIOSH Mine Roof Simulator and during the longwall recovery in this study are shown in figure 3. As seen, the pumpable support is very stiff with peak load occurring at less than 0.5 in of displacement. The support sheds load during yielding as the bag acts to provide confinement and maintain a residual loading capacity.

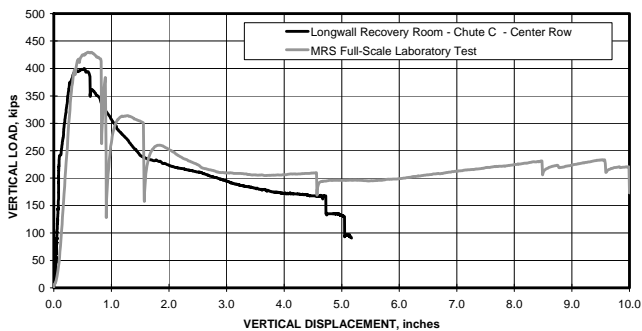
Figure 3. Comparison of the pumpable support full-scale laboratory tests and performance measured in the longwall recovery room.

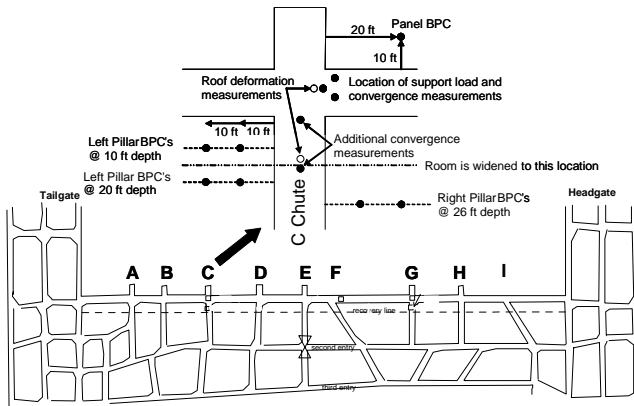
Figure 4. Diagram showing instrumentation in the longwall recovery room.

A diagram depicting the approaching longwall panel, predriven recovery room and outby pillar configuration is shown in figure 4. The instrumentation for this study was clustered in areas near Chutes C, F, and G and included:

- Borehole Pressure Cells were used to measure panel and outby pillar stress development in the C chute area. Figure 4 depicts the location of the cells. One cell was installed in the panel 10-ft from the recovery room to measure yielding of the panel fender as the longwall face approached, two cells were installed in the outby pillars at a depth of 10-ft and two other cells 20-ft from the from the outby edge of the recovery room to measure load transfer from the panel to the outby pillars. Two more cells were installed 26-ft from the outby edge of the recovery room in the adjacent pillar of the C chute location, again to measure load transfer from the longwall panel as the fender yielded.

The shield leg pressures provide further insight into the loading mechanisms associated with the panel fender yielding. The panel stress measurements are located adjacent to the C Chute location and shield number 175 (see figure 4), which is about 1,000 ft from the headgate on

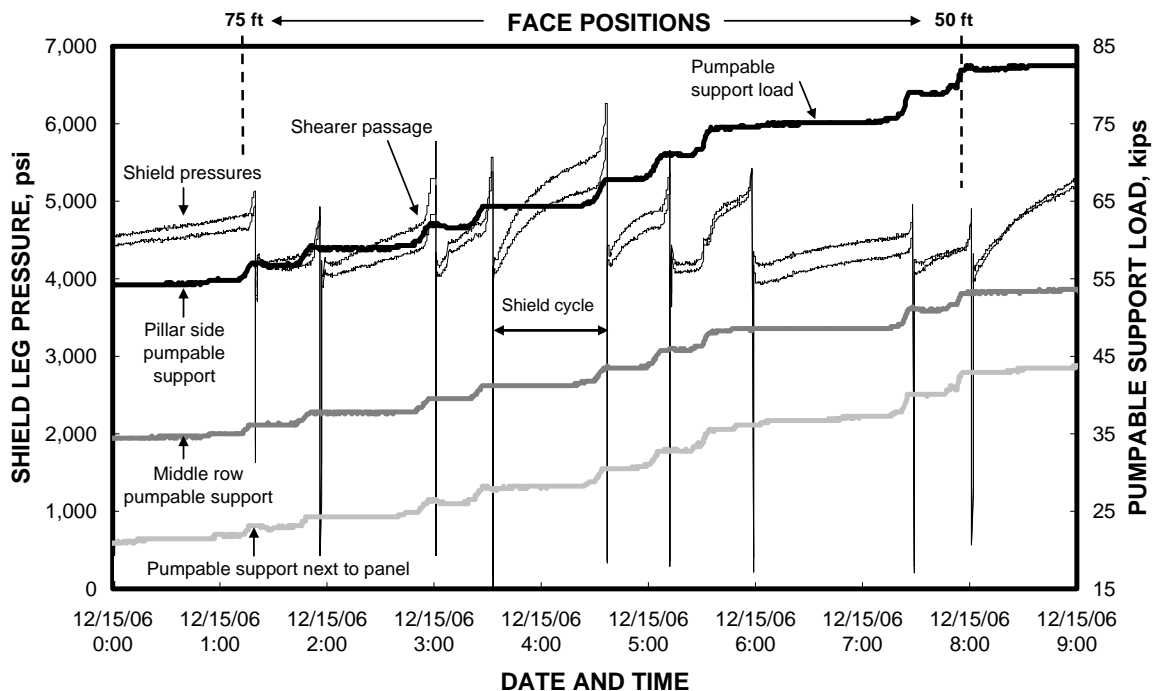
Figure 5. Correlation between pumpable support load and shield cycle showing load increase during shearer passage.

the main roof activity. Figure 5 shows an example for shield number 175 (adjacent to Chute C in the recovery room) as the face advanced from a location 75 ft away to 50 ft away the recovery room. As the face advanced closer than the 50 ft location, the pumpable supports began to increase in loading during the full shield cycle, but the majority of the load increase continued to be consistent with the shearer passage and a step-type function in the load development continued.

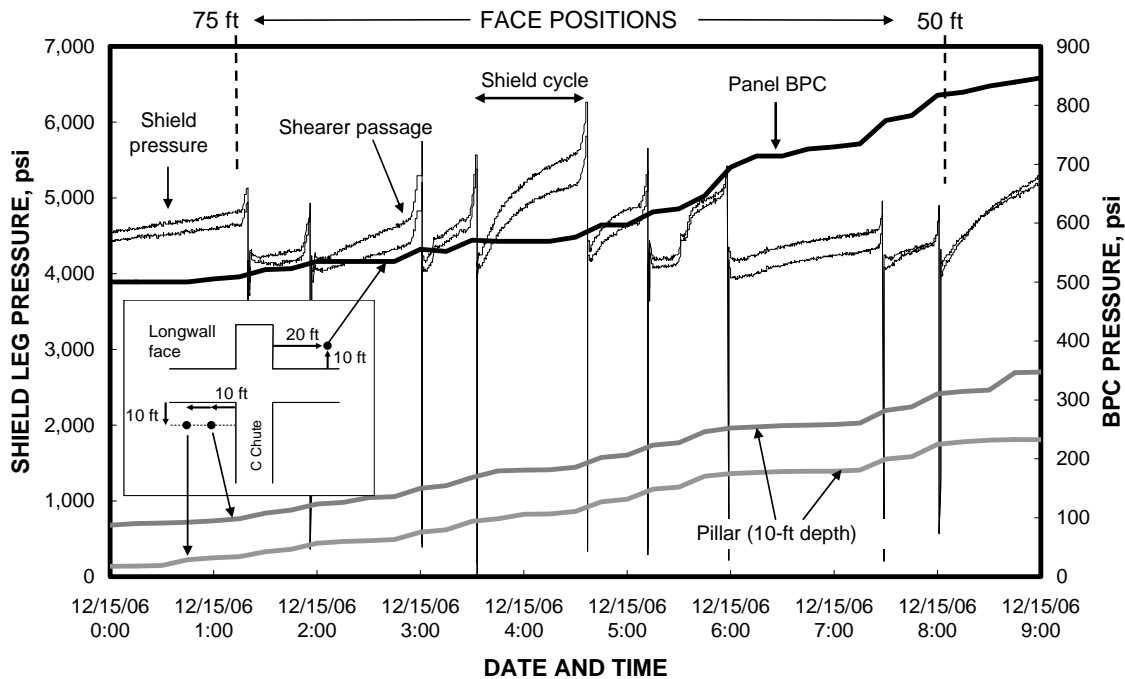
Figure 6. Correlation between borehole pressure cells and shield cycles.

The Borehole Pressure Cells (BPCs) monitoring the panel and pillar stress followed a similar pattern, although not as distinct as the support loads (see figure 6). Part of this was due to the much

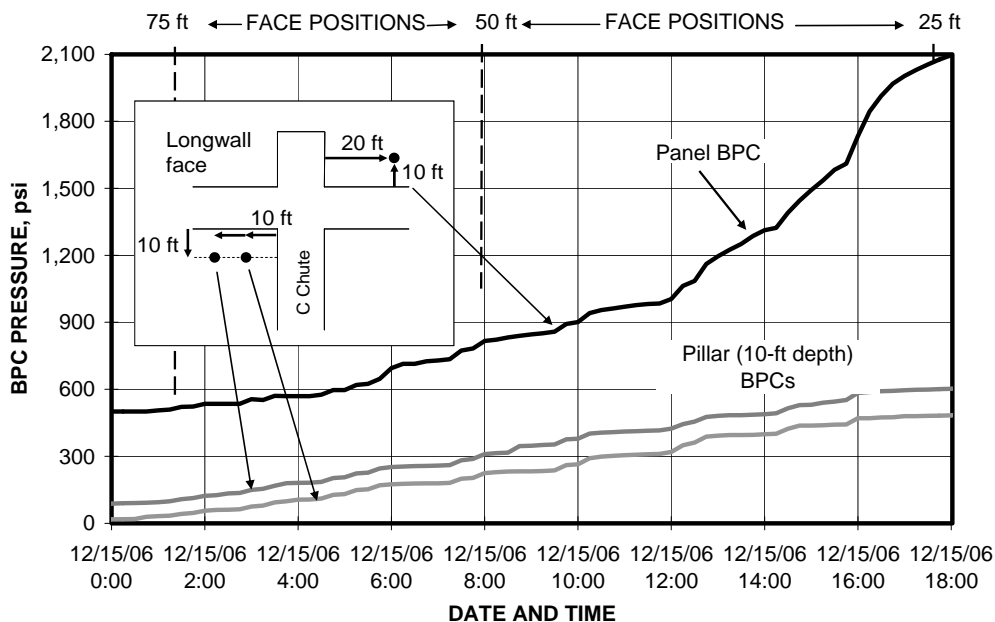
Figure 7. Stress on the panel BPC began to increase at a faster rate than the pillar BPC as the face advanced closer to the recovery room.

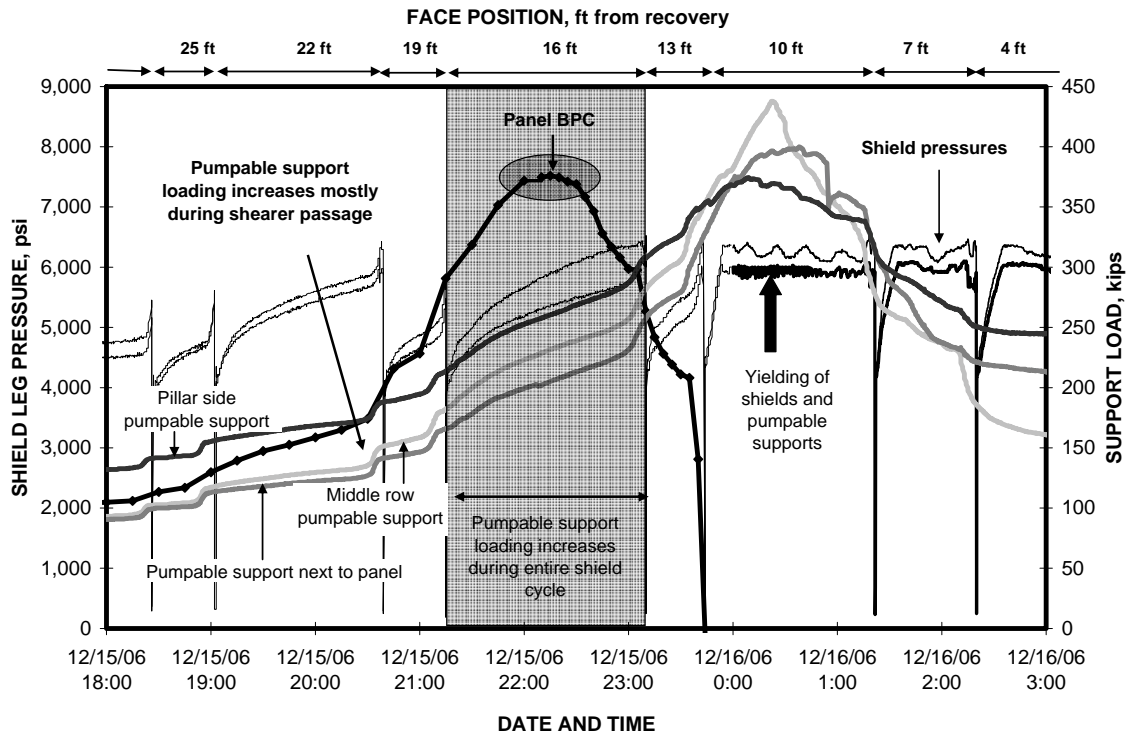
Figure 8. When the longwall face was approximately 16 ft inby the recovery room, the pumpable support loading increased during the full shield cycle.

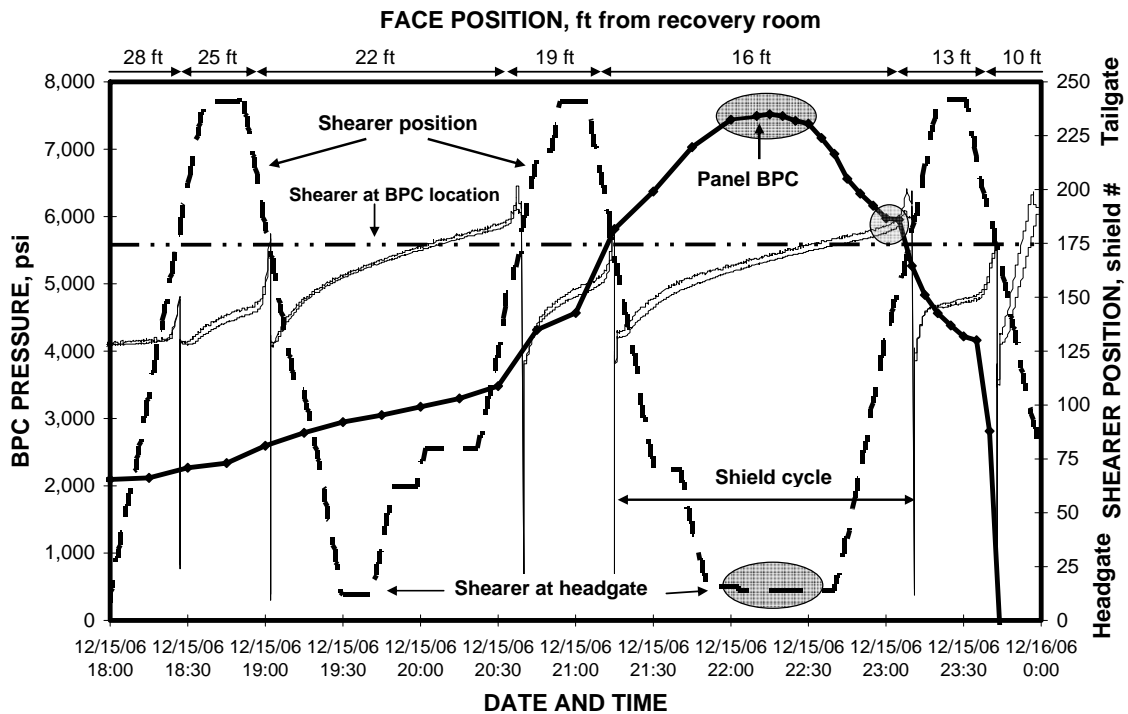
Figure 9. Yielding of panel BPC occurred when the longwall shearer was approximately 1,000 ft away from the cell location.

this 1,450 ft-long face. For bidirectional cutting, the shield cycles are likely to alternate between short and long cycles since the support is located away from the center of the panel where the shield cycle time differential would be minimized. As shown in figure 9, the panel fender yielded during a long cycle (114-minute duration) as the shearer had to move to the headgate and back to complete the loading cycle. It was somewhat surprising to observe that the peak stress occurred not when the shearer passed by this location, but when the shearer was over 1,000 ft away at the headgate, particularly given the close proximity of the longwall face to the stress cell (approximately 6 ft away). This could be the result of the time dependent properties of the coal, in which the highly stressed coal will continue to deform (strain) even under static load conditions. The unloading rate is also nearly the same as the loading rate during this shield cycle. The detail of the loading is magnificent as exemplified by the temporary stop in load shedding when the shearer passes back in front of the pressure cell (see figure 9).

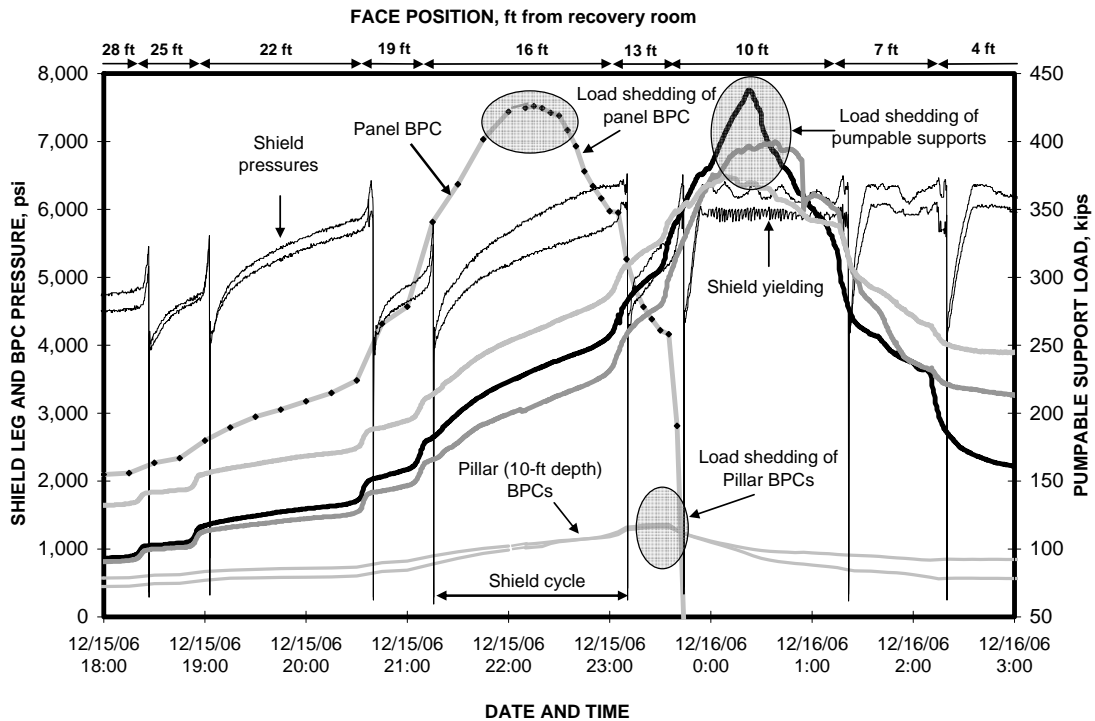
Figure 10. Evaluation of load shedding associated with pumpable supports and BPCs measuring panel and pillar stress.

These two cells peak and then gradually shed load during the shearer passage on the shield cycle following the peak loading of the panel cell (figure 10). Since the stress levels on the pillar cells were only 25% of the level that caused yielding of the panel cell, it is unlikely that the coal pillar at the cell location was actually yielding due to loading

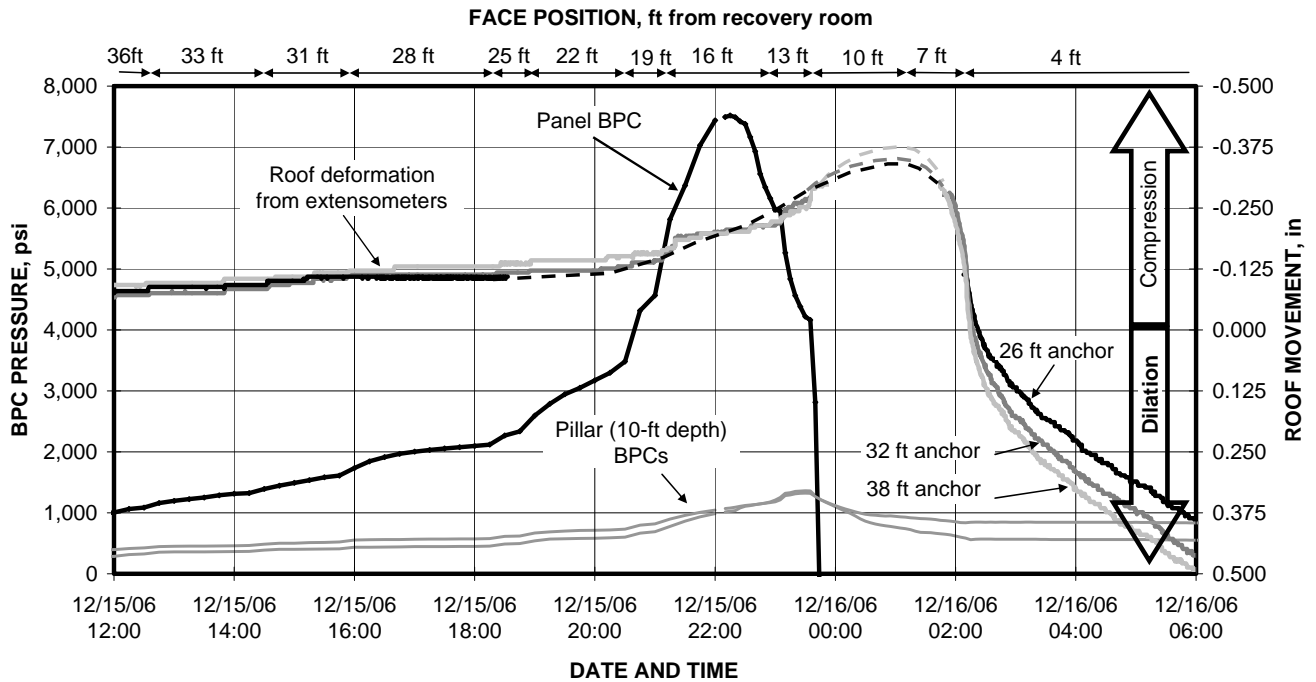
Figure 11. Roof initially is compressed during yielding of panel fender and then begins to deform downward into the recovery room.

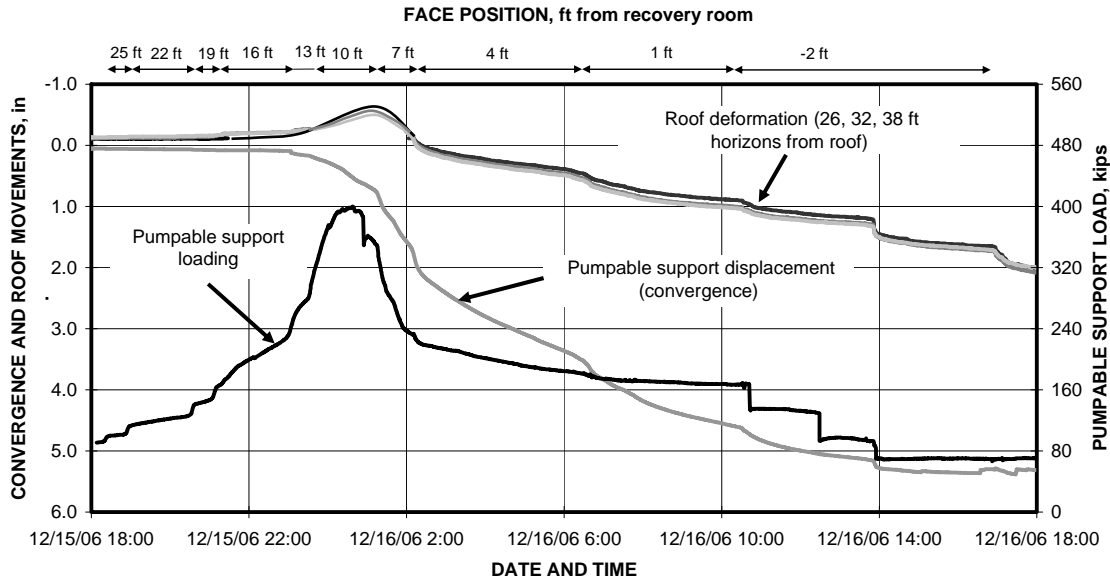
Figure 12. Roof deformations and convergence profile during pumpable support loading and failure.

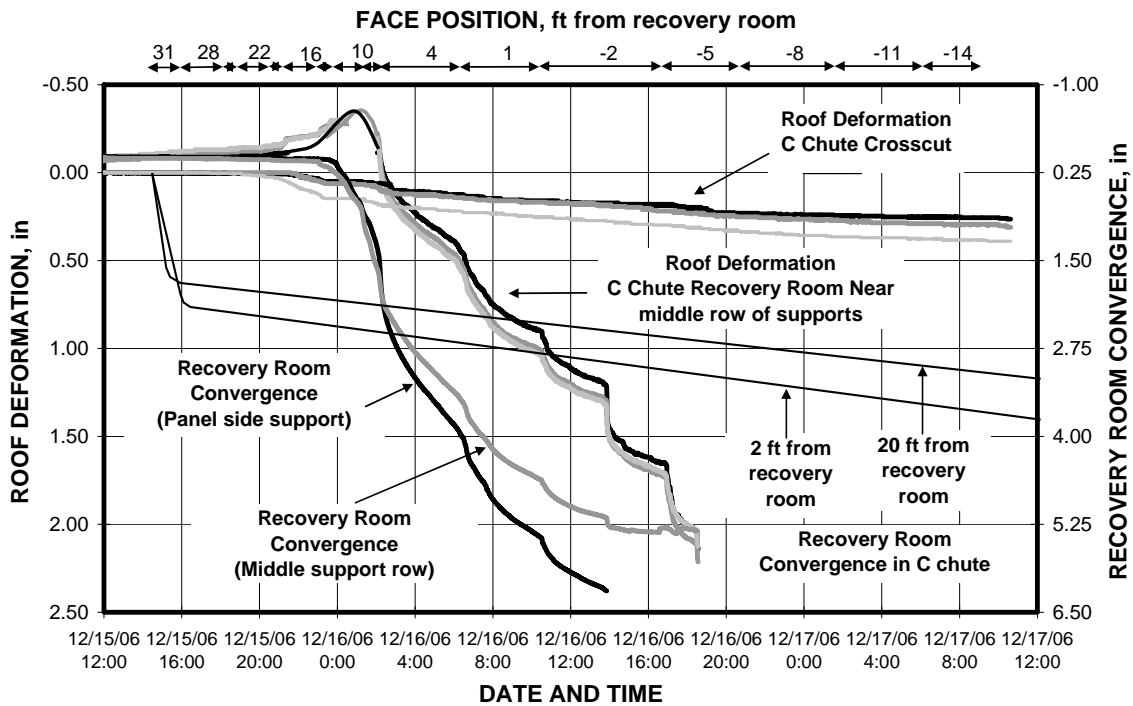
Figure 13. Convergence and roof deformation profiles in C Chute area of recovery room.

locations from the edge of the recovery room, remained fairly constant during this process. The roof continued to deform slightly in the chute as measured by a three-point extensometer in the center of the entry located 16 ft from the outby edge of the pre-driven recovery room, but the deformations were nearly an order of magnitude less than that seen in the recovery room. An additional 1 in of closure occurred for a distance of about 20 ft in the C chute crosscut as measured by electronic closure meters measuring roof-to-floor displacement (see figure 13).

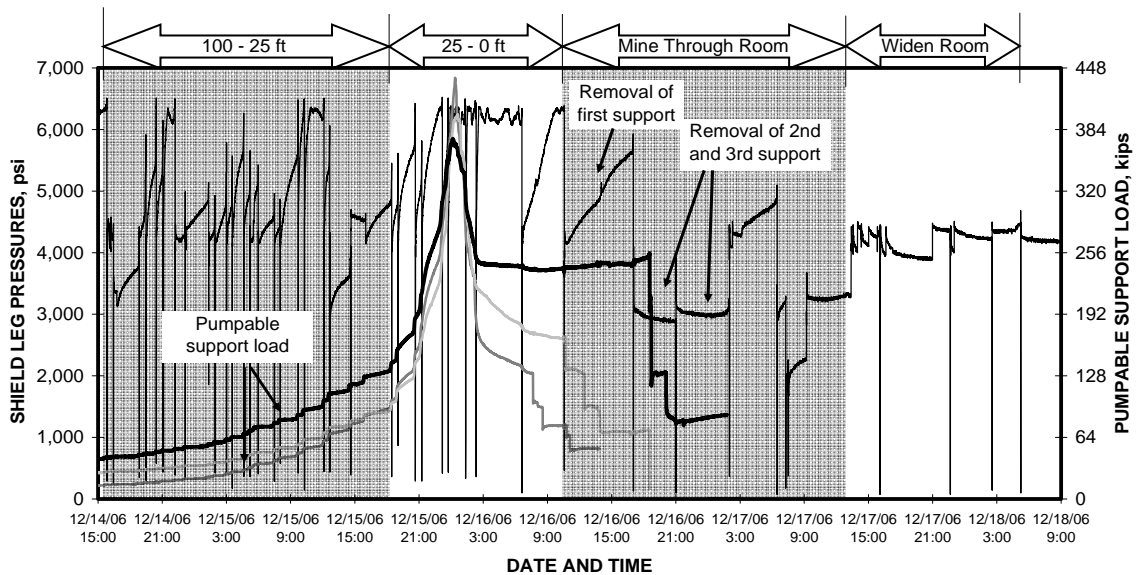
Figure 14. Shield loading decreased as the pumpable supports were extracted from the longwall recovery room.

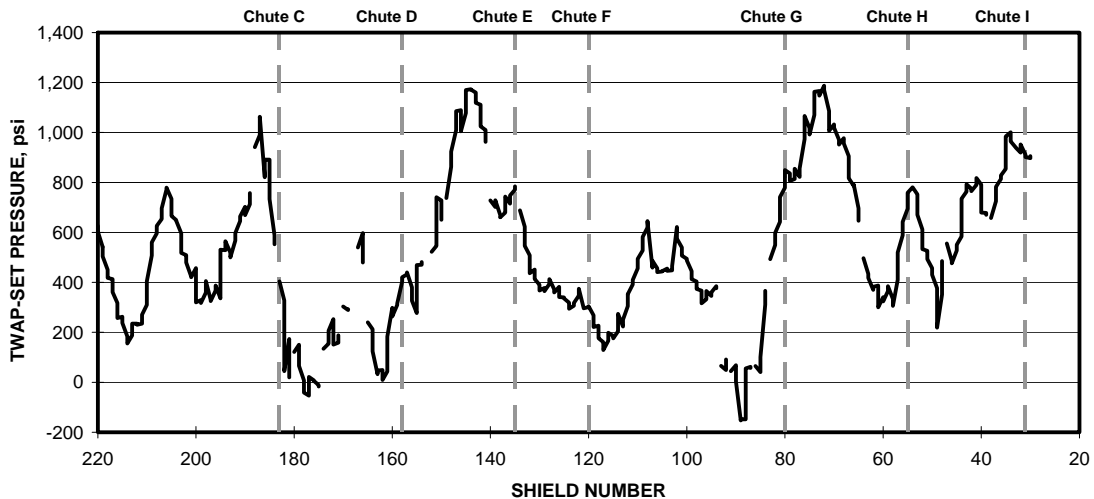
Figure 15. Shield loading was low but did vary across the face during and after the extraction of the pumpable supports.

The time-weighted average shield pressure varied across the longwall face during the phase of mining in which the supports were cut out and the face was advanced through the pre-driven recovery room. This is shown in figure 15, which plots the change in shield loading (difference between the time-weighted average pressure and the setting pressure), as the last row of supports were being extracted and the face advanced to the pillar line. The shield loading at some locations was considerably higher than that observed at the three instrumentation sites. One example is shown in figure 16, where shield number 185 yielded on all cycles during the extraction of the pumpable supports and advancement through the pre-driven recovery room compared to shield 175 which had little change in loading during and following the extraction of the last row of supports. There was no obvious visual physical difference in the recovery room condition. Without

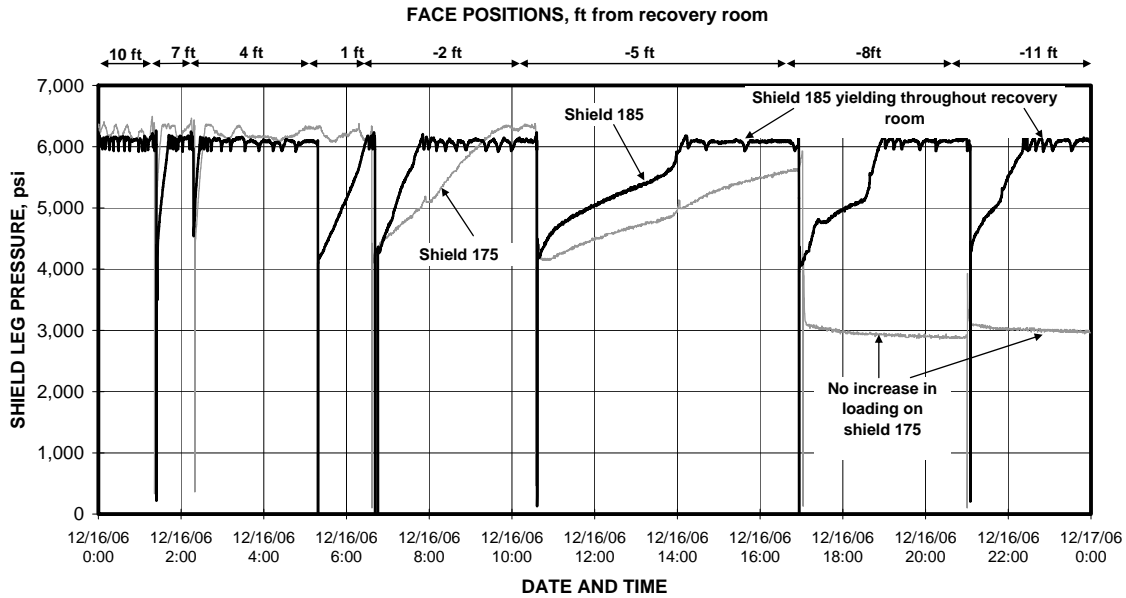
Figure 16. Comparison of two shields, one with high shield loading and one with low shield loading, during and after pumpable support removal.

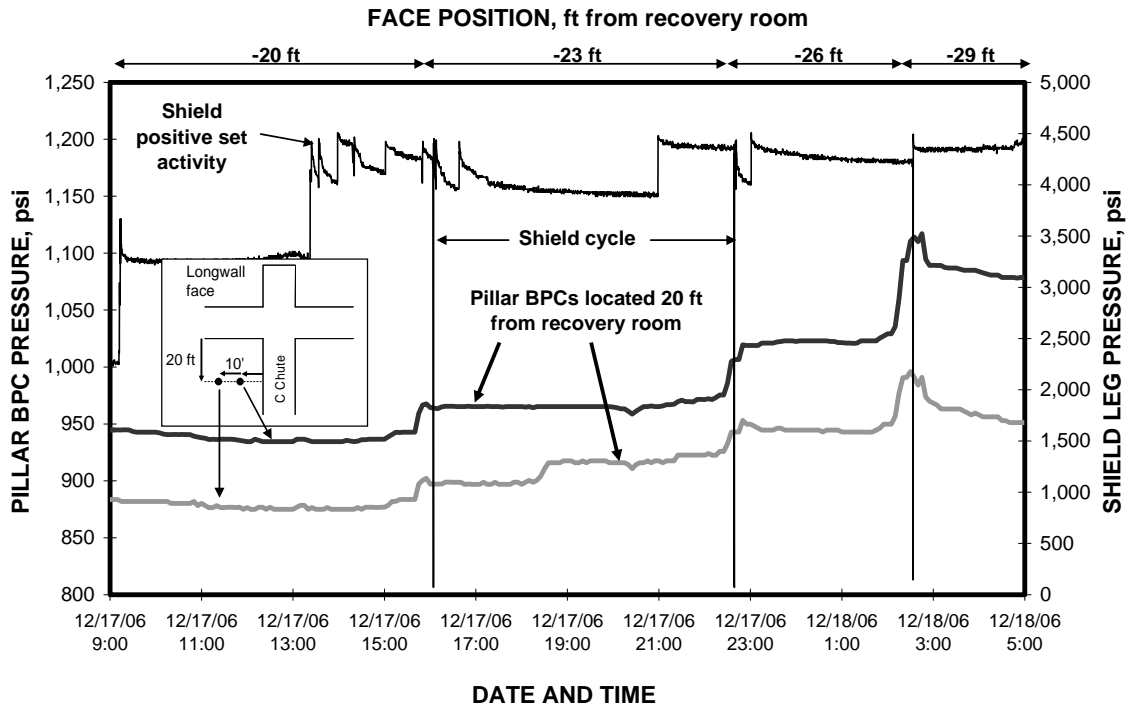
Figure 17. Outby pillar pressure cells show effects of shearer advance as pillar is extracted to widen room.
