Using Infrared Imaging to Evaluate Bond Uniformity in Si Structures: JPL Meso-Gyro Failure Analysis Study

Joanne Wellman, Karl Yee, – *Jet Propulsion Laboratory, Pasadena, CA*

November 30, 2002

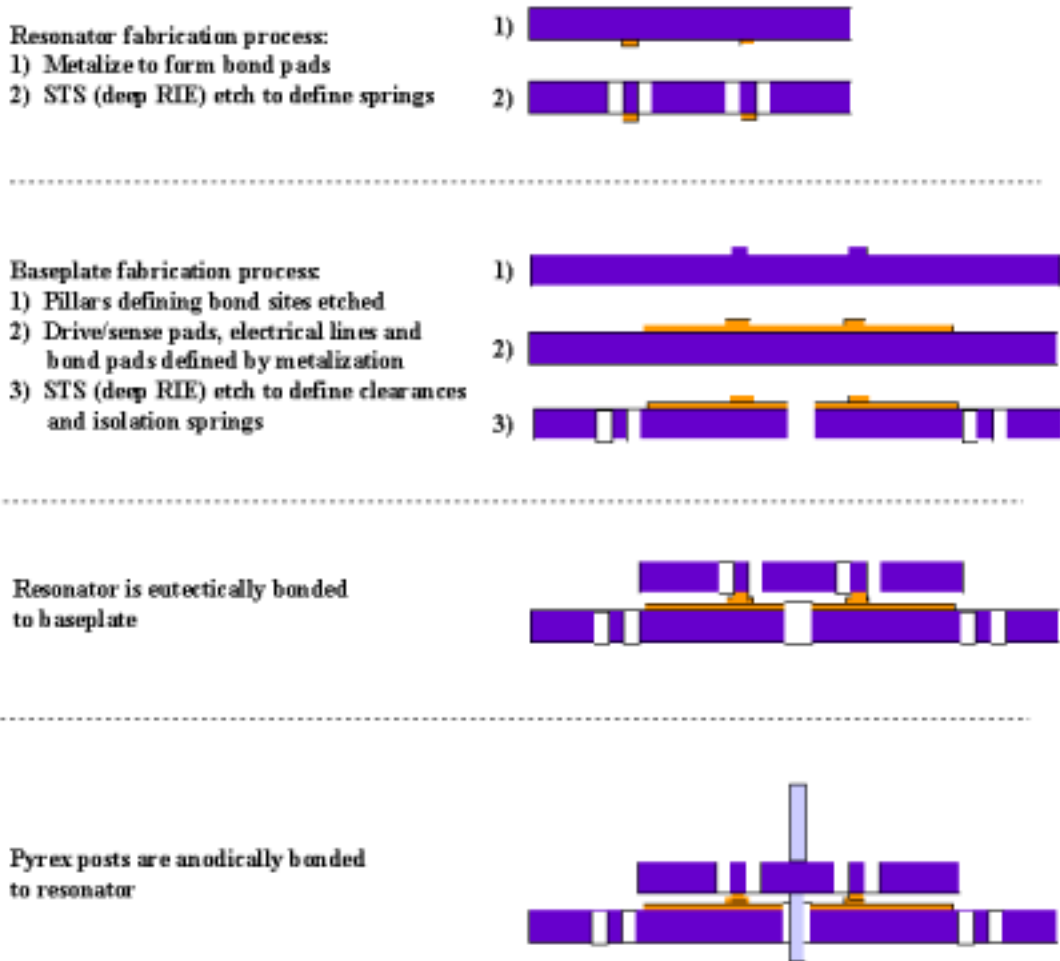
Figure 3. JPL Meso-gyro fabrication process.

The sensor part of the meso-gyro is fabricated using standard bulk micro-machining techniques. Two silicon wafers (the resonator and the baseplate) are wet etched and plasma etched to define the geometry of the gyro. They are then metalized to form the drive and sense pads, the electrical lines and the bond pads. The resonator and base plate are then bonded together at four points, which are the only points of contact between the resonator and base plate. (This resonator/base plate bond is the interface of interest in the infrared imaging study.) Pyrex posts are then anodically bonded to the top and bottom of the resonator. The Pyrex posts are the part of the gyro that couples to the Coriolis force. The fabrication process is illustrated in Figure 3.

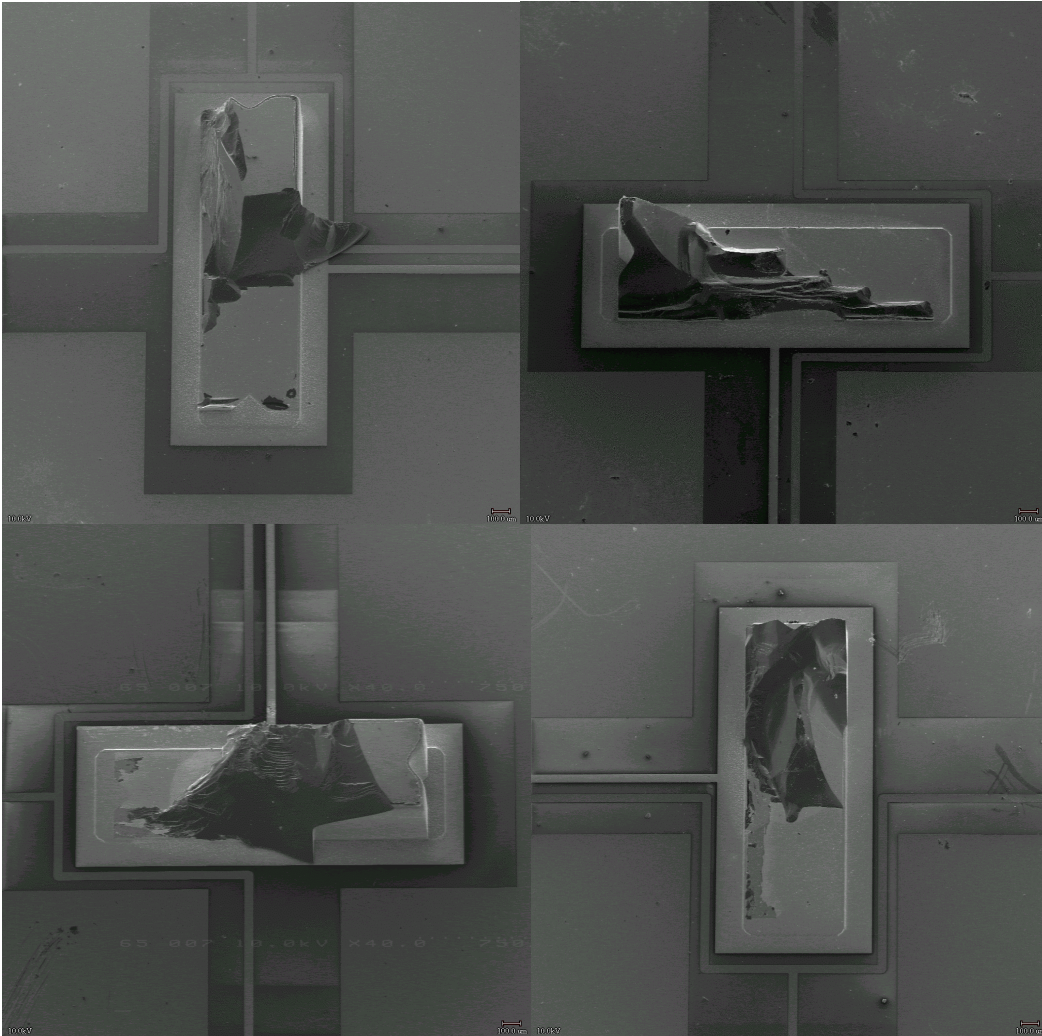
Shown below in Figure 7 are SEM micrographs of the bond sites of a typical, early design meso-gyro, where the resonator and baseplate have been pulled apart. The results clearly show that a significant fraction of the bond pad area is not successfully bonding. Complementary EDS analysis showed that the seemingly unbonded areas are primarily gold; thus, one can conclude that the bond failure occurred at the gold to gold interface between the resonator and baseplate.

Figure 7. 40x magnification SEM micrographs of the four baseplate bond pads after removal of the resonator plate

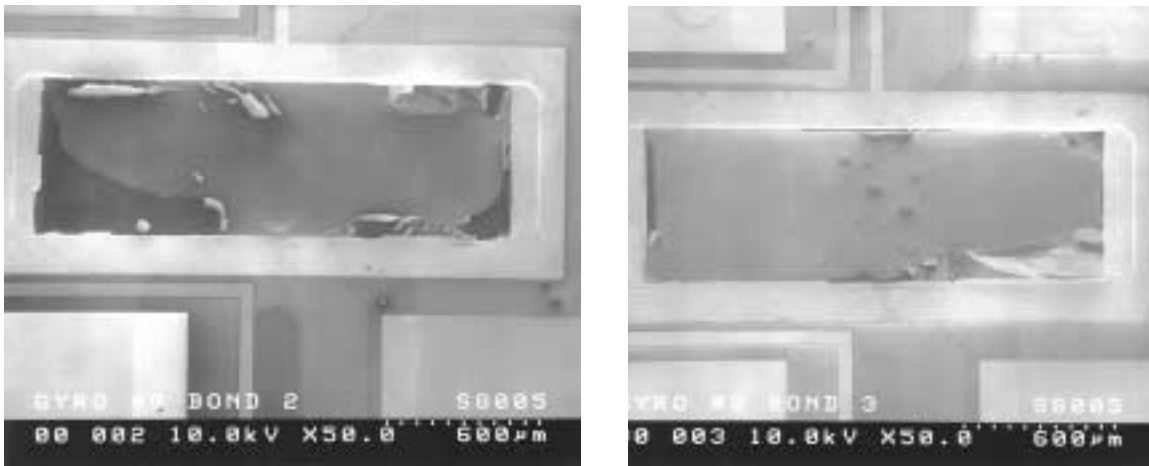
Initial eutectic bonding results for the meso-gyro were poor; IR imaging showed promise in revealing this. Figure 12 shows SEM micrographs of baseplate bond pads on an early eutectic bond attempt. This particular sample exhibited total bond failure (the resonator and baseplate fell apart when dicing was attempted to get access to the bond sites). The relatively smooth surfaces are indicative of material flow. EDS analysis (Figure 13) showed that the failure of the bond occurred at the SiO_2 interface of the baseplate. Figure 14 shows the IR images of the same sample before dicing was attempted. The data was taken after initially cooling the samples, then monitoring the evolution of temperature gradients as the samples were brought to room temperature. Apparent in the images is the existence of structure primarily at the periphery of the bond pads, indicative of bonding taking place only over a very small region.

Figure 12. SEM micrographs of bond pads of initial eutectic bond attempt
