MNMM Fatal 2008-14

- Machinery Accident
- August 18, 2008 (Pennsylvania)
- Crushed Stone Operation
- Contractor Welder
- 28 years old
- 8 years experience

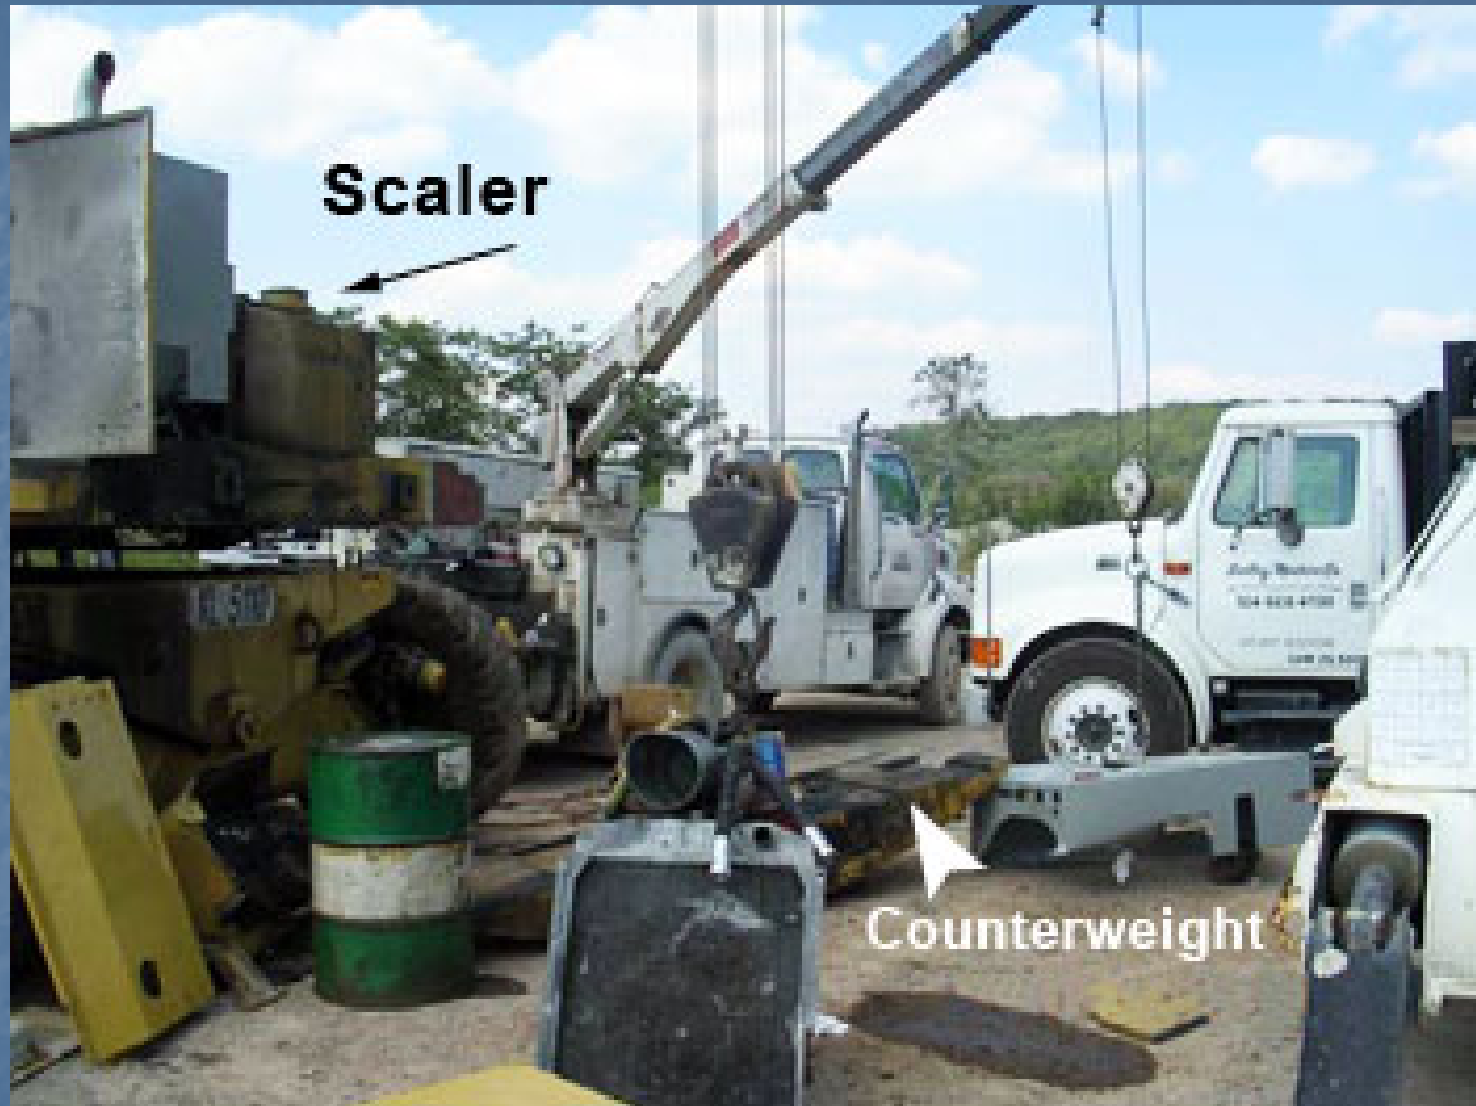
The victim was fatally injured when while helping to install a 7,000 pound counterweight on a mine scaler. The chain being used to lift the counterweight failed, causing the counterweight to fall and strike the victim.

Scaler

Counterweight

- A risk assessment to determine potential hazards and to establish safe work procedures was not conducted prior to lifting the 7,000 pound counterweight.
- Management policies, procedures, and controls were inadequate and failed to ensure that the chain, attached connectors, and rigging, were examined prior to lifting the counterweight.
- Management policies, procedures, and controls were inadequate and failed to ensure that proper training regarding lifting suspended loads was provided to all persons before performing the task.

- Establish and discuss safe work procedures. Identify and control all hazards to finish the job safely.
- Train all persons to recognize and understand safe procedures to perform tasks before beginning work.
- Keep all persons clear of suspended loads.
- Use sling or chain assemblies (rigging) specifically intended for lifting and adequately rated for the loads being lifted.
- Carefully inspect all rigging prior to each use.
- Properly attach or rig slings, chains, and hooks.
