Damage Survey Report

Central and Southern Oklahoma Tornadoes of 11 April 2001

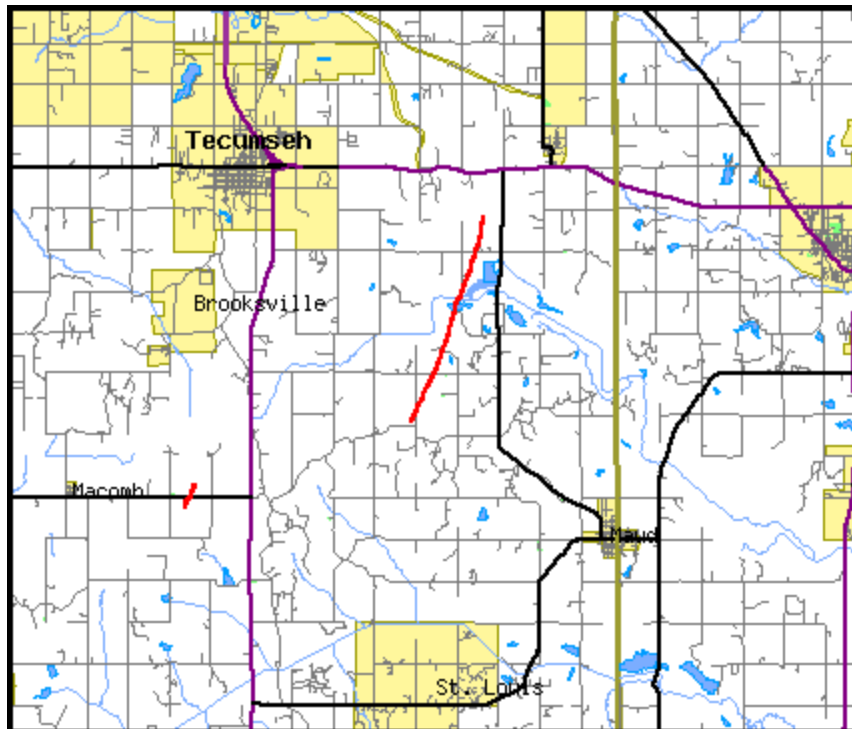
Figure 2: Detailed path map of Tornado 1, Pottawatomie County, OK (Inset 1 from Figure 1). The red line indicates path of the tornado. The red slash 3 miles east of Macomb indicates the location of non-tornadic wind damage. No photographs of the damage were available for this report.

Tornado 1: Began 4 miles northwest of Maud, OK, at approximately 200 AM CDT (0800 UTC). Dissipated 1.5 miles north-northwest of Harjo, OK, at approximately 206 AM CDT (0806 UTC). A detailed path map of Tornado 1 can be seen in Figure 2. This tornado caused structural damage to oil pumping and storage equipment approximately 2 miles southwest of Harjo, and caused structural damage to trailer homes 1 mile west of Harjo. Damage to the oil pumping and storage equipment justifies an F1 rating.

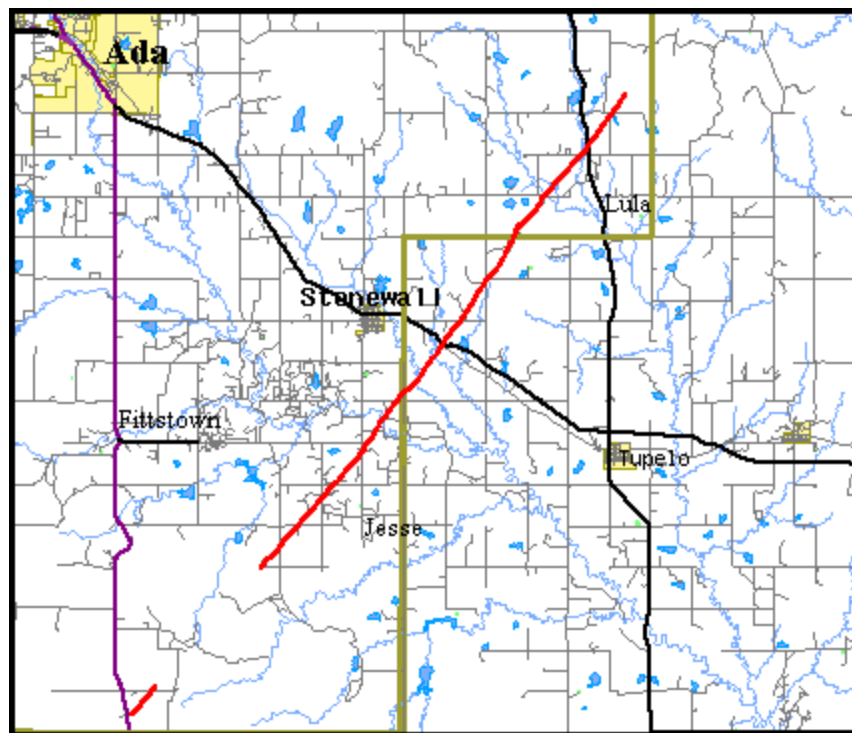
Figure 3: Same as Figure 2, except for Tornado 2, Pontotoc County/Coal County, OK. (Inset 2 from Figure 1). The long red slash 6.5 miles south of Fittstown indicates the location of non-tornadic wind damage.

Tornado 2: Began 2.5 miles west-southwest of Jesse, OK, at approximately 440 AM CDT (0940 UTC). Dissipated 2 miles north-northeast of Lula, OK, at approximately 505 AM CDT (1005 UTC) after moving across the extreme northwest part of Coal County, and then back into extreme southeast Pontotoc County. A detailed path map of Tornado 2 can be seen in Figure 3. This tornado may have been the strongest tornado of the event. The most impressive damage occurred from just west of Jesse, northeastward across far northwest Coal County, to just southwest of Lula, once again in Pontotoc County. 1.5 miles west of Jesse, a mobile home and barn were destroyed and power poles downed. The mobile home was picked up, thrown northward over a fence, and completely broken apart with contents spread over a half-mile area. 1 mile west and 3/4 mile north of Jesse, a barn was destroyed, two oil storage tanks were overturned and smashed, power poles were downed, fences were downed, and extreme tree damage occurred. 3/4 mile west and 1 mile north of Jesse, oil storage tanks were overturned, an oil pumping unit was overturned and torn apart, power poles were downed, severe tree damage and grass scouring occurred. In Coal County, 1.5 miles south and 1 mile east of Stonewall, three power transmission towers for major trunk power lines were downed. 3 miles east and approximately 1 mile north of Stonewall, a one-mile section of transmission towers (16 towers) were downed. According to power company repair crews, the towers were engineered to withstand 125 mph wind speeds. Additional power transmission towers were downed, and substantial damage to a power substation occurred about 1 mile southwest of Lula, back in Pontotoc County once again. The magnitude of the damage to the power transmission towers, power substation, and oil drilling and storage equipment in these areas justifies a solid F2 rating.

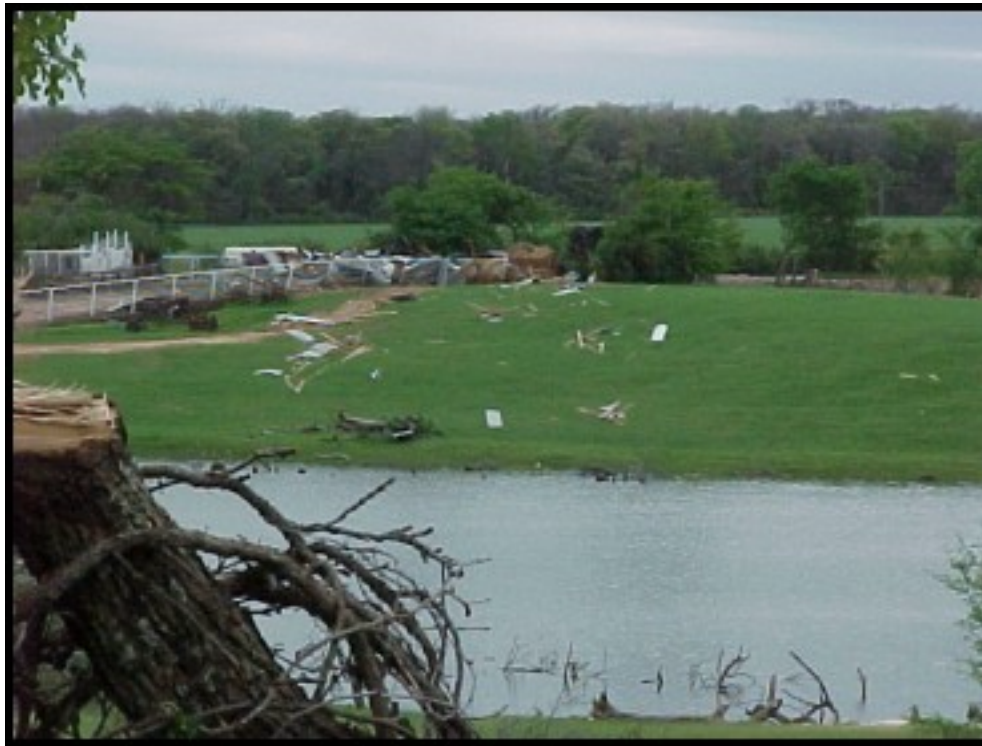
Picture 1: Looking southwest. A barn was destroyed. Just northeast of this location, a mobile home was severely damaged. Debris was scattered about 2 miles downstream to the Red River. (See Figure 4 for location of picture).

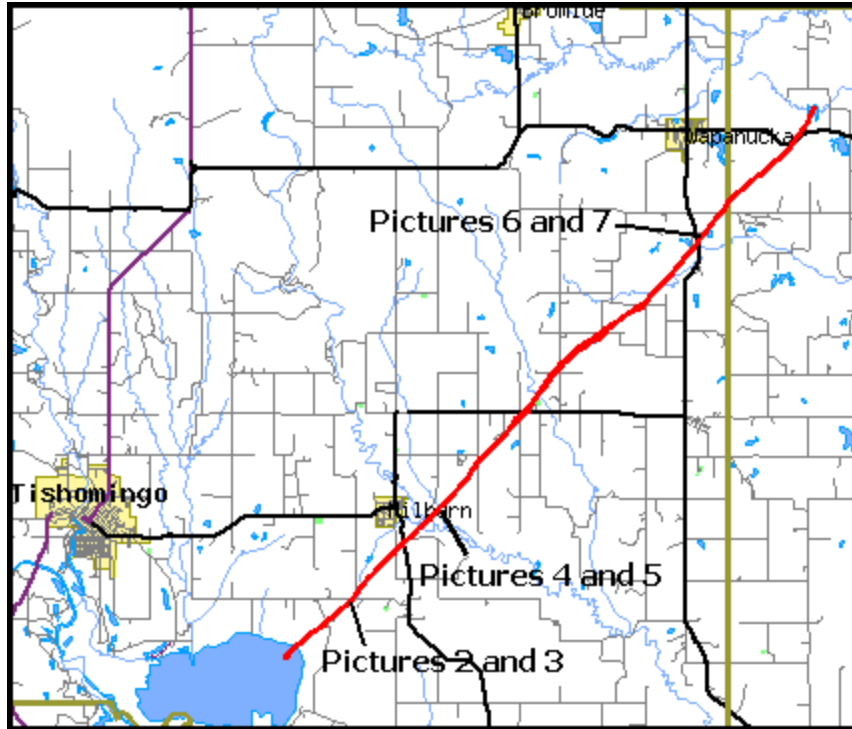
Figure 5. Same as Figure 2, except for Tornado 4, Johnston County/Atoka County, OK (Inset 4 from Figure 1). Annotation indicates the locations for Pictures 2, 3, 4, 5, 6 and 7.

Tornado 4: Began over the far northern extension of Lake Texoma, 6 miles southeast of Tishomingo, OK at approximately 445 AM CDT (0945 UTC). Dissipated 3 miles east-northeast of Wapanucka, OK, at approximately 510 AM CDT (1010 UTC). A detailed path map of Tornado 4 can be seen in Figure 5. The damage path of this tornado broadened, and damage intensity weakened, over southeast Johnston County about 6 miles southwest of Wapanucka for a distance of approximately 3 miles before the tornado re-intensified and the path width narrowed again, just to the west of Highway 48 south of Wapanucka. This evidence suggests that it is possible that the storm made an attempt at cyclic tornadogenesis during this time. However, since there was no obvious break in the damage seen through this part of the path from either the ground or aerial survey, this event is classified as one continuous tornado. Two injuries, both requiring hospital care, occurred when a mobile home was flipped over and destroyed about 5 miles east of Tishomingo (see Pictures 2 and 3). According to information from Johnston County Emergency Management as of this writing, Tornado 4 destroyed 4 mobile homes and damaged or destroyed 21 other structures within Johnston County, including one business (see Pictures 6 and 7) and two churches. Total damage was estimated at \$2.5 million. Most of the damage was to manufactured, or sheet metal buildings, and thus generally of F1 intensity. However, damage to one home just east of Milburn (see Pictures 4 and 5) justifies an F2 rating.

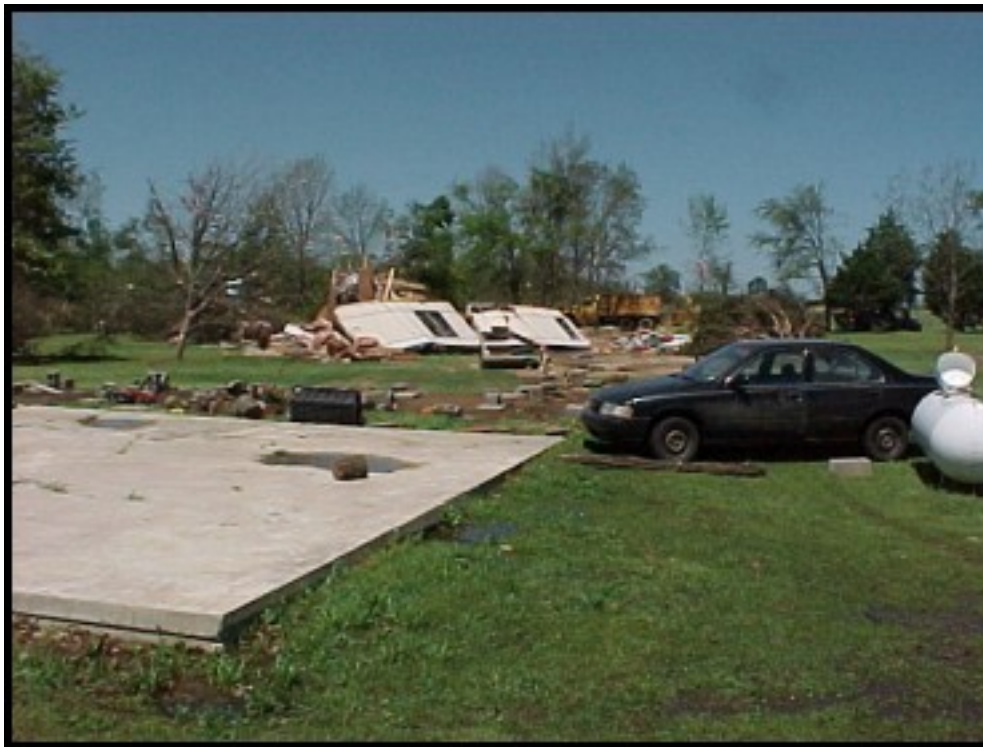
Picture 2: Looking north-northwest. A mobile home was lofted and deposited upside-down about 40 yards from its original location on the blocks just to the left of the automobile. Two injuries requiring hospitalization occurred at this location. Note the vehicle was not moved. (See Figure 5 for location of picture).

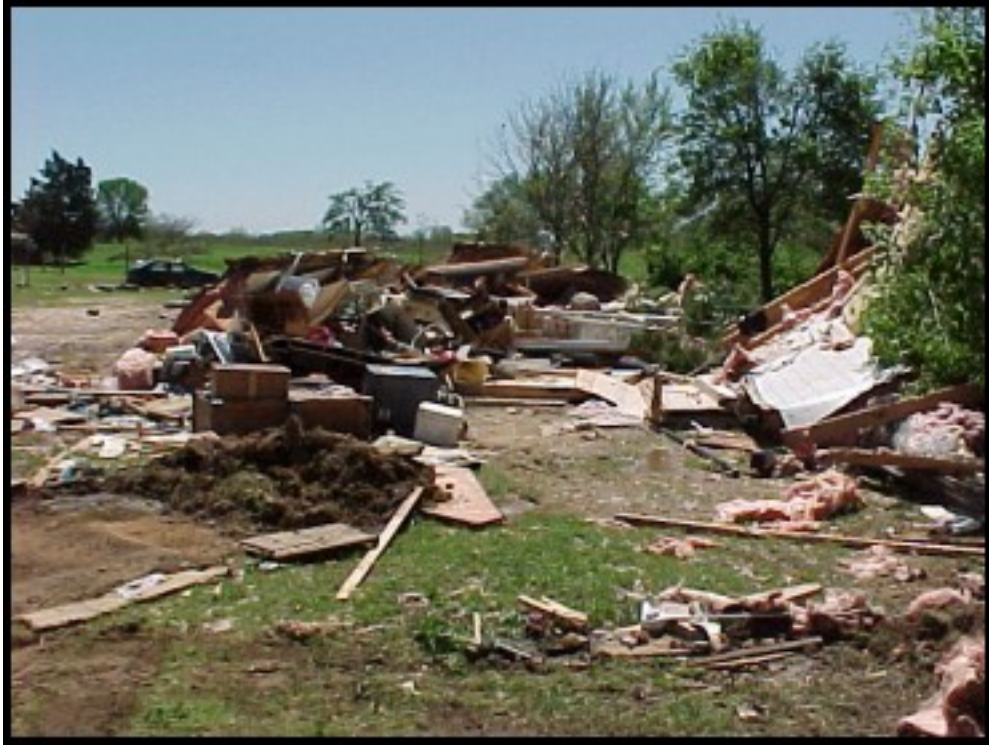
Picture 3: Close up view of the destroyed mobile home above in Picture 2. Looking south. (See Figure 5 for location of picture).

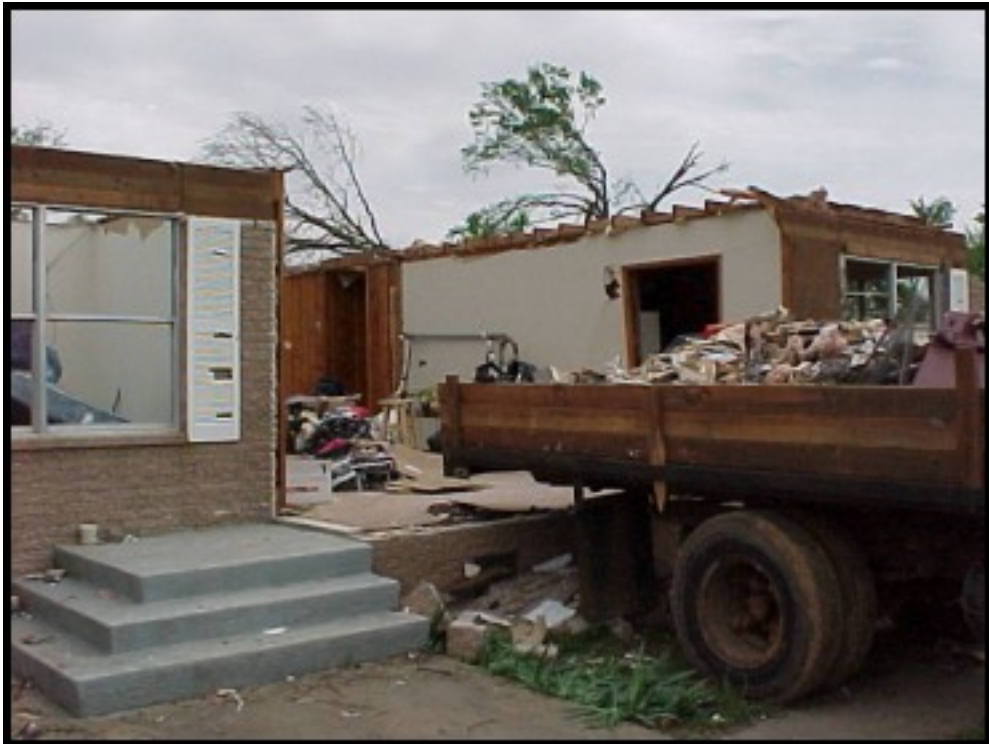
Picture 4: Looking northeast. A frame home was severely damaged 1 mile east of Milburn. The roof was completely removed, and portions of the front and rear walls of the structure were blown out. (See Figure 5 for location of picture).

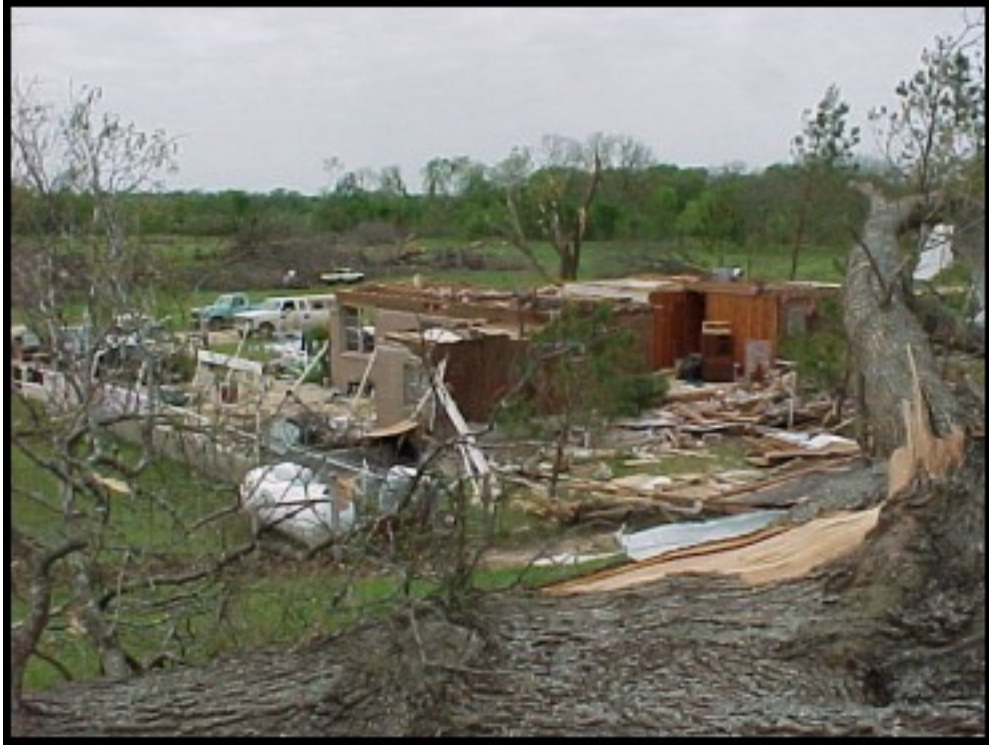
Picture 5: Another view of the same home as in Picture 4. Looking southwest. (See Figure 5 for location of picture).

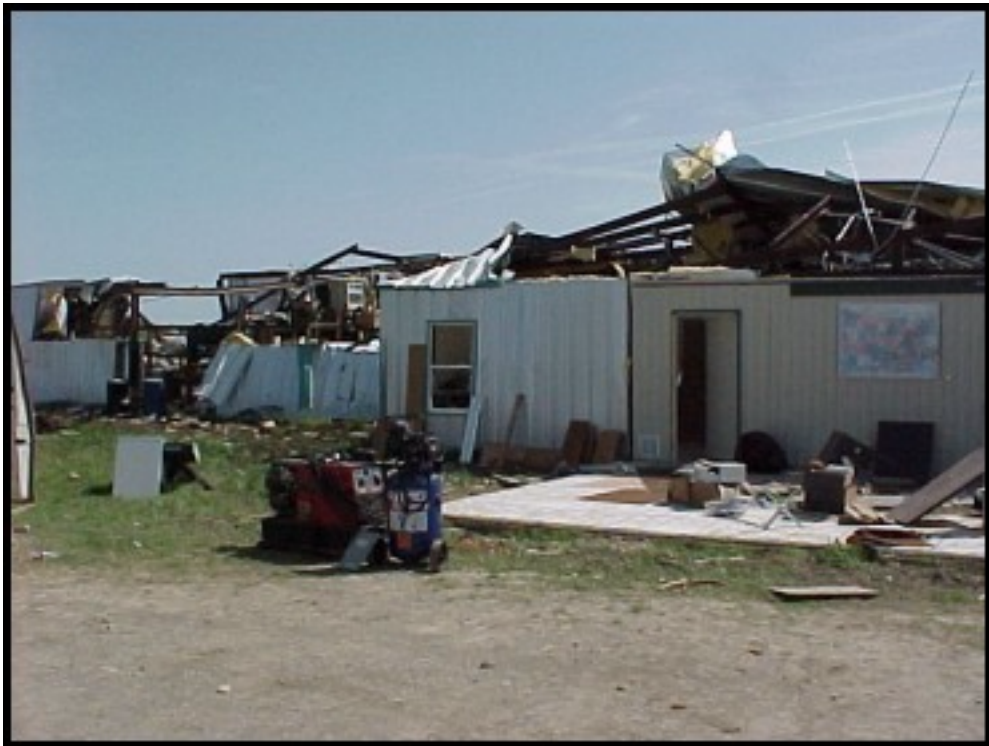
Picture 6: Looking northeast. Severely damaged business 2.5 miles south of Wapanucka. (See Figure 5 for location of picture).

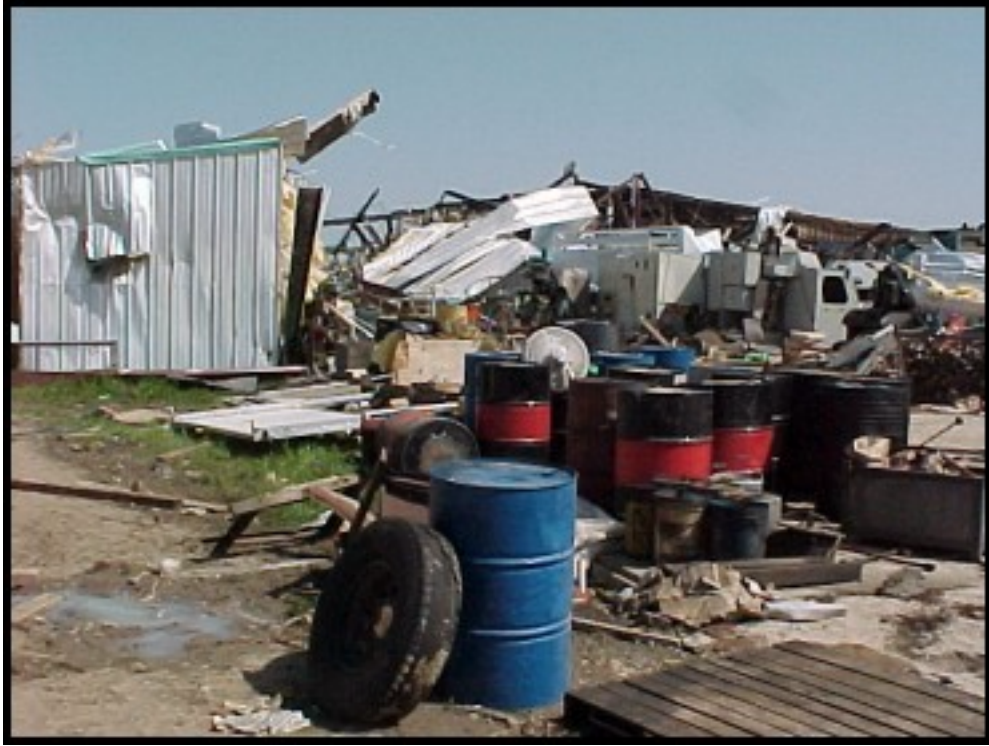
Picture 7: Another view of the same structure as in Picture 6. Looking east. Debris from this building was scattered for several miles to the northeast. (See Figure 5 for location of picture).

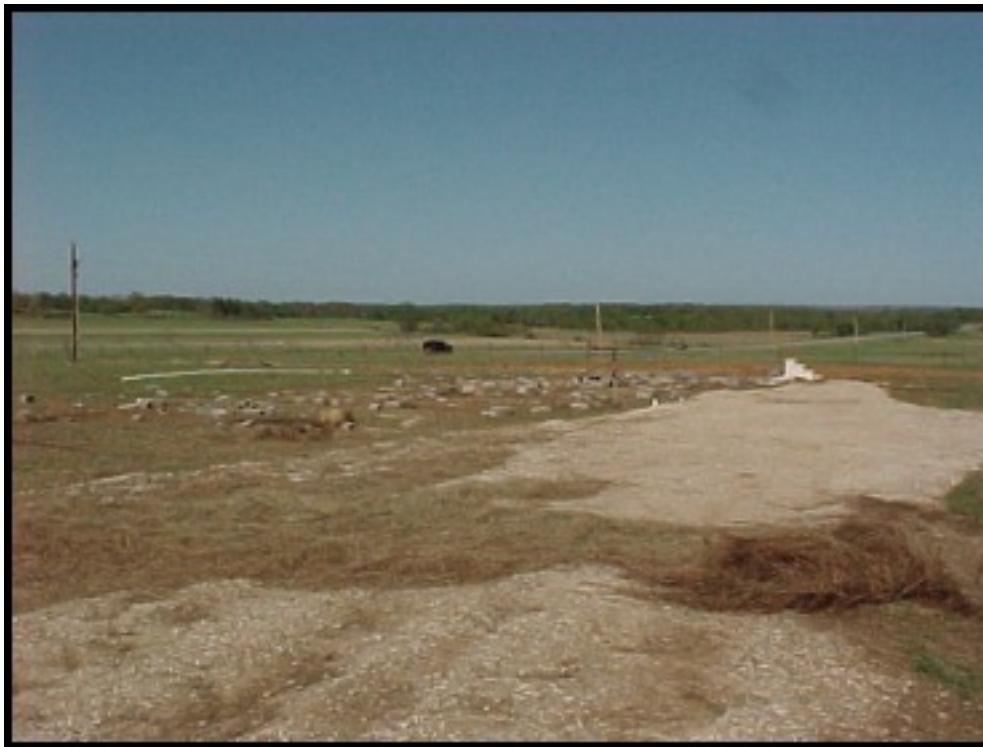
Picture 8: Former location of a completely destroyed mobile home 4 miles east of Coalgate, OK, looking east-northeast. One fatality, and minor injuries to another person, occurred at this location. (See Figure 6 for location of picture).

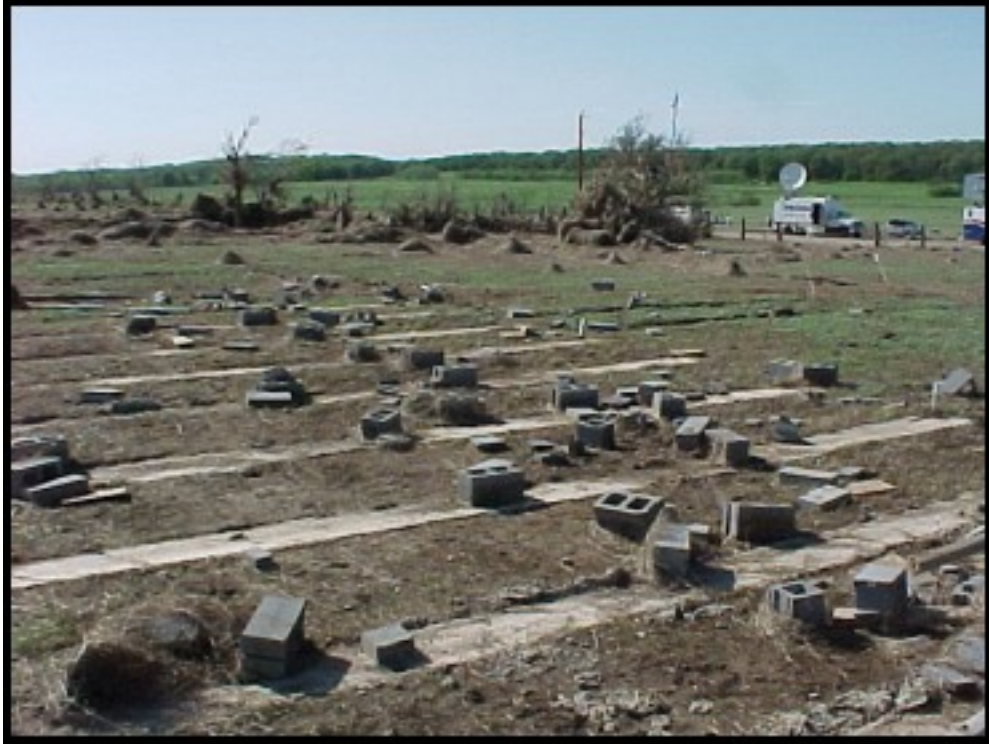
Picture 9: Close-up view of the same destroyed mobile home site as in Picture 8, except looking northwest. The only remnant of the mobile home was the steel beam frame, found approximately 200 yards to the northwest of the original home location. (In the field behind, and to the left of, the television satellite truck in the background of this photograph.) (See Figure 6 for location of picture).

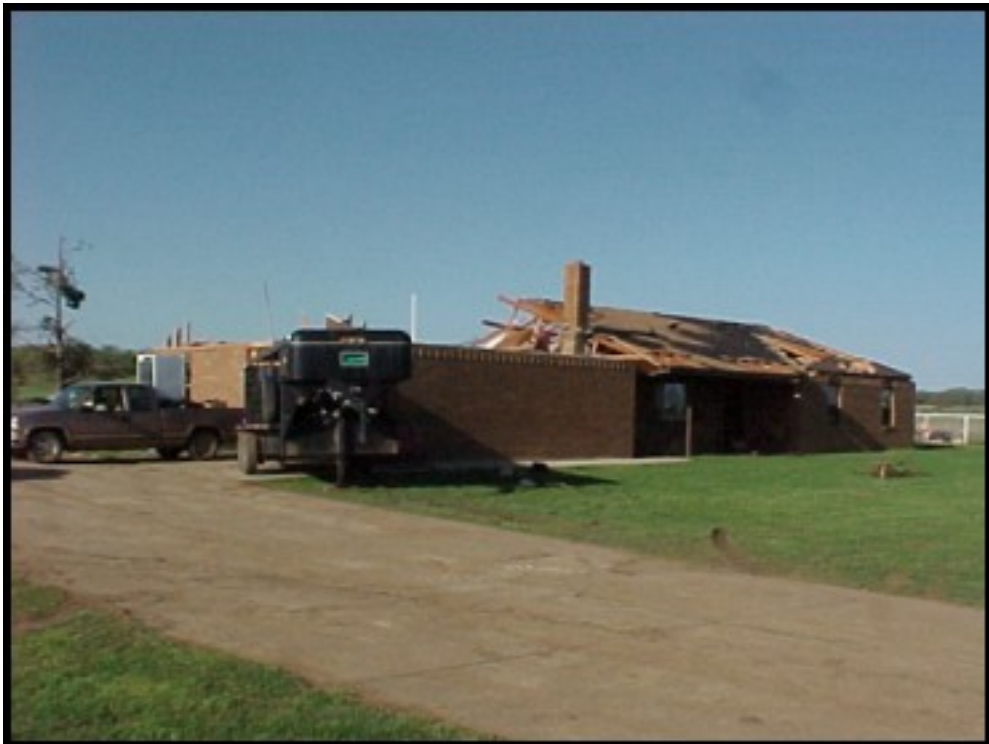
Tornado 5: Began 3 miles southeast of Coalgate, OK, at approximately 525 AM CDT (1025 UTC). Dissipated 1 mile northwest of Wardville, OK, at approximately 540 AM CDT (1040 UTC). A detailed path map of Tornado 5 can be seen in Figure 6. This tornado developed from a different circulation within the complex of thunderstorms than Tornado 2. The parent circulation exhibited a rapid intensification in radial velocity data from the Twin Lakes (KTLX) WSR-88D Doppler radar between 500 AM and 515 AM CDT (1000-1015 UTC). One fatality, and injuries to another person, occurred when a mobile home was destroyed 4 miles east of Coalgate (see Pictures 8 and 9). The mobile home was thrown approximately 200 yards and disintegrated. The only part of the mobile home still recognizable was the steel frame. A well-constructed frame home suffered severe roof and exterior wall damage in extreme eastern Coal County (see Picture 10). Damage to these two structures justifies an F2 rating.

Picture 10: Damage to frame home. Approximately half of the roof has been destroyed with minor damage to most of the exterior walls. Picture is looking northeast. (See Figure 6 for location of picture).
