# MOTOR COACH FIRES – ANALYSIS AND SUGGESTIONS FOR SAFETY ENHANCEMENT

DEKRA Automobil GmbH

Paper Number 05-0094

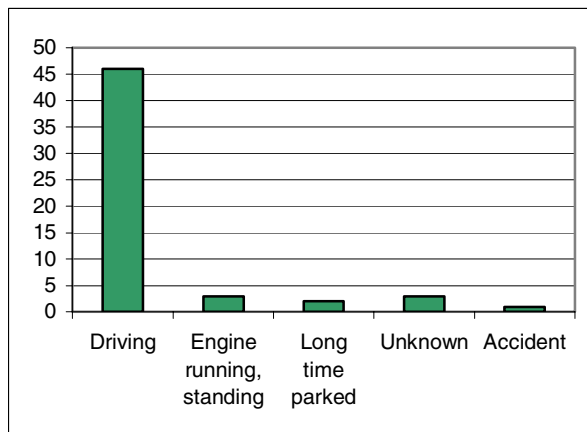
Most of the analysed fires started while the engine was running. In 46 (84%) out of 55 cases the coach was driving, in three other cases (5.5%) the coach was stationary with the engine running. This is of great importance for the risk estimation – these are the states of operation occupants may be on board. The operation status while ignition is shown in Figure 1.

**Figure 1 Operation status in the moment of ignition.**

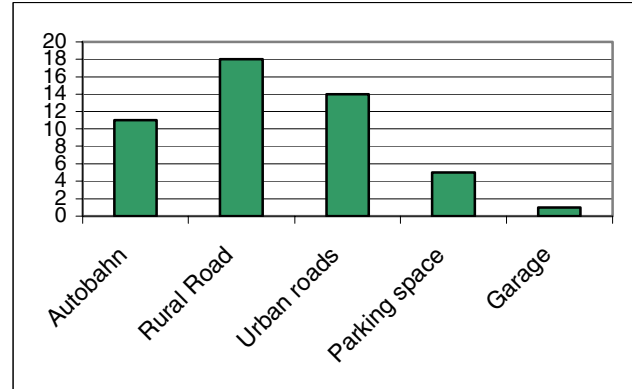
Taking a closer view to the locations the fires started, the urban roads and the rural roads are most frequently represented, followed by the Autobahns, Figure 2. Thus, it appears that the driven speed plays a subsidiary role. The engine temperature is of more importance. There was no ignition in the engine compartment while the engine was cold.

**Figure 2 Location of ignition.**

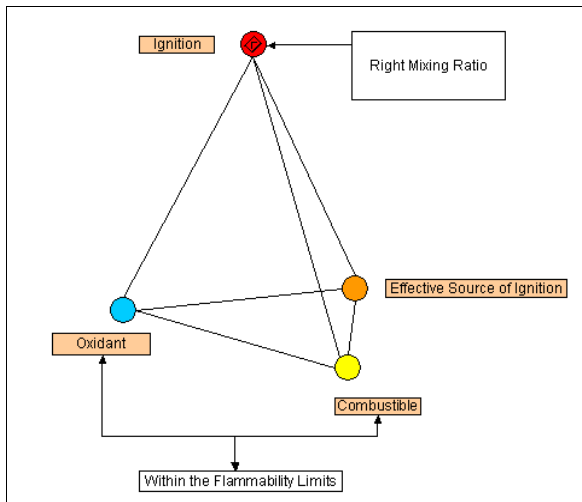
Figure 4 Ignition Tetrahedron based on Emmons

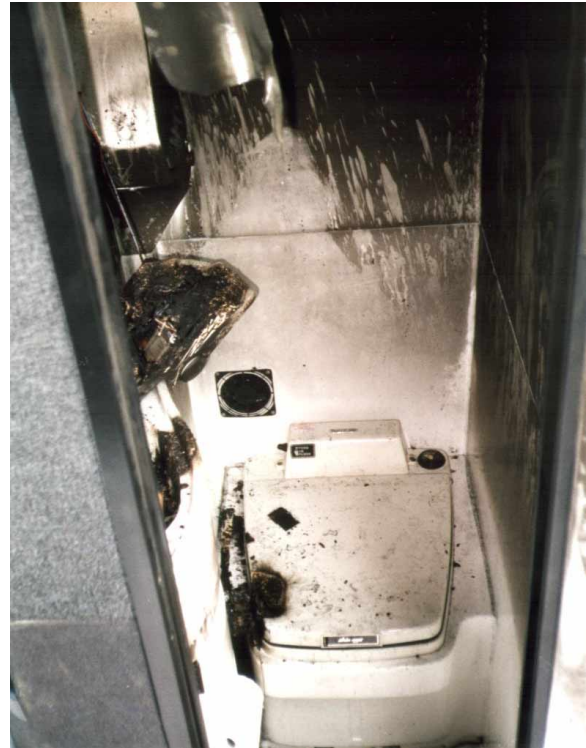
Exemplarily two cases are displayed here in the paper. In the first an electric defect of a hand-dryer led to a fire in a toilet of a parked coach. The plastic body of the dryer burnt, emitting large amounts of smoke. Moreover the plastic dropped on the floor burning. The close locking of the toilet’s door cut off the oxygen supply, the fire died down itself, Figure 5, and Figure 6.

Figure 5 Melted hand-dryer and smoke damage.

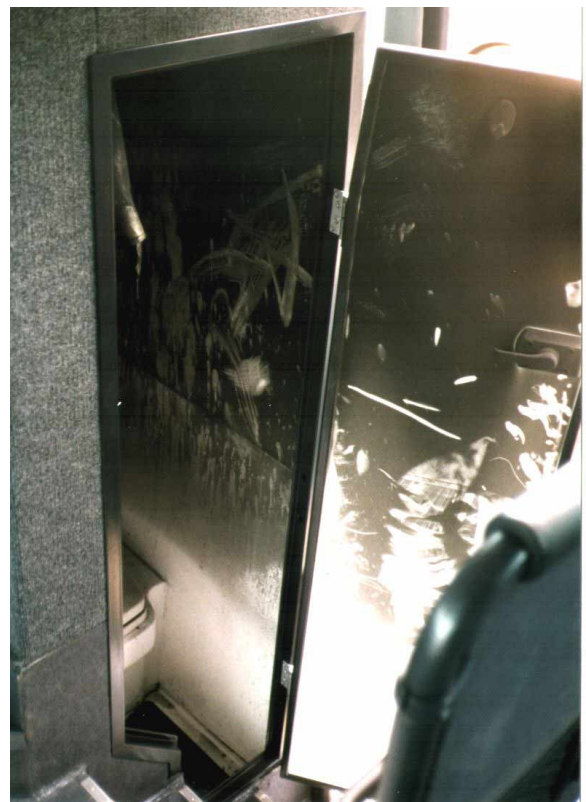
Figure 6 Toilet door with smoke-marks.

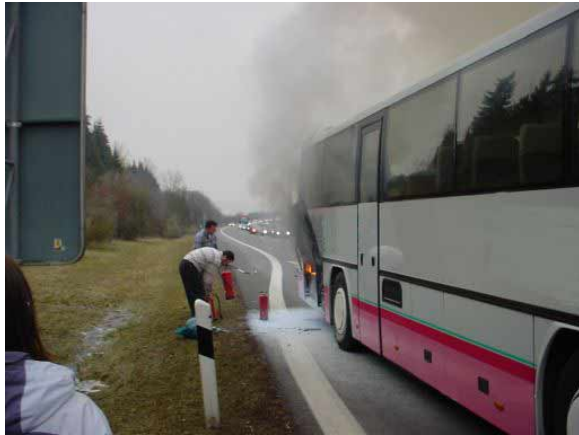
The fire was detected when the front door opened while driving on the Autobahn. After evacuating the coach, the driver tried to extinguish the fire, using the coaches fire extinguisher and two additional ones, made available by passing by truck drivers. Because of a lack of training in fire extinguisher handling the driver did not manage to put the fire out Figure 7.

**Figure 7 Driver's attempts to extinguish the fire [5].**

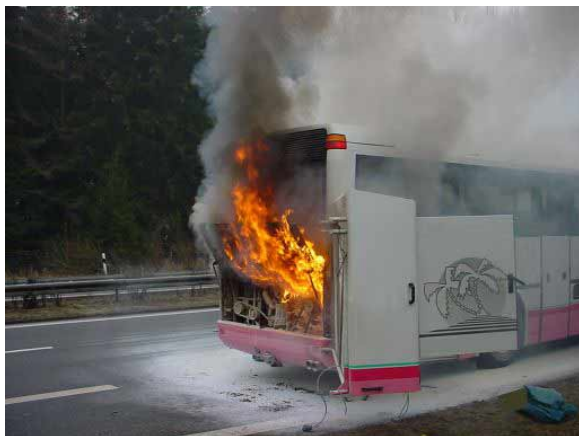
After turning away the attached luggage box, the engine fire spread very fast, the occupant compartment is already filled with smoke. Nevertheless some passengers re-entered the coach to get out personal belongings, Figure 8, Figure 9.

**Figure 8 Engine fire after turning away the luggage box [5].**

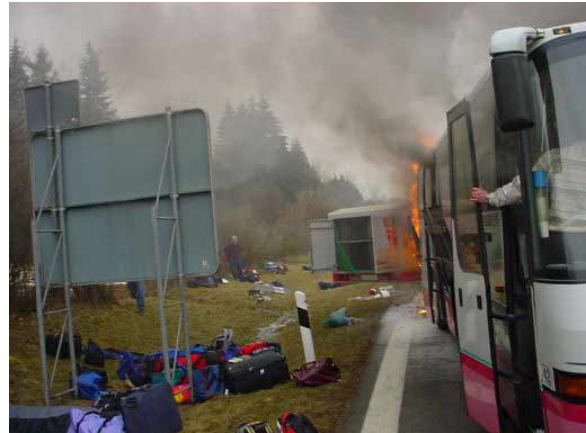
**Figure 9 Passengers re-entering the coach [5].**

Most passengers injured during the analysed fires have already been brought out of the bus, before they re-entered it to get out personal belongings. Hereby they sustained smoke intoxications. It is the bus driver's job to evacuate the vehicle completely and lead the passengers to a safe place. He additionally has to avert that anybody is re-entering the bus, expect for live saving measurements. The right behaviour in case of a fire needs to be an important point in the drivers education.

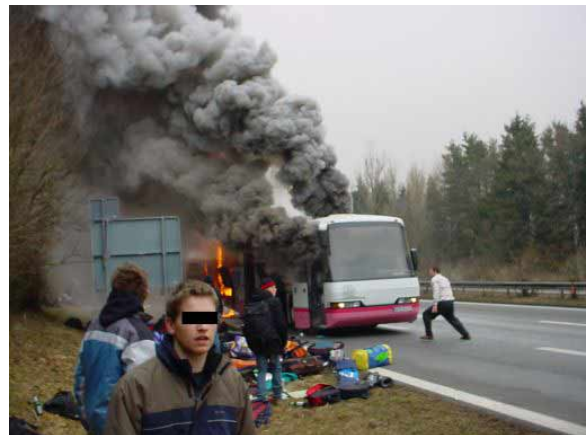
After about 10 minutes the rear part of the occupant's compartment is on fire, the whole compartment is filled with thick smoke, Figure 10. Less than one minute later a flashover sets the complete coach on fire, Figure 11. The thermal radiation heats up the luggage stored next to the bus, leading to a pyrolysis, Figure 12, and a self ignition, Figure 13.

**Figure 10 Fast fire spread, the complete coach is filled with thick smoke after about 10 minutes [5].**

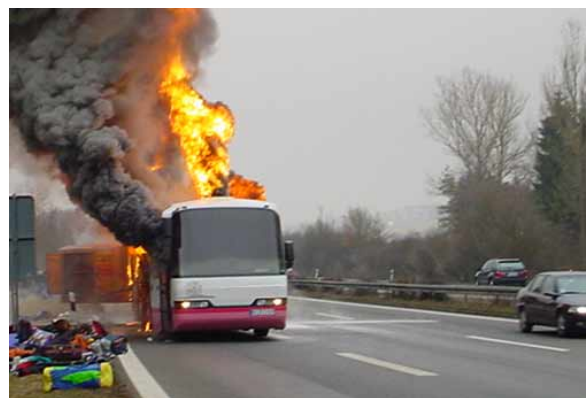
**Figure 11 Flashover [5].**

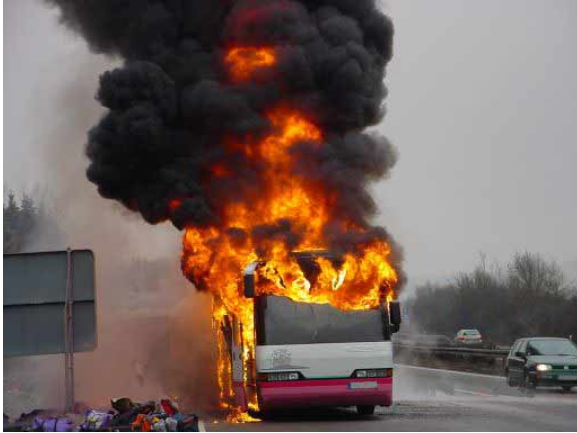
**Figure 12** Pyrolysis of the luggage stored besides the bus [5].

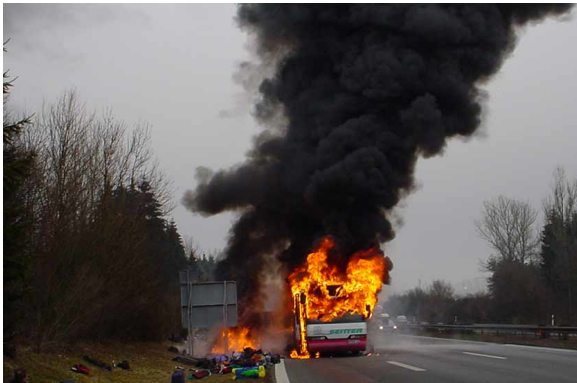
**Figure 13** Self ignition of the luggage [5].

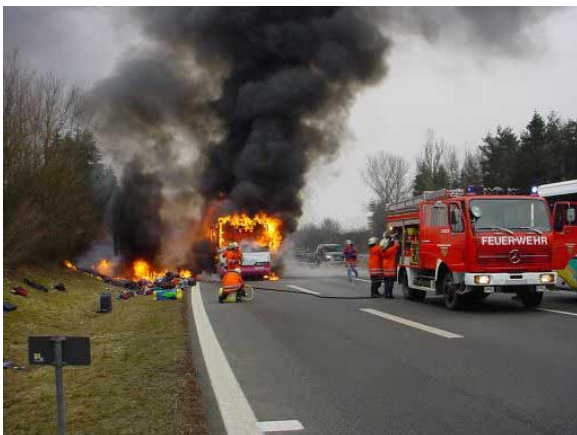
When the fire brigade arrived about 16 minutes after the detection of the fire, neither the coach nor the luggage could be rescued, Figure 14. The Autobahn has not been closed before the fire brigade arrived. The occupants have additionally been endangered by the running traffic.

**Figure 14** Arriving of the fire brigade after about 16 minutes [5].

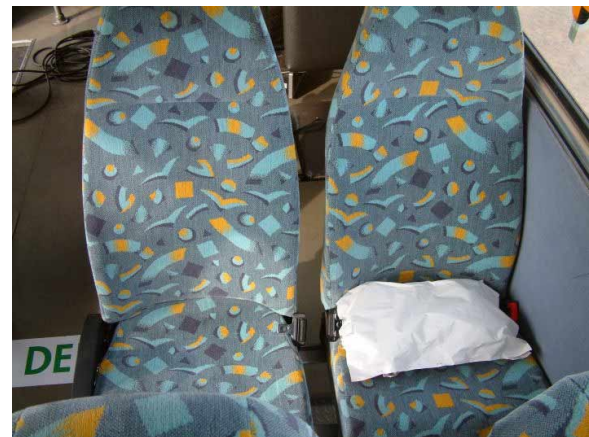
For the tests an old coach was equipped with different actual seats and an actual floor and wall lining. In the first step an on-seat-paper-cushion test was carried out. The seat passed that test explicitly. The first smoke detector, attached to the ceiling nearby the rear exit, set off after about two minutes, immediately after the seat started to emit smoke. The CO-concentration arose to 44 ppm in the fifth minute before declining again (AEGL-2 limit: 420 ppm, AEGL = Acute Exposure Guideline Levels, [17]). The HCN concentration reached the ETW-limit of 5 ppm but did not exceed it (ETW = Einsatz Toleranz Wert [18]). Both measuring points were located nearby the seat, an endangerment for occupants has not existed at any time, Figure 16 and Figure 17.

**Figure 16 Configuration of test 1 with paper cushion.**

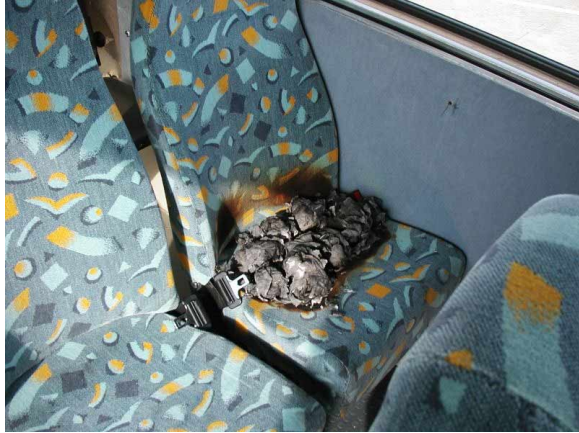
**Figure 17 Burnt down paper cushion.**

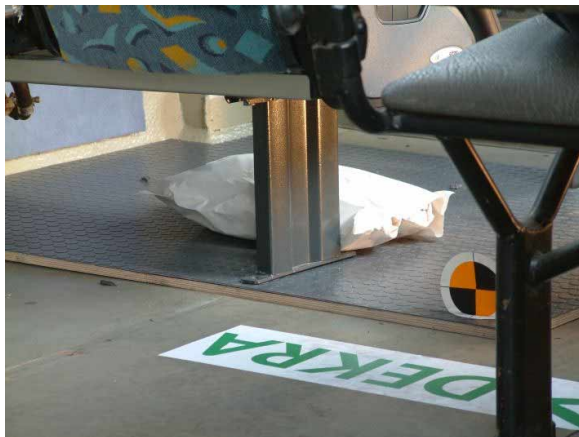
In the second test a paper cushion was placed under a seat. Also that test was passed by the seat explicitly. The thermal load of the floor-lining led to an enormous smoke emission. The CO-concentration climbed to uncritical 84 ppm, HCN could not be detected. The smoke emitted by the floor lining would have led to line-of-sight obstructions and irritations of the respiratory tract, Figure 18 and Figure 19.

**Figure 18 Configuration of test 2 with paper cushion.**

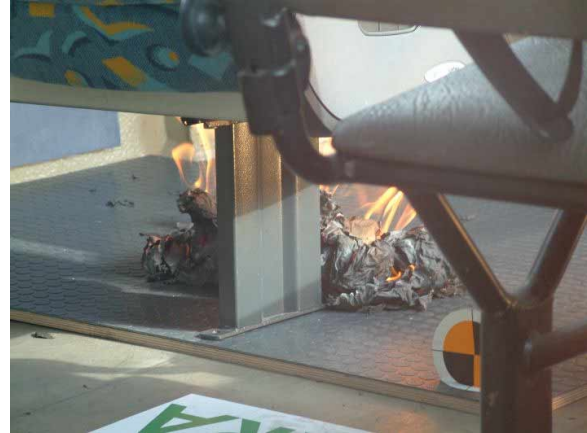
**Figure 19 Burning paper cushion.**

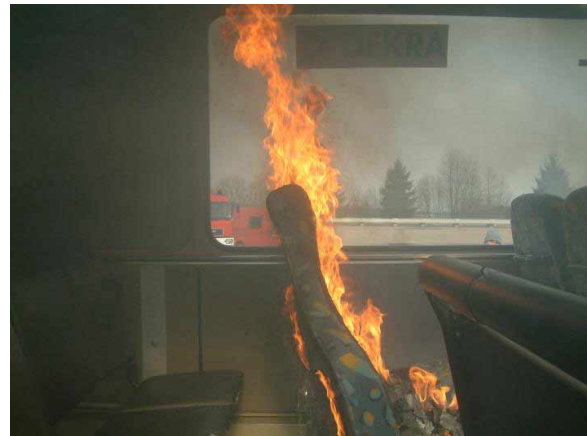
In a third test the seat was set on fire by using half a litre of fuel. The smoke alarm set off after just 16 seconds. The luggage rack started to burn with burning drops falling on the floor, igniting that. It took 44 seconds until the smoke filled the complete bus down to the upper edge of the backrests. The complete passenger compartment was filled with smoke after 160 seconds. A self-rescue was impossible after 84 seconds.

**Figure 20 Seat set on fire with 0,5l of fuel (t = 10s).**

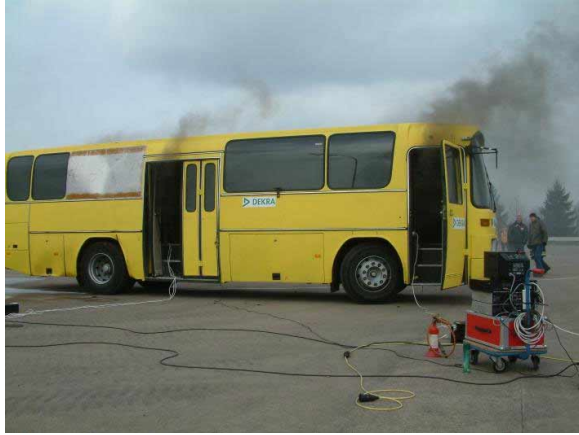
The coach was completely closed during the first 530 seconds after ignition to get further information about the influence of air ventilation. The flash-over started 70 seconds after opening the doors.

**Figure 21** Smoke-filled coach after opening the doors in second 530.

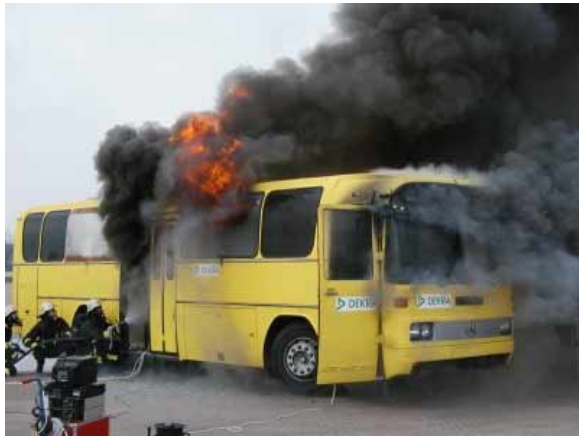
The maximal temperature was measured in the moment of the flash-over. The temperature at the ceiling reached nearly 1,000°C, Figure 20 to Figure 23.

**Figure 22** Flash-over and start of fire fighting (t = 600s).

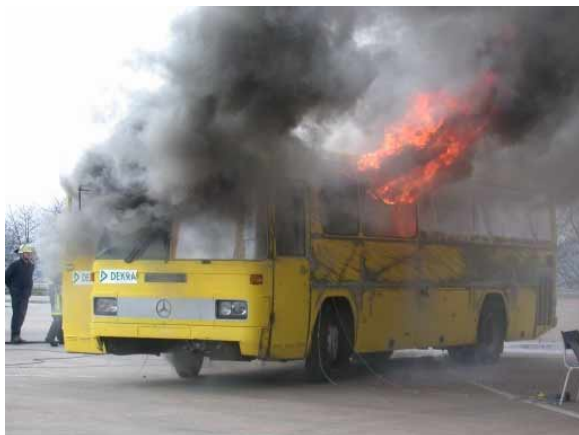
**Figure 23** Breaking of the side windows during the flash-over (t = 600s).

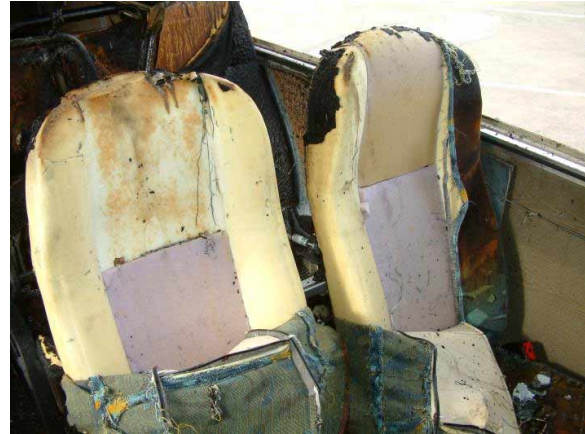
The very high level of fire performance of the tested seats was obvious after that test. The seats located in front of the ignited one had only received little fire

damage. That status could be documented by starting the fire extinguishing immediately after the flash-over, Figure 24.

**Figure 24** Seat row in front of the ignited seat. Covering removed by the fire brigade.
