Laboratory Scale Evaluation of Hydra-Tone Graff-Off™ Coconut Oil- Based Degreaser

**James R. Nutor and James K. Rose
Battelle
505 King Avenue
Columbus, Ohio 43201-2693**

**U.S. Environmental Protection Agency
National Risk Management Research Laboratory
Cincinnati, Ohio 45268**

February 28, 2001

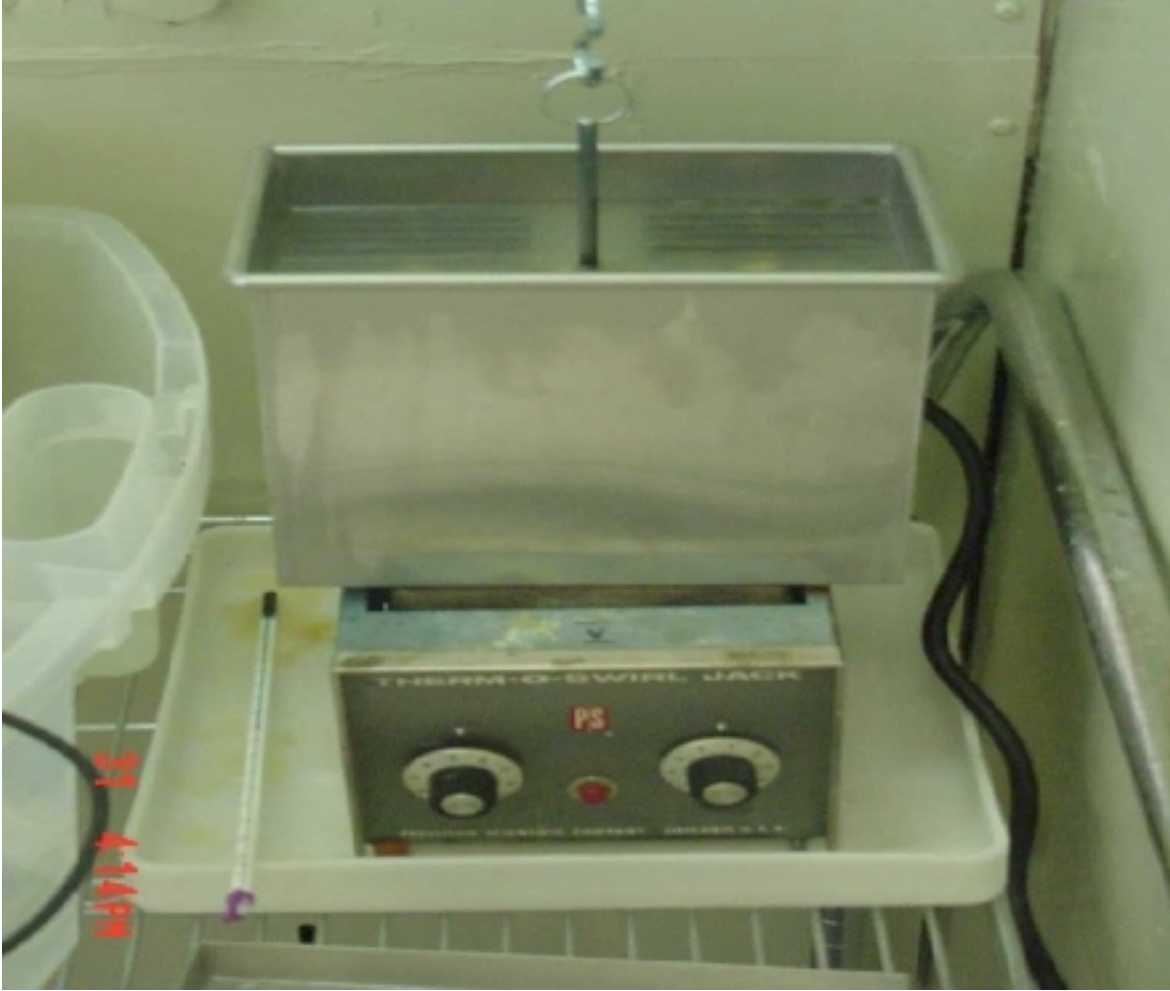
Figure 3. Cleaner Bath with Submerged Rack and Panels

The cleaning bath consisted of a 4-L capacity 316 stainless steel tank. This tank was filled with 3.5 L of degreaser, which allowed for total immersion of the panels and unrestricted stir bar operation. The 316 stainless steel was compatible with TCA, DN-30 and Graff-Off™. There was no evidence of chemical attack on the steel in the duration of the project. Figure 3 shows a cleaning bath with panels completely immersed.

Magnetic stir bars of 4 x 0.6-cm diameter size were used in each degreaser bath. Each cleaning bath was set on a stir plate, and in the case of DN-30, a hot plate/stir plate was used as well. Air spargers, thermometers, and pH probes were mounted onto the cleaning system. A hook on a cable was used to create a pulley system for moving the rack of panels in and out of the cleaning and rinsing baths.

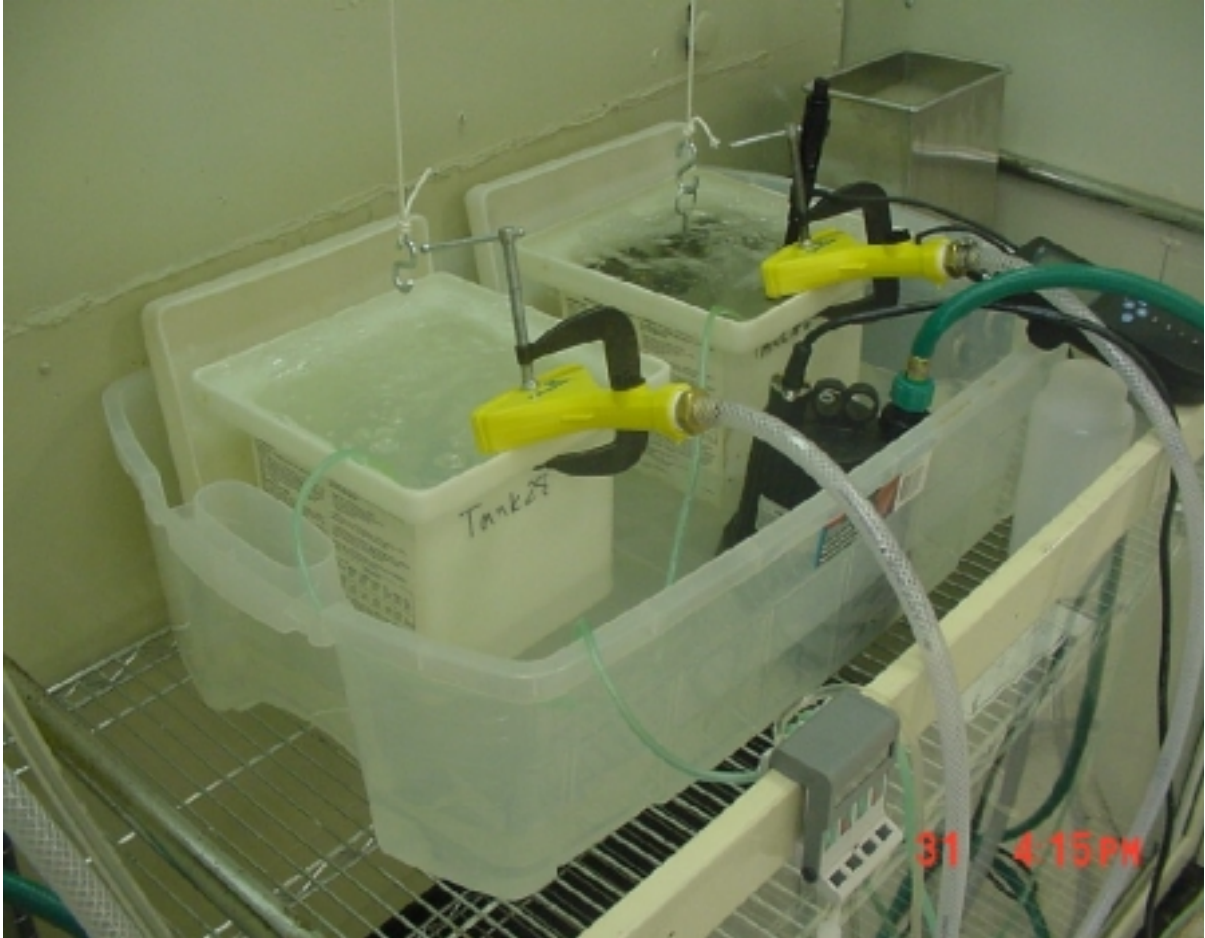
Figure 4. Rinse Tanks with Rinse Water Addition Nozzles

degreaser bath was 3 minutes. Afterwards, the panels were removed and rinsed sequentially in the two rinse baths. The rinsed panels were allowed to drip dry and then stored for further analysis. The aqueous degreaser baths and the rinse baths were monitored for changes in temperature and pH.

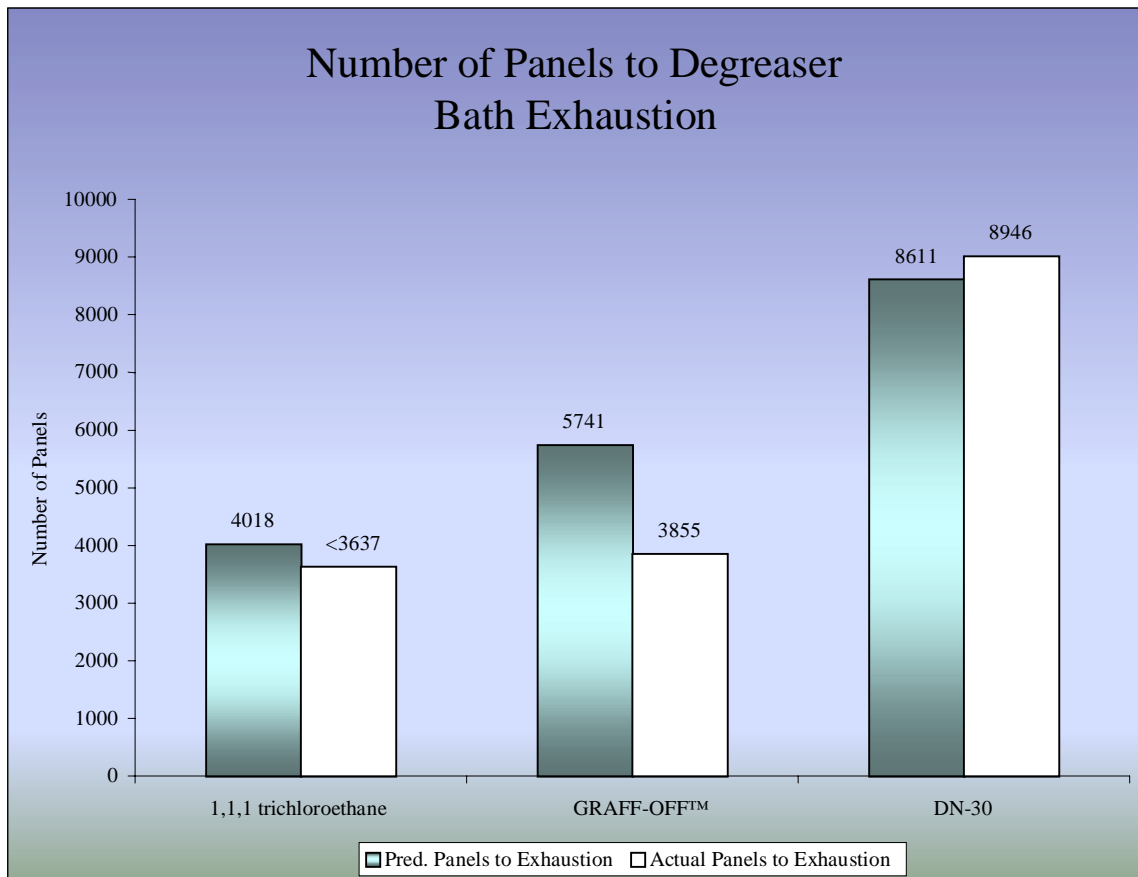
Figure 5. Beaker Test Results Compared to Actual Bath Cleaning Results

Figure 5 shows the estimated exhaustion levels via the beaker test compared to the exhaustion levels found after cleaning contaminated panels. Within a 10% margin of error, the beaker test estimate for bath exhaustion panels was equal to the actual exhaustion levels determined for TCA and DN-30. For the Graff-Off™, the beaker test predicted a slightly higher level for bath exhaustion than the actual exhaustion level determined by the water-break test. The beaker test has proven to be a quick estimator of cleaner performance.

The exhaustion levels were equal for TCA because the first set of contaminated panels that passed through the pre-contaminated TCA bath failed the water-break test. Obviously, the pre-contamination level for TCA was very close to the exhaustion point. Verification tests were less sensitive because they were conducted using fresh panels instead of contaminated panels.

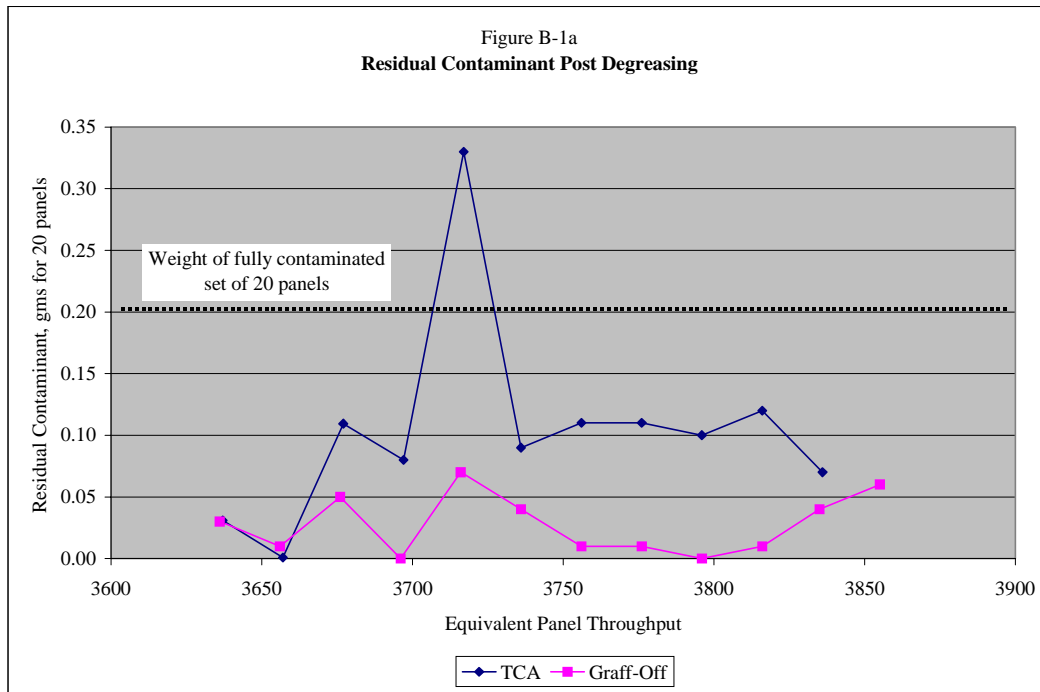
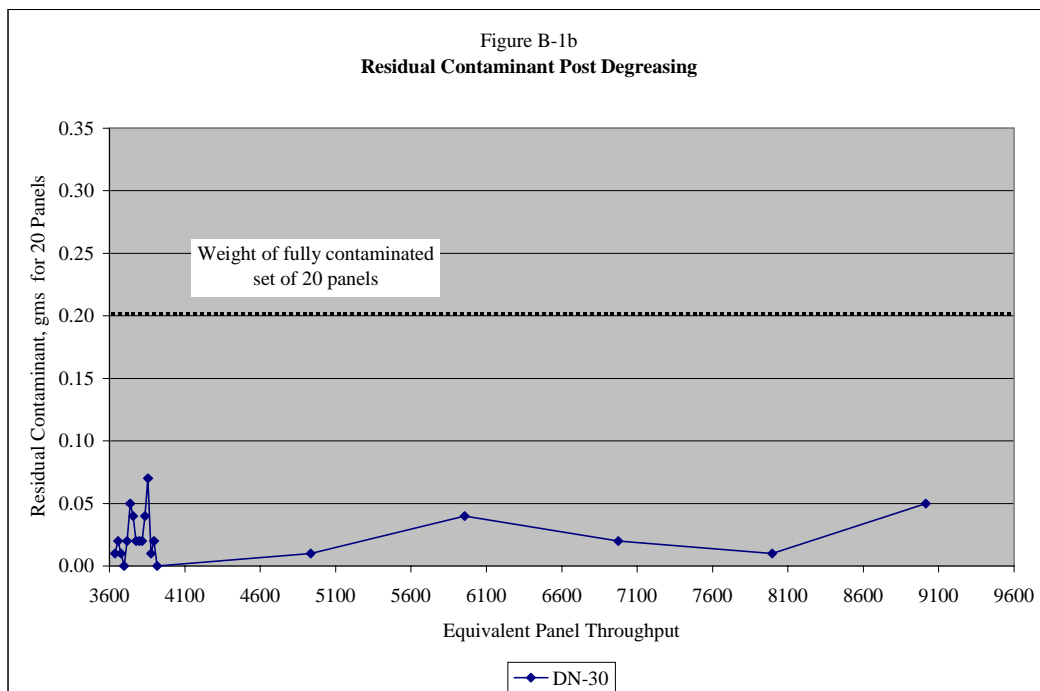
Figure B-1. Weight Reduction for Degreasing Baths

The weight of the test panel after degreasing and air-drying was compared to the test panel containing the jet engine oil prior to degreasing. Results were reported in mg of contaminant/ft² of panel. The samples were weighed before contamination and weighed after contamination to establish the contaminant load. After the cleaning process, the samples were dried in a clean atmosphere and weighed again to find out how much material was retained on the sample. The amount of residue left on the sample was an indication of how much cleaning had taken place. Test data were included in the TCA, Graff-Off™, and DN-30 tables in Appendix A.

Weight reduction analysis has been found to be an accurate and sensitive measure of cleanliness. It, however, has an inherent problem with detection of very small amounts of soils or residues. Figures B-1a and B-1b show the results of the weight reduction analysis. In general, panels coming out of any degreaser process had greater than 70% of the contaminant load removed. The weight reduction results showed significant scatter and did not show a trend useful for predicting the level of cleanliness. This could be due to the inherent problem of measuring very small amounts of contaminants. Another reason could be that as the bath approached exhaustion, more residual deposits (e.g., phosphate deposits from the alkaline cleaners) adhered to the panels leading to scatter in the weight differences. The weight reduction analysis did not compliment the water-break test and was not a good performance measurement for panel cleaning in this project.

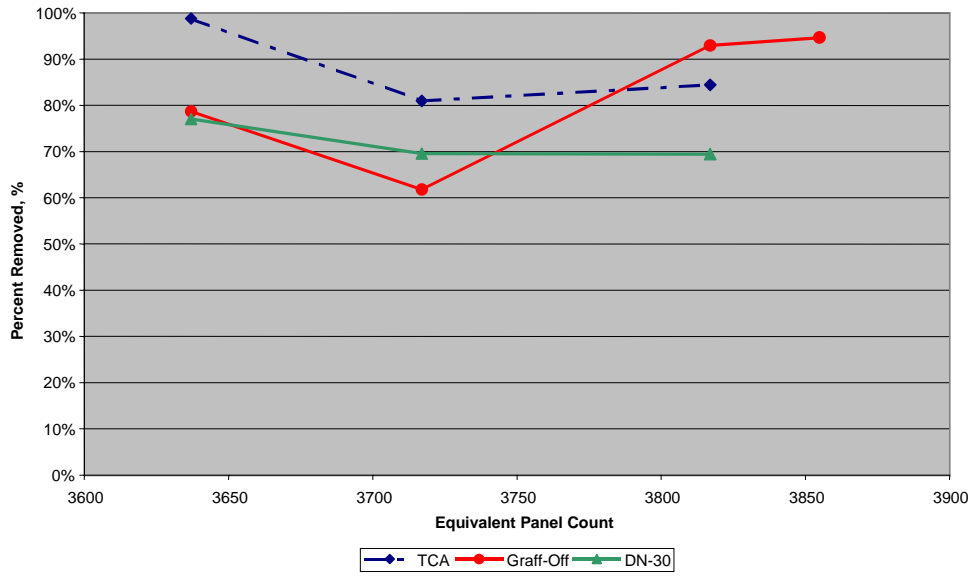
Figure B-2. NVR Data on Cleaned Panels

The NVR measures the residue contaminants left on the surface of the panels following degreasing. It should provide information similar to weight reduction test. The contamination load for 20 panels ranged from 0.1 to 0.3 g and the residual contamination after a cleaning cycle, but before bath exhaustion on 20 panels ranged from less than 0.01 to 0.1 g. Therefore, the contamination load on a single panel would be expected to range from 0.005 to 0.015 g and the residual contamination per panel to range from 0.0005 to 0.005 g (0.5 to 5 mg). These contamination levels for individual panels border around the limits of instrumentation and accuracy. The data for the NVR tests are shown in Figures B-2a and B-2b. The results, reported in terms of percent oil removed, indicate that 70% or more of the contamination is removed by all 3 degreaser baths, but the non-volatile residual weight change does not vary significantly with the number of panels cleaned. This is expected since the residual contamination from an individual panel is in the 0.5 to 5 mg range. The water-break tests indicated that the TCA, Graff Off™, and DN-30 failed at 3,637, 3,855, and 9,016 panels, respectively, but the NVR data does not show any indication of changes in the residual removed from the panels at or near these exhaustion points. Thus, no correlation between the exhaustion levels could be identified. Therefore, the NVR was not found to be an effective performance measure.

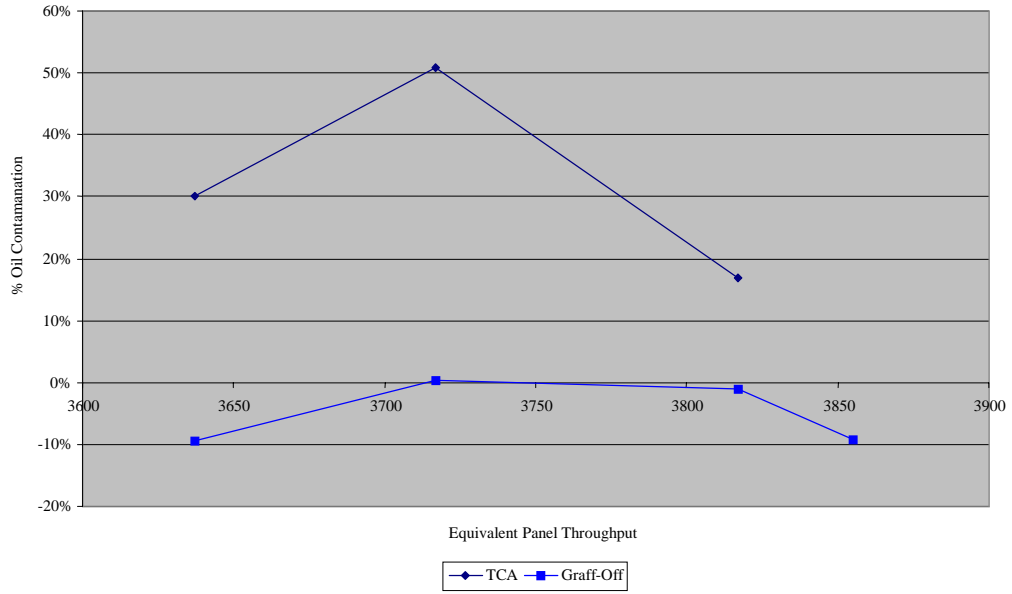
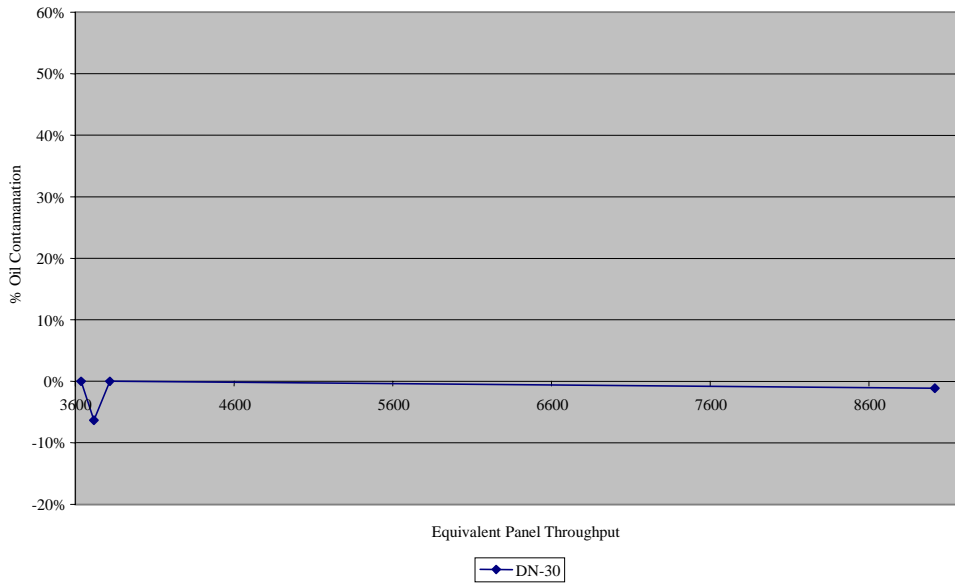
Figure B-3. FTIR Analysis on Cleaned Panels

The FTIR measured absorption was compared to this 2-point calibration curve and a relative cleanliness measure was determined as a percent of oil retained (i.e., contamination). As in the case of weight-change and NVR tests, there was no correlation between FTIR results and the water-break test results. As noted in Figure B-3a and B-3b, and Table B-1, as the bath became progressively more contaminated, there was no trend in predicted contamination level. Even at bath exhaustion points, there was no change in predicted contamination level.

Thus, FTIR was not found to be a useful performance measure.
