# **Final Report: Guided Acoustic Wave Monitoring of Corrosion in Recovery Boiler Tubing**

*Diane J. Chinn, Michael J. Quarry  
Lawrence Livermore National Laboratory*

**February 22, 2005**

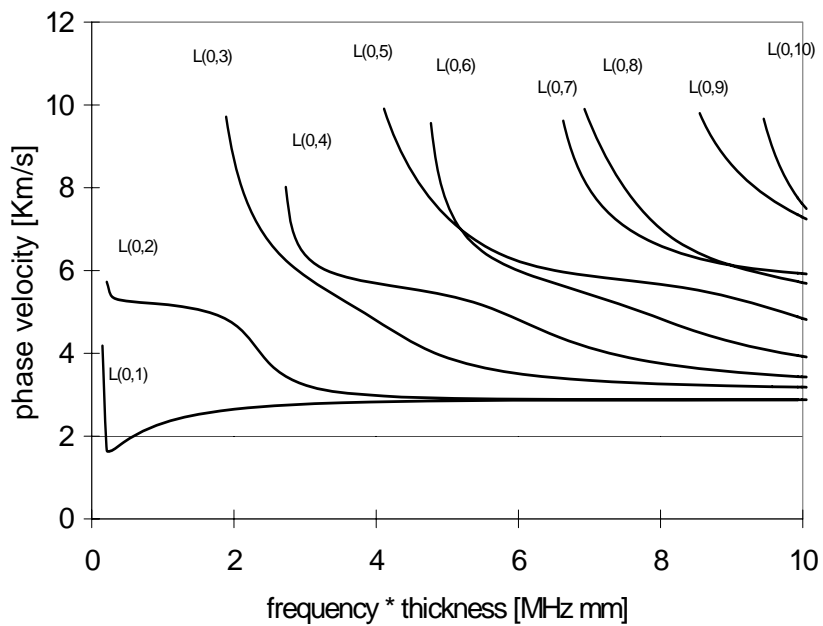
Figure 2A. The first 10 axisymmetric guided wave modes are described by phase velocity dispersion curves for a 3" O.D. carbon steel tube with a thickness of 0.210". Phase velocity is important for sensor design.

Using the analysis, sensors were designed to optimize the guided wave technique for application to recovery boiler tubing. Numerous guided acoustic wave modes can be excited in the tube. All possible modes of propagation are represented in phase and group velocity dispersion curves. For a tube, the curves are calculated by solving eigenvalues of the wave equation with boundary conditions of free surfaces on the outer and inner diameter of the tubes. The dispersion curves of the first 10 axisymmetric modes of propagation for a 3” outer diameter carbon steel tube with a thickness of 0.210” are shown in Figure 2. Phase velocity (Figure 2A), is the speed of the phase of the guided wave. Group velocity (Figure 2B), different from the phase velocity in a guided wave, describes the speed at which the guided wave “packet” propagates. Phase velocity is utilized in the design of a guided wave sensor for mode excitation while group velocity is used to identify and locate a defect.

where  $\theta$  is the incident angle from the wedge and  $V_{pl}$  is the longitudinal wave speed in the Lucite wedge. The range of excitation of the wedge is a constant phase velocity at any frequency. For example the wedge in Figure 3 excites all modes in Figure 2A where  $V_{ph} = 3.1$  km/s. The wedge determines the phase velocity (vertical axis) of the excited modes. The sensors must be driven by a tone-burst (gated sine wave) to excite a single dominant mode at one time. The narrow frequency band of a tone-burst excites virtually a single frequency on the dispersion curves. The point on the dispersion curve at the frequency and phase velocity chosen will be the mode excited for the given angle of incidence and frequency. An incident angle of 28 degrees ( $V_{ph} = 5.8$  km/s) driven at a frequency\*thickness of 4 MHz mm will excite the L(0,4) mode in Figure 2A.

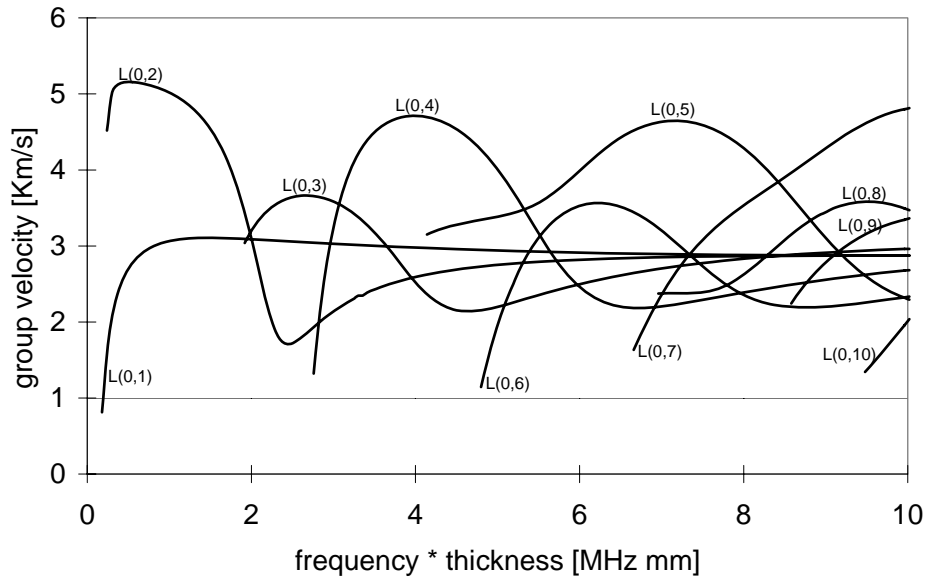
Figure 2B. Group velocity dispersion curves for the first 10 axisymmetric modes in Figure 2A show the velocity of the wave “packet”. Group velocity is used to locate flaws.

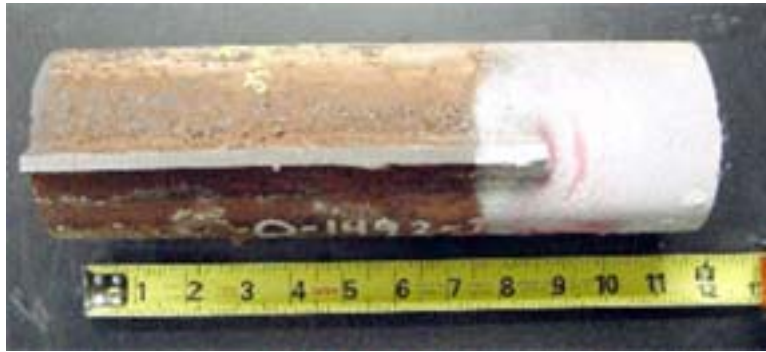
Figure 4. A piece of boiler tube was pulled out of service because of a crack, located just beyond the membrane, is indicated by a dye penetrant. The section was welded between two 10 ft. lengths of tube to test guided wave detection.

Figure 4 shows a section of boiler tube that was pulled out of service due to circumferential cracking. The crack in Figure 4 located at approximately 9" according to the scale is highlighted by dye penetrant. X-ray computed tomography (CT) was performed on this section to obtain an image of the crack. Circumferential X-ray CT slices of the inner and outer diameter in Figure 5 show that the crack initiated on the I.D. and grew to the O.D. To test guided wave detection on this type of crack, the 12" section of tube was then welded between two - 10' lengths of tubes according to industry welding guidelines.

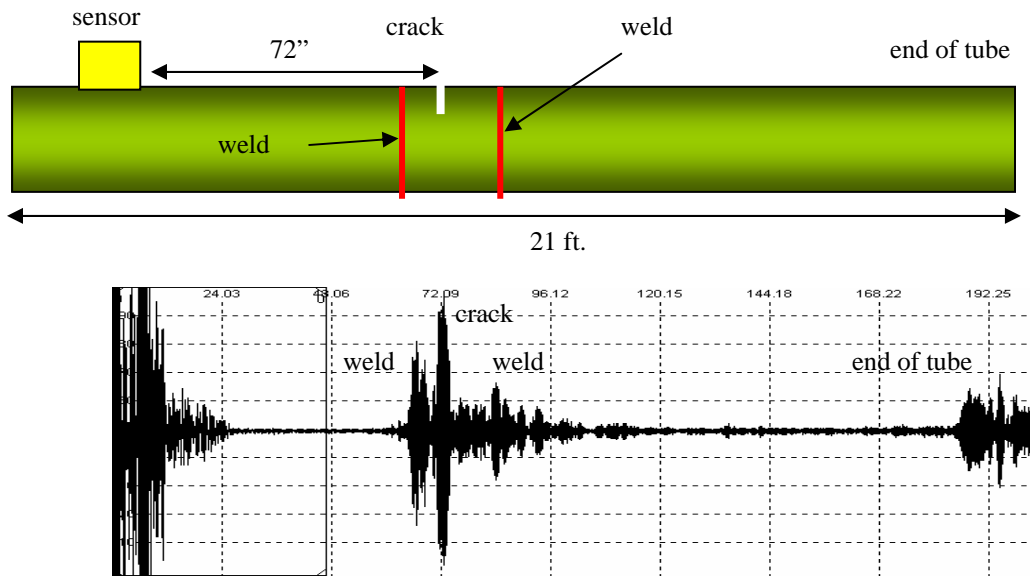
Figure 6. A sample RF waveform shows detection of a crack at 72" and the end of the tube at 16.5 ft.

A guided wave signal detecting the crack is shown in Figure 6. The tone burst excitation frequency was tuned to 510 kHz to maximize the reflection from the crack. Reflections from the welds also appear before and after the crack reflection. A reflection from the end of the tube, 16 ft. away, also appears in the signal. The results demonstrate long-distance detection of a real circumferential crack by the guided wave technique.

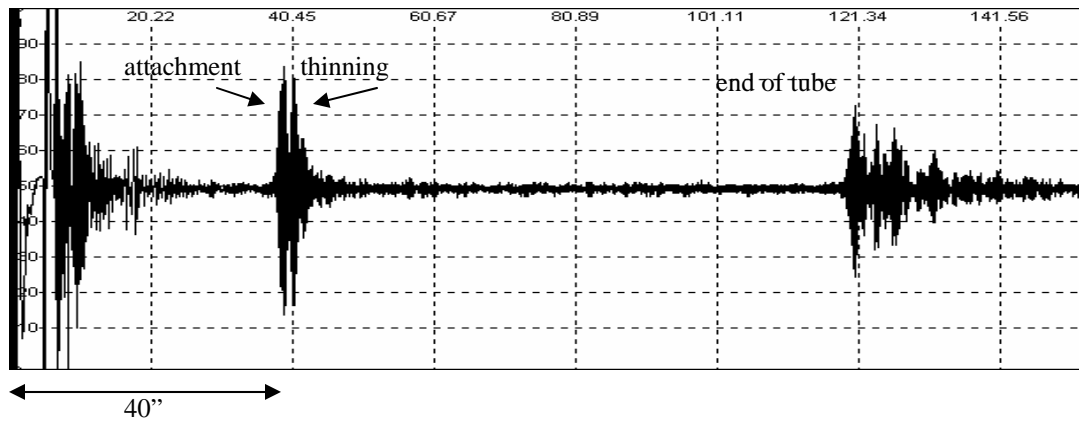
Figure 8. A guided wave signal in reflection mode shows the detection of simulated wall thinning near a welded attachment.

The tube in Figure 7 was tested using the guided wave technique with the sensor approximately 40" from the thinning and attachment. The simulated thinning was easily detected in reflection mode as shown in the guided wave signal in Figure 8. Detection of the thinning was verified by group velocity calculations of the mode as well as damping the signal on the tube around the thinning.

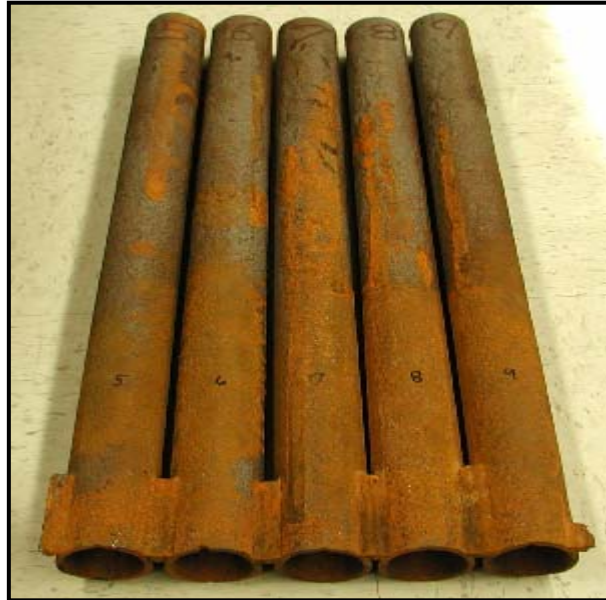
Figure 9. A panel of tangent tubes with suspected stress-assisted corrosion was tested with guided waves.

Tests were performed on panels of tubes having areas suspected of having stress-assisted corrosion (SAC). The panels, as shown in Figure 9, were tangent tubes, 24" in length, 2" in diameter and 0.170" thick. The panels were removed from the sidewall of the boiler above the secondary airports and below the nose arch. Buckeye Technologies contributed these tubes for guided wave testing. Radiographs were taken of the panels to identify tubes with SAC. The depth of the SAC was roughly estimated at about 20% through-wall. The SAC had several orientations. A typical radiograph of the SAC area of a tube is shown in Figure 9.

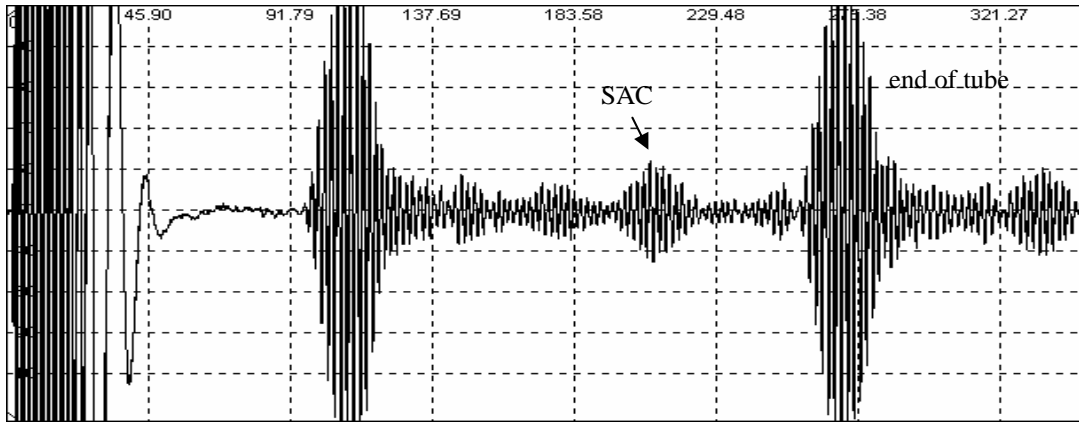
Figure 11C. A guided wave signal generated with EMAT sensors shows detection of SAC.

create an acoustic wave. EMATs were designed to excite torsional modes in the 60 to 250 kHz region. EMATs consist of a periodic permanent array of magnets that are placed over an electrical coil and use the Lorentz force to generate ultrasound. The electrical coil generates eddy currents in the surface of the tube, and the cross product of this current with the external magnetic field of the magnets creates the ultrasound. The advantage of this method for generation of ultrasound is that EMAT's are much less affected by surface conditions. For comparison, the tangent tube with SAC was tested using a flat EMAT. The guided wave signal using an EMAT send/receive pair is shown in Figure 11C. The arrival time of the reflection from the SAC defect differs from the piezoelectric array transducer (Figure 11A) because a different mode with a different group velocity was excited by the EMAT. Detection of SAC shows the potential of using EMAT sensors on rough dirty tube surfaces. A picture of an EMAT sensor is shown in Figure 12.

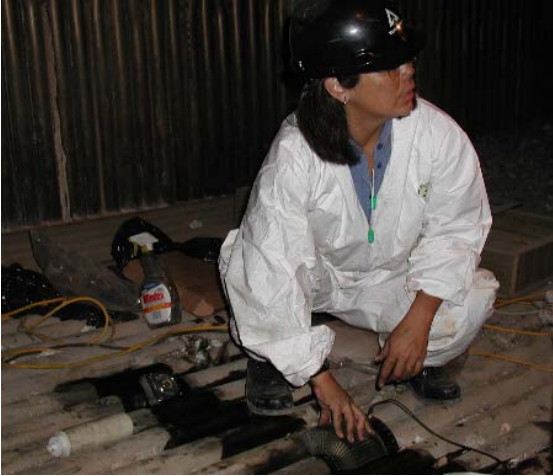
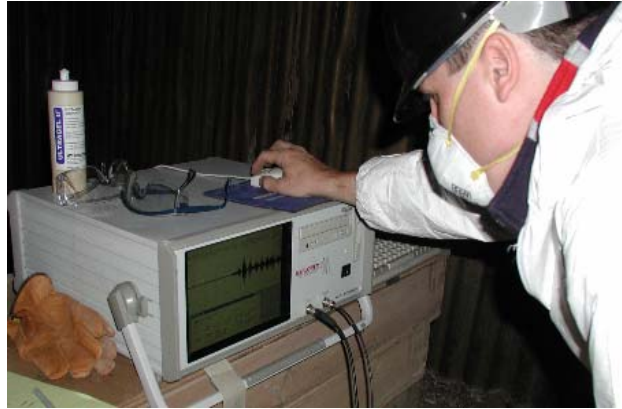
Figure 13. Photos show the field test and demonstration at the Prince Albert mill.

A field test was conducted at a shut down boiler to test the guided wave technique under field conditions and determine propagation distances. Figure 13 shows pictures of the system being tested in a recovery boiler at the Prince Albert Mill in Saskatchewan. The tubes in the shutdown boiler were 0.280" dia. composite tubes. Although the tubes were water washed, a few brushes with a wire brush were still required. The floor tubes were filled with water and the general conditions were the same as during annual maintenance shutdown conditions. Propagation distances of 26' were recorded on both flat and bent tubing. Wall thinning was detected on one tube. The field test showed that guided waves could propagate around bends. Electrical equipment and other operating devices did not produce any noise in the ultrasonic guided wave signals.
