# 233-S PCF Demolition Project

RadCon practices and techniques

233-S Plutonium Concentration Facility  
D&D Project

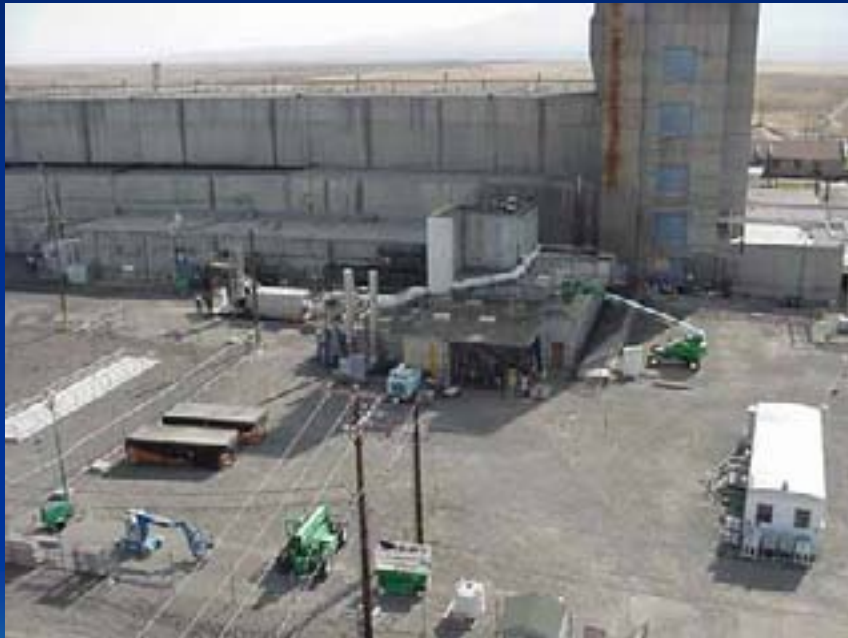
- Located North of the 202-S “Redox” Facility.
- The process area was a reinforced concrete structure 37 feet high, 86 feet long and 43 feet wide with twelve-inch walls and six-inch thick floors.
- The non-process areas were a single story structure with eight-inch walls and six-inch thick floors.

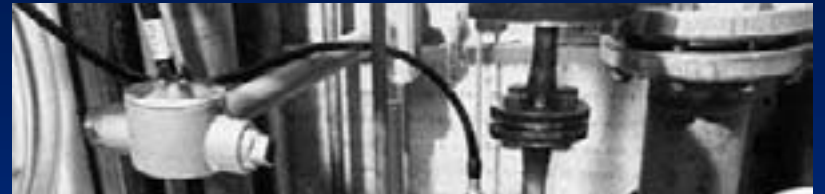
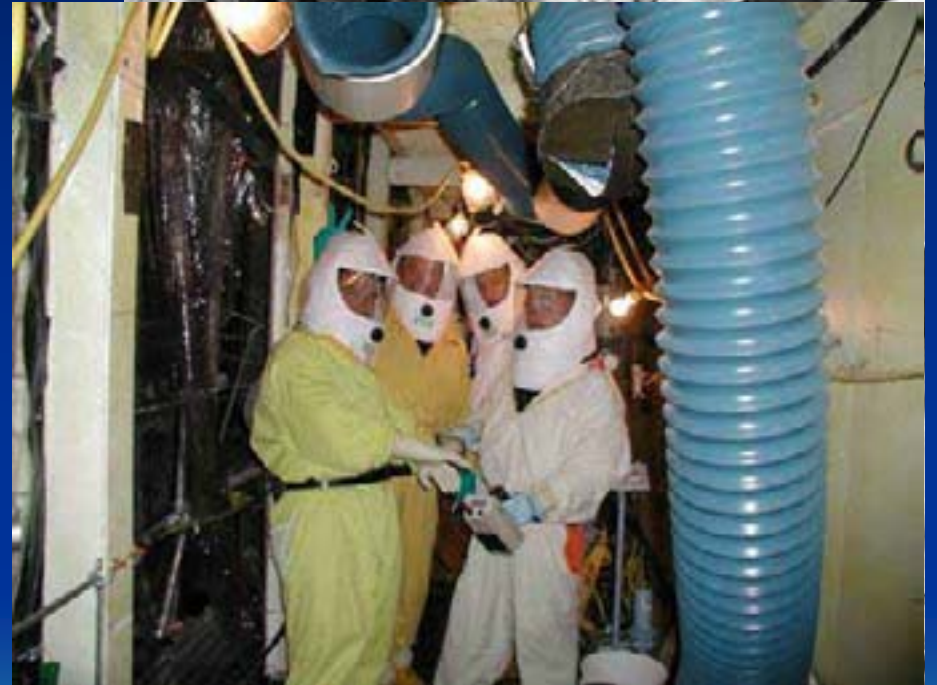
- In 1956 a spill of approximately 32 grams of plutonium solution caused extensive contamination of the facility, including outside areas.
- In 1963 a fire spread gross alpha contamination to all areas of the facility, including the outside roof area.
- Major Decon activities occurred from 1978 to 1981. Stabilization of the facility was completed in 1987.
- Dismantlement and removal of process equipment began in 1996. Contamination levels range from 2,000 d/m/100 cm<sup>2</sup> to greater than 20,000,000 d/m/100 cm<sup>2</sup>.

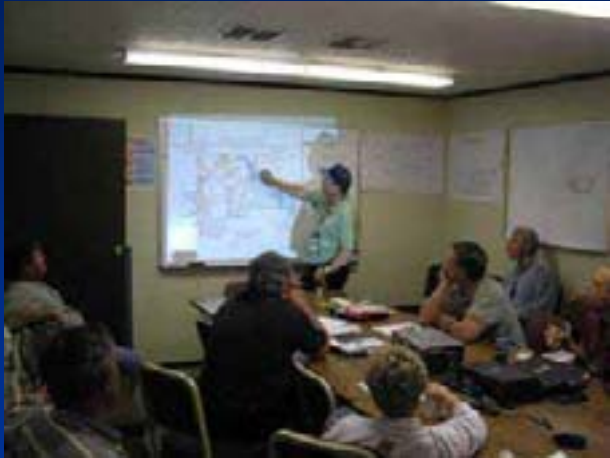
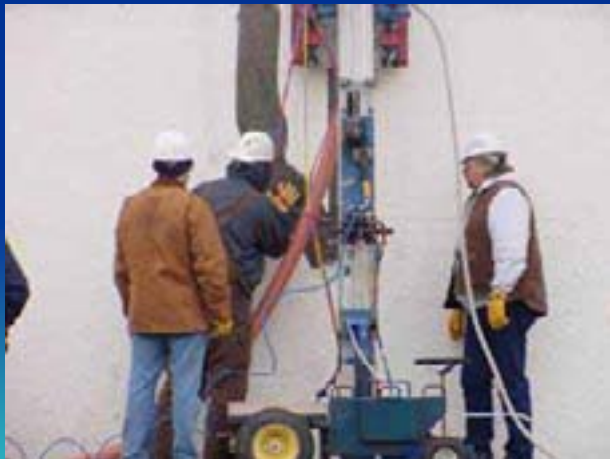
- Extensive interfacing with D&D Operations, Waste Management, and demolition vendors is needed in order to establish an effective contamination control program while allowing efficient personnel and vehicle access.
- Planning and execution of an effective decontamination program is a vital part of the process.

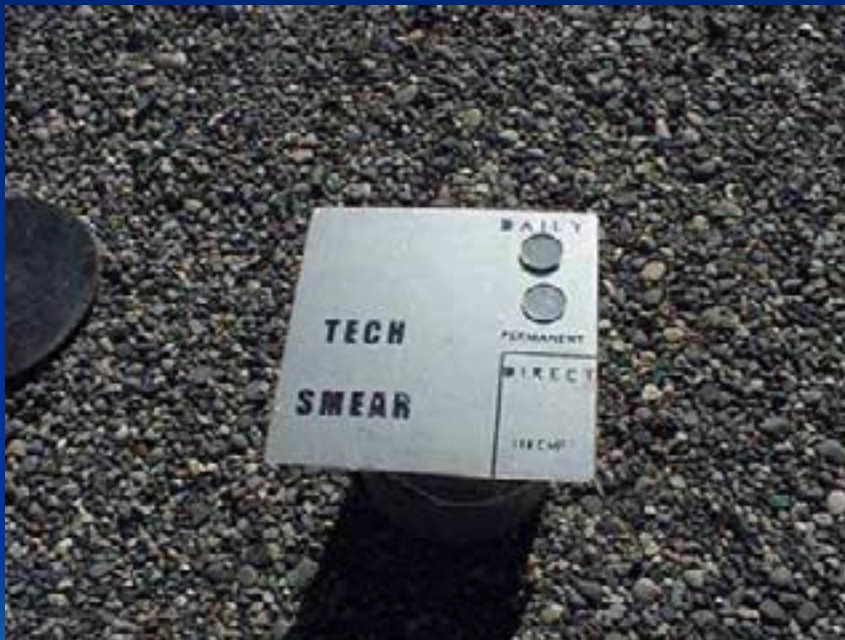
- Establishment of routine sample points at the CA/RBA boundary allows the detection of low level contamination in time to effect remediation efforts without impacting demolition activities.

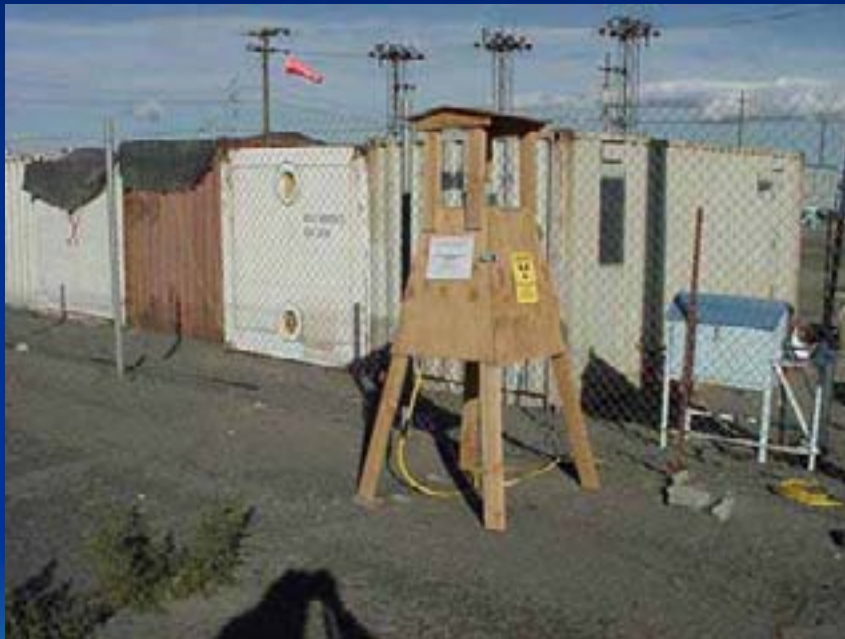
Continuous monitoring of Airborne contamination levels is a necessity.

- Four Canberra “Alpha Sentry” Continuous Air Monitors provided real time remote monitoring.
- A portable Eberline Alpha-5 monitor provided spot monitoring.

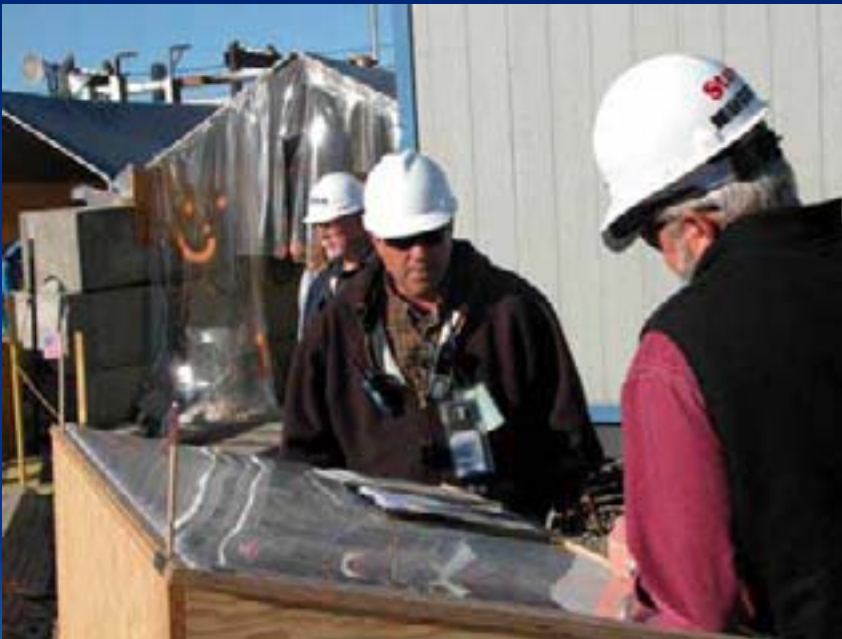
- A control point desk at the demolition area access point allows on the spot decisions to expedite job flow.

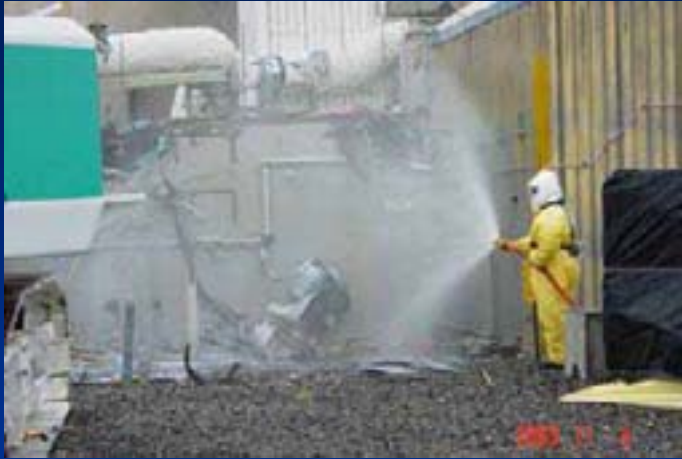
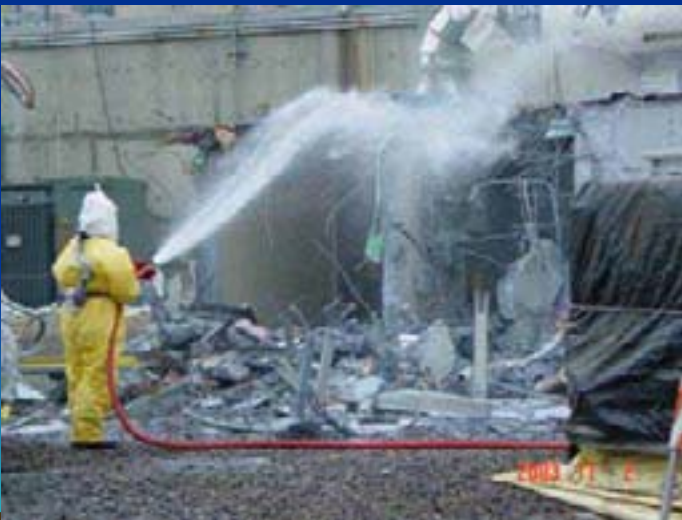
- Whenever active demolition was paused, the application of fixatives to the demolition site mitigated the windborne spread of radioactive material.

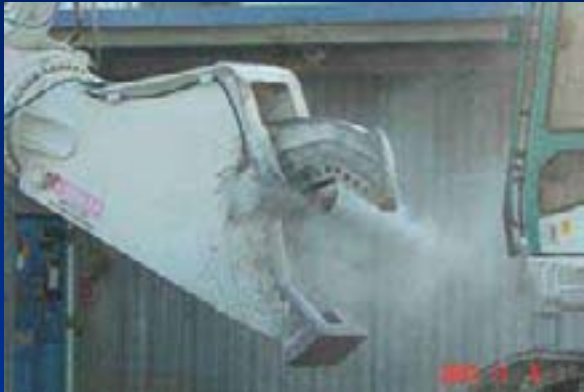
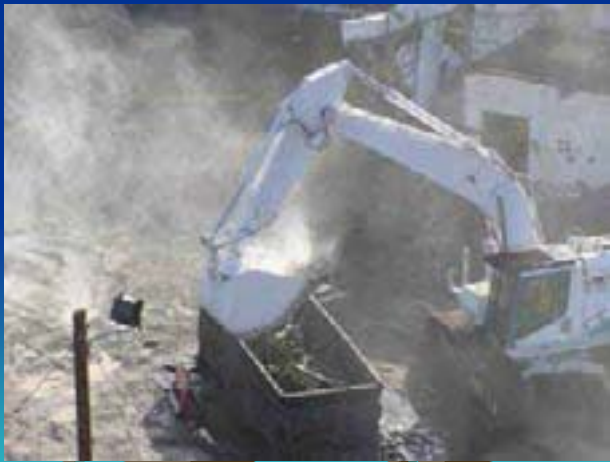
- Misting Nozzles were installed on the Shear and bucket to mitigate the spread of airborne contamination at the source.

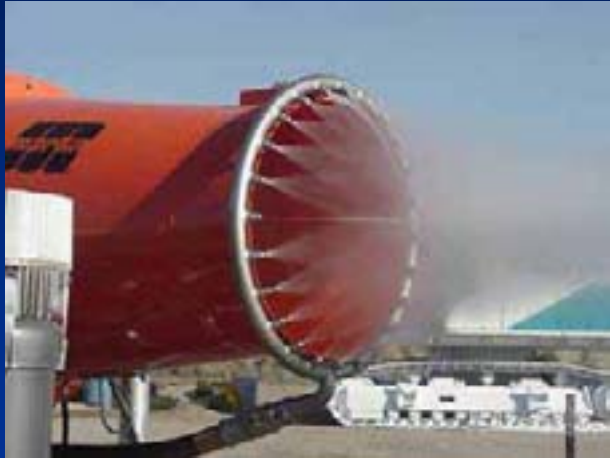
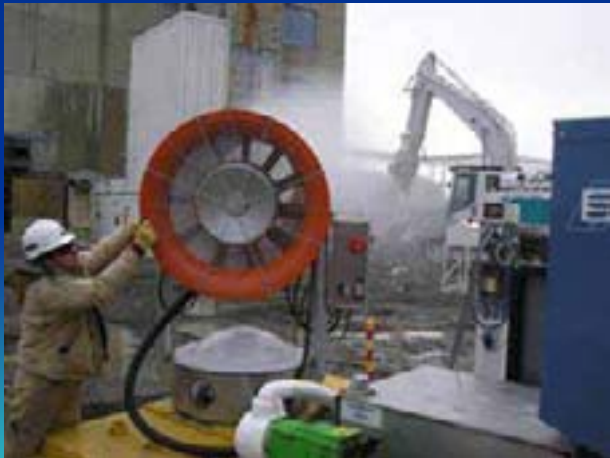
- Fog Canons provide an effective way to further limit the spread of airborne contamination during active demolition.

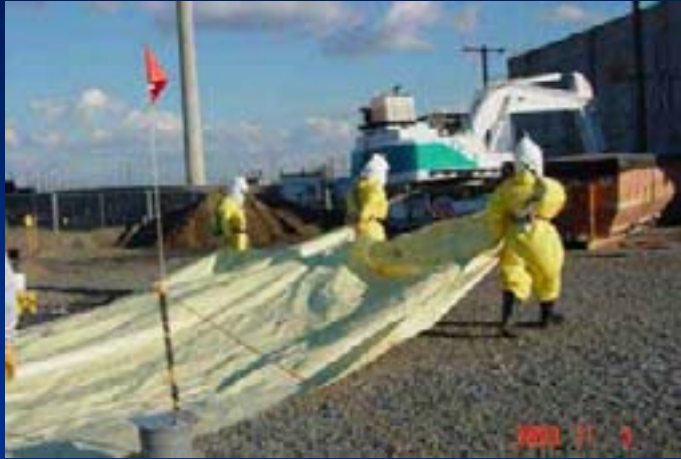
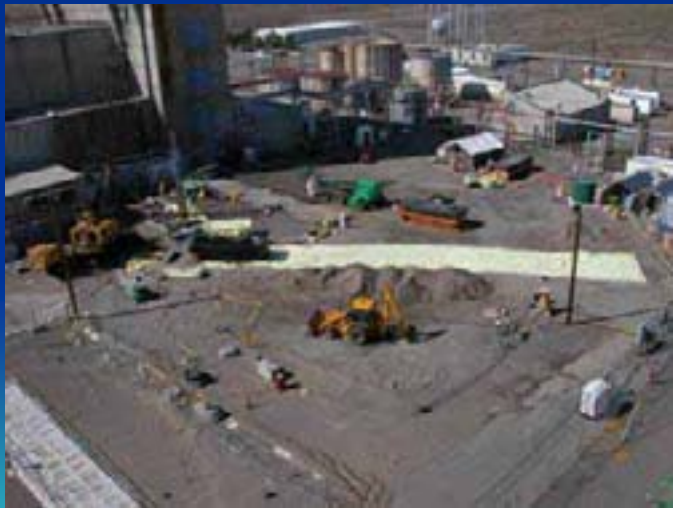
- In order to expedite the release of transport vehicles, a clean pathway to the ERDF Box was created using disposable plastic sheeting.

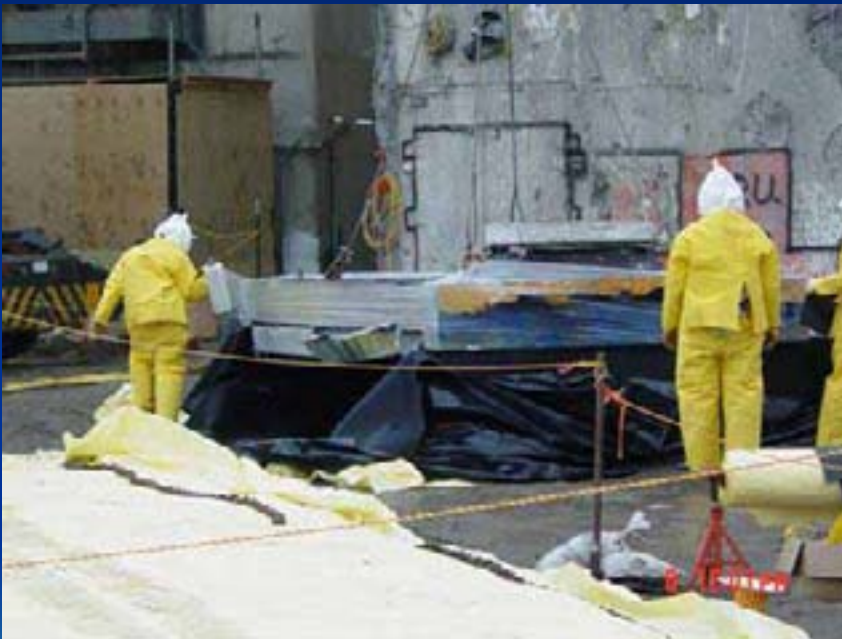
- The application of plastic wrap allowed highly contaminated areas of contamination exposed during cutting to be rapidly fixed prior to packaging.

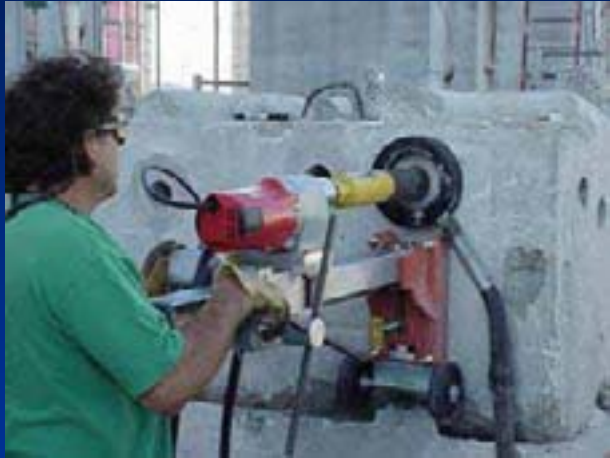
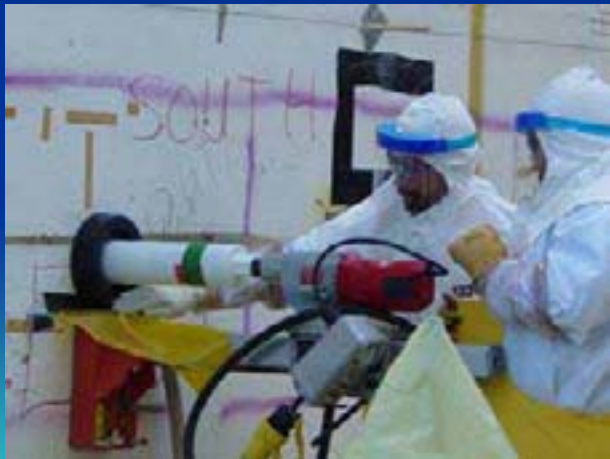
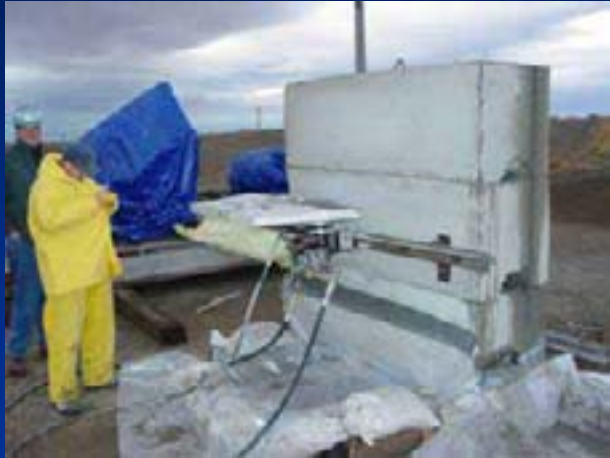
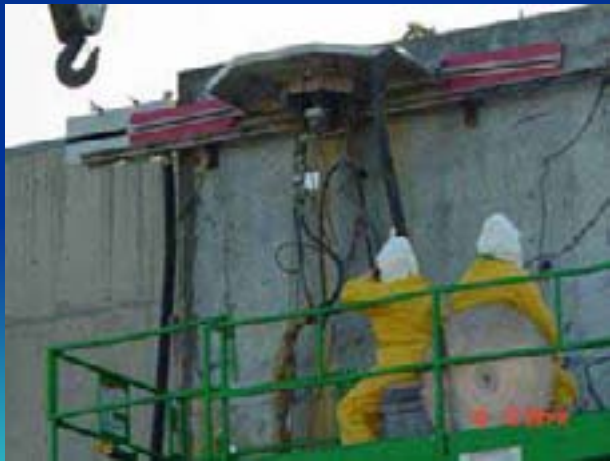
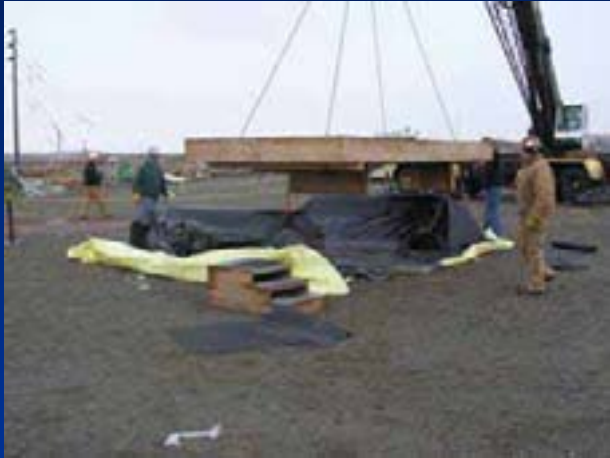
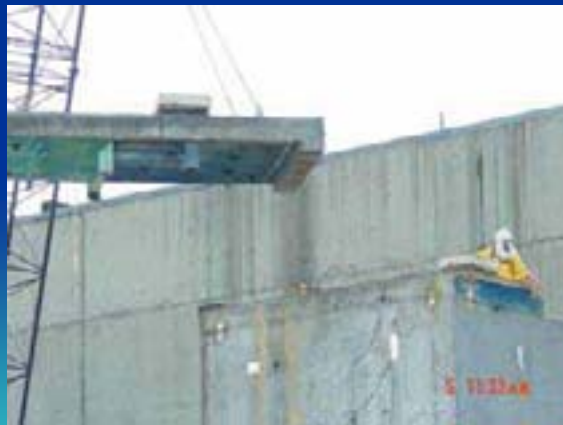
- Utilizing Mockups and walk downs allowed workers to solve problems and refine procedures in a safe environment, saving time and exposure in the demolition zone.

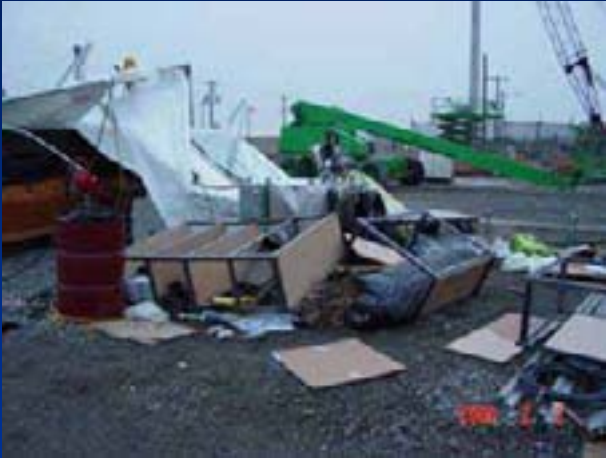
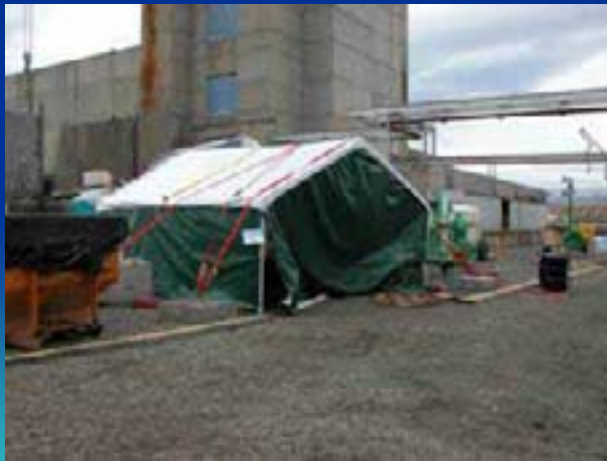
- Wind speeds in excess of 65 mph were recorded at the demolition site. Although the application of fixatives prevented the spread of contamination, equipment tents did not fair so well.
- “Hardening” of the tents to survive higher winds speeds was necessary.

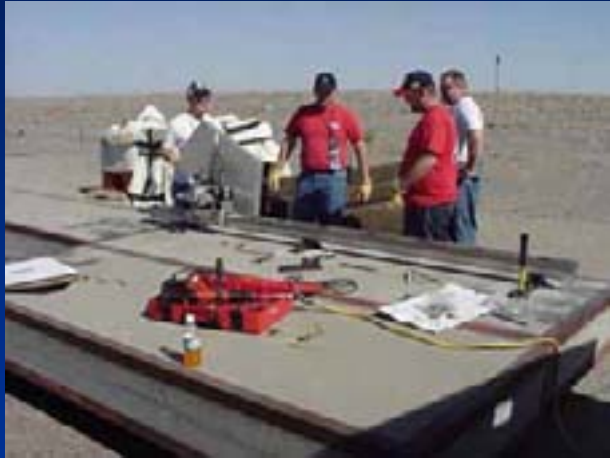
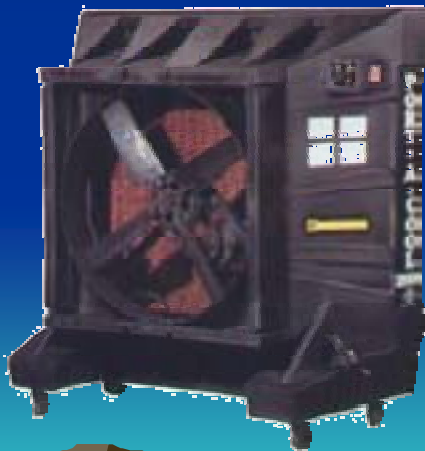
High Temperatures reached 112°

- A work/rest regimen based on WBGT index was used.
- Evaporative coolers were located in worker cool down areas.

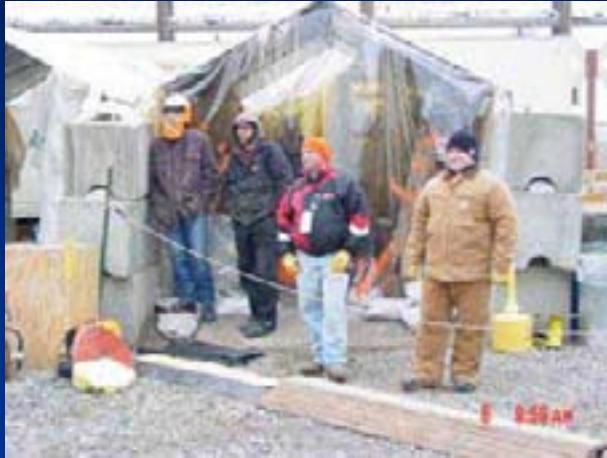
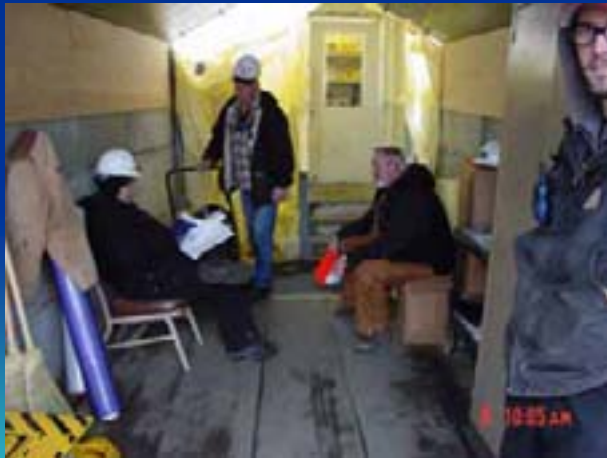
Low Temperatures reached -14°

- Cold weather gear was issued to all outside workers.
- Modifications were made to existing RWPs to allow workers to wear cold weather gear under their protective clothing.
- A heated staging area was built to allow workers to remain warm without leaving the area.

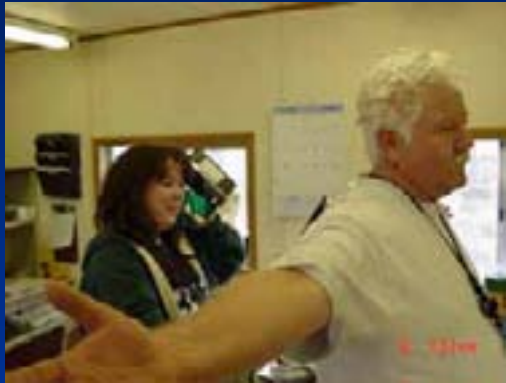
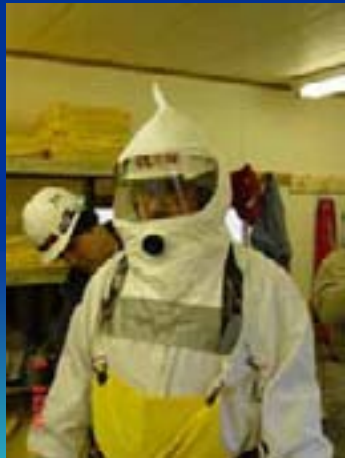
## Change Trailer Size

- The size of the change trailer was inadequate for the number of personnel entering and exiting the area.
- The level of PPE required for entry into the demolition area required the presence of additional personnel to assist workers.
- A new trailer was procured and configured based on feedback from the workers in the field.

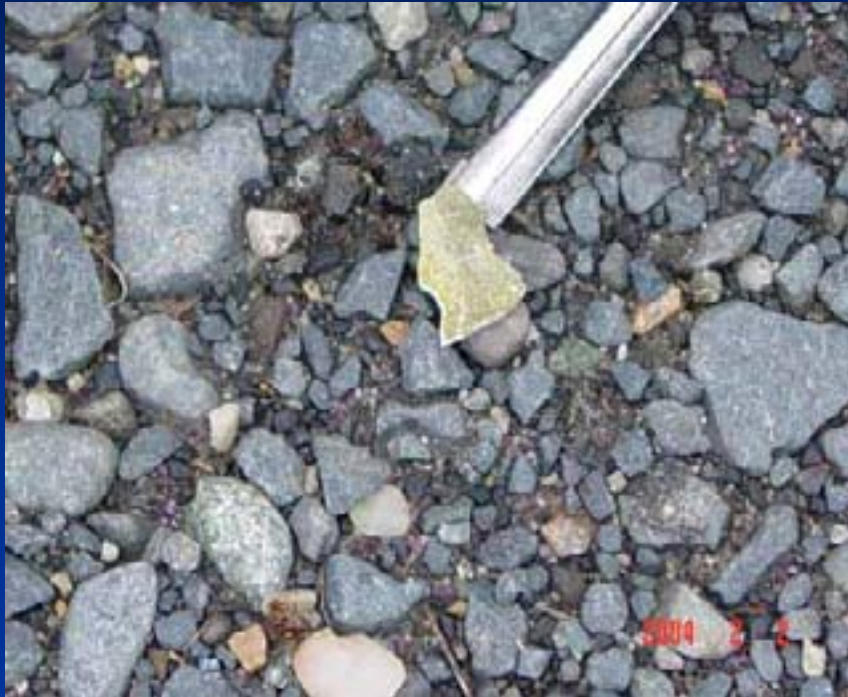
**Contaminated Paint  
Flaking Off Pipes**

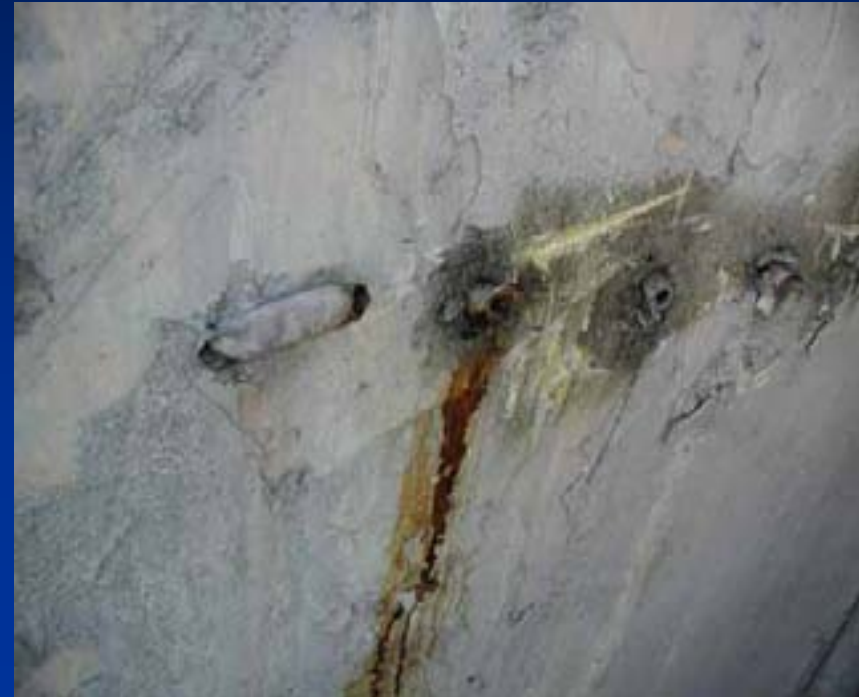
**Pipe With Legacy Nitric  
Acid...Found When Cut**

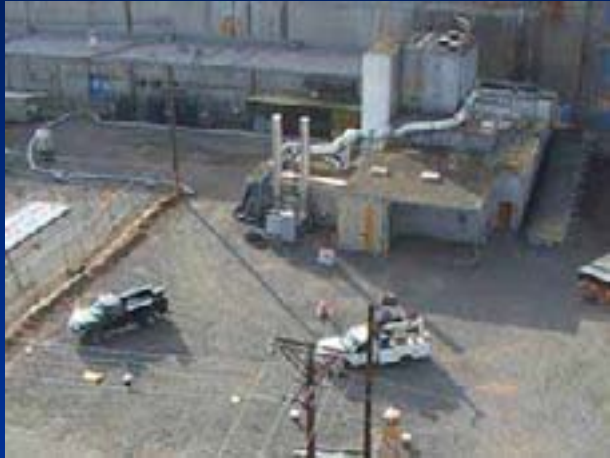
- Demolition commenced October 22<sup>nd</sup>, 2003.

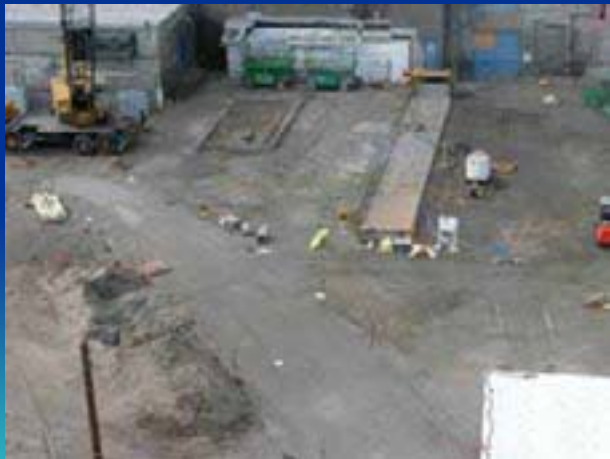
- Slab on Grade was achieved April 30<sup>th</sup>, 2004

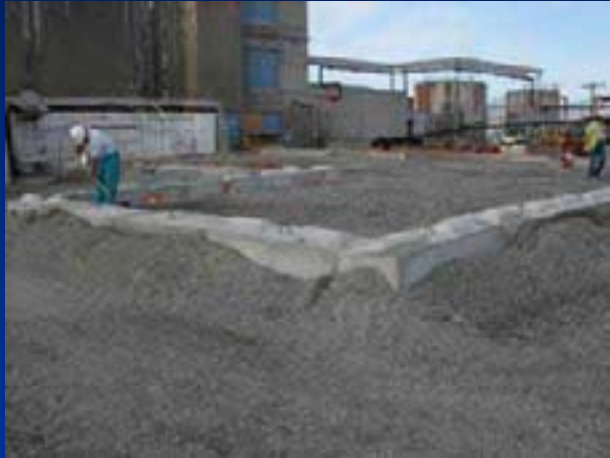
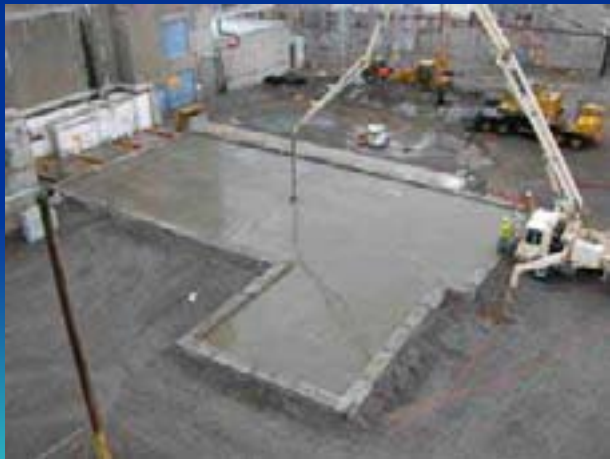
- June 3<sup>rd</sup>, 2004 - A worker levels the clean gravel fill in preparation for pouring the final grout cap.
- June 8<sup>th</sup>, 2004 - The final concrete cap is poured.
