*U.S. Department  
of Transportation*

## ***Evaluation of Infrared Brake Screening Technology: Final Report***

***DOT-MC-01-007***

***December 2000***

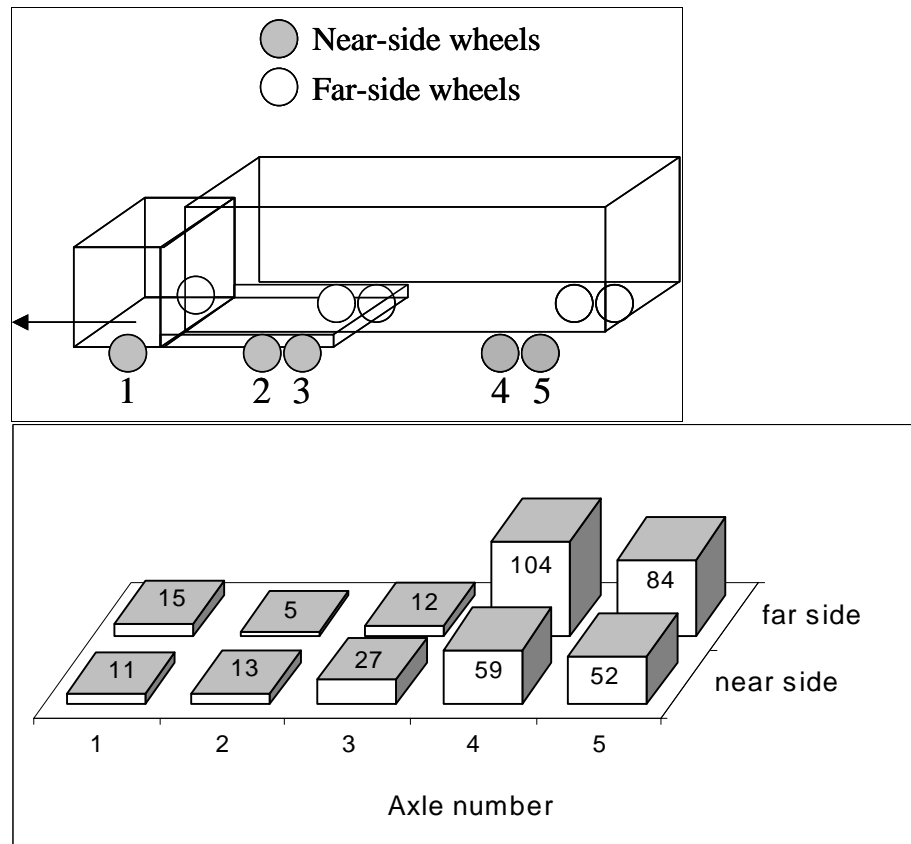
**Figure 1. Number of problematic wheels identified by IRISystem as a function of wheel location on a 3-S2 CMV. The data are for all states. The arrow indicates the direction of the vehicle. The schematic illustrates the near-side and far-side wheel location as well as the axle numbers.**

Most of the problems identified during the IRISystem screening were located on the trailer wheels located on the far side of the CMV (with respect to the IRISystem van). Wheel covers on the near-side wheels tended to obscure the infrared image, whereas the far-side wheels were easier to evaluate because of a better line of sight to the back of the wheel and slightly more viewing time as the CMV passed in front of the IRISystem van. The presence of brake defects or deficiencies was a good indicator that other repairs were needed on the CMV.

the wheels, and the near-side wheels passed through the camera range more quickly than the far-side wheels (Appendix A, Figure A-6). On average, the majority of problems identified during the IRISystem screening were located on the trailer wheels on the far side of the CMV with respect to the IRISystem van (Figure 1). However, this result was dependent on the operator, as shown in Appendix G where figures similar to Figure 1 are included for each state.

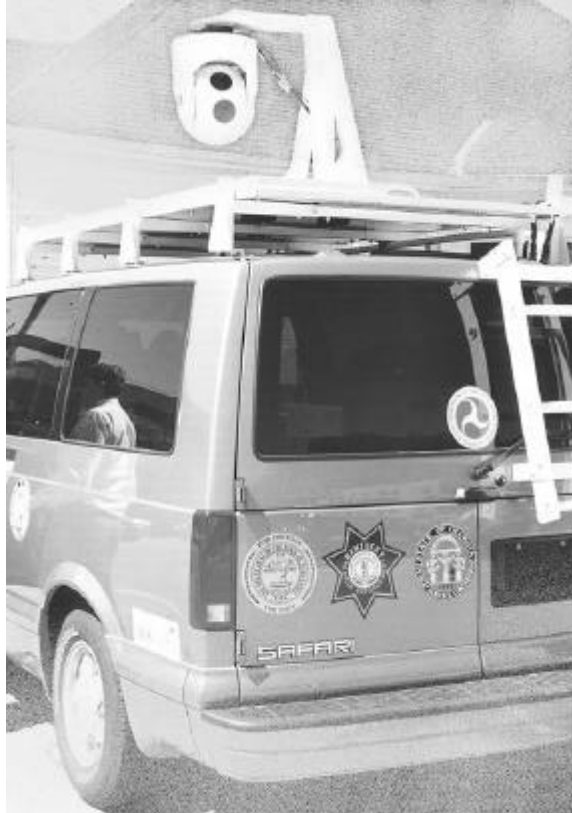
**Figure A-1.** The IRISystem, showing the housing minivan, and the camera mount on the roof (Photo courtesy of J. Bibb).

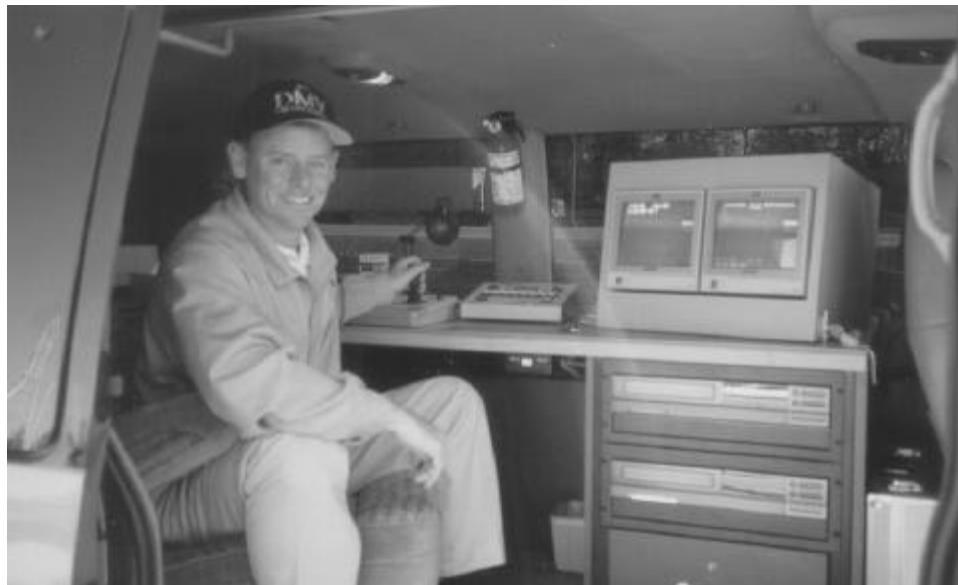
**Figure A-2.** The IRISystem minivan interior with video screens, VCRs and the joystick which operates the camera.

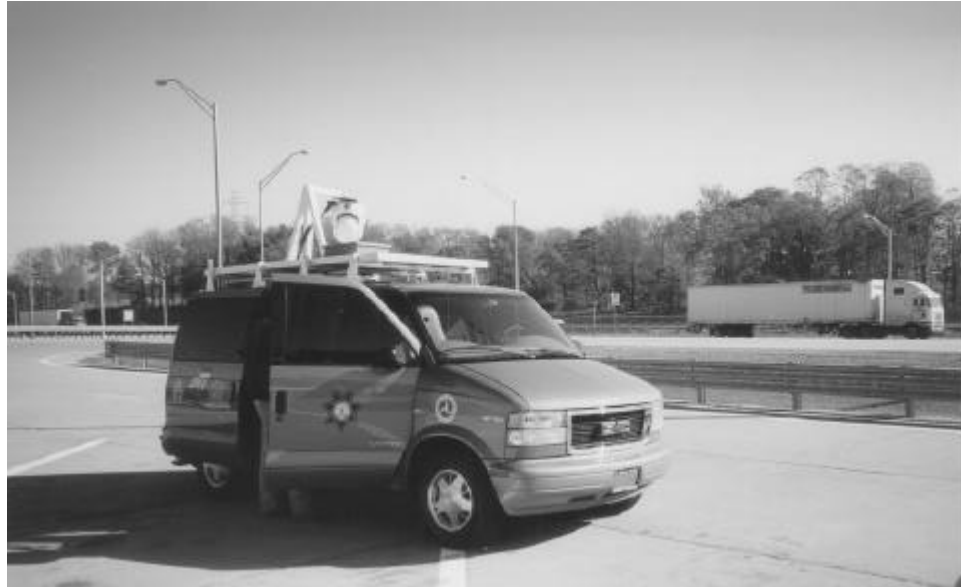
**Figure A-3. The IRISystem, set-up at a scale site in Kentucky.**

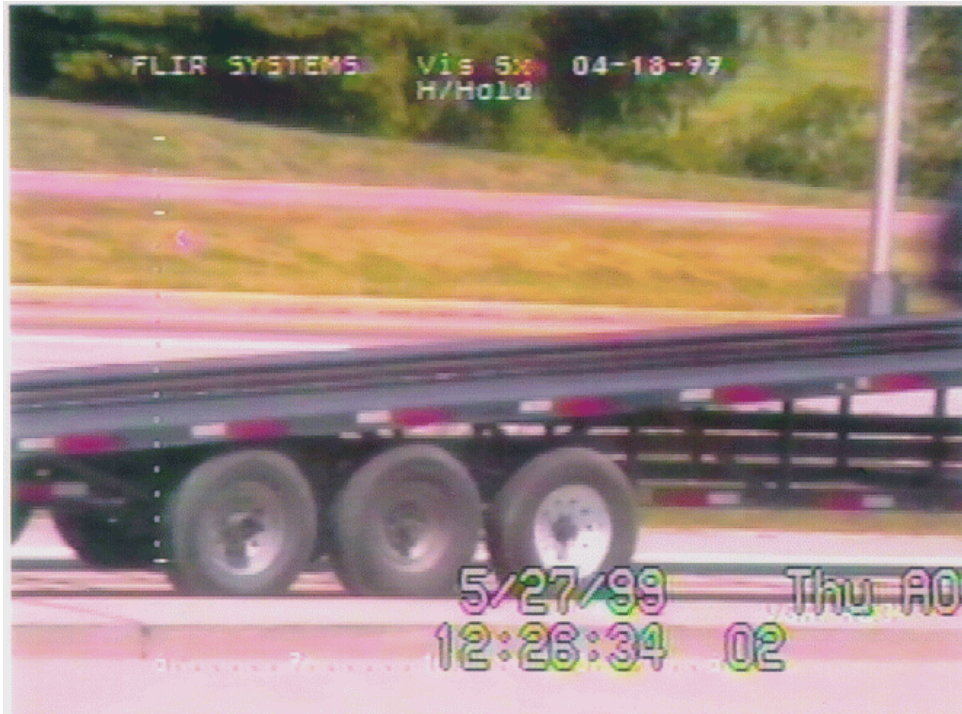
Figure A-4. Color and corresponding thermal images of a screened CMV.

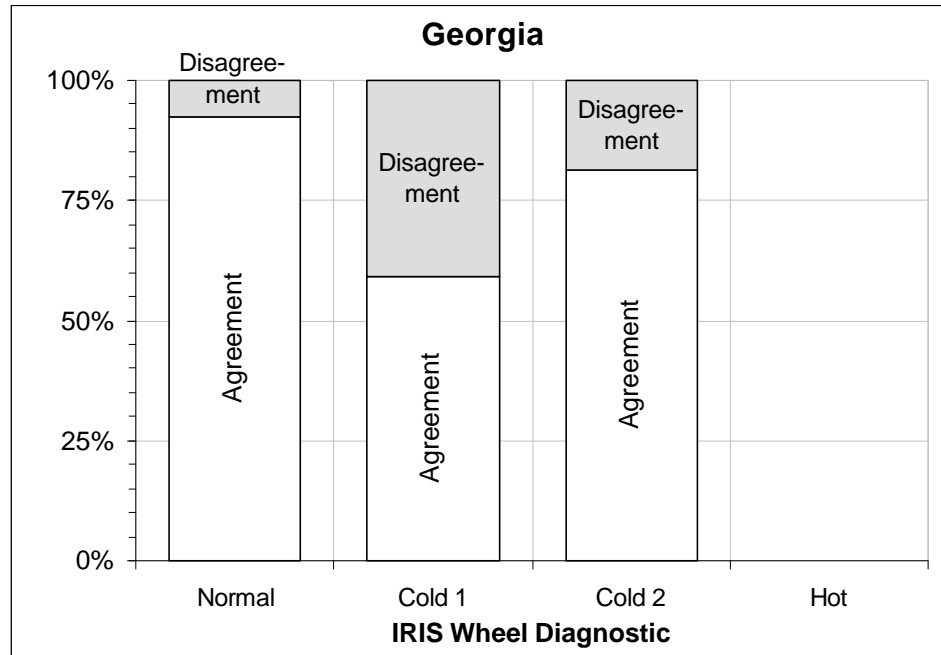
**Figure I-2. Percentage of agreement between the IRISystem screening results and the Level 1 inspection results as a function of IRISystem wheel diagnostic. “Cold 1” and “Cold 2” refer to two different comparisons, with wheel-specific violations and brake-related violations, respectively.**

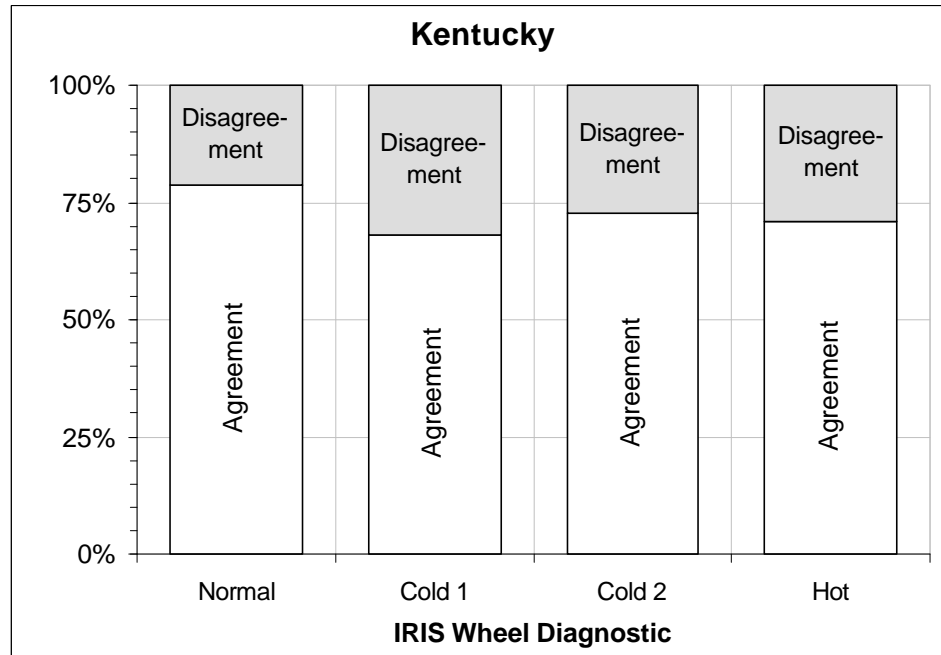
**Figure I-3. Percentage of agreement between the IRISystem screening results and the Level 1 inspection results as a function of IRISystem wheel diagnostic. “Cold 1” and “Cold 2” refer to two different comparisons, with wheel-specific violations and brake-related violations, respectively.**

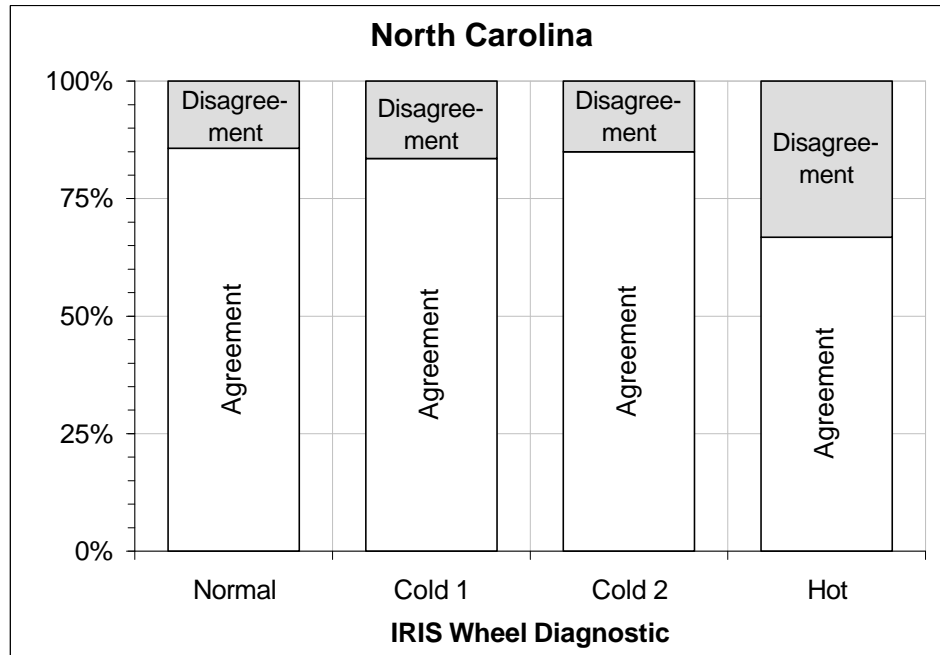
**Figure I-4. Percentage of agreement between the IRISystem screening results and the Level 1 inspection results as a function of IRISystem wheel diagnostic. “Cold 1” and “Cold 2” refer to two different comparisons, with wheel-specific violations and brake-related violations, respectively.**

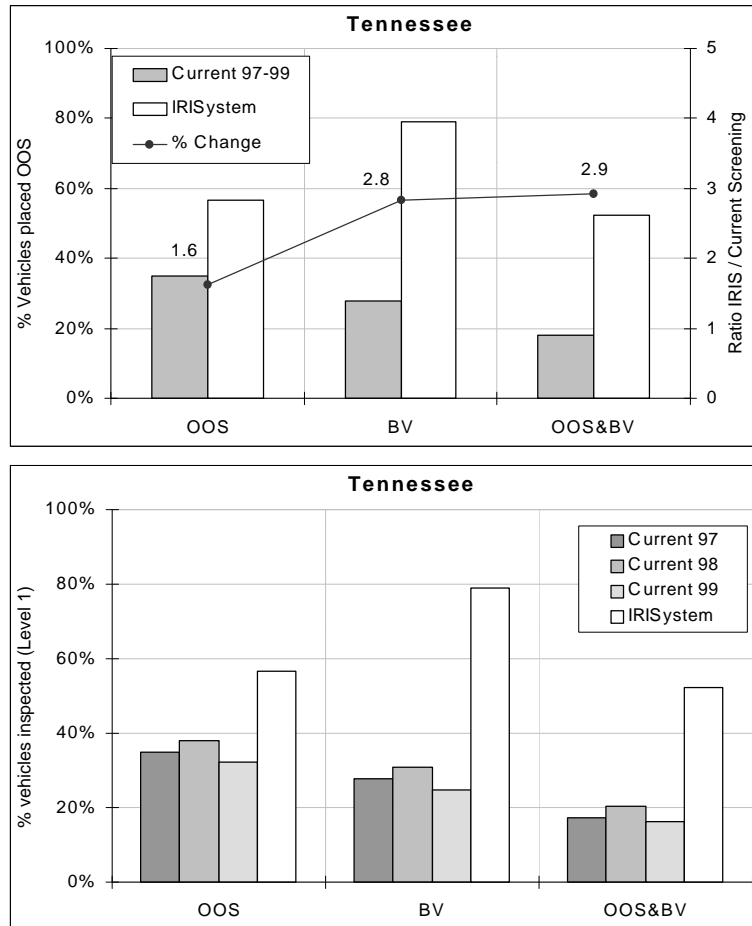
**Figure K-5. Tennessee**

**Top plot**      **Percentage of CMV placed OOS for Tennessee after IRISystem screening (no blind vehicles) and after current screening (SAFETYNET data, for 1997-1999 and Level 1 inspections).**

**Bottom plot**    **Same as top plot, but showing SAFETYNET data per year.**
