THREE-YEAR COMPREHENSIVE MONITORING REPORT

**BOSTON CANAL/VERMILION BAY SHORELINE
PROTECTION
T/V-09**

**Second Priority List Shoreline Protection Project
of the Coastal Wetlands Planning, Protection, and Restoration Act
(Public Law 101-646)**

September 1998

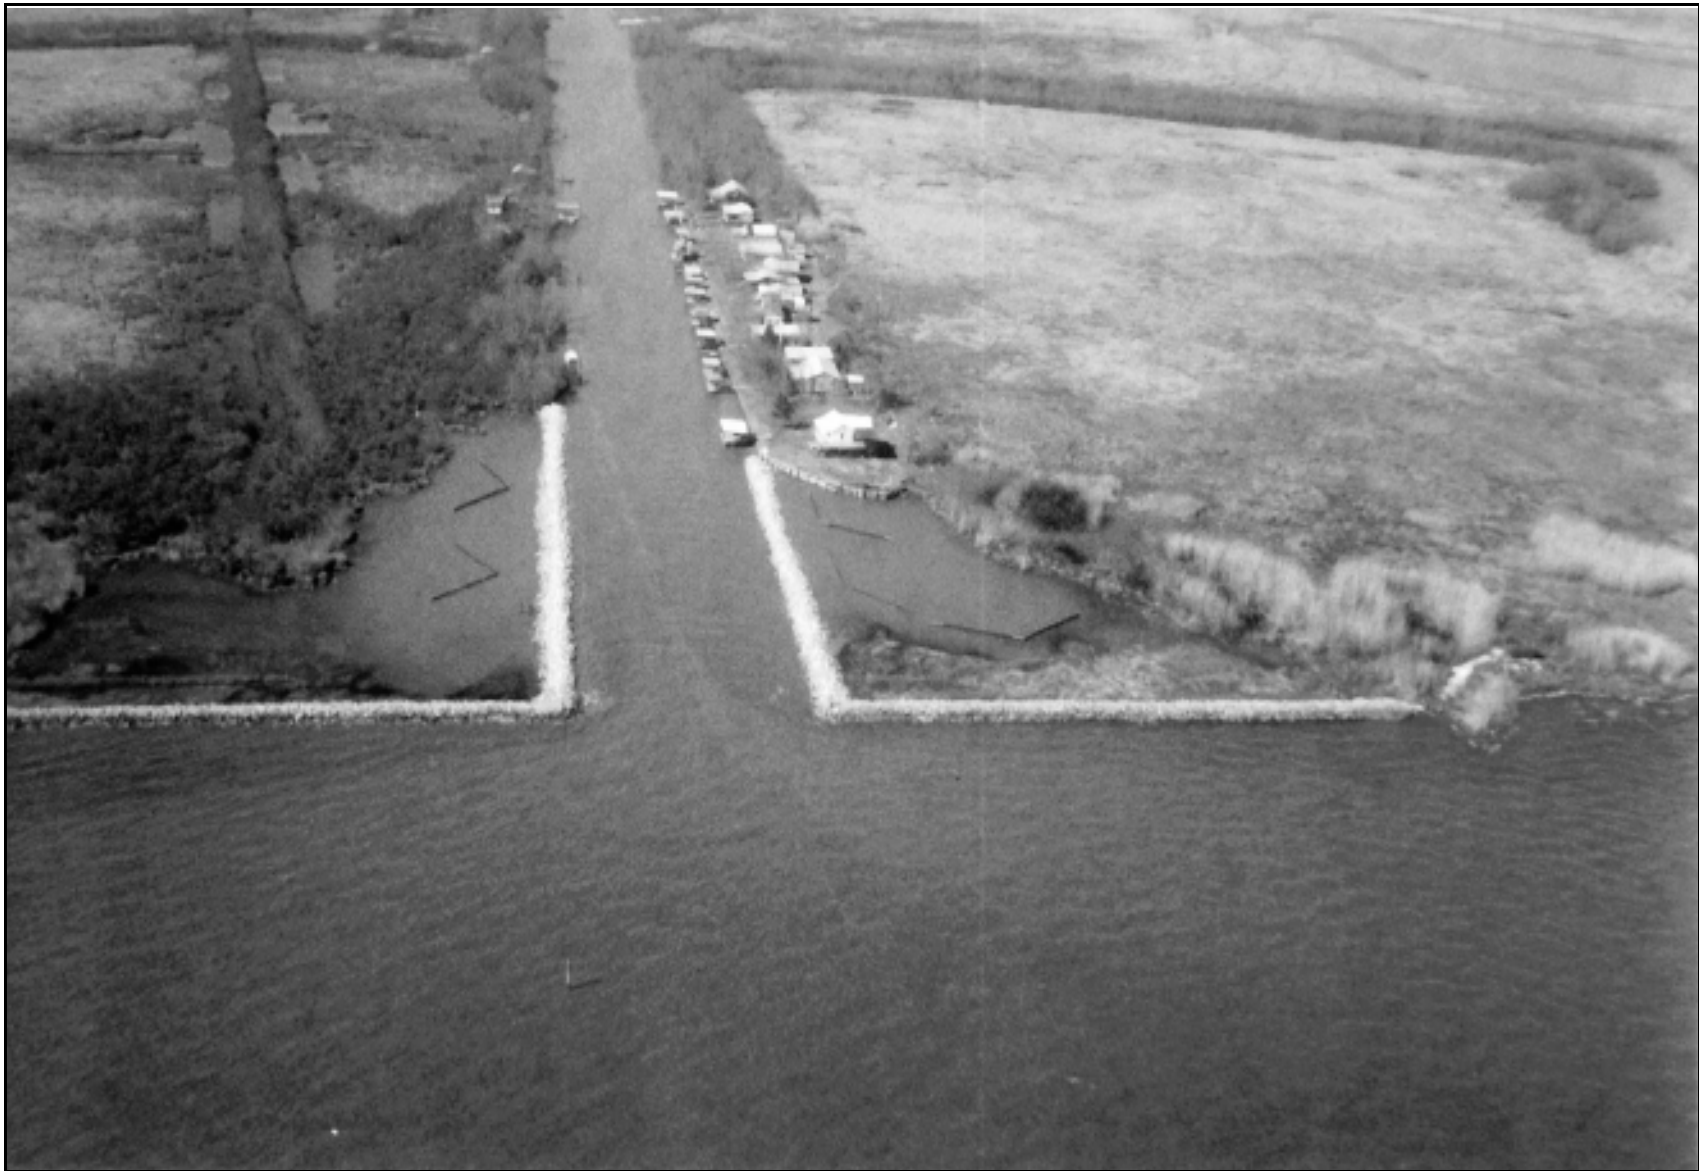
Figure 2. Boston Canal/Vermilion Bay Shoreline Protection (T/V-09) rock breakwaters and sediment fences at the mouth of Boston Canal.

The Boston Canal/Vermilion Bay Shoreline Stabilization (T/V-09) project was designed to abate wind-driven wave erosion along Vermilion Bay and at the mouth of Boston Canal. In December 1994, rock breakwaters were constructed parallel to the banks of Boston Canal, extending into Vermilion Bay and then turning 90 degrees to follow the bay shoreline (figure 2). Behind the breakwaters, sediment fences were installed to capture sediment during overwash events. In October 1995, approximately 34,000 trade gallon-size plants of *S. alterniflora* were installed along 14.3 mi (23 km) of bay shoreline, from Mud Point on the western end to Oaks Canal on the eastern end.

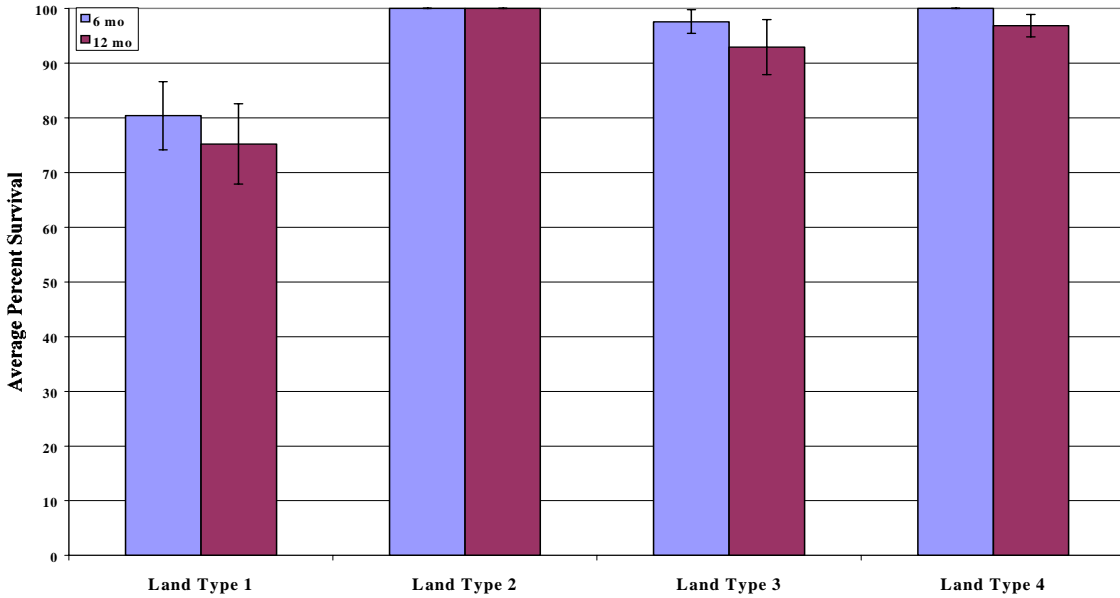
Figure 3. Boston Canal/Vermilion Bay Shoreline Protection (T/V-09) average percent survival of *Spartina alterniflora* plantings in land types 1–4 observed at 6 and 12 months postplanting, 1995 and 1996, means \pm SE.

Among land types, survivorship of *S. alterniflora* plantings differed significantly only at 6 mo postplanting ($F = 3.16$, $P = 0.03$). Average percent survival among land types ranged from 80.43 to 100% at 6 mo and from 75.25 to 100% at 12 mo postplanting (figure 3). Percent cover differed significantly among land types at both 6 mo ($F = 4.76$, $P < 0.01$) and 12 mo ($F = 3.86$, $P < 0.01$) postplanting (figure 4). Some differences in survival and percent cover of plantings among land types may have been attributed to differences in *P. australis* coverage within land types (table 2); however, due to non-normality, we could not check for interactions between land type and *P. australis* cover. Among levels of *P. australis* coverage, survivorship of *S. alterniflora* differed

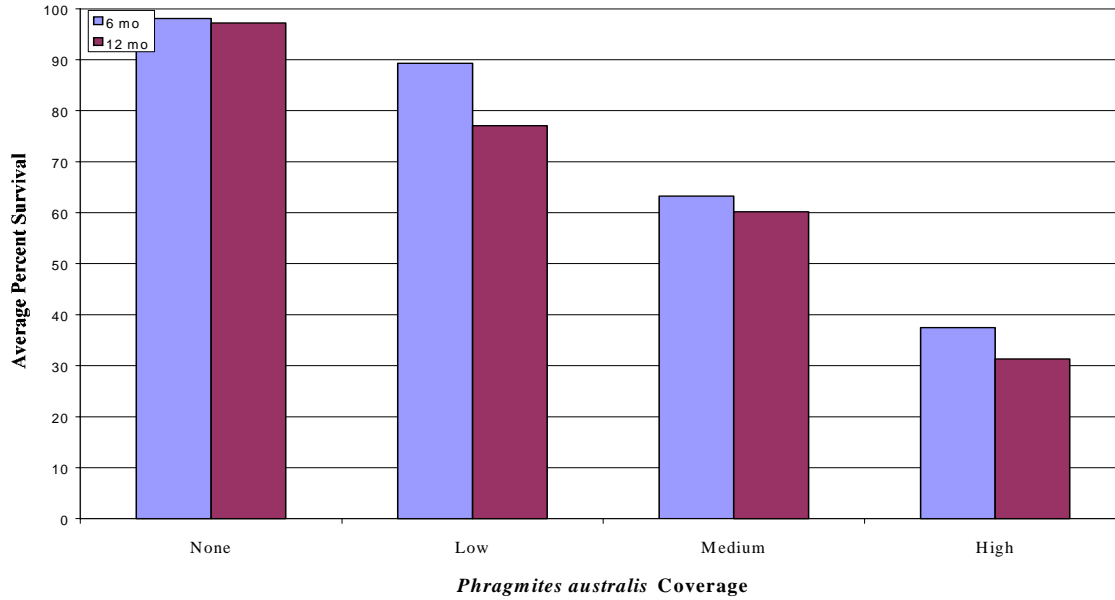
Figure 5. Boston Canal/Vermilion Bay Shoreline Protection (T/V-09) average percent survival of *Spartina alterniflora* plantings at 6 mo and 12 mo postplanting in none, low, medium, and high levels of *Phragmites australis* coverage.

significantly at 6 mo ($F = 7.85, p < 0.01$) and 12 mo ($F = 6.11, p < 0.01$) postplanting, as did percent cover at 6 mo ($F = 5.91, p < 0.01$) and 12 mo ($F = 11.57, p < 0.01$) post planting. The highest mean survival and mean percent cover of plantings occurred at the lowest levels of *P. australis* coverage during both sampling periods (figures 5 and 6).

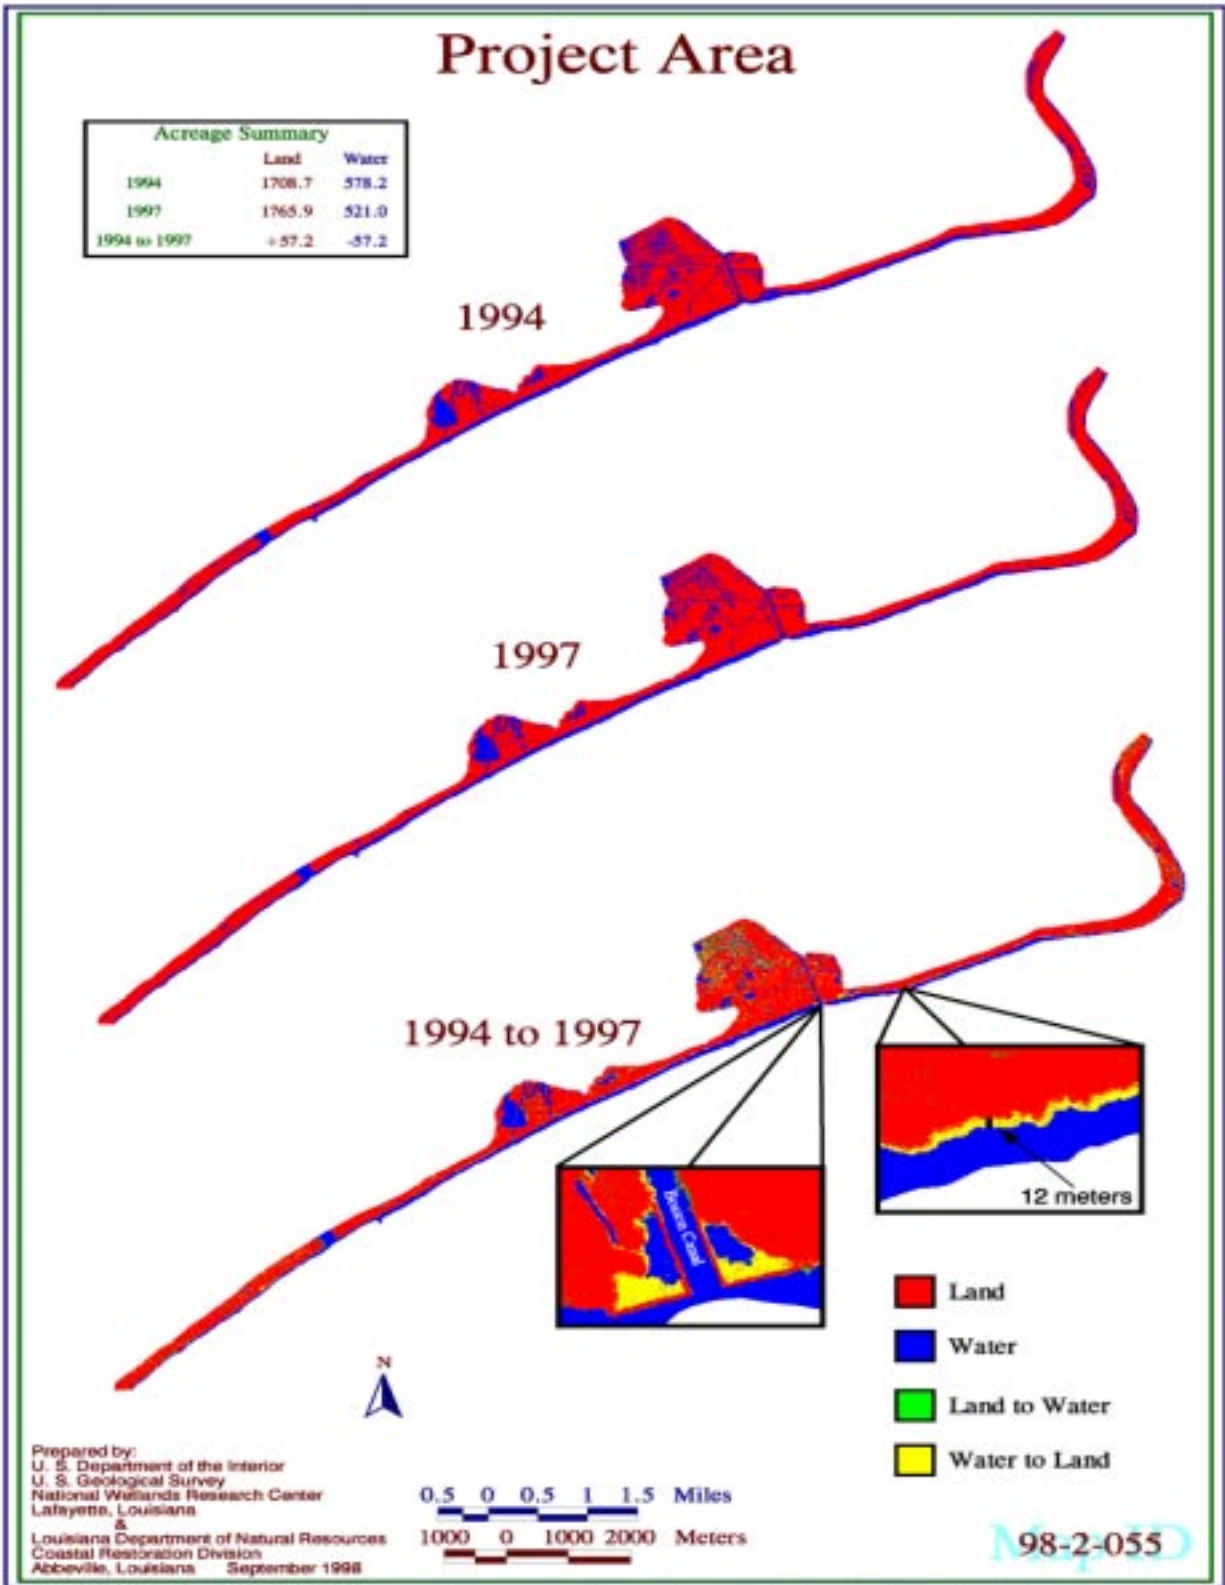
Figure 10. Boston Canal/Vermilion Bay Shoreline Protection (T/V-09) GIS Land/Water analysis of project area.

GIS Land/Water analysis comparing preconstruction and postconstruction photography revealed shoreline regression in the reference area, whereas the project area showed a marked increase in the ratio of water to land. Difficulties associated with the interpretation of this photography included marsh burn, which could be interpreted as water, and wave white capping, which could be interpreted as shoreline. One of the heaviest shoreline erosion rates occurred on the west side of the shoreline at the intersection of Vermilion River Cutoff and Vermilion Bay.

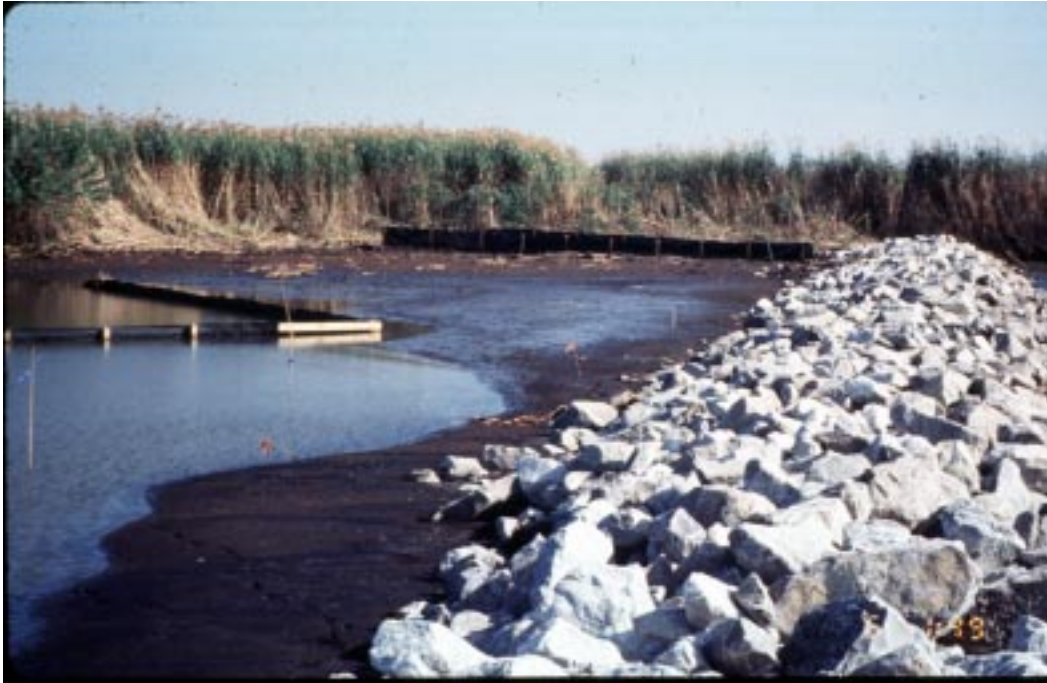
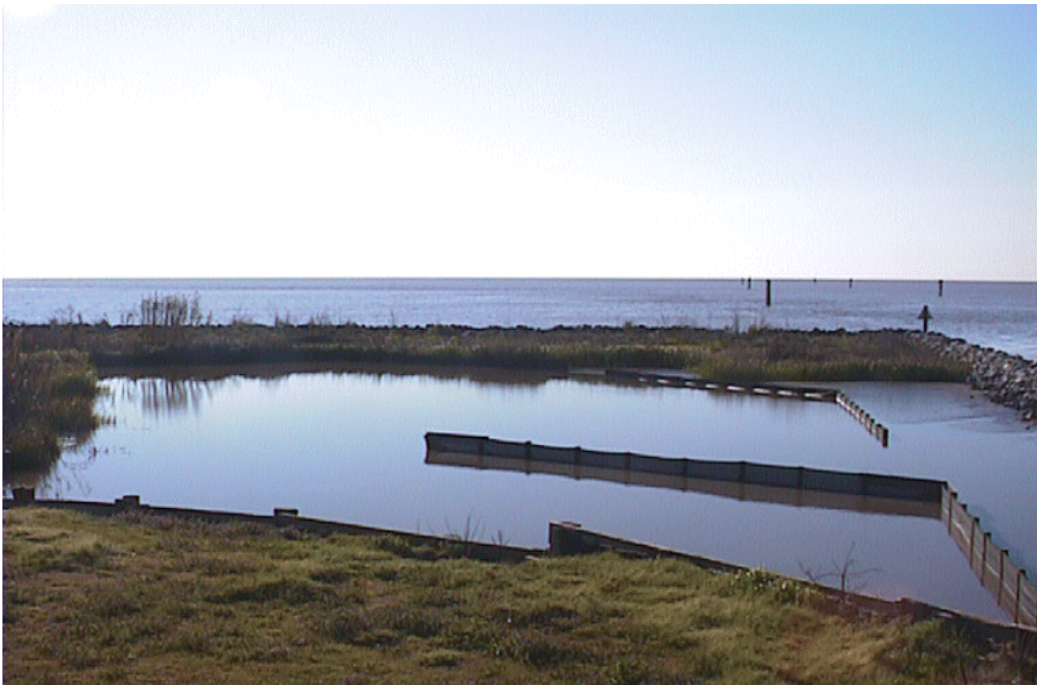
Figure 12. Boston Canal/Vermilion Bay Shoreline Protection (T/V-09) photographs: (A) sediment deposition, December 1994; (B) vegetation behind rock breakwater; February 1998.

Observations to date suggest that the rock breakwaters have been effective in promoting sediment deposition and retaining this sediment at the mouth of Boston Canal (figure 12). Sediment laden waters appear to be overtopping the rock breakwater due to high water periods and boat traffic near the mouth of Boston Canal. Thus far, sedimentation is greatest in front of the sediment fences on the bay side. It appears that the fences closest to the bay are impeding the uniform distribution of sediments. Therefore, it is recommended that the sediment fences be removed to allow more uniform accumulation of sediment throughout the entire area behind the breakwater.

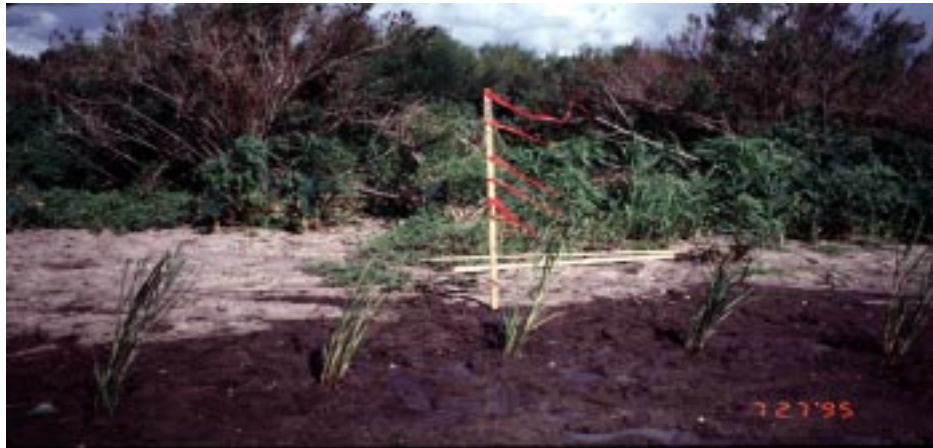
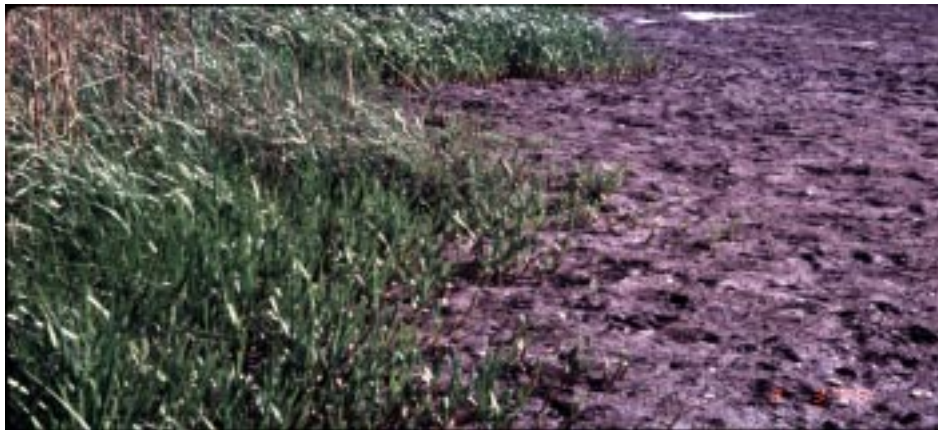
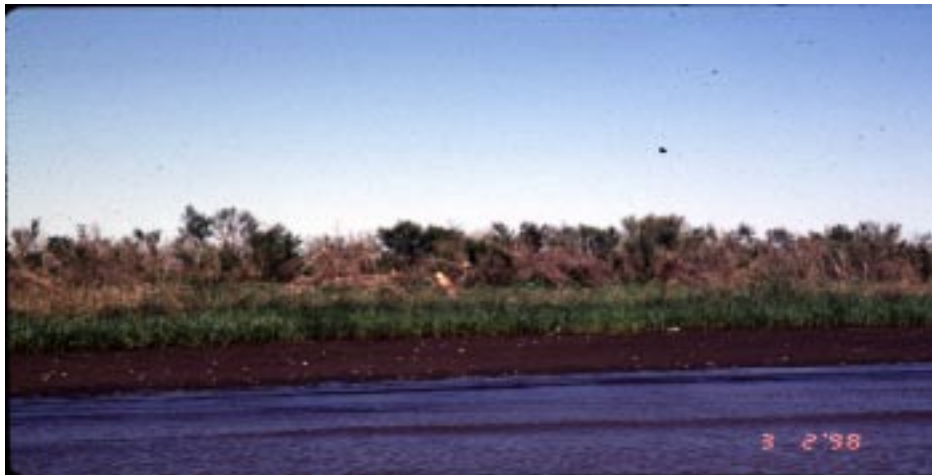
Figure 13. Boston Canal/Vermilion Bay Shoreline Protection (T/V-09) photographs: (A) *Spartina alterniflora* planting, July 1995; (B) tillering of *Spartina alterniflora*, March 1998; (C) three year growth of plantings, March 1998.

The high survival rates of *S. alterniflora* plantings recorded after one year indicate that this is an ideal species for establishment in this environment. Personal observation of the plantings in May 1998 indicate that the 1999 vegetation survey may reveal the original plants to be indistinguishable from each other due to tillering resulting in lateral spread of the plantings (figure 13). Their effectiveness in minimizing shoreline erosion will be determined after all subsequent shoreline surveys are conducted. The data indicates that *S. alterniflora* should not be installed in well established stands of *P. australis*. However, plants installed bayward of *P. australis* exhibited high rates of survival. This information may be used to modify future projects being constructed to prevent planting in environments where there may be little likelihood of survival.
