Michael F. Crowe

Turning White Elephants Into White Knights

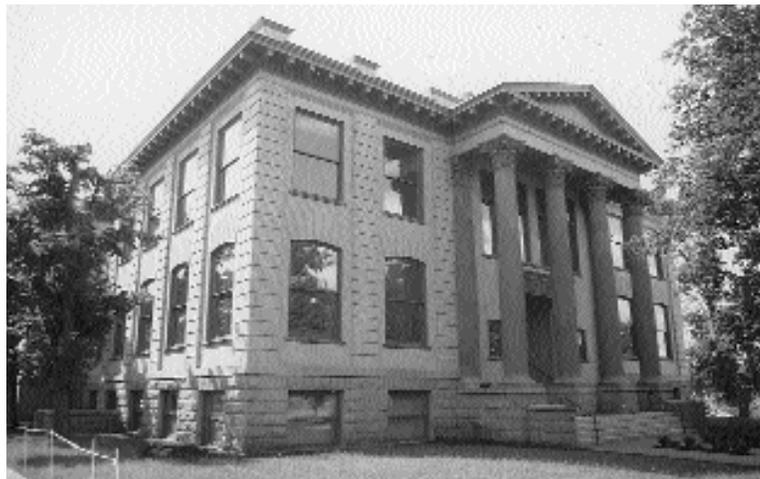
The former Spokane Main Public Library, Spokane, Washington, was rehabilitated into the Integrus Architectural offices. Photo courtesy NPS.

The former Main Public Library occupies a unique site at the edge of downtown Spokane, Washington in the Riverside Avenue Historic District. Because of the confluence of several streets, it is the single occupant of an unusually shaped lot, giving it a marked visual presence in the community. In 1962, the building changed use from a library and became the Intercollegiate School of Nursing through the late 1970s, when the school closed. Despite its prominent location, it remained a tarnished presence until 1992, when a local architectural firm saw the building's potential and submitted plans for the adaptive re-use as its offices.

The library building is part of a thematic district of Carnegie libraries in the State of Washington. It was built in 1904 from the designs of the local firm of Preusse and Zittel. The building is a good example of the Classic Revival Style, popularized by the 1893 World's Columbian Exposition held in Chicago. The grey brick building is most notable for its imposing two-story pedimented porch with terra cotta Corinthian columns, large windows, and central two-story skylit atrium. Large reading rooms with decorative brick fireplaces and wide-arched openings flank the atrium space on the first floor. There were other notable details on the interior including a patterned tile floor, finely detailed metal stair railings, and two tiers of free-standing Tuscan columns supporting the second floor walkway and skylight.

A local architectural firm selected the building because of its prominent central location and the support from the community for its preservation. The large reading rooms were ideal for the large open spaces needed for drafting and designing. Clear glazing was added in the arched

openings to provide open office areas shielded from the atrium entrance noises. There was still a need for smaller offices for the principals in the firm. These were inserted at one end of the reading room opposite the fireplace. Less than full height partitions allowed the sense of space to be retained while providing the sound privacy needed. The smaller back-office areas, with minor alterations, were able to be adapted for additional private offices. The architects also took great care to minimize the impact of installing new HVAC by concealing it, particularly in the former reading rooms and other public spaces.

Disabled access was provided at a near-grade entrance immediately adjacent to the parking lot. Because of its proximity to the parking lot, this entrance is the preferred entrance. With grading, removal of a few steps, retention and repair of a stone retaining wall, the entrance could accommodate wheelchair access. This entrance also provided access to an existing elevator which was upgraded and now provides access to all floors.

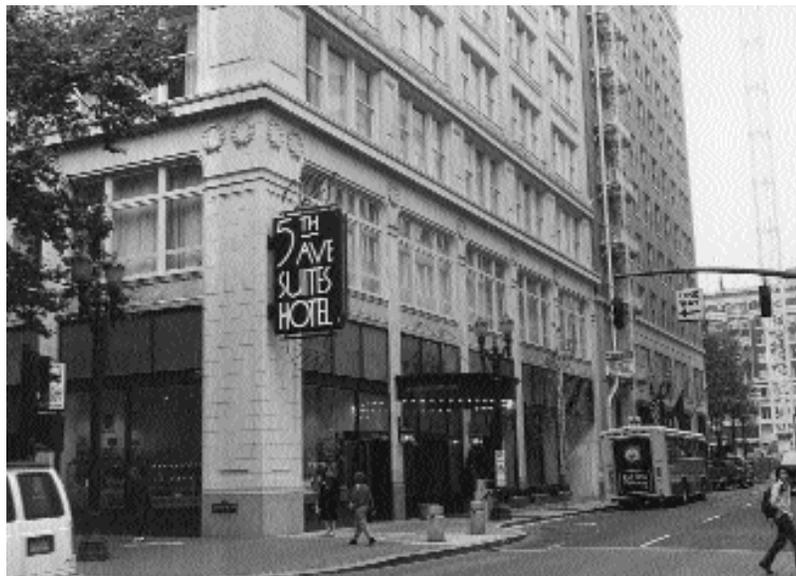
The former Lipman Wolfe and Company building, Portland, Oregon, is now the Kimco Company's 5th Avenue Suites Hotel. Photo courtesy Heritage Investment Company.

In Portland, Oregon, the Lipman Wolfe and Company Department Store building had been a white elephant in the downtown since 1980 when the company ceased operations. Its 10-story classically-detailed white terra cotta exterior is most notable but its re-use was uncertain. The building is individually listed in the National Register for the significance of its association with the Lipman

bosses had been lost from the cornice and other areas had damage. The Chicago-style windows, edged with spiral moldings and paneled spandrels, were in fairly good shape. Wreaths, egg and dart moldings, water leaf moldings, and meander frets enriched the monochromatic color scheme. Insensitive first floor canopies hid other details.

For these reasons, the adaptive re-use for hotel, restaurant, and commercial use did not present such formidable problems to the new owner, a San Francisco-based hotel chain, which acquired the building in 1995. First floor commercial uses could be easily established with new entries and reopening of the partially blocked windows. Other exterior work included the restoration of the missing terra cotta decorative details such as the lions heads. Two new canopies to mark the new hotel and restaurant uses were added along with signage to mark the commercial shops.

Because of the large, relatively unobstructed floor plate configuration, the insertion of hotel room suites could be accomplished without impacting historic features. Room suites were placed along the three sides of the building with windows. The large windows were ideal in creating the rooms because of the commanding views of downtown Portland. Meeting and conference rooms were placed in the center core of the plate. Emergency exit stairs, elevators, and other services not requiring natural light and ventilation were

One of the constraints was aligning the new walls of the rooms with the window configuration. All walls were able to be placed against vertical dividers or recessed away from the vertical muntins to minimize any visual impact. The project, which was just recently completed, has returned a major building in the heart of a thriving downtown to a viable new use.

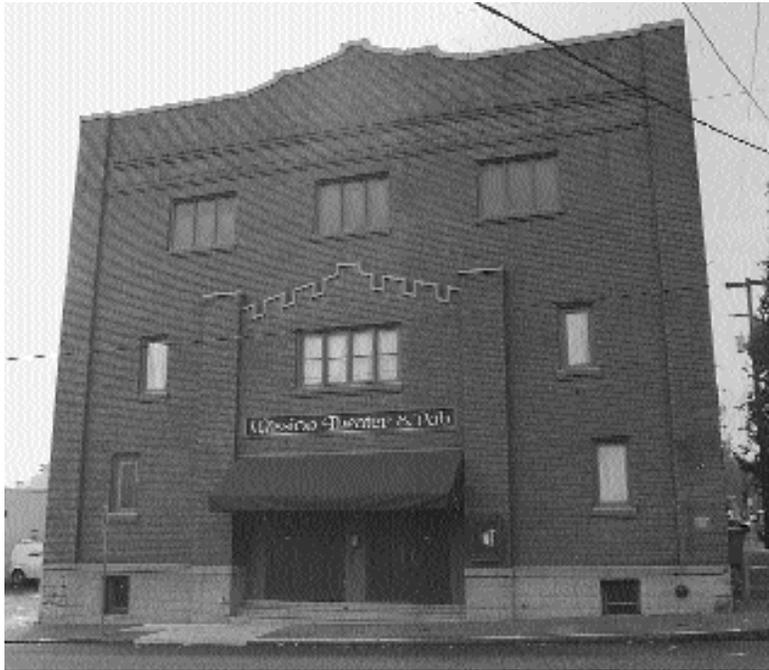
The former Swedish Evangelical Mission Covenant Church, Portland, Oregon, was transformed into the Mission Theater and Pub. Photo courtesy Heritage Investment Company.

Although the designer is unknown, the two-and-a-half-story red brick building has minimal architectural features suggesting an ecclesiastical use. It has a very solid appearance, possibly due to the congregation's thinking that it could eventually be sold as a warehouse should such a need arise in the future. The main entrance is marked by a raked machicolated pediment. On the west elevation, simple pilaster strips separate three segmental brick wall arches which enframe two tiers of windows. The other elevations are minimally detailed. The Union had removed the crosses from the parapets when it used the building.

The rehabilitation work entailed the repainting and repair of the windows and doors, adding an entrance canopy, and signage. The single panel metal entry doors were replaced with paneled wood doors similar to those on

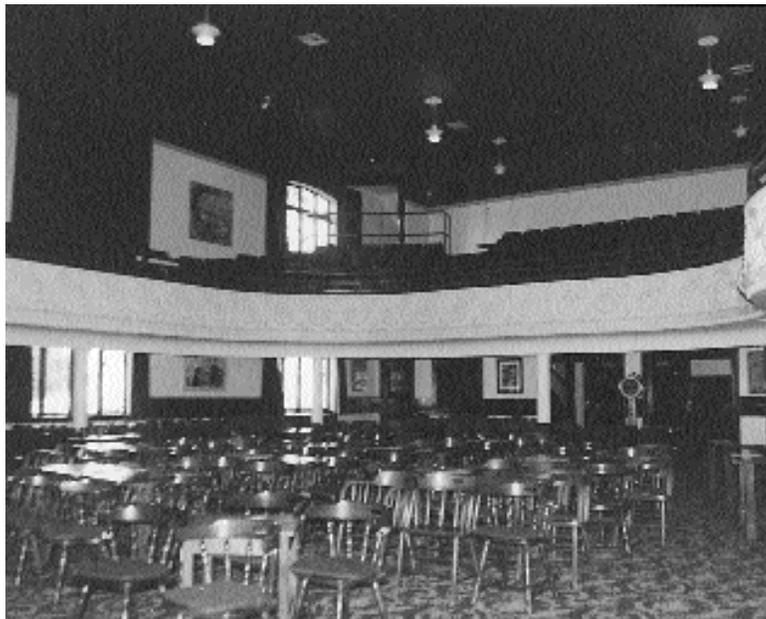
The interior of the former Swedish Evangelical Mission Covenant Church, Portland, Oregon, now the Mission Theater and Pub, illustrates the adaptation of the building to a new use. Photo courtesy Heritage Investment Company.

The two-story interior is also simply detailed and had been modified when used by the Union. At that time, the first floor pews were removed and the wood floor was surfaced with linoleum tile. However, the balcony with its decorative fascia apron remained as did some of the theater style seats.

the interior. The primary change on the interior was the addition of a railing along the balcony to raise the height to meet code. The linoleum was covered with carpeting and service bars were added to the rear of both the first floor and balcony.

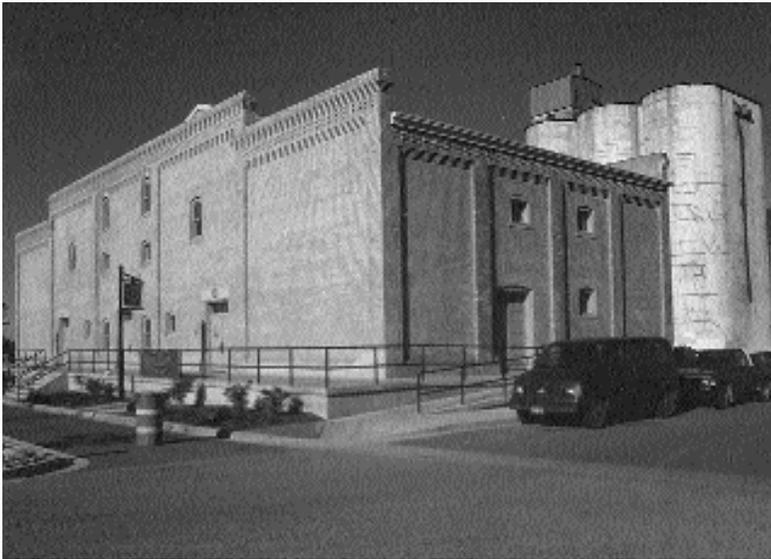
The former Twin Falls Milling and Elevator Company Warehouse, now the Old Mill Building Brew Pub in Twin Falls, Idaho, was rehabilitated while providing a new disabled access ramp. The silos to the right of the picture are separate structures and were not part of the tax credit project. Photo courtesy NPS.

Although constructed for an agricultural/ industrial purpose, the building is not without architectural interest. Apart from its sheer size, the buff colored brick building's main elevation features a stepped cornice with corbeled banding and narrow pilaster strips. The three five-paneled double doors with transoms and segmentally arched single and double-hung windows are arranged in a symmetrical pattern. The other elevations are simi-

The exterior brick was gently cleaned and repointed. The former concrete loading dock was repaired and a new industrial type railing was added. An extension of the loading dock along a side elevation immediately adjacent to the parking area easily accommodated disabled access. Landscaping was kept to a minimum to enhance the industrial character.
