Monitoring Series No. TE-23-MSTY-0605-1

COMPREHENSIVE REPORT NO. 1  
For the Period November 8, 1997 to February 18, 2004

**West Belle Pass Headland Restoration  
TE-23 (PTE-27)**

**Second Priority List Marsh Creation and Shoreline Protection Project  
of the Coastal Wetlands Planning, Protection, and Restoration Act  
(Public Law 101-646)**

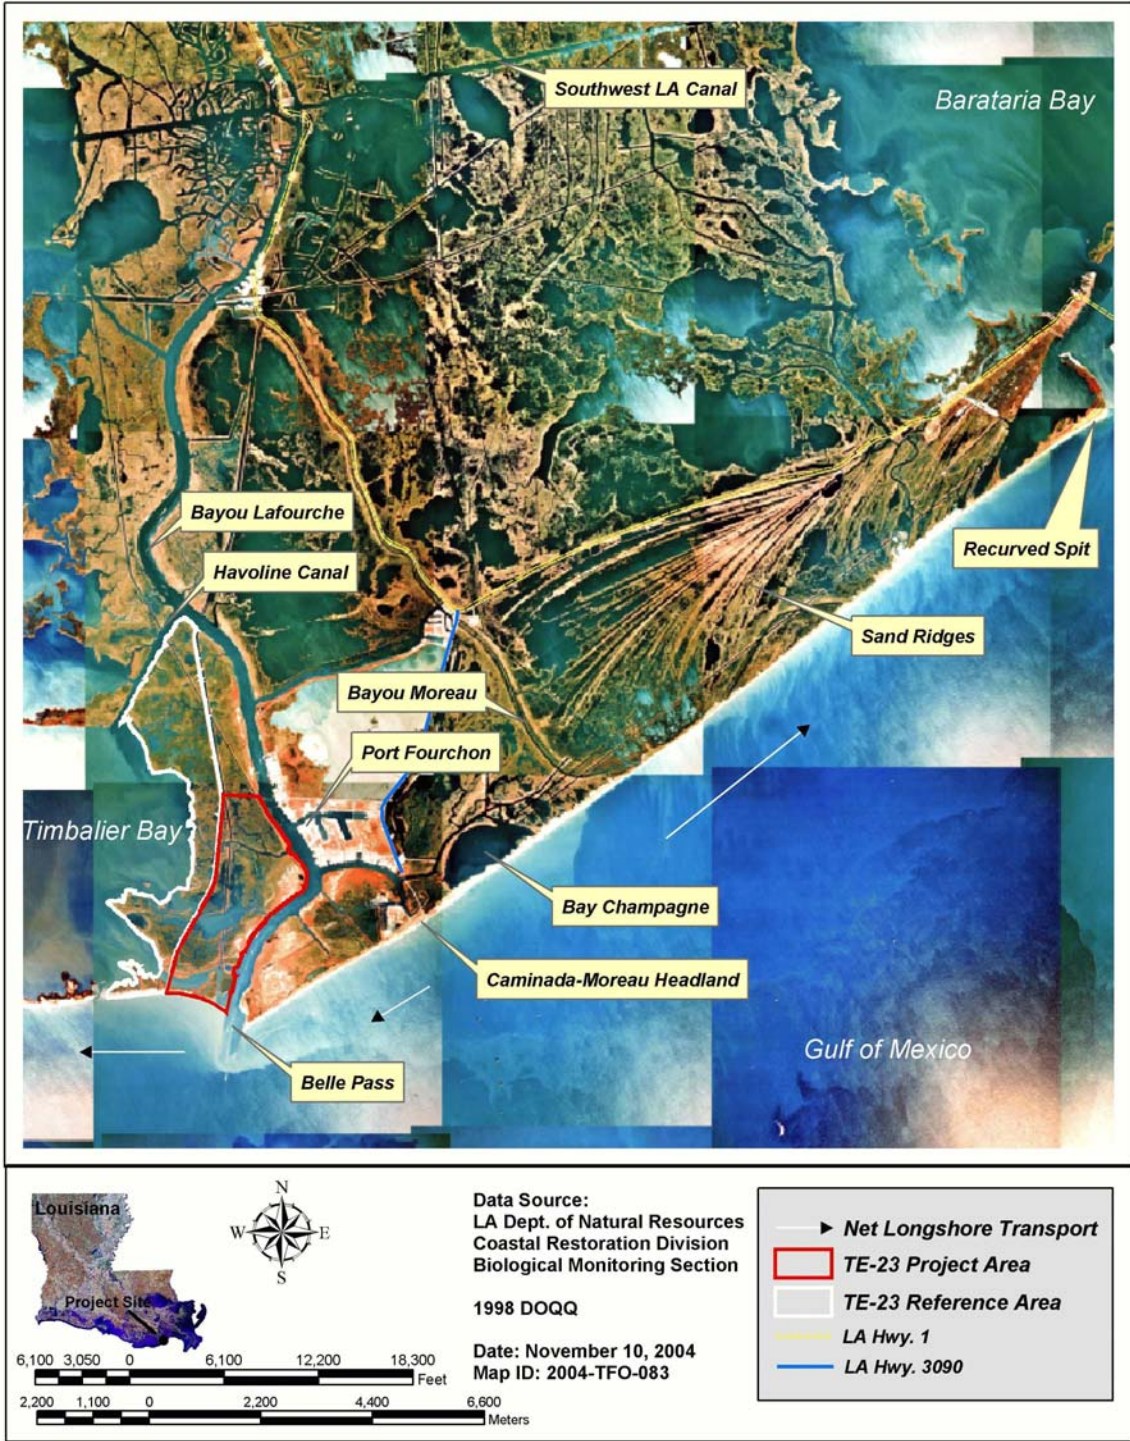
Figure 2. Geomorphic features of the Caminada-Moreau Headland.

Natural and anthropogenic changes have modified the longshore transport and geomorphology of the Caminada-Moreau Headland. Jetties and groins have been found to obstruct sand transport along beaches causing erosion on the downdrift side of these structures (Komar 1998; Conaster 1971) and are likely contributors to alterations in sediment transport in the project area. The direction of the net longshore transport along the headland has been altered by the creation of a wave shadow and the installation of rock jetties at Belle Pass. The extension of the Modern delta lobe to the continental shelf has created a wave shadow, which has caused the net longshore transport to shift in a direction contrary to the geological record (Otvos 1969; Conaster 1971; Harper 1977). The net longshore transport now flows in a northeastern direction throughout half of the Caminada-Moreau Headland, causing accretion and recurved spit formation on the eastern portion of this headland while the central portion is transgressing (figure 2) (Stone and Zhang 2001; Otvos 1969; Conaster 1971; Harper 1977; Dantin et al. 1978). On the other half of the headland, net longshore transport is in the southwestern direction, causing accretion on the updrift side (eastern jetty) and erosion on the downdrift side (western jetty) of the Belle Pass rock jetties (figures 2 and 4) (Stone and Zhang 2001; Harper 1977; Ritchie and Penland 1988b; Dantin et al. 1978; Boyd and Penland 1981). West of the rock jetties net longshore transport is in the western direction (figures 2 and 4) (Stone and Zhang 2001; Ritchie and Penland 1988b; Peyronnin 1962; Dantin et al. 1978).

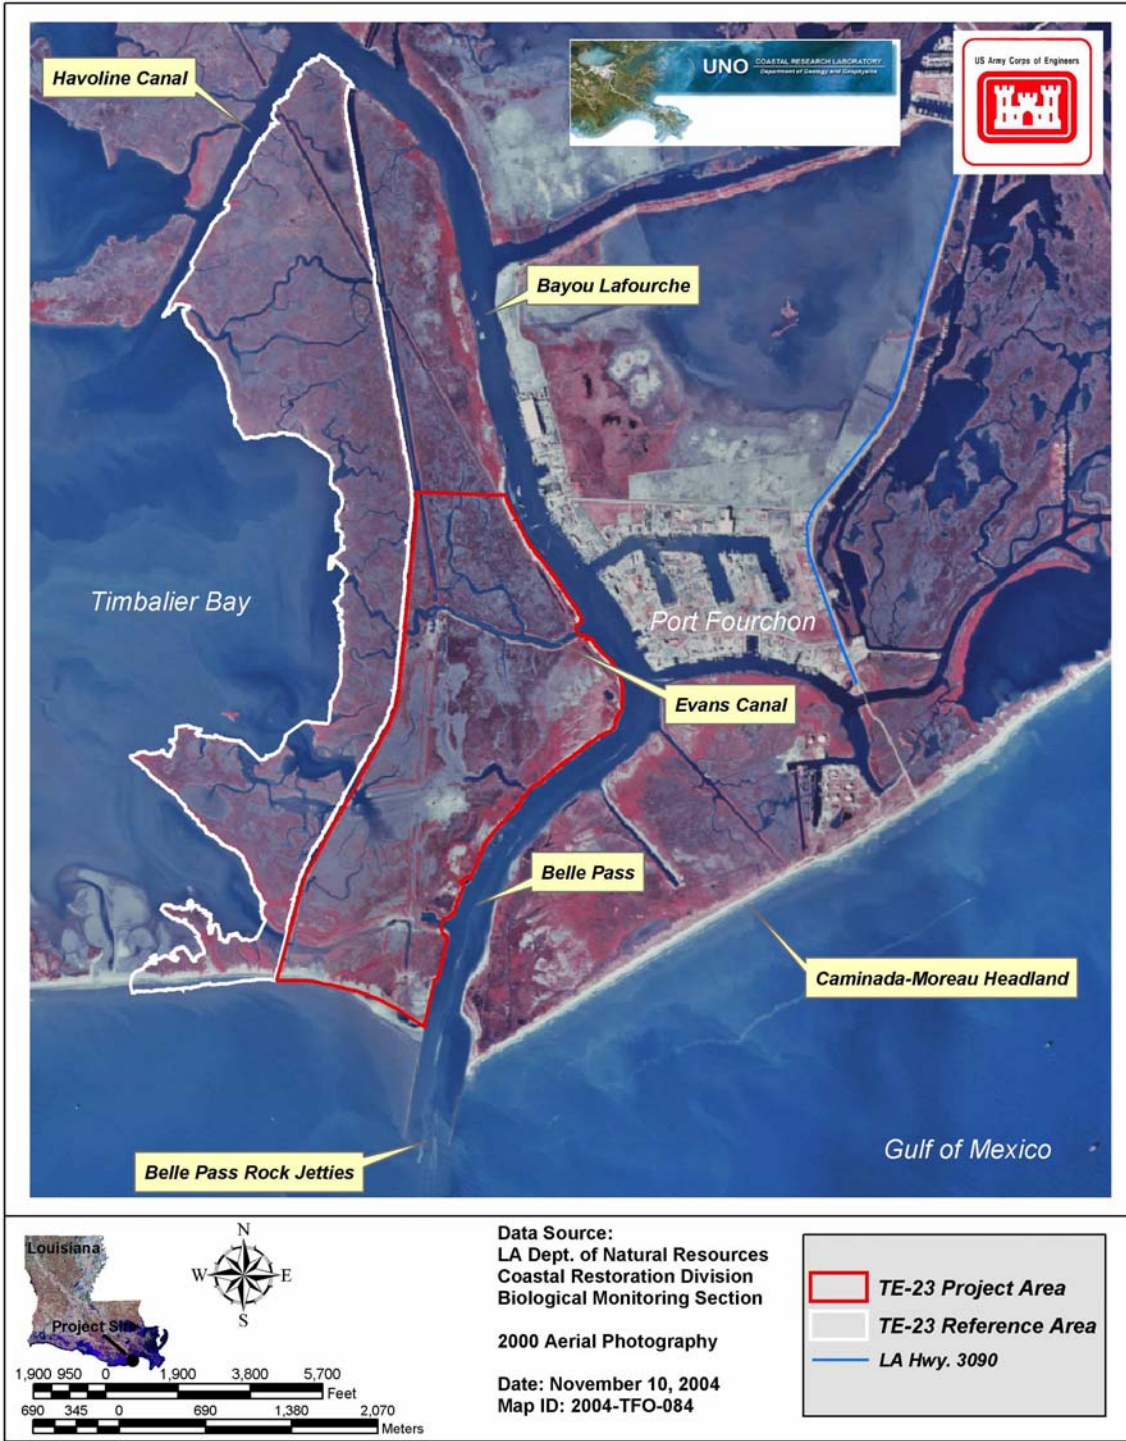
**Figure 3.** Location of the West Belle Pass Headland Restoration (TE-23) project and reference areas. 2000 aerial photography provided courtesy of the University of New Orleans/Coastal Research Laboratory (UNO/CRL) and USACE-NOD.

The West Belle Pass Headland Restoration (TE-23) project is a shoreline protection and saline marsh creation project located on the southwestern portion of the Caminada-Moreau Headland at the interface of the Belle Pass navigation channel and the Gulf of Mexico in Lafourche Parish, Louisiana (figures 1, 2, and 3). This project is located directly across the Bayou Lafourche navigation channel from Port Fourchon (figures 2 and 3). The project was federally sponsored by the United States Army Corps of Engineers, New Orleans District (USACE-NOD) and locally sponsored by the Louisiana Department of Natural Resources/Coastal Restoration Division (LDNR/CRD) under the Coastal Wetlands Planning, Protection, and Restoration Act (CWPPRA, Public Law 101-646, Title III). The project area consists of 1341 acres (543 ha) of saline marsh, scrub-shrub, beach/bar/flat, and open water habitats (figure 3).

Pass Headland Restoration (TE-23) project's habitat mapping reference area lies directly west of the project area, forms its western border with Timbalier Bay , and stretches from the Gulf of Mexico to the Havoline Canal (figures 1, 2, and 3). This area was selected because it has similar vegetation, soils, and hydrology as the project area. The reference area is dominated by *S. alterniflora* and possesses a similar mixture of other plant species found in the project area.

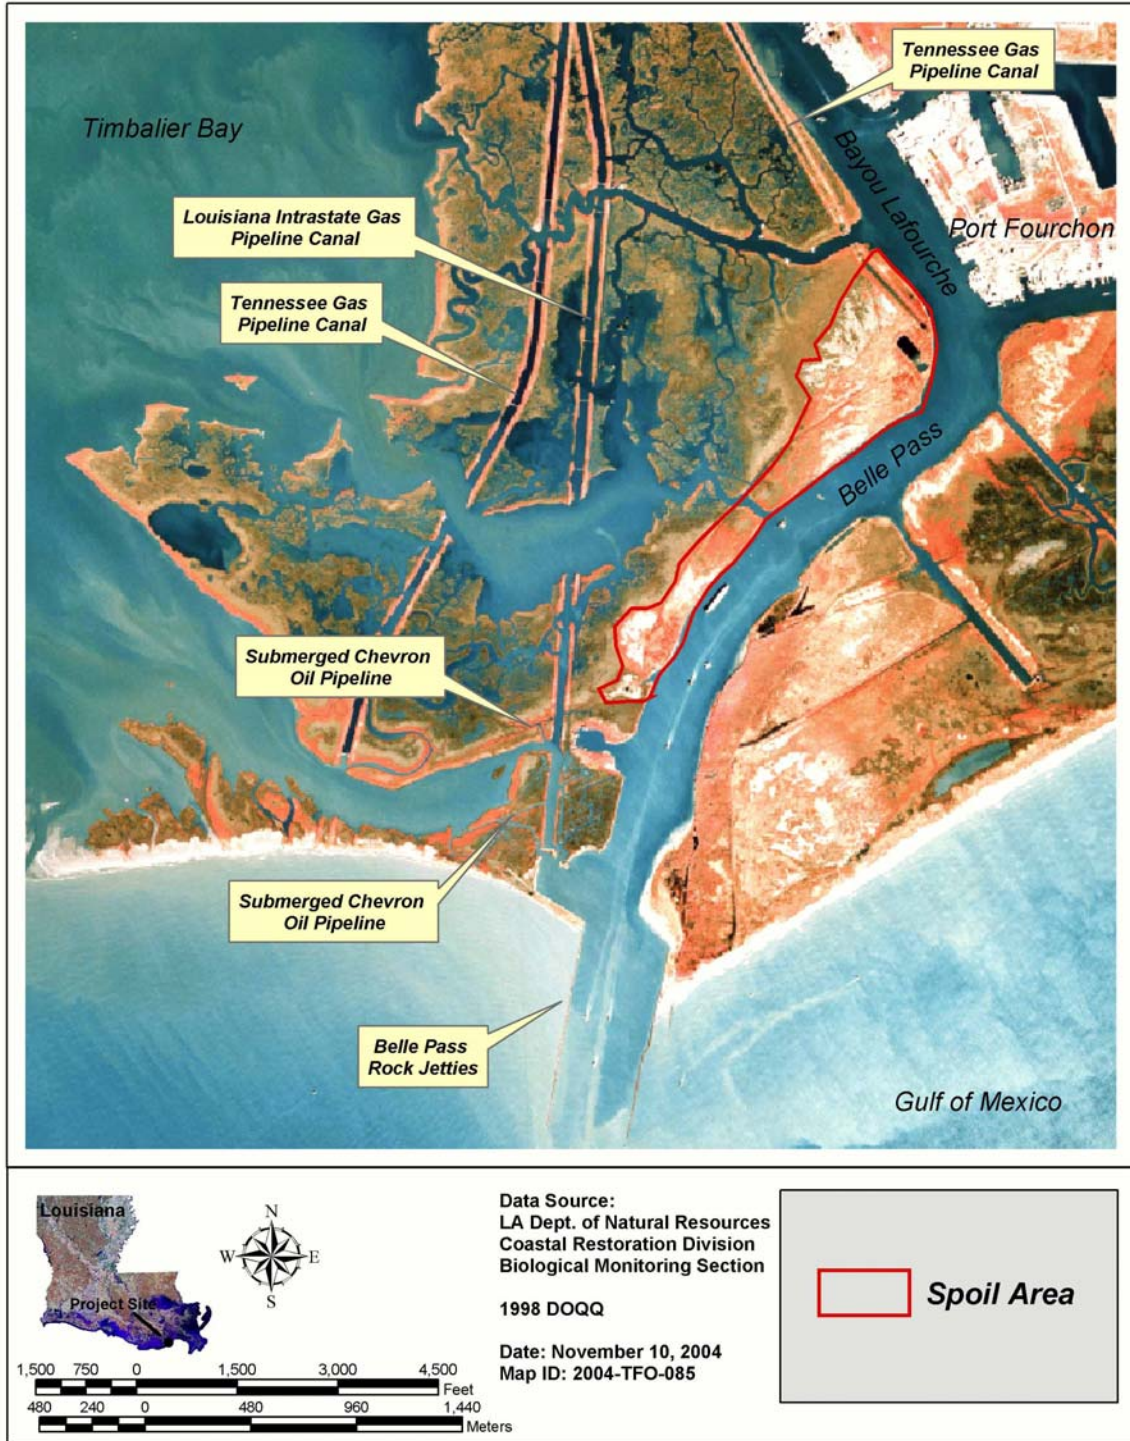
**Figure 4.** Anthropogenic modifications affecting hydrology and sediment distributions at the West Belle Pass Headland Restoration (TE-23) project. These alterations predate project construction.

The construction of the Bayou Lafourche and Belle Pass navigation channel, the Belle Pass rock jetties, three pipeline canals, and two submerged pipelines (figure 4) have altered the West Belle Pass Headland Restoration (TE-23) project area marshes. Belle Pass dredging and jetty construction began in 1940 by increasing the depth and width of the channel to unspecified dimensions and constructing parallel rock jetties 500.0 ft (152.0 m) in length and 200.0 ft (61.0 m) in width. The jetties were extended by 300.0 ft (90.0m) in 1945 due to shoreline erosion. In 1958, the navigation channel was enlarged to a depth of -12 ft (-3.7 m) Mean Low Gulf (MLG) and a width of 100 ft (30.5 m). The channel was expanded to a 125.0 ft (38.0 m) bottom width and relocated to the west of the jetties in 1963 leaving only an eastern jetty (Dantin et al. 1978). A western jetty was installed in 1974, and Belle Pass was dredged to a -20 ft (-6.1 m) MLG depth and a 300.0 ft (91.4 m) wide extent in 1975. In 1980, the jetties were extended to their current 2,600.0 ft (792.5 m) length and 1,200.0 ft (365.8 m) width (figure 4). Finally, the navigation channel was dredged to a -27.0 ft (-8.2 m) MLG depth in 2001 (D. Breaux, GLPC, pers. comm.). As previously discussed, the construction of these rock jetties disrupted the longshore transport processes along the Caminada-Moreau Headland considerably reducing the sand and sediment supply available to project area beaches (Stone and Zhang 2001; Harper 1977; Ritchie and Penland 1988b; Dantin et al. 1978; Boyd and Penland 1981). In addition, a second consequence of navigation channel expansion was caused by the establishment of a highly elevated spoil area (figure 4) along the project area shoreline prior to 1972 (Harper 1977). Moreover, this spoil bank was formed by disposing dredged materials onto the existing marsh surface causing the project area to become semi-impounded. The project area was further modified by construction of three pipeline canals and two submerged pipelines between 1952 and 1972 (Harper 1977; Williams et al. 1992). The pipeline canals also impounded and probably induced tidal scouring in project area marshes (Gagliano and Wicker 1989). The elevated spoil bank, the pipeline canals, and the submerged pipelines aided in the destruction of the remaining remnants of the western Belle Pass sand ridges and disrupted the natural hydrology of project area marshes (Ritchie 1972). Moreover, semi-impounded and impounded marshes have been found to prolong the

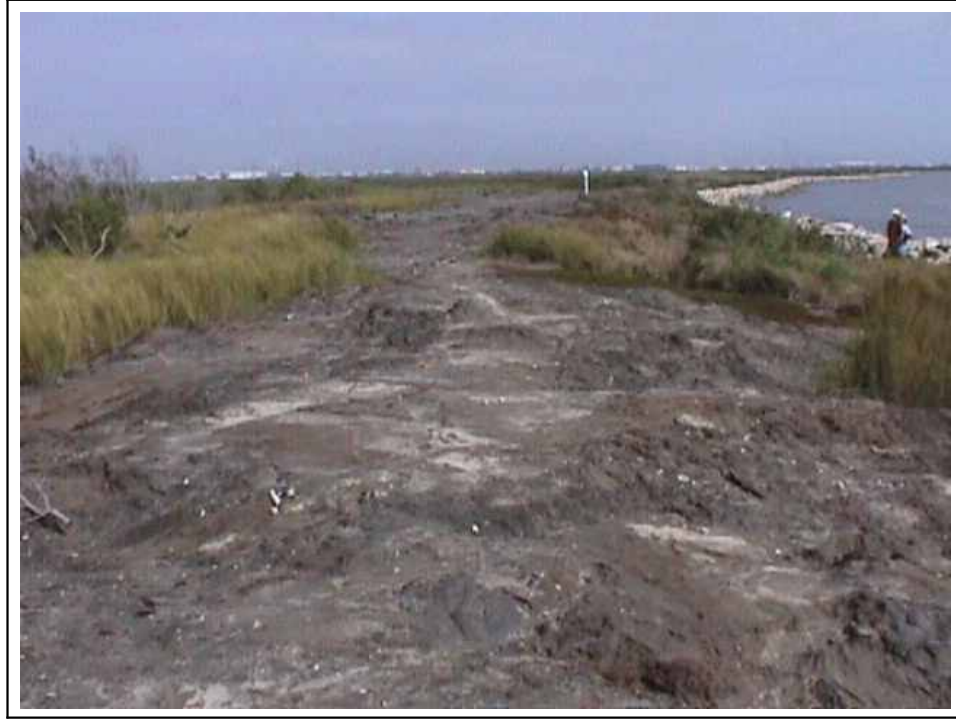
**Figure 7. February 2001 view of a segment of the flotation spoil bank at the West Belle Pass Headland Restoration (TE-23) project.**

*Foreshore Rock Dike:* To access the shallow areas close to the shoreline while constructing the foreshore rock dike, a 75.0 ft (22.9 m) wide flotation channel was dredged to a maximum depth of -8.0 ft (-2.4 m) Mean Low Gulf (MLG) along the entire length of the rock structure using a 6.0 yd<sup>3</sup> (4.6 m<sup>3</sup>) bucket dredge. The sediments dredged from the flotation channel were stacked behind the foreshore rock dike creating an elevated spoil bank directly behind the rock structure (figure 7). Approximately, 20,600 yd<sup>3</sup> (15,750 m<sup>3</sup>) of benthic sediments were displaced to create the flotation channel. The construction of the flotation channel began on February 23, 1998 and was completed on April 12, 1998.

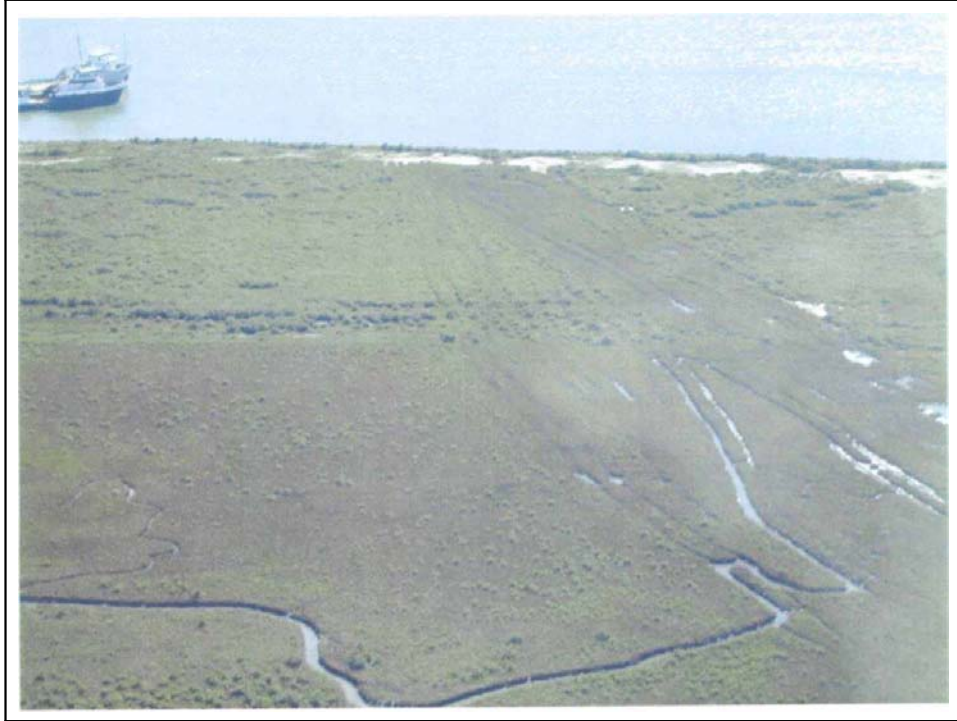
*Adverse Impacts:* Vegetated wetlands were needlessly damaged through improper construction procedures in violation of the West Belle Pass Headland Restoration (TE-23) project's consistency determination. Marsh buggies traversed across the project area repeatedly and often outside of the predetermined access corridors causing severe and moderate rutting throughout the project area (figures 8, 10, 11, and 12) (J. Harris, LDNR/CMD, pers. comm.). Moreover, the access corridors

**Figure 11.** February 2003 aerial view of severe marsh tracks located along Belle Pass in the vicinity of closure 4 at the West Belle Pass Restoration (TE-23) project.

*Remedial Activities:* Several restorative measures have been undertaken or proposed to alleviate the failures and impacts of the West Belle Pass Headland Restoration (TE-23) project. First, a second marsh creation phase is being planned for the closure 1 marsh creation area using funds remaining in the West Belle Pass Headland Restoration (TE-23) project construction budget (approx. \$800,000). Sediments will again be supplied through maintenance dredging of the Bayou Lafourche Navigation Channel. To date, a bathymetric survey of closure 1 and the closure 1 marsh creation area was completed in February 2004 by Louisiana Department of Natural Resources/Coastal Engineering Division (LDNR/CED), and closure 1 is being redesigned by USACE-NOD (D. Dearmond, LDNR/CED, pers. comm.). Once closure 1 is reconstructed, the second marsh creation phase of this project will begin during the next navigation channel maintenance dredging cycle. Secondly, the marsh buggy tracks and burial issues were resolved with the primary contractor depositing \$100,000 in the Louisiana Wetlands Conservation and Restoration Fund. However, no attempts have been made to restore the compacted or buried marshes.

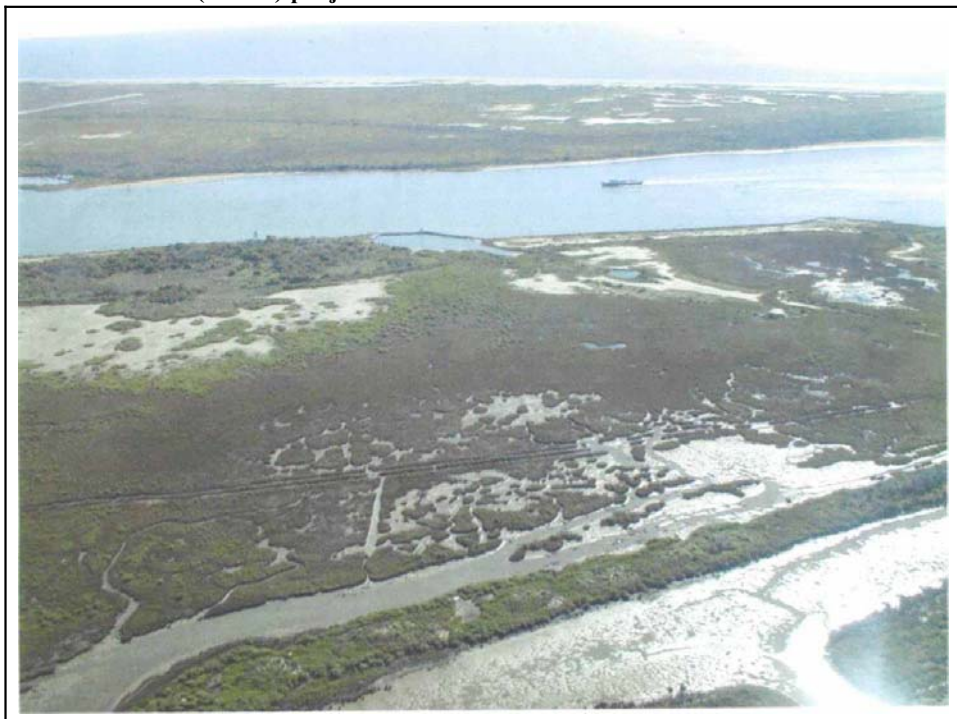
**Figure 12.** February 2003 aerial view of severe marsh tracks located just east of the Louisiana Intrastate Gas Pipeline Canal in the vicinity of the closure 1 marsh creation area at the West Belle Pass Headland Restoration (TE-23) project.

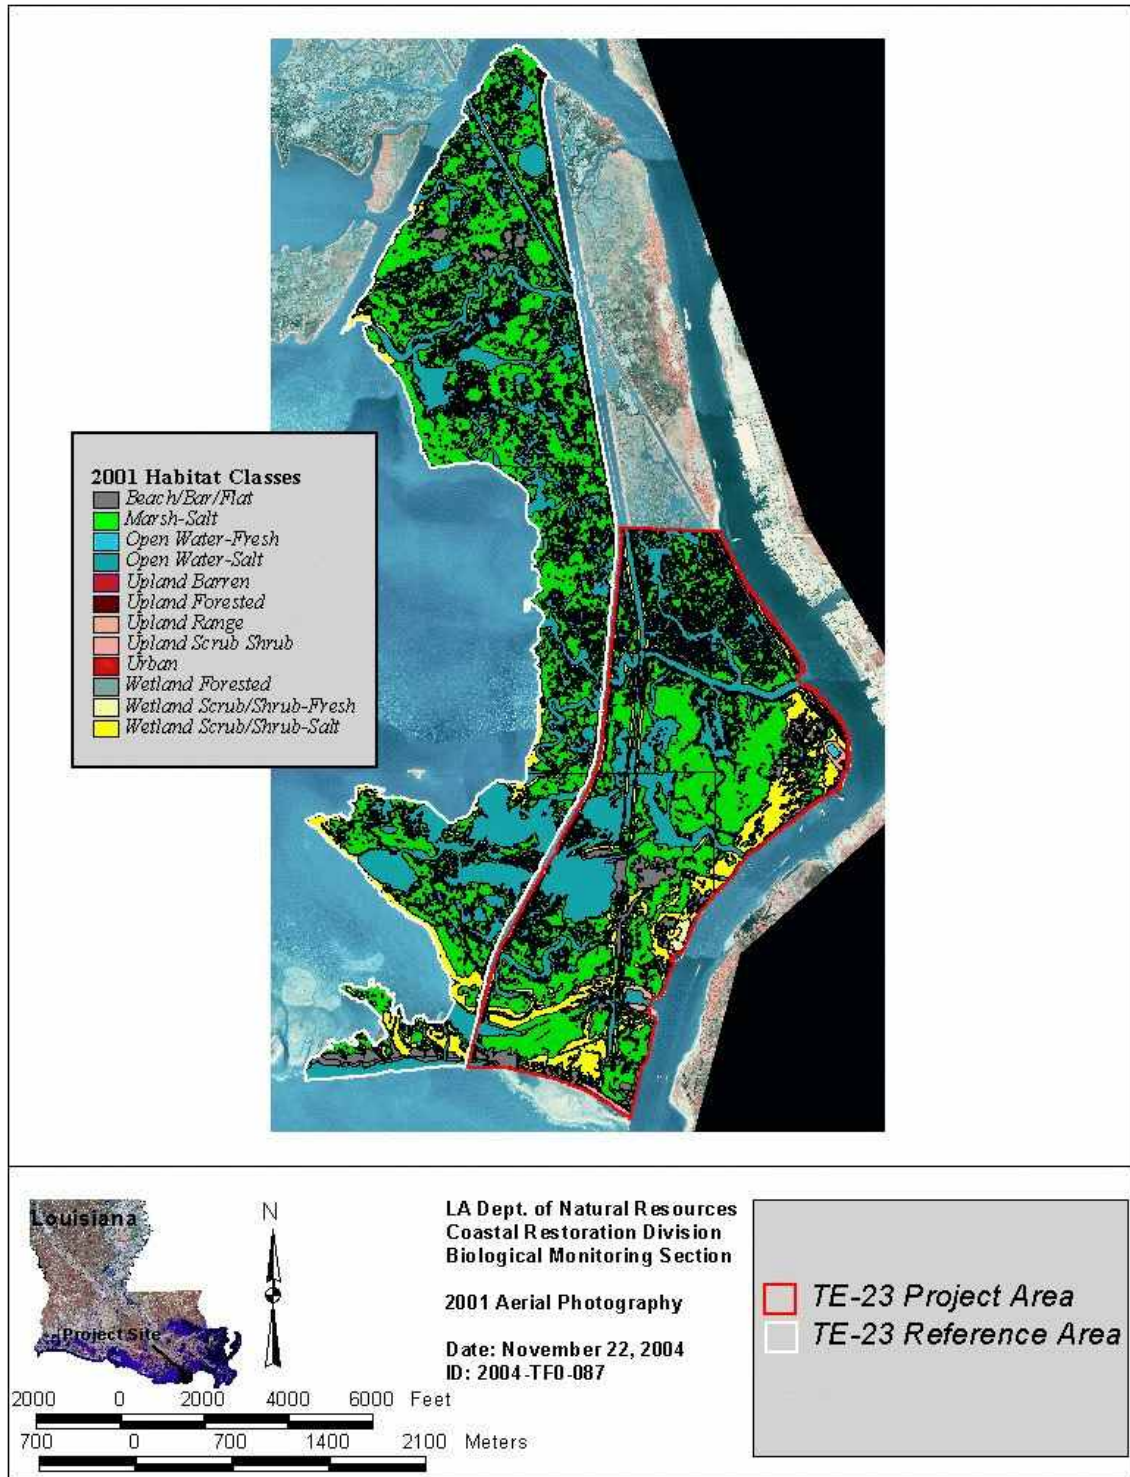
**Figure 15.** Post-construction (2001) habitat classifications of the West Belle Pass Headland Restoration (TE-23) project and reference areas.

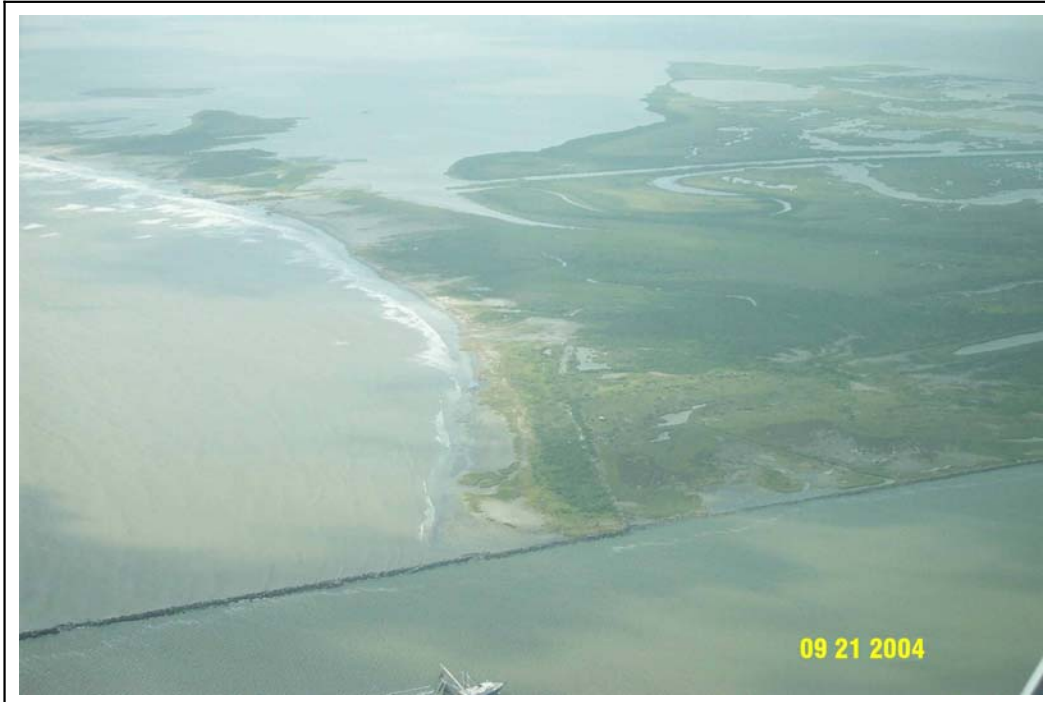
**Figure 21.** September 2004 aerial image depicting shoreline transgressions in the beach fill and project areas at the West Belle Pass Headland Restoration (TE-23) project.

al. 1978; McBride and Byrnes 1997; May and Britsch 1987). However, the project area shoreline was relatively stable over the sampling period because it is probably buffered from overwash events by the 228,000 yd<sup>3</sup> (174,319 m<sup>3</sup>) of dredged materials deposited on the beach (beach fill) just south of the project area (figures 13, 14, and 15). Although no quantitative data are available, it appears that the beach fill area has transgressed (since 2001) to its preconstruction position leaving the project area exposed to geomorphic processes (figure 21). In addition, the creation of a large wetland scrub/shrub-salt habitat on the marsh platform behind the eroded reference area shoreline was probably induced by overwash events (Courtemanche et al. 1999; Harper 1977; Ritiche and Penland 1998a; Ritiche and Penland 1998b; Penland and Ritiche 1979; Boyd and Penland 1981) and/or spillover effects of construction in marsh (closure 3 marsh creation area) and beach fill areas.
