Evaluation of Post-Wildfire Debris Flow Mitigation Methods and Development of Decision-Support Tools

Final Report to the Joint Fire Science Program

JFSP Contract 03-1-4-14
USGS Contract 04CRGR0001

FINAL REPORT

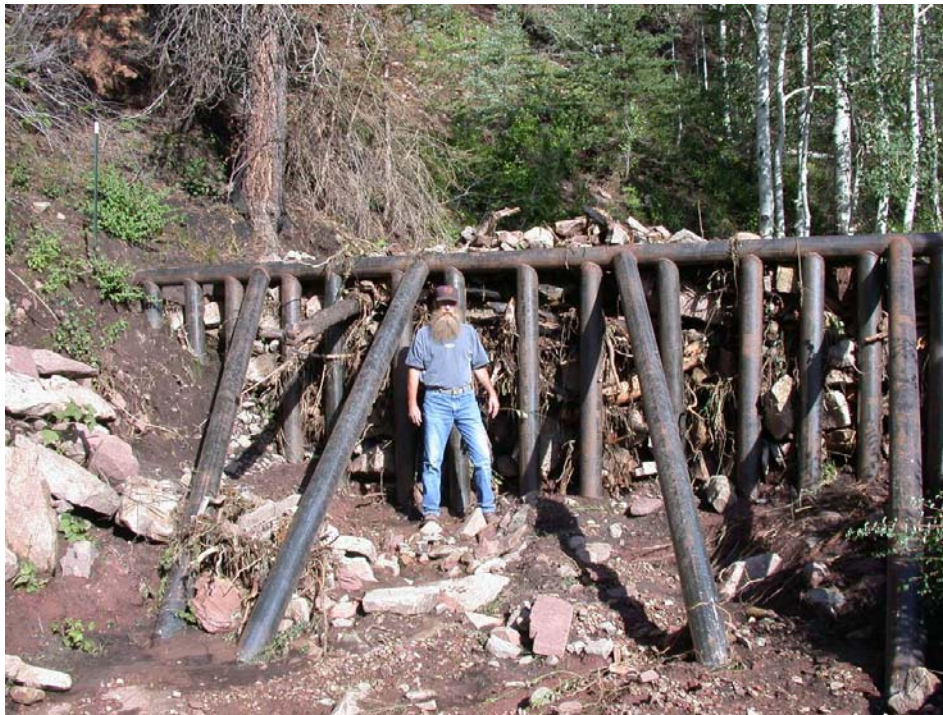
Figure 3 – Photograph of a debris rack retaining debris above a road and the spillway of Lemon Dam (from Florida Water Conservation District, 2003).

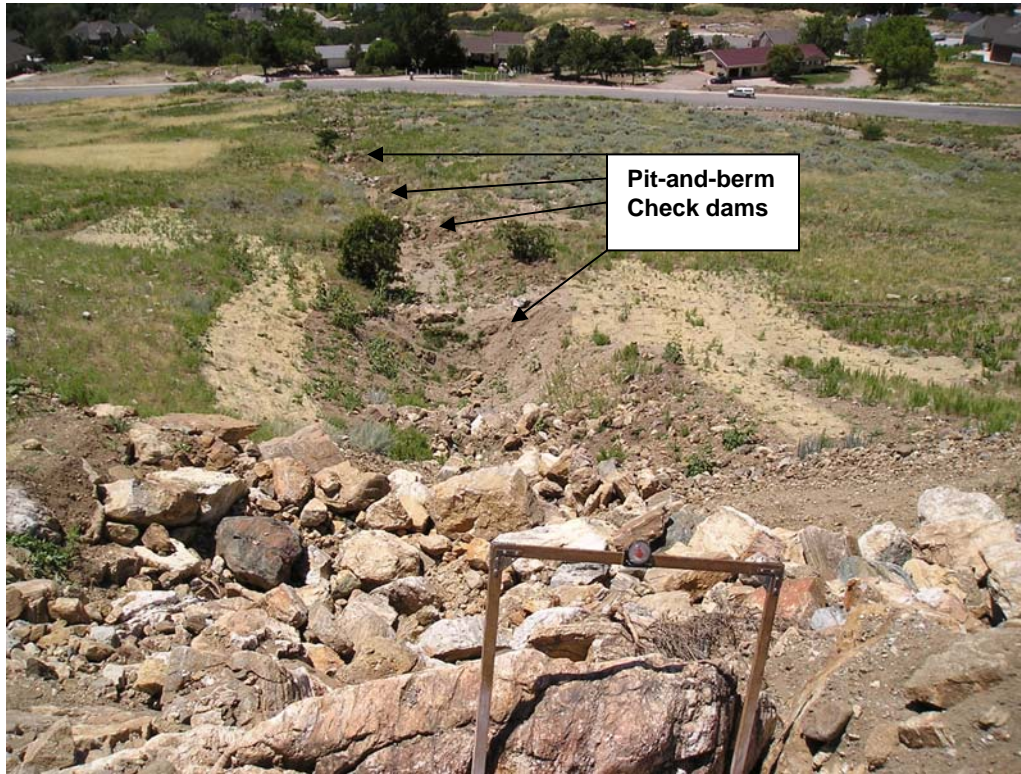
Figure 6 – Excavated pit and berm style check dams in Farmington, Utah.

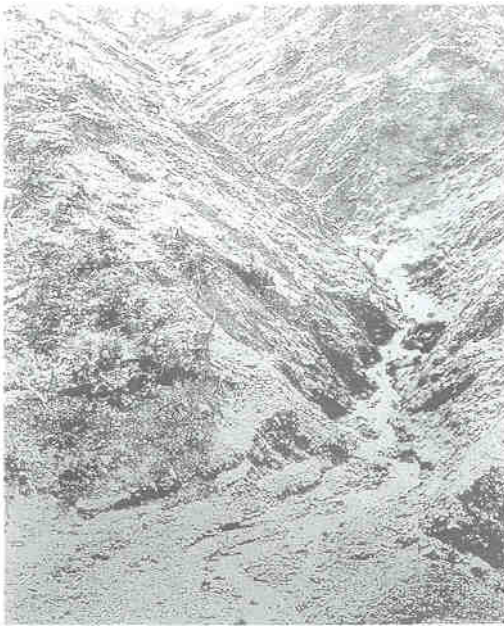
Figure 7 – Photographs of a debris torrent in the Lienz/Tyrol district of Austria showing A) eroded debris channel after a debris-flow event in 1882 and B) the same reach about 100 years later. The series of check dams have stabilized the channel and protected the road below. Also notice the reforestation of the slopes (from Heumader, 2000).

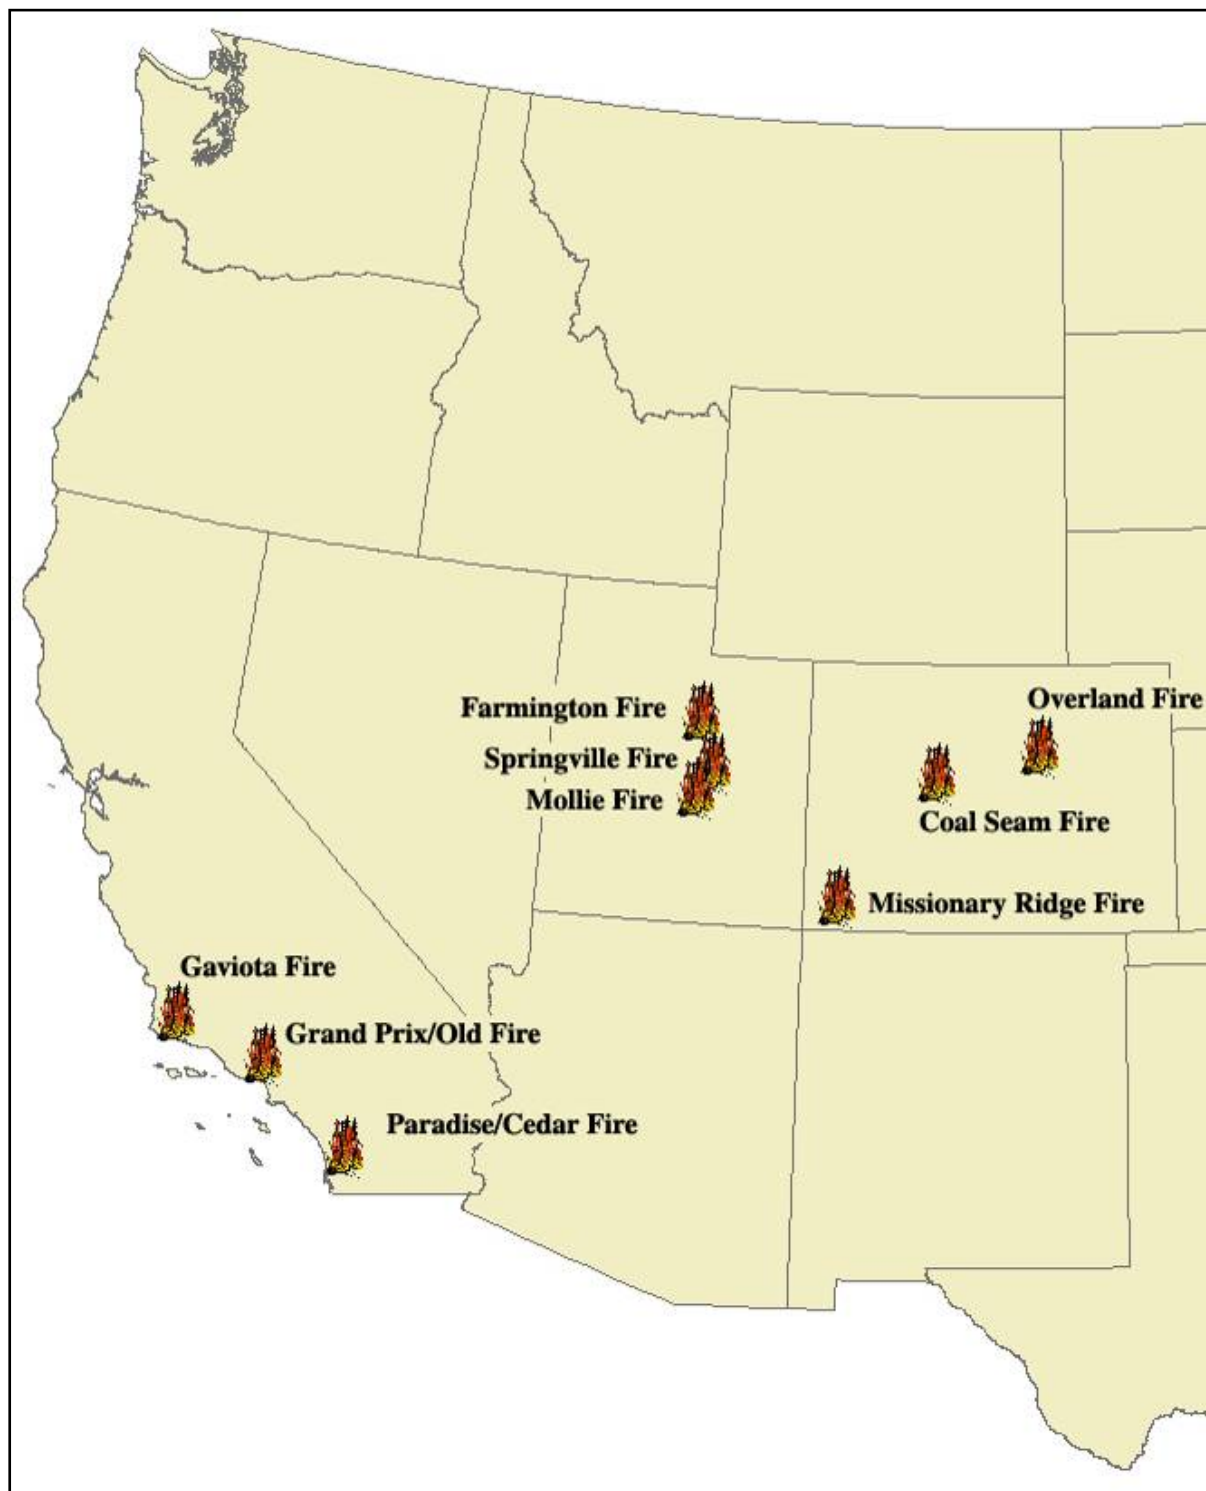
Figure 9 – Locations of wildfires where debris-flow erosion was measured for this study.

Debris-flow volume data was collected during 2004 and 2005 from 46 drainage basins in nine burn areas in California, Colorado and Utah (Figure 9) (deWolfe, 2006). For each fire, debris-flow and treatments are shown in relative chronologic order in Figure 10.

State	Fire Name	Locale
California	Grand Prix/Old Fire	San Bernardino, CA
	Paradise/Cedar Fire	El Capitan Reservoir, CA
	Gaviota Fire	Gaviota, CA
Colorado	Missionary Ridge Fire	Durango, CO
	Coal Seam Fire	Glenwood Springs, CO
	Overland Fire	Jamestown, CO
Utah	Mollie Fire	Santaquin, UT
	Springville Fire	Springville, UT
	Farmington Fire	Farmington, UT

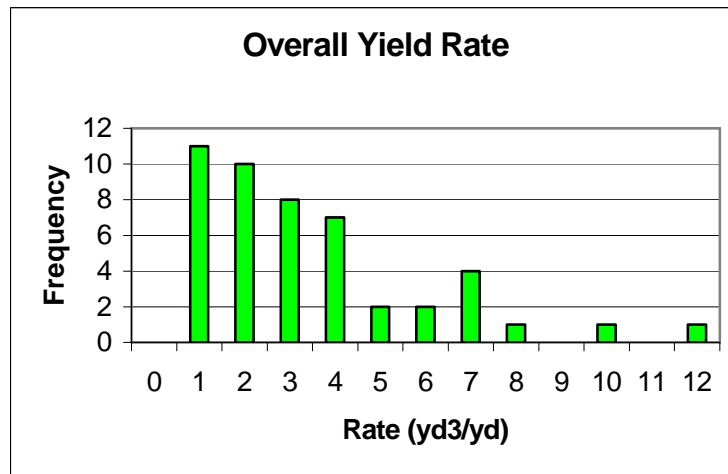
Figure 13. Distribution of calculated average channel yield rates. Mean = 0.36 yd³/yd; maximum = 11.88 yd³/yd; mean = 2.96 yd³/yd ; median = 2.23 yd³/yd.

All 46 surveyed debris-flow channels showed significant scour and erosion, with average yield rates ranging from 0.4 to 12 cubic yards of material produced for every yard of channel length, with an overall average of 3.0 yd³/yd (Figure 13). Yield rates for short channel reaches (up to several hundred yards) ranged as high as 26.7 yd³/yd (Figure 14)

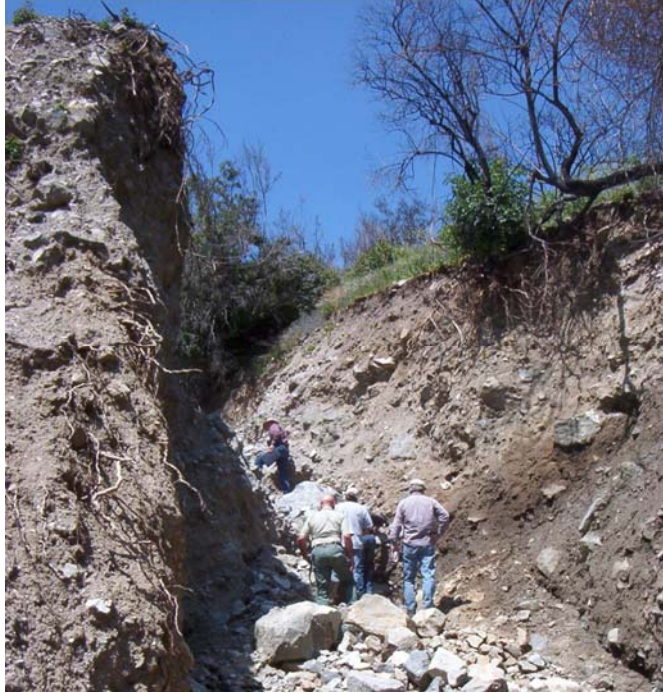
Figure 14. Photograph of deeply incised channel reach in Devore Canyon, southern California, where the highest value of channel yield rate of 26.7 yd³/yd was measured.

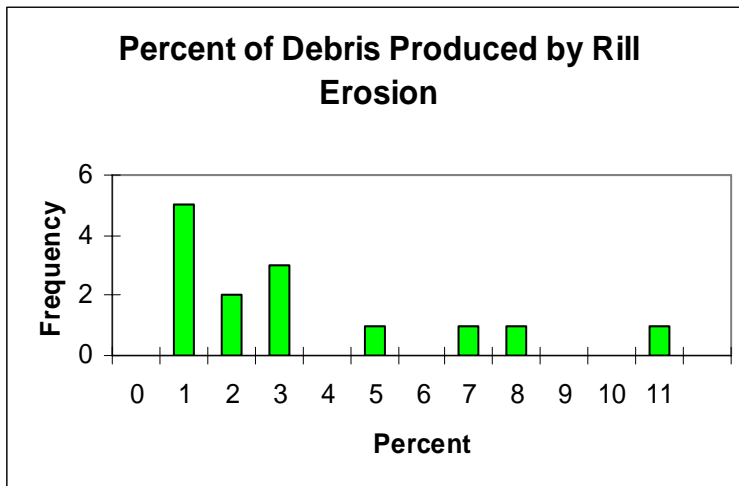
Figure 15. Percent of material contributed to debris flows from hillslope rilling. Minimum = 0.1%; maximum = 10.5%; mean = 2.9%; median = 1.9%.

The cumulative volume graphs show that the volume of material eroded from hillslopes in the form of rills represents only a small percentage of the total debris-flow volume. Rill erosion was identified for 30% of the flows, with rills contributing only between 0.1 and 10.5% of the total volume, with an average of just 3% (Figure 15). This finding suggests that material eroded from hillslopes may not significantly affect debris-flow volume in burned areas, but perhaps influences the likelihood of debris-flow generation.

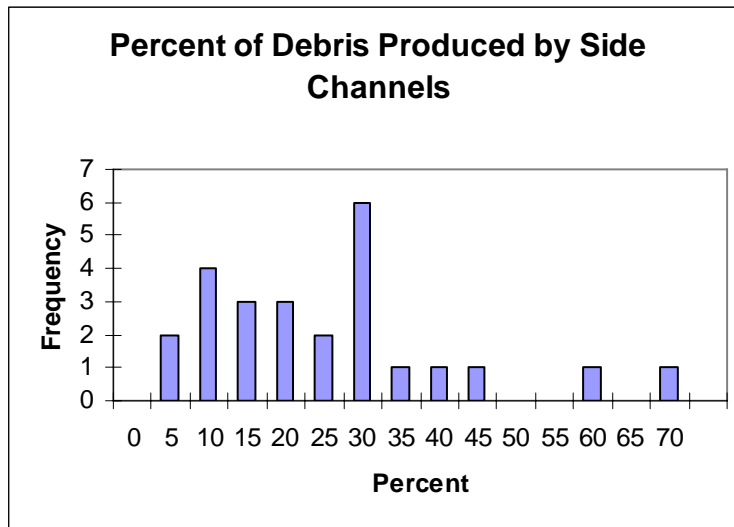
Figure 16. Percent of material contributed to debris flows from side channels. Minimum = 1.9%; maximum = 65.5%; mean = 22.8% ; median = 22.1%.

Material was contributed from side channels into the main channels for 52% of the flows. An average of 23%, ranging up to 65.5%, of the total volume came from side channels (Figure 16).

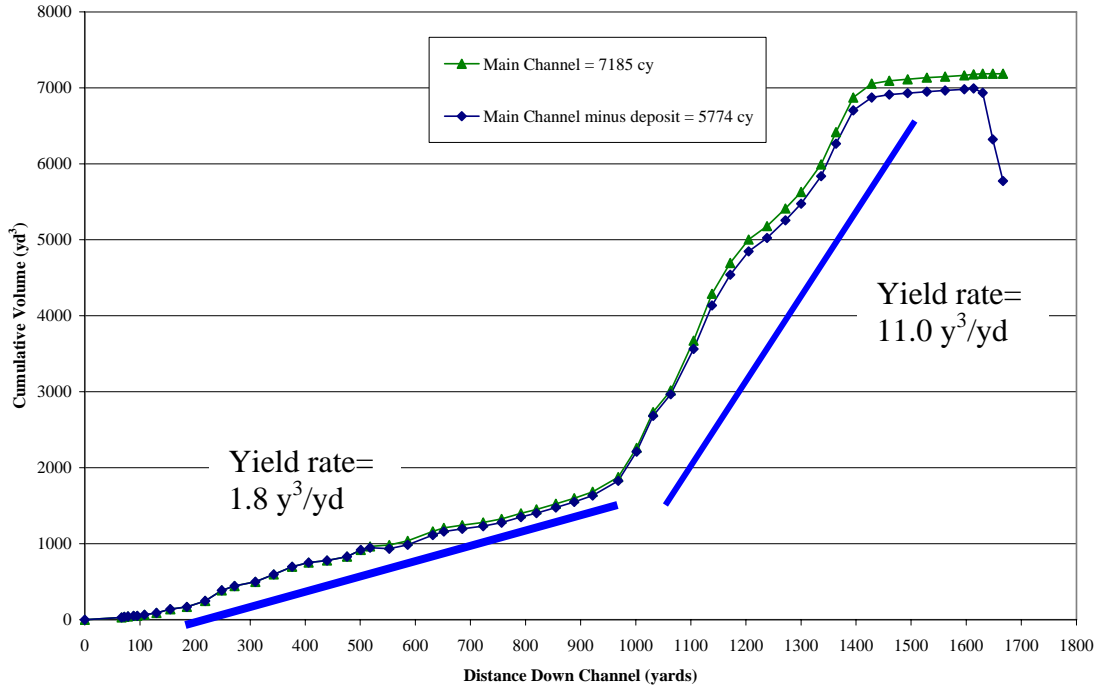
Elkhorn Canyon Channel Length vs. Cumulative Volume

Figure 17 – Graph of cumulative volume with distance down channel for Elkhorn Canyon, Missionary Ridge Fire, Colorado. Blue lines show average yield rate for a section of channel. Note the inflection between low channel yield rates and significantly higher values with distance down channel. Either hillslope or channel mitigation measures might be beneficial in the area of lower yield rates.

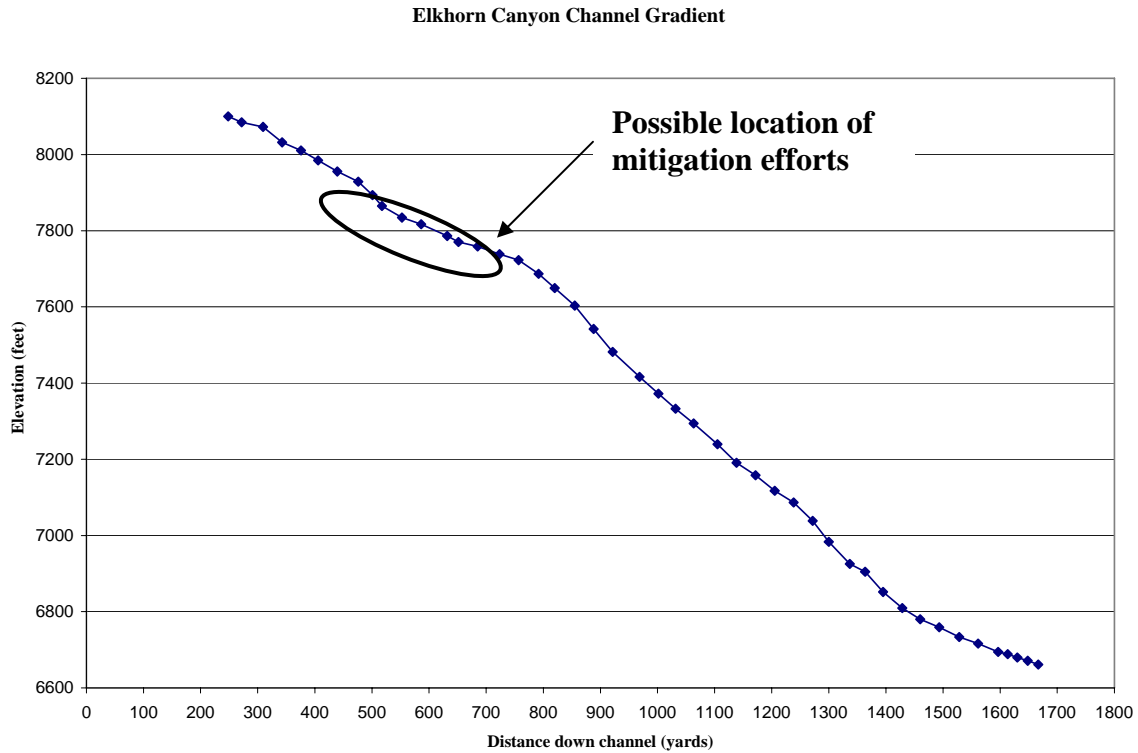
Figure 18 – Graph showing the channel gradients measured in Elkhorn Canyon, Missionary Ridge Fire, Colorado. Note the reach of channel with the lowest gradients where mitigation may be beneficial. This type of analysis can be used in burned canyons that have not experienced debris-flows.

Possible locations for mitigation efforts can thus be identified in a burned basin that has not experienced a debris flow by measuring the channel gradients. The locations of the lowest channel yield rates most often occur in areas of the lowest channel gradients. This is illustrated in Figure 18 where a graph of measured channel gradients in Elkhorn Canyon shows that areas of low yield rates (from Figure 17) corresponds fairly well with areas of lowest channel gradients. This relation suggests the strategy of locating hillslope or channel erosion control measures with the basin above the areas of the lowest channel gradients.

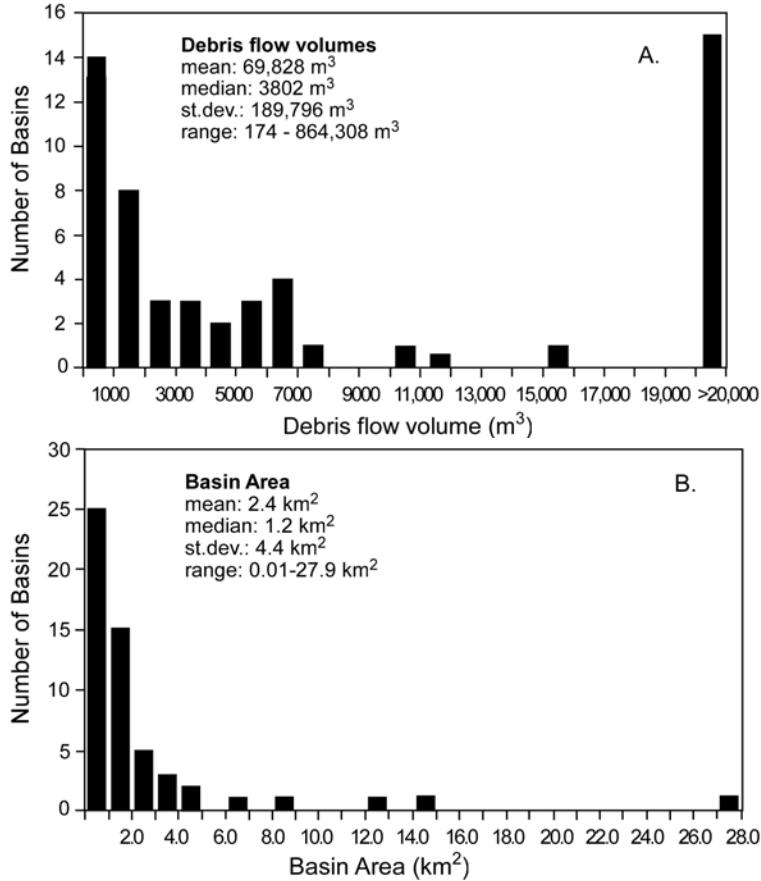
Figure 19. Histograms showing A) values of debris flow volume used in the development of the volume model, and B) the areas of basins included in the database.

The total volume of material in each of the debris flows in 46 basins were estimated by measuring the amount of material eroded from main channels with a series of closely-spaced cross sections (deWolfe, 2006). This sample was augmented with measurements of volume from six debris basins in southern California (Mead, Written Communication, 2003). Measured volumes ranged between 174 and 864,308 m³, and were obtained from basins between 0.01 and 27.9 km² in area (Figure 19, Appendix A).

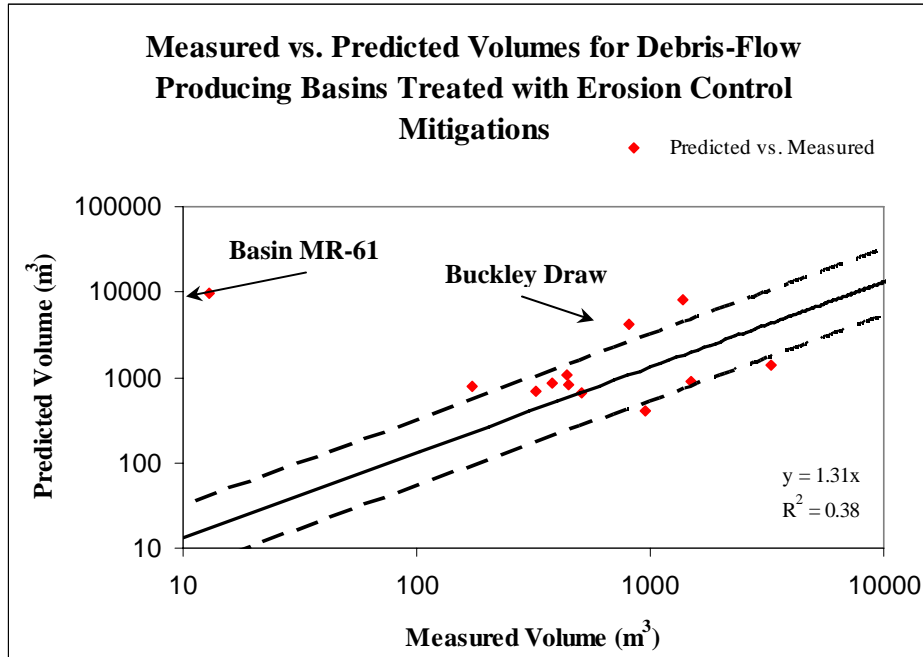
Figure 21 – Relationship between measured and predicted volumes for treated basins. Dashed lines represent one standard deviation off the mean (68% confidence interval), or one standard error.

The model for debris flow volume (Equation 1) was used to calculate the volume of material that could issue from a basin outlet for each of the basins in this study that had been treated with some kind of erosion control mitigation(s). Figure 21 shows the relationship between measured and predicted volumes: values for six out of twelve (50%) basins are within one standard error, while five others are very close to the error envelope. Four of the twelve data points (33%) are above the error envelop, while two (17%) are below.

We observed heli-mulch treatment in two settings; a localized application to severely burned areas in the Old Fire near Devore, California, and a basin-wide application to Buckley Draw near Provo, Utah (Figure 25). On the hillslopes above Devore, just two months after the application, the wind had removed the mulch from the hillslopes and deposited it as collars around the remaining vegetation masses and protruding rocks. A debris flow of approximately 22,000 yd³ was produced from this basin on December 25, 2003: the mulch apparently had very little effect. Conversely, the mulching at Buckley Draw appeared to be successful at reducing debris flow volume. A debris flow of approximately 800 yd³ was produced from the treated Buckley Draw, which is significantly less than the volume of approximately 4000 yd³ predicted by our model (Figure 21).

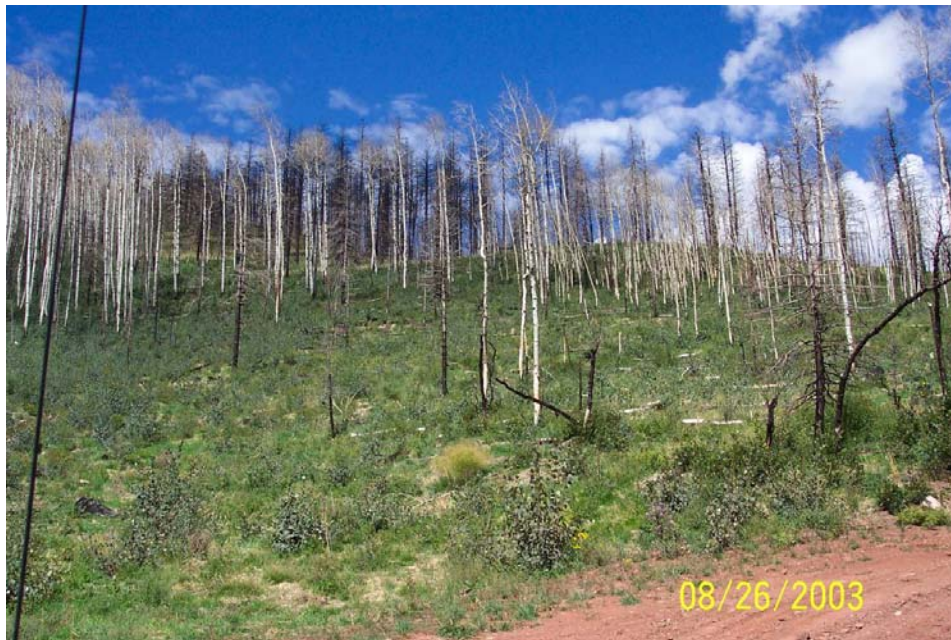
Figure 22 – Photograph showing vegetative cover by August, 2003 approximately 13 months after the fire, in Basin MR-61 at Lemon Dam. Seeds were hand-spread at a rate of 60-75 lbs/acre amongst LEBs and straw mulch crimped into the soil. Some of the vegetation is natural growth (photo from FWCD, 2003).

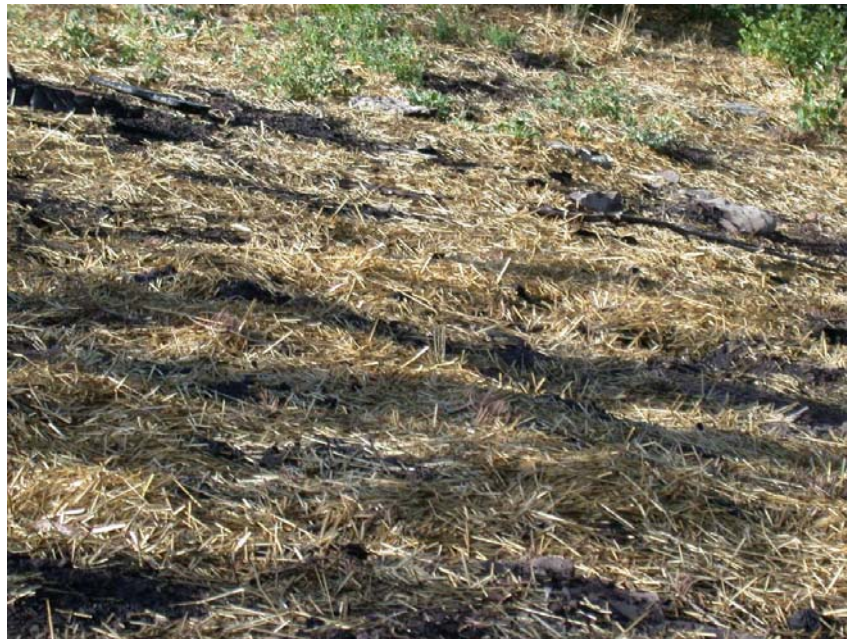
Figure 23 – Condition of hand-spread and crimped mulch at Lemon Dam. Notice the vertical straws, products of crimping (photo from FWCD, 2003).

Our field observations are of applications spread both by hand and by helicopter. At Lemon Dam, over 190 tons of mulch were spread over 250 acres of burned slopes by hand and crimped into the soil with a shovel (WWE, 2005) (Table 3, Figure 23). The hand application was spread thinly and evenly over the targeted slopes. Observations of those slopes show that the crimped mulch, combined with an intensive seeding program and LEBs, resulted in a substantial and extensive vegetative cover during the first growing season (Figure 22). A rainstorm on September 9th, 2003 triggered a debris flow from the adjacent untreated basin, but not from the treated basin. The measured sediment yield for the treated basin was only 13 yd³, while the adjacent basin produced approximately 2800 yd³ of material.

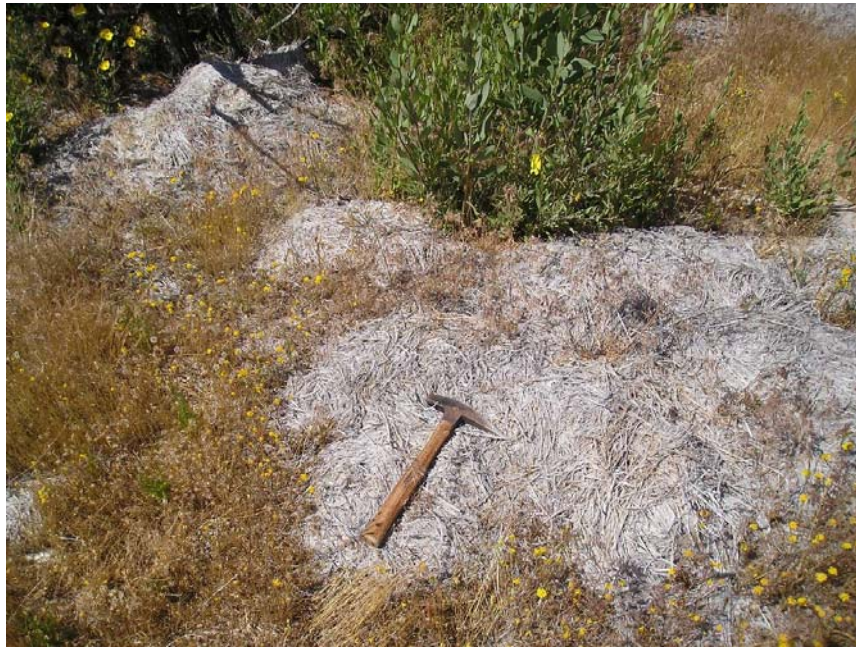
Figure 24 – Photograph illustrating the clumping character of heli-mulch dropped in 2003 and the lack of vegetation growth from within the mulch two years later (Photo by V. deWolfe, 2005).

The most common characteristics of helicopter mulching include thick mounds and relatively uneven spreading patterns of the material. The mounds form primarily due to insufficient breakup of air-born straw bales or to wind blowing the mulch into piles in the lee of obstacles such as trees or rocks. In response to heavy rains, burned soil mantle was observed to be eroded from between the clumps by rilling, sheetwash and rainsplash processes. The lack of vegetative growth observed beneath clumps of mulch indicates that they can inhibit seed germination for at least two years following a fire (Figure 24).

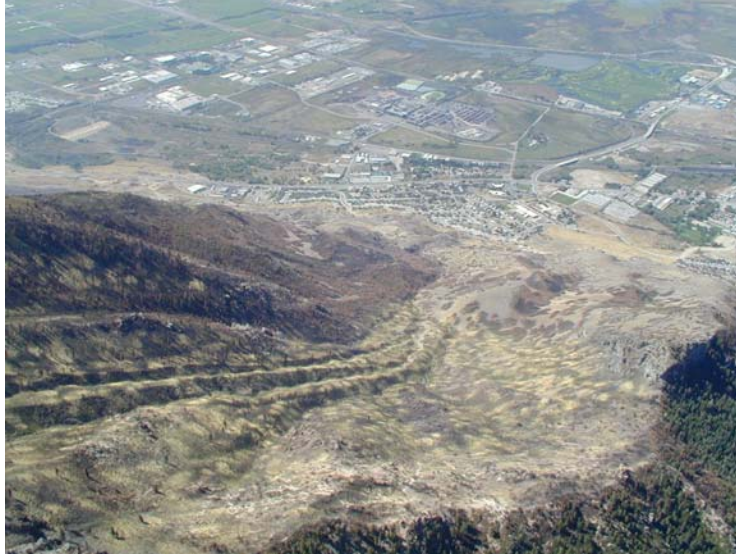
Figure 25 – Aerial photograph of Buckley Draw near Provo, UT showing the pattern of helicopter spread mulch over much of the basin (photo from USDA Forest Service, 2002).

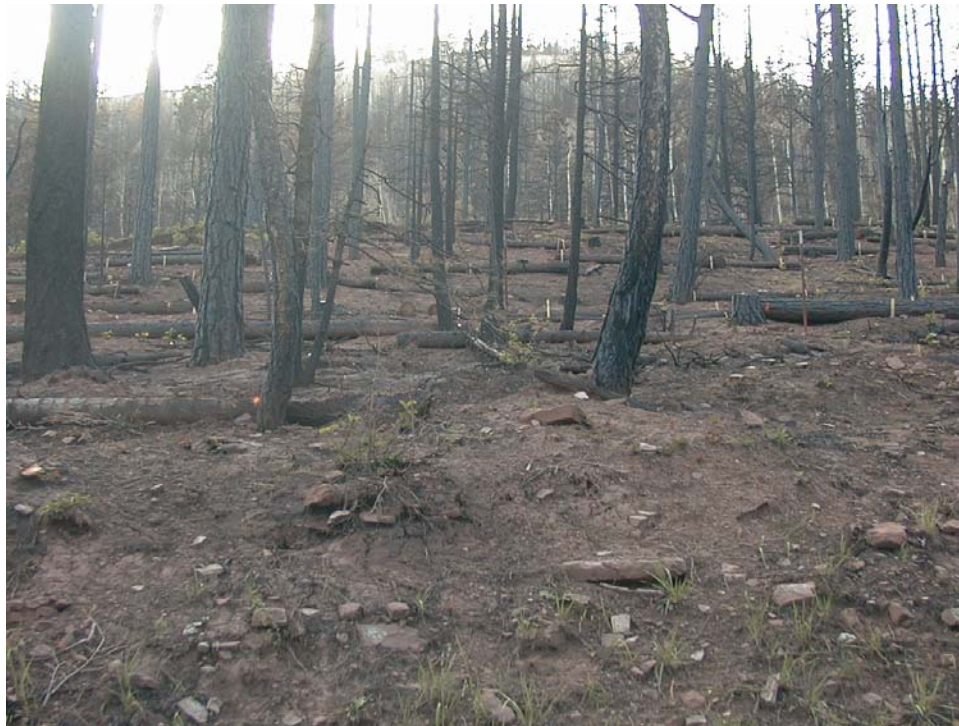
Figure 26 – Photograph of LEBs installed on burned slopes at Lemon Dam (Photo by J. Ey, 2003).

At Lemon Dam, 231 acres of a severely burned basin above the dam's spillway and intake structures were treated with concentrations between 90 and 250 LEBs/acre (Table 3, Figure 26). This is over two to six times the normal concentration of about 40 LEBs/acre (Table 4). The LEBs were installed on hillslopes that were also treated with straw mulch crimped into the soil and seed (Table 3), were carefully placed along contour, and exhibited ground contact along their entire lengths. The LEBs were emptied of soil each time they were filled following rainstorms (Ey, P.C., 2004), and the removed material was packed along the front of the LEB. Observations of the treated hillslopes show that the LEBs, combined with the seeding and mulch treatments, resulted in a substantial and extensive vegetative cover during the first growing season (Figure 22). Again, the negligible post-fire response of the treated basin to a storm that triggered debris flows in an adjacent untreated basin suggests that this combined treatment, applied throughout nearly the entire basin, may have effectively reduced debris flow volume by two to three orders of magnitude.

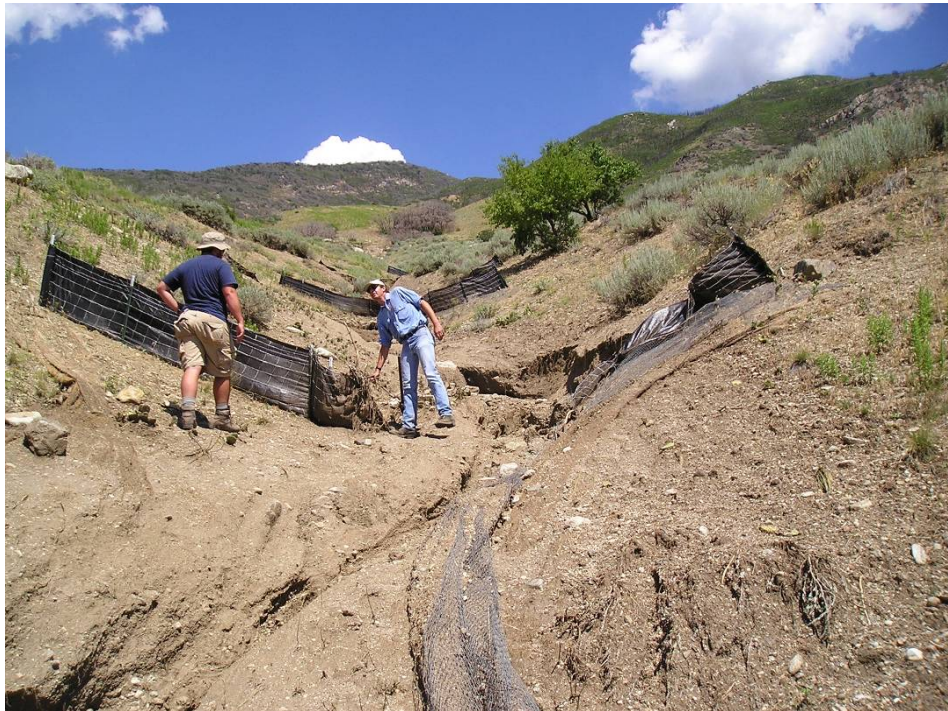
Figure 27 – Photograph of a failed channel silt fence installation (photo by V. deWolfe, 2004).

Following the Farmington Fire of July 2003, a series of silt fences were constructed across a potential debris-flow channel above a neighborhood that could be impacted by post-fire debris-flow activity. On July 17th, 2004, a debris flow occurred in that drainage, allowing first-hand observation of the effectiveness of the silt fences during a site visit the following week. Most of the silt fences were destroyed in the axis of the channel, and any stored material continued through the channel. Some deposition was observed in places behind the relatively intact parts of the fences (Figure 27). Debris reached the neighborhood below, but sandbags prevented all but a small amount from entering houses.

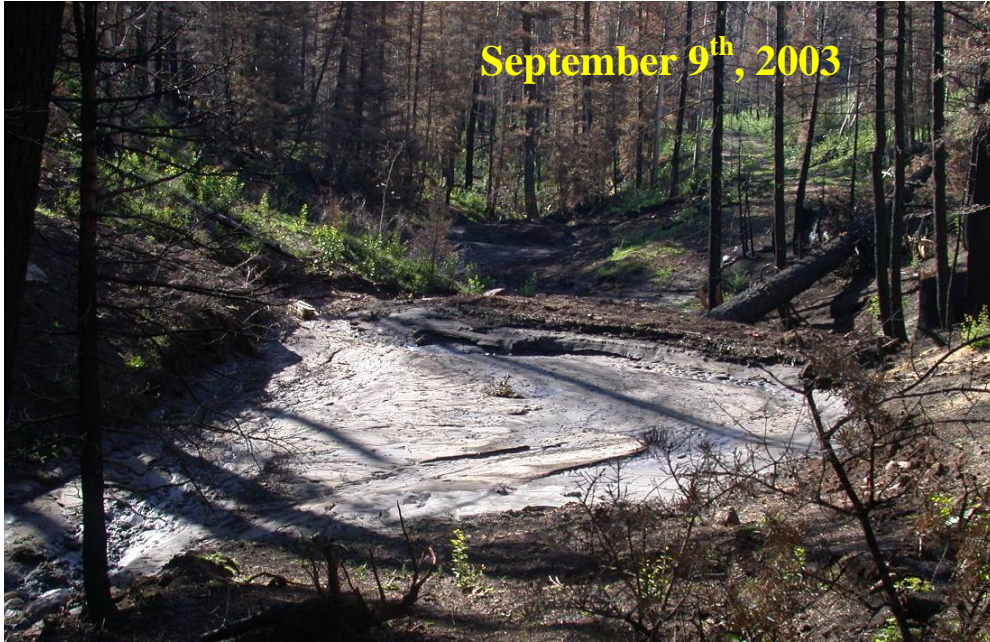
Figure 28 – A check dam full of mud and debris constructed in the upper reaches of Basin MR-61 above Lemon Dam (photo from FWCD, 2003).

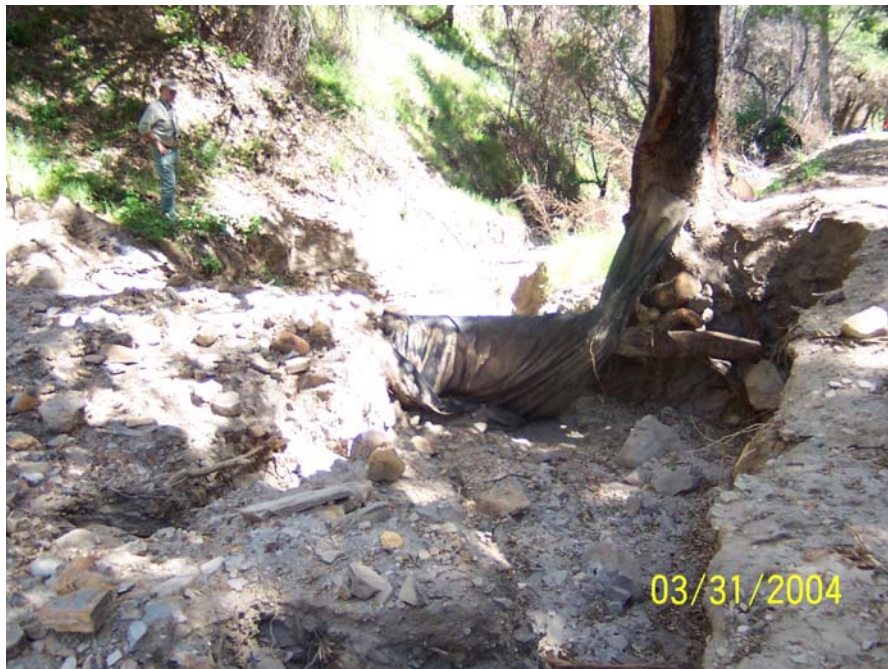
Figure 29 - Failed log-barrier checks dams in Dominguez Canyon, southern California.

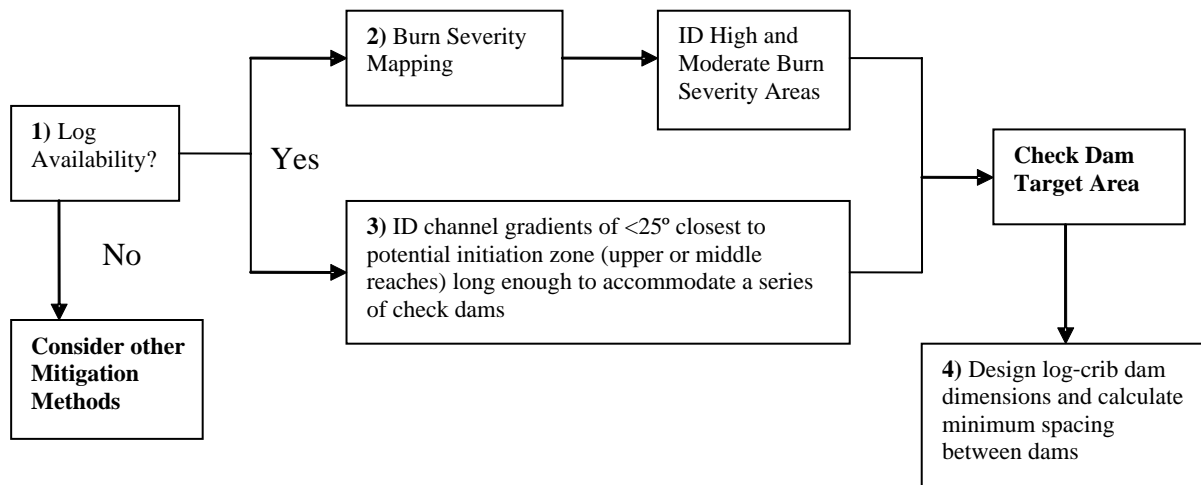
Figure B6 – Flow chart outlining the process of positioning of log crib check dams in a burned channel that may experience debris flows.
