Section 3 Streambank and Shoreline Erosion

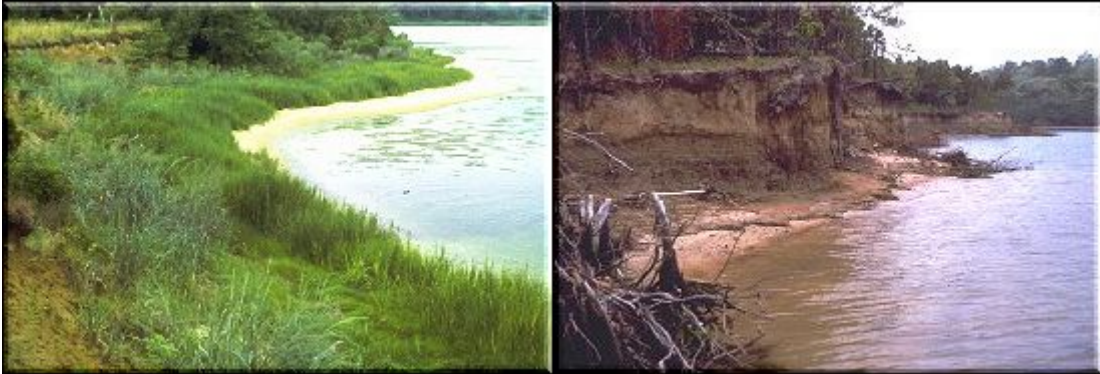
Figure 3.1 Shoreline Erosion: Before and After Photos
 (Source: <http://www.dcr.state.va.us/sw/seas.htm>)

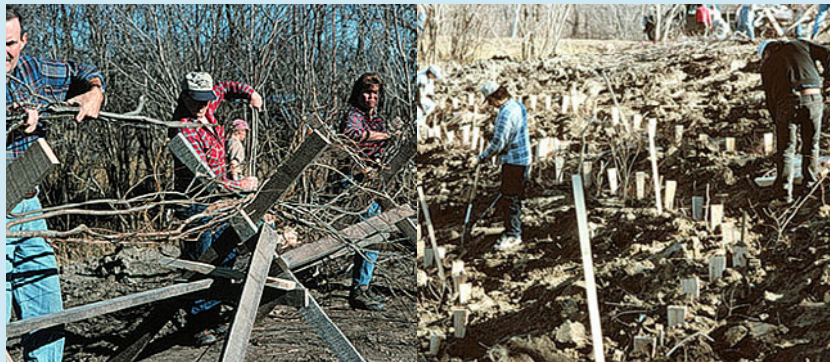
The Natural Resources Conservation Service demonstrated the implementation of several bioengineering techniques during a workshop (left). Willows were planted along the restoration site to provide long-term stability (right).

In 1995, efforts were made to stabilize the bank and stop further migration toward the road using multiple bioengineering techniques. The first step was to create a stable slope for the vegetation. The 14-foot vertical bank was reshaped to a 3:1 slope, using the waste from the top as fill at the toe. Riprap, willow fascines, a brush mattress, and grasses and shrubs were installed along the bank to aid in the revegetation process.

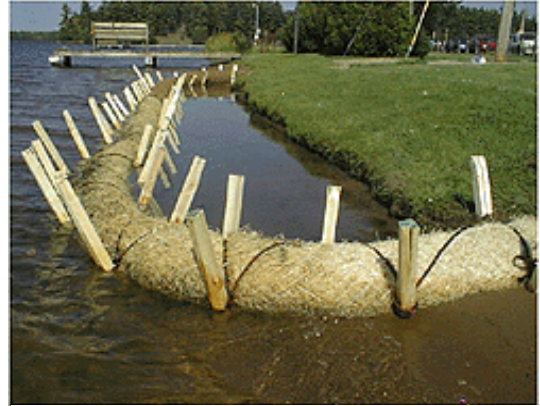
Figure 3.8 Coconut Fiber Roll Picture
(Source: Montgomery Watson, 2001)

The method is typically installed near the toe of the streambank with dormant cuttings and rooted plants inserted into holes cut into the fiber rolls. This provides a good substrate for promoting plant growth and is appropriate where short-term moderate toe stabilization is needed. Installation of this design requires minimal site disturbance and is ideal for sites that are especially sensitive to disturbance. A limitation of this system is that it cannot withstand high velocities or large ice buildup and it can be fairly expensive to construct. Coconut fiber rolls have an effective life of 6 to 10 years. In some locations, similar and abundant locally available materials, such as corn stalks, are being used instead of coconut materials (FISRWG, 1998).

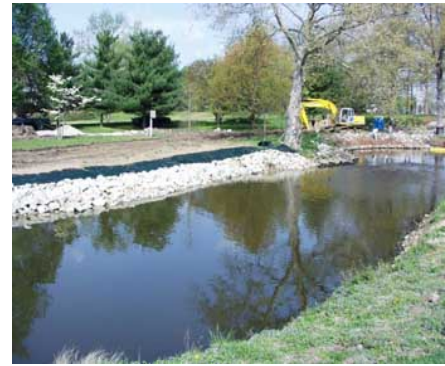
Figure 3.13 Riprap (Source: <http://www.dnrec.state.de.us/dnrec2000/Divisions/Soil/dcmp/cdhydro.htm>)

Riprap is a blanket of appropriately sized stones extending from the toe of the slope to a height needed for long term durability (Figures 3.13 and 3.14). (Joint plantings is an integrated version of the riprap method). This method is suitable where stream flow velocity is high or where there is a threat to life or property. This method can be expensive particularly if materials are not locally available. This method should be combined with soil bioengineering techniques, particularly revegetation efforts, to achieve a comprehensive streambank restoration design (FISRWG, 1998).

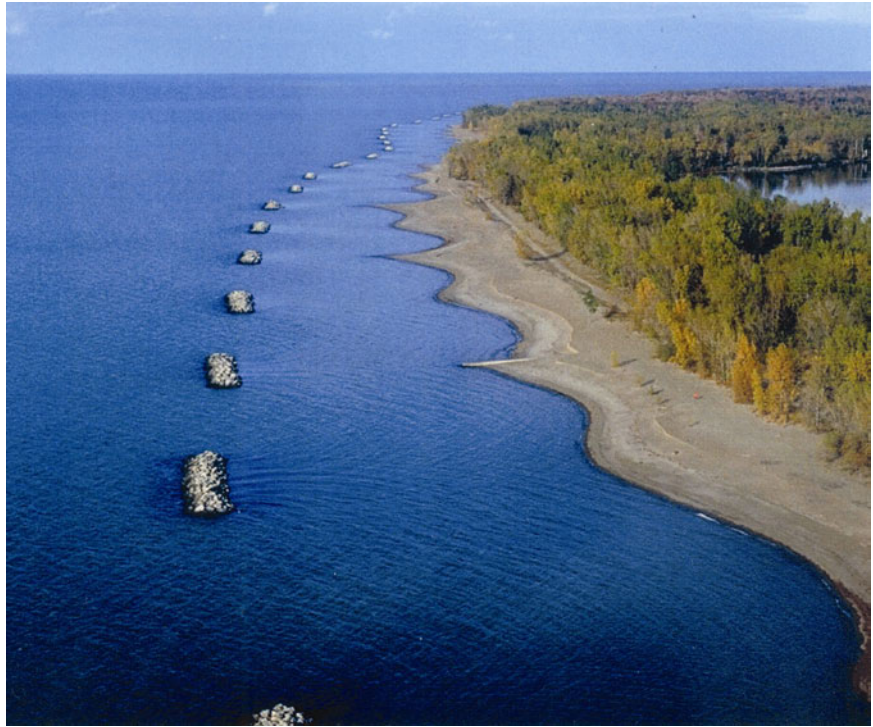
Figure 3.19 Breakwaters – View of Presque Isle, Pennsylvania
(Source: USACE, 2003)

Figure 3.19 provides a view of breakwaters off the coast of Pennsylvania and Figure 3.20 illustrates single and multiple breakwaters.

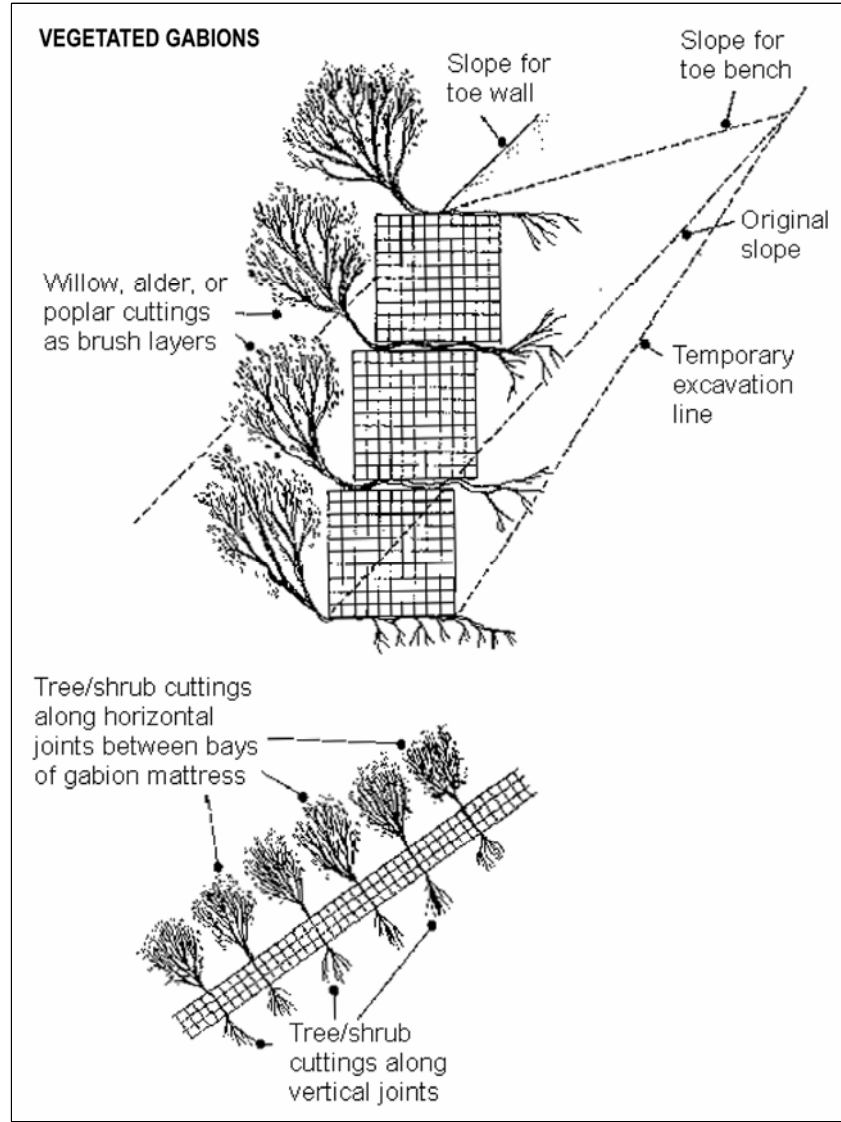
Figure 3.27 Vegetated Gabion (Source: Allen and Leech, 1997)

Vegetated gabions (Figure 3.27) start with wire-mesh, rectangular baskets filled with small to medium rock and soil. The baskets are then laced together to form a structural toe or sidewall. Live branches (0.5 to 1 inch in diameter) are then placed on each consecutive layer between the rock filled baskets to take root, join together the structure and bind it to the slope. This method is effective for protecting steep slopes where scouring or undercutting is occurring. However, this method is not appropriate in streams with heavy bed load or where severe ice damage occurs. This method provides moderate structural support and should be placed at the base of a slope to stabilize the slope and reduce slope steepness. A stable foundation is required for the installation of these structures. When the rock size needed is not locally available, this design is effective because smaller rocks can be used. A limiting factor of this method is that it is expensive to install and to replace. These structures are relatively expensive to construct and frequently require costly repairs. This method should be combined with other soil bioengineering techniques, particularly revegetation efforts, to achieve a comprehensive streambank restoration design (FISRWG, 1998). There is often opposition to these structures based on their inability to blend in with natural settings and their general lack of aesthetically pleasing qualities (Gore, 1985).

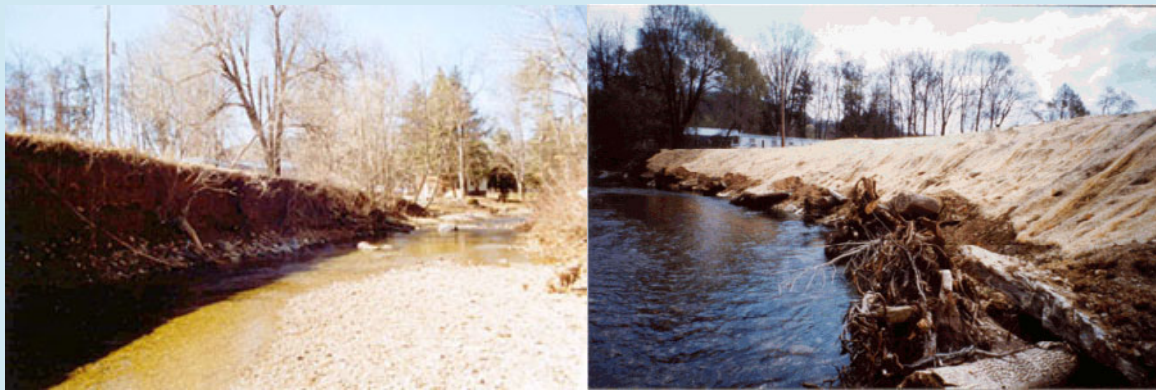
The streambank at the McDannel site was severely eroded at the beginning of the project in February 1999.

Improvements to the area included measures such as smoothing and reducing the bank slope and installation of native rock and root wads along the streambank. Fallen trees at the site were used as root wads to help stabilize the toe of the bank, and the root wads and rock provided the large, heavy material necessary to stabilize the toe of the eroding slope and prevent further undercutting. The steep bank was regraded using the gravel material removed from the adjacent streambank. This process “softened” the streambank, allowing the stream to flow away from the newly stabilized banks. Following construction, local groups assisted in revegetation of the sites. The Adams County Chapter of Trout Unlimited donated trees for planting. The planted trees and grass improved the aesthetics of the site and further reduced erosion.

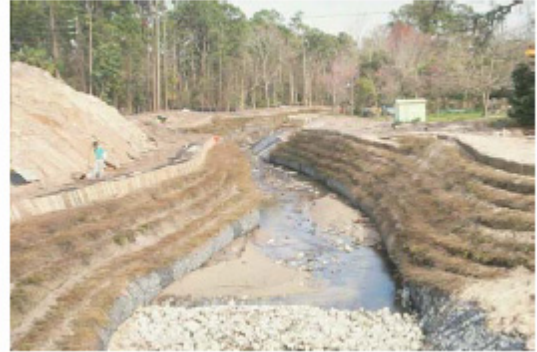
Figure 3.31 VRSS Structure After Construction
(Source: Sotir and Fischenich, 2003)

The vegetated reinforced soil slope (VRSS) soil bioengineering system (Figures 3.31 and 3.32) is an earthen structure constructed from living, rootable, live-cut, woody plant material branches, bare root, tubling or container plant stock, along with rock, geosynthetics, geogrids, and/or geocomposites. The VRSS system is useful for immediately repairing or preventing deeper failures, providing a structurally sound system with soil reinforcement, drainage, and erosion control (typically on steepened slope sites where space is limited). With this system, living cut branches and plants are expected to grow and perform additional soil reinforcement via the roots and surface protection via the top growth (Sotir and Fischenich, 2003).

Live vegetation in the VRSS is typically installed from just above the baseflow elevation and up the face of the reconstructed streambank, acting mainly to protect the bank through immediate mechanical soil reinforcement and confinement, drainage, and, in the toe area, with rock. The VRSS system extends below the depth of scour, typically with rock, which is useful in improving infiltration and supporting the riparian zone. The internal systems such as rock, live cut branches, geogrids, geosynthetics, and geocomposites can also be configured to act as drains that redirect and/or collect internal bank seepage and transport the water to the stream via a rock toe (Sotir and Fischenich, 2003).

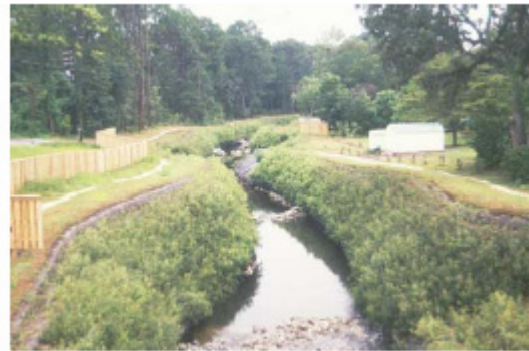
Figure 3.32 Established VRSS Structure
(Source: Sotir and Fischenich, 2003)

Plants within the VRSS structure may be selected to provide color, texture, and other attributes to add a pleasant, natural landscape appearance. Examples, of plants for the structure could include buttonbush, dogwood, willow, hibiscus, and *Viburnum* spp. Check with your local NRCS office to make sure these are appropriate for your location and for alternate suitable plant species. If a compound channel cross section is desirable near or just below the baseflow elevation, a step-back terrace may be incorporated to offer an enhanced riparian zone, where emergent aquatic plants, such as bulrush and sedges may invade over time. Although the total mass uptake may be small, they will assimilate contaminants within the water column. Aquatic wetland plants that may be installed in the VRSS adjacent to the stream include blueflag, pickerelweed, and monkey flower. Again, consult your local NRCS office for information on locally appropriate plants. VRSS systems can be constructed on slopes ranging from 1V on 2H (1:2) to 1:0.5. When constructed in step or terrace fashion, they can improve non-point pollution control by intercepting sediment and attached pollutants during overbank flows (Sotir and Fischenich, 2003).
