# Draft Environmental Assessment Monte Cristo Grade Road Bridge

Snohomish County, Washington  
FEMA-1499-DR-WA (Public Assistance)  
*June 2008*

**Prepared by Snohomish County Public Works  
3000 Rockefeller Place  
Everett, WA 98201**

**June 2008**

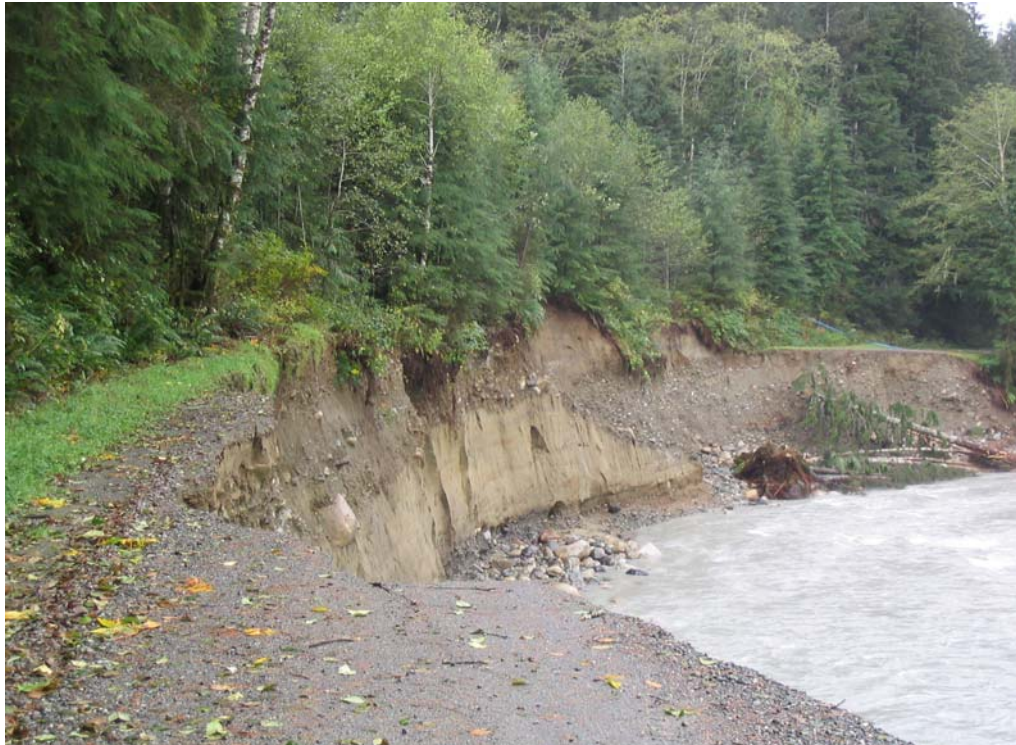
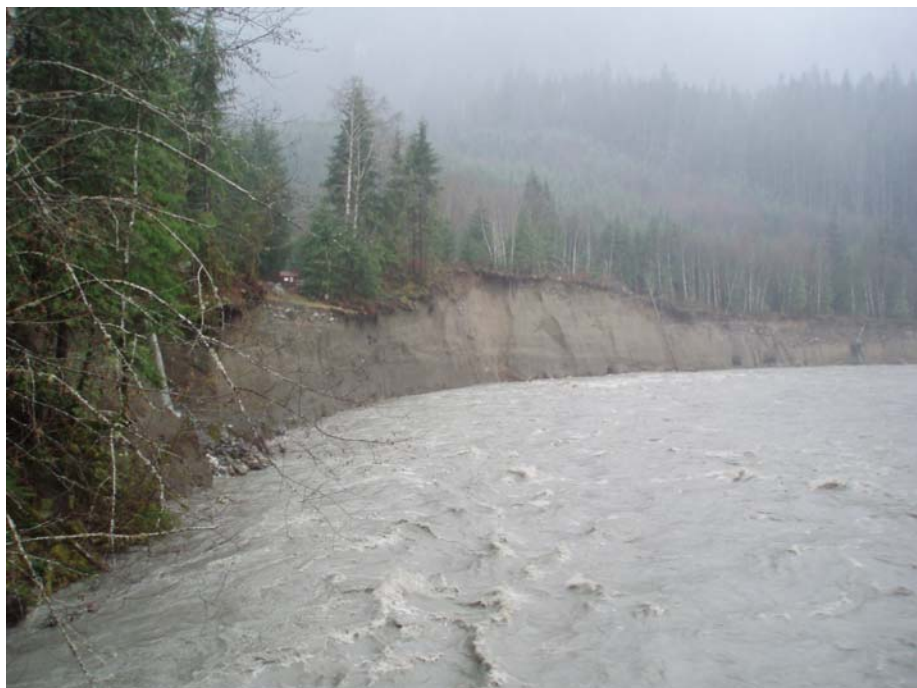
### **Figure 3: 2003 Washout Site**

Site of Monte Cristo Grade Road washout, October 22, 2003 (looking downriver).

Washout site on December 3, 2007 during high flow (looking downriver from Blue Bridge).

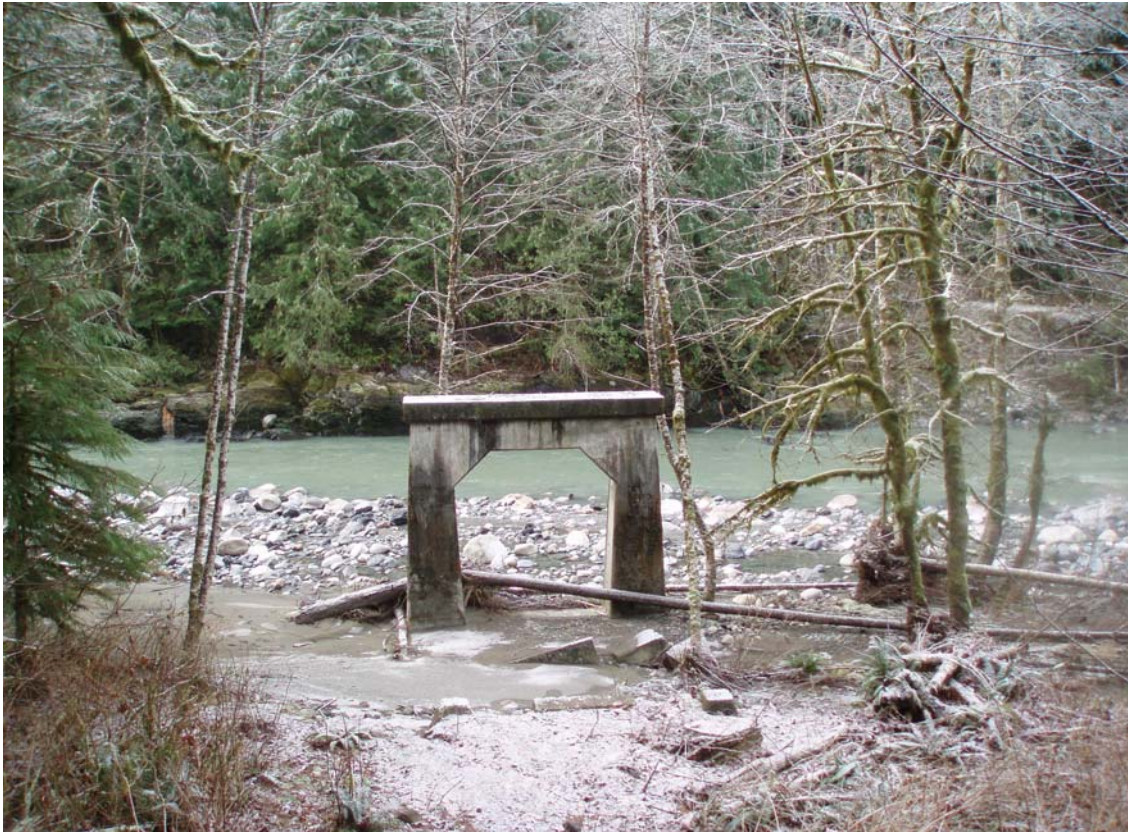
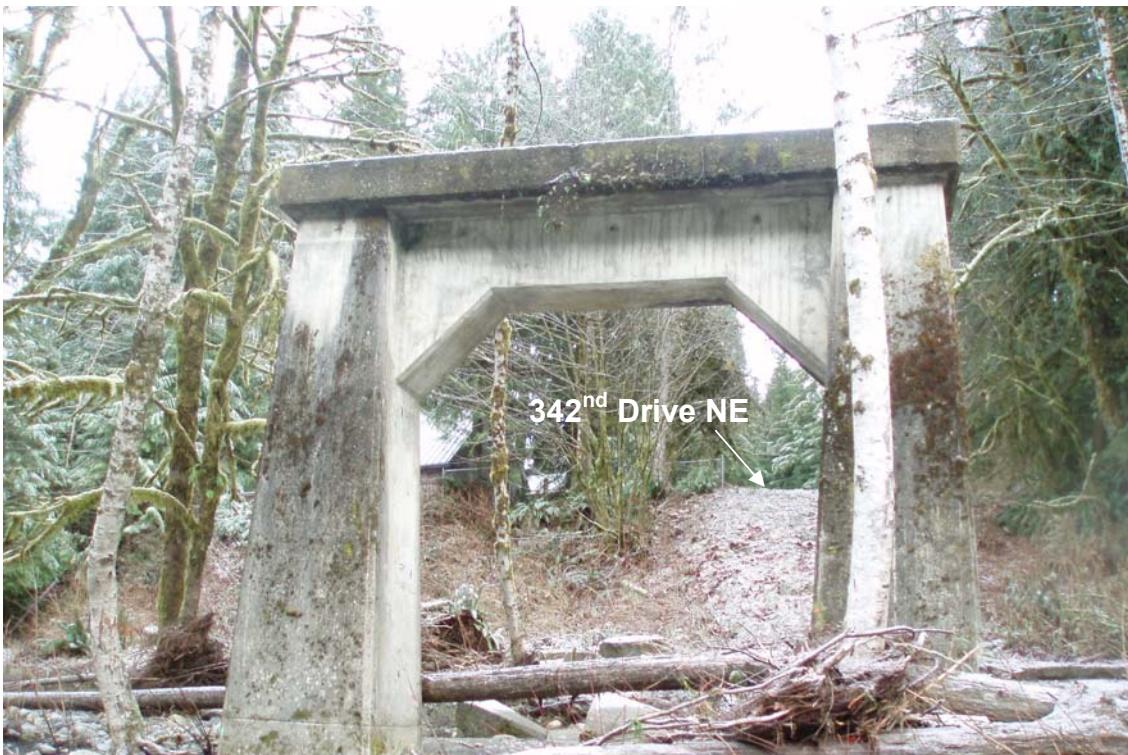
**Figure 7: Existing Concrete Pier**

Existing concrete pier to be removed: Top photo is looking south. Bottom photo is looking north.

A geotechnical evaluation of the remaining structures was conducted in 2006. According to this study, the existing center pier would need to be removed and replaced due to inadequate scour resistance and vertical load capacity. It is anticipated that the concrete abutment on the south side of the river would be left in place and modified to accommodate the new superstructure. If after more detailed analysis it is determined to be deficient, the abutment would be removed and replaced in the same location. A new abutment would also be constructed at the north end of the bridge at the end of 342<sup>nd</sup> Drive NE.

Construction would occur during the dry season. Ground impacts on the north side of the river include excavation for removal of the center pier and construction of a new pier. The proposed center pier would be at approximately the same location as the existing pier. The old pier is a cast-in-place structure with two columns supporting a concrete cap. (See Figure 7: Existing Concrete Pier). Impacts would also include excavation and removal of the existing north abutment where 342<sup>nd</sup> Drive NE dead ends. The abutment would be replaced with piles.

The new center pier will be supported by seven 24-inch diameter pipe piles driven to refusal. The north abutment would be supported by five 18-inch piles driven to refusal. Open-ended pipe piles are recommended due to their drivability in the granular soils encountered at the site. The depth of excavation for the center pier and north abutment piles is not determined at this time. Additional investigation is planned to determine the site design scour depth, the elevation and shape of the pile cap and pile depth.

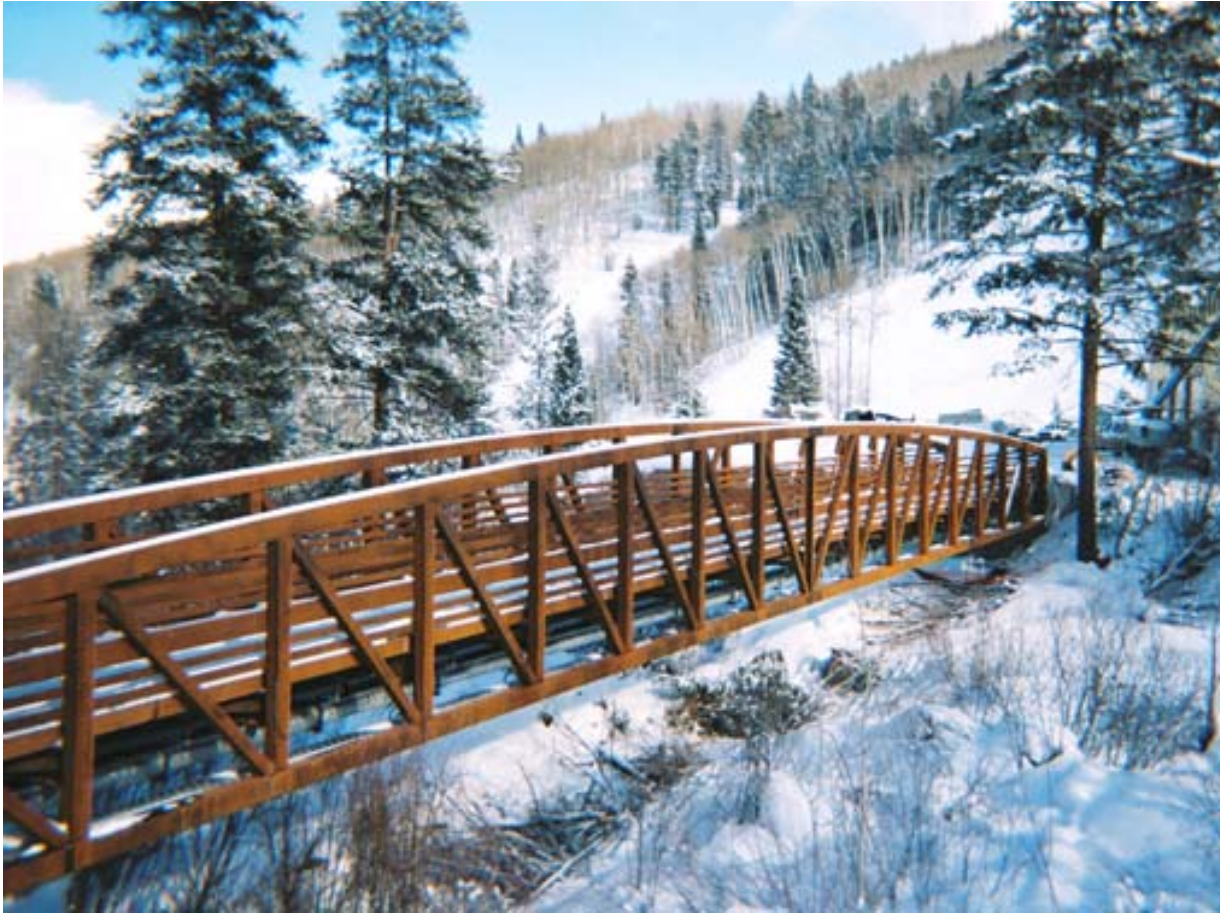
**Figure 9: Bridge Design**

**This bridge shown above is similar in design to the one proposed for the Monte Cristo Grade Road Bridge. The photo shows a prefabricated steel truss bridge.**

A prefabricated two-span, steel bow truss is planned for the superstructure. The first span between the north abutment and the center pier would be approximately 92 feet long and the second span over the main river channel would be approximately 152 feet long. Each span would be fabricated and installed as simple-spans. The horizontal alignment is straight with no skew at the new pier and abutment. The center pier and north abutment will be supported by pile foundations. The piles are planned to be vibrated in place. If it is not possible to vibrate the piles they would be driven into place.

Under the Bridge Option the existing concrete center pier would be removed and replaced with a similar structure. The new bridge is planned to be a prefabricated steel truss similar to the one pictured in Figure 9: Bridge Design. The bridge would be visible from the end of 342<sup>nd</sup> Drive NE. The bridge would also be visible from the river and the adjacent beach around the bridge site. The bridge may be visible from some of the cabins and homes off of 102<sup>nd</sup> Street NE just west of the bridge site. Due to the heavy vegetation and distance it is not likely the bridge would be visible from the Mountain Loop Highway.
