**Vehicle Research and Test Center
2001 Ford Taurus
Roof Crush Research
with 5° Pitch, 25° Roll
TRC Inc. Test Number: F030915**

**Prepared By:
Transportation Research Center Inc.
10820 State Route 347
East Liberty, OH 43319**

**Final Report
September - October 2003**

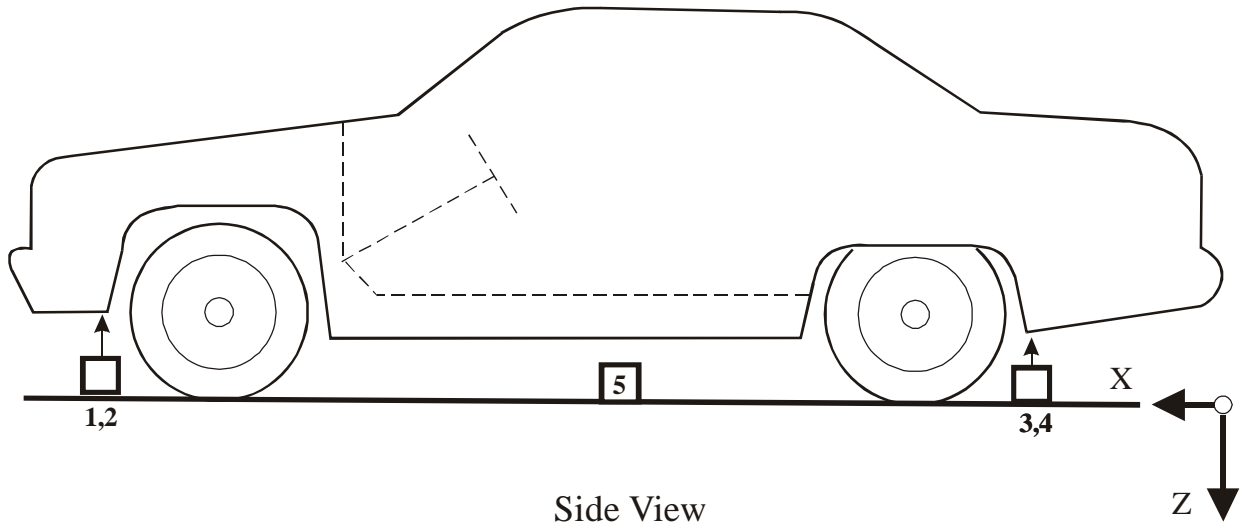
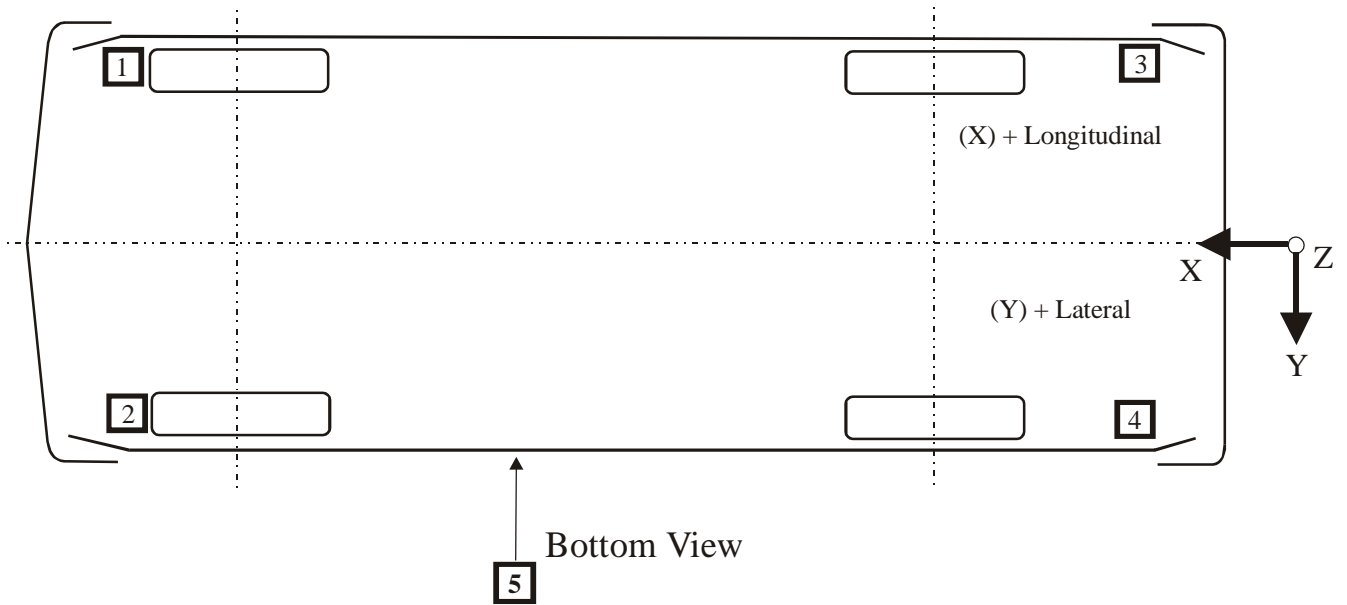
Figure 1 Vehicle Transducer Placement

The data channels were digitally sampled at twenty-five samples per second. The loading device was instrumented with two (2) force load cells and two (2) displacement potentiometers on the loading device cylinders. To collect additional data on the movement of the vehicle during the crush event, five (5) additional string potentiometers were recorded: four (4) potentiometers mounted to the bed plate and connected at the four corners of the vehicle behind

the bumper fascia and one (1) potentiometer mounted on an offboard stand and connected to the side sill opposite the loading side.

Figure Number	Description	Maximum Value	Time of Maximum
	Load Cell 1 Force	10026.7 N	24.84 s
	Load Cell 2 Force	38075.5 N	36.48 s
	Total Load Cell Force	43000.0 N	27.00 s
	Cylinder 1 Displacement	252.1 mm	36.48 s
	Cylinder 2 Displacement	252.9 mm	36.48 s
	Average Cylinder Displacement	252.5 mm	36.48 s
1	Left Front Vehicle Vertical Displacement	3.3 mm	13.00 s
2	Right Front Vehicle Vertical Displacement	-3.7 mm	32.48 s
3	Left Rear Vehicle Vertical Displacement	20.6 mm	30.96 s
4	Right Rear Vehicle Vertical Displacement	15.2 mm	31.96 s
5	Opposite Side Vehicle Lateral Displacement	0.3 mm	17.80 s

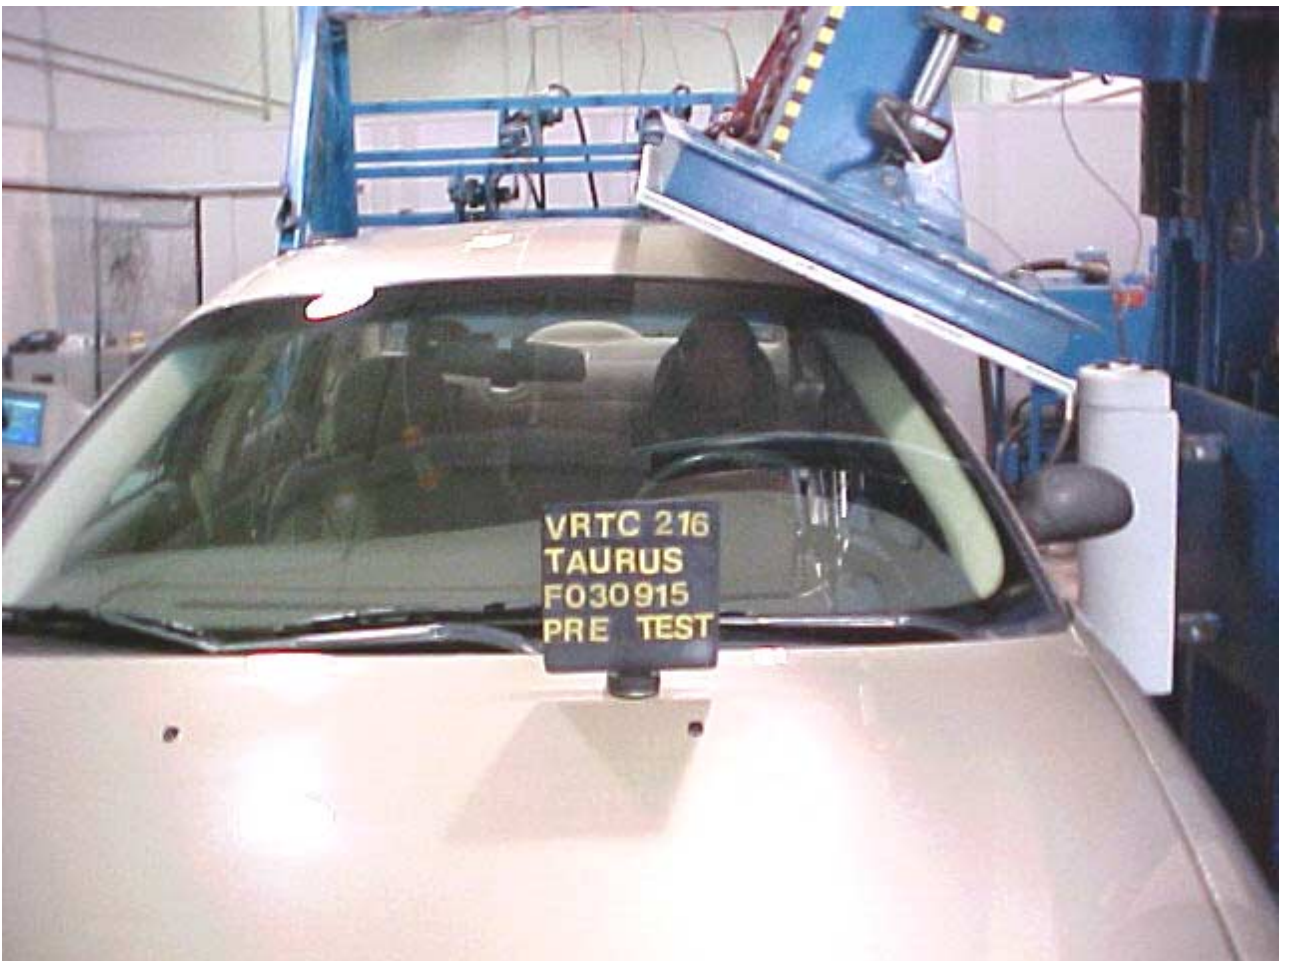
Figure A-12 Pre-Test Loading Device Initial Contact Point View

The test vehicle was subjected to a 254 mm (10-inch) stroke of the loading device, not to exceed a 60,000 N load. The load was applied to the left forward edge of the vehicle roof. A flat rectangular rigid loading device 30 inches wide by 72 inches long was used to apply the load. The loading device was oriented with its longitudinal axis at a forward angle of 5° below the horizontal and parallel to a vertical plane through the vehicle longitudinal centerline. The loading device was oriented with its lateral axis at an angle of 25° below the horizontal. The forward-most edge of the loading device, along its longitudinal centerline, was located 10 inches forward of the forward-most portion of the roof, including windshield moulding.

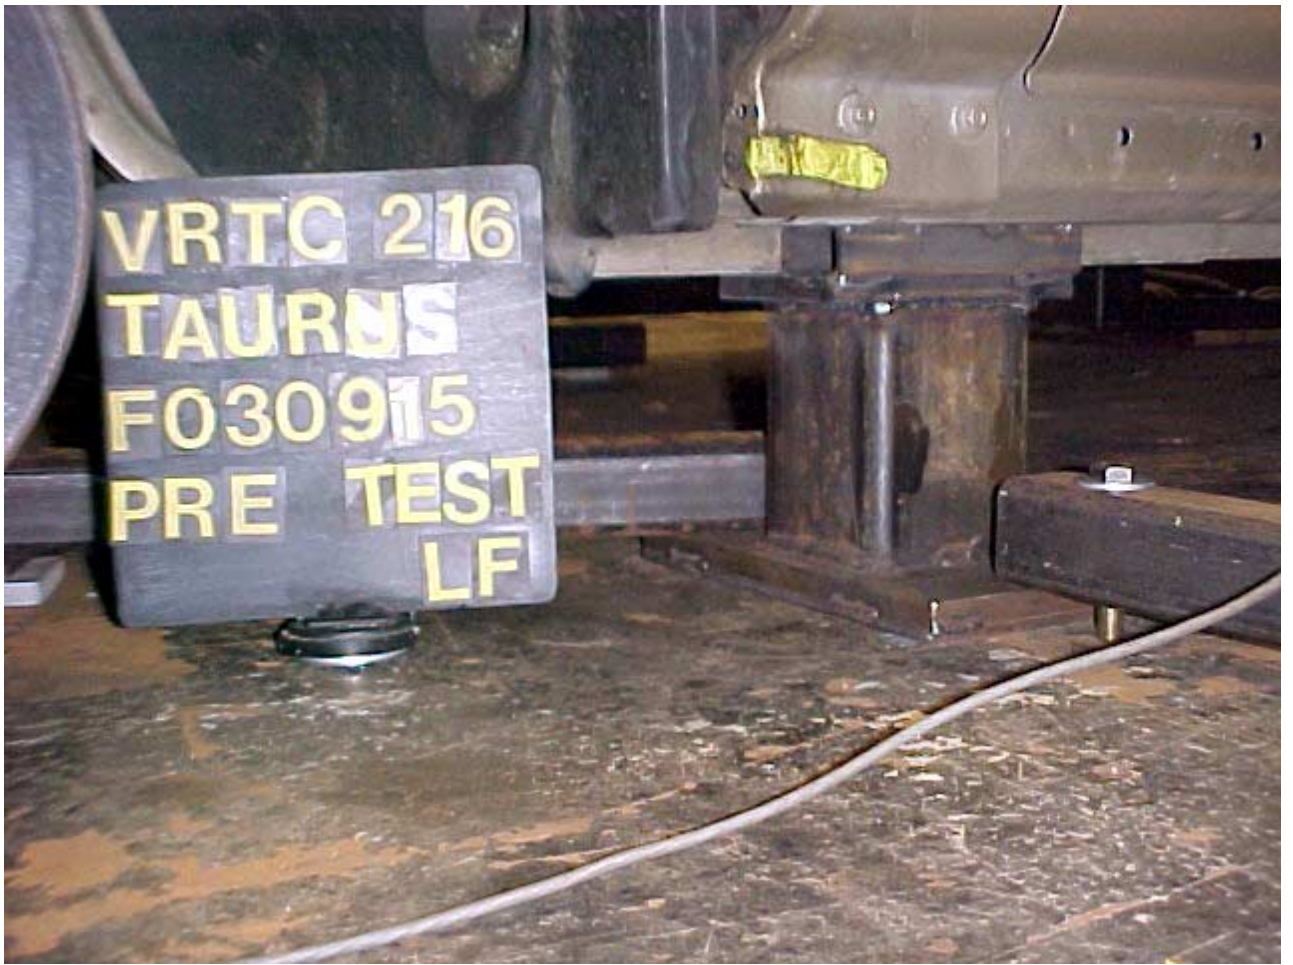
Figure A-13 Pre-Test Left Front Stand and Reinforcement View

The test vehicle was mounted on four (4) bedplate stands that were affixed to the bedplate with pinch bars. The stands were welded to the vehicle at the four manufacturer designated jacking points. (See photographs in Appendix A.)

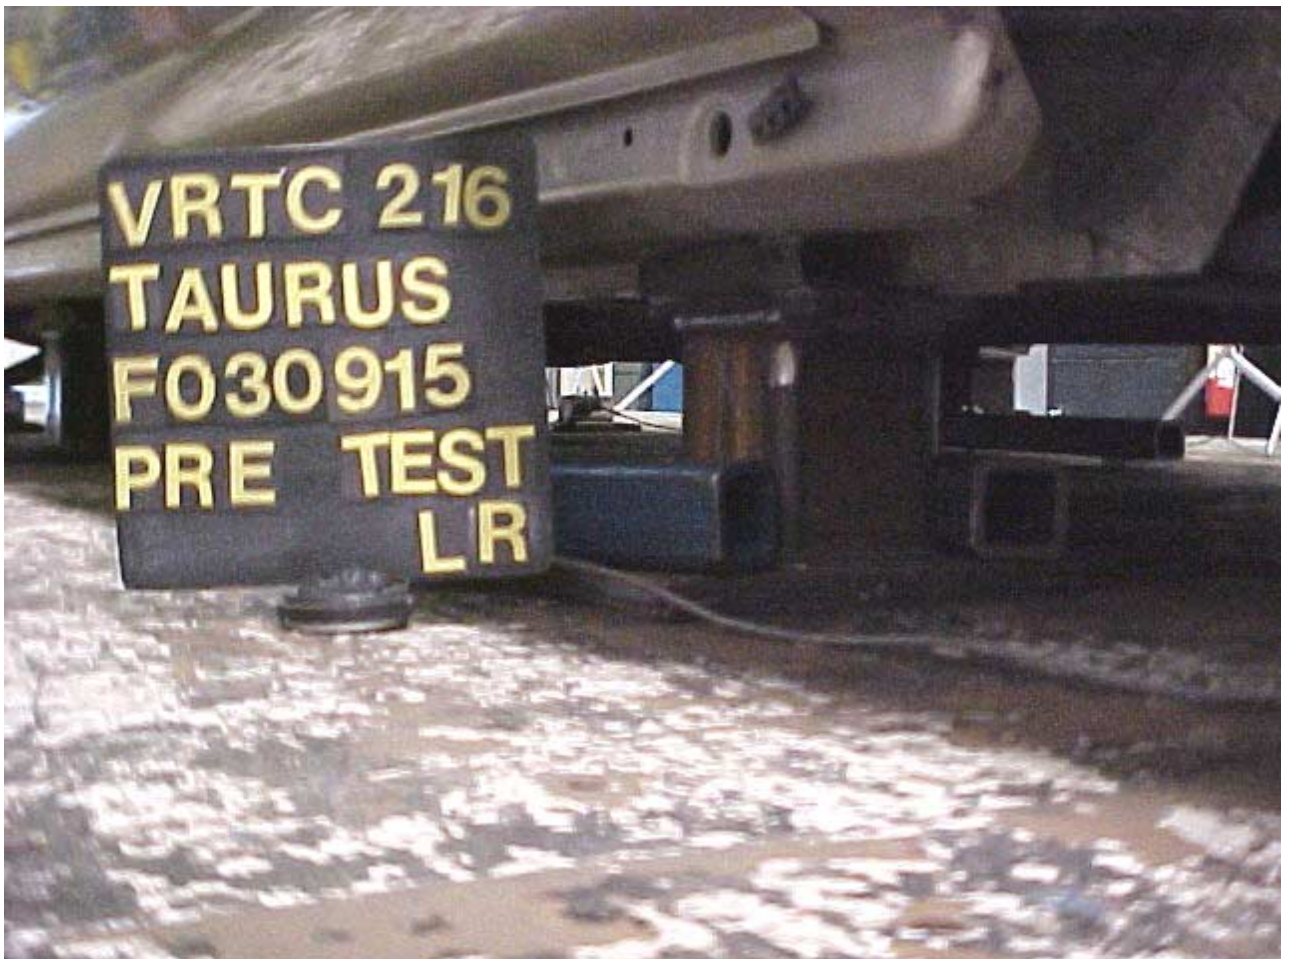
Figure A-14 Pre-Test Left Rear Stand and Reinforcement View

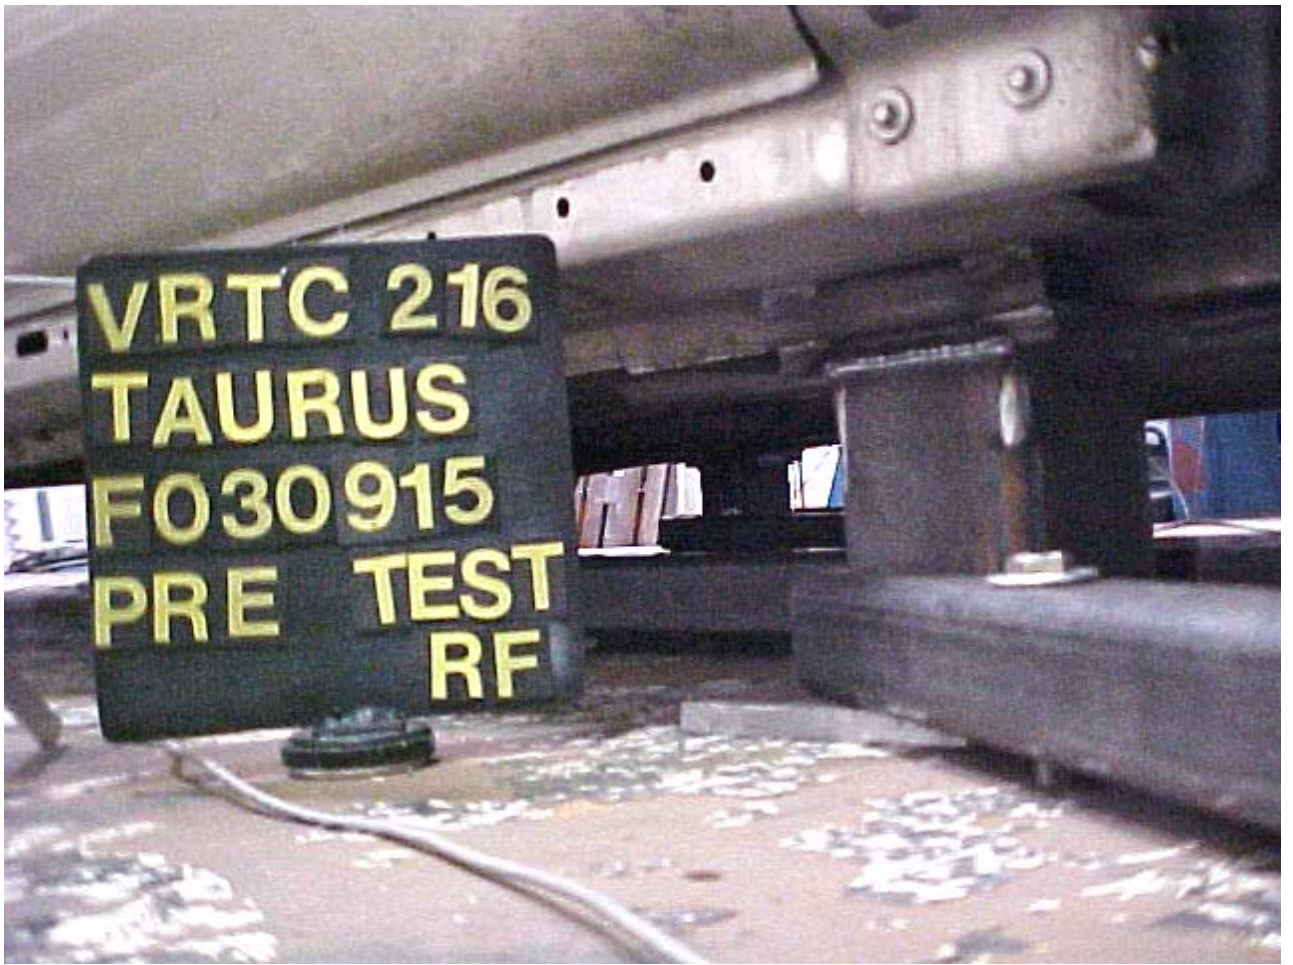
Figure A-15 Pre-Test Right Front Stand and Reinforcement View

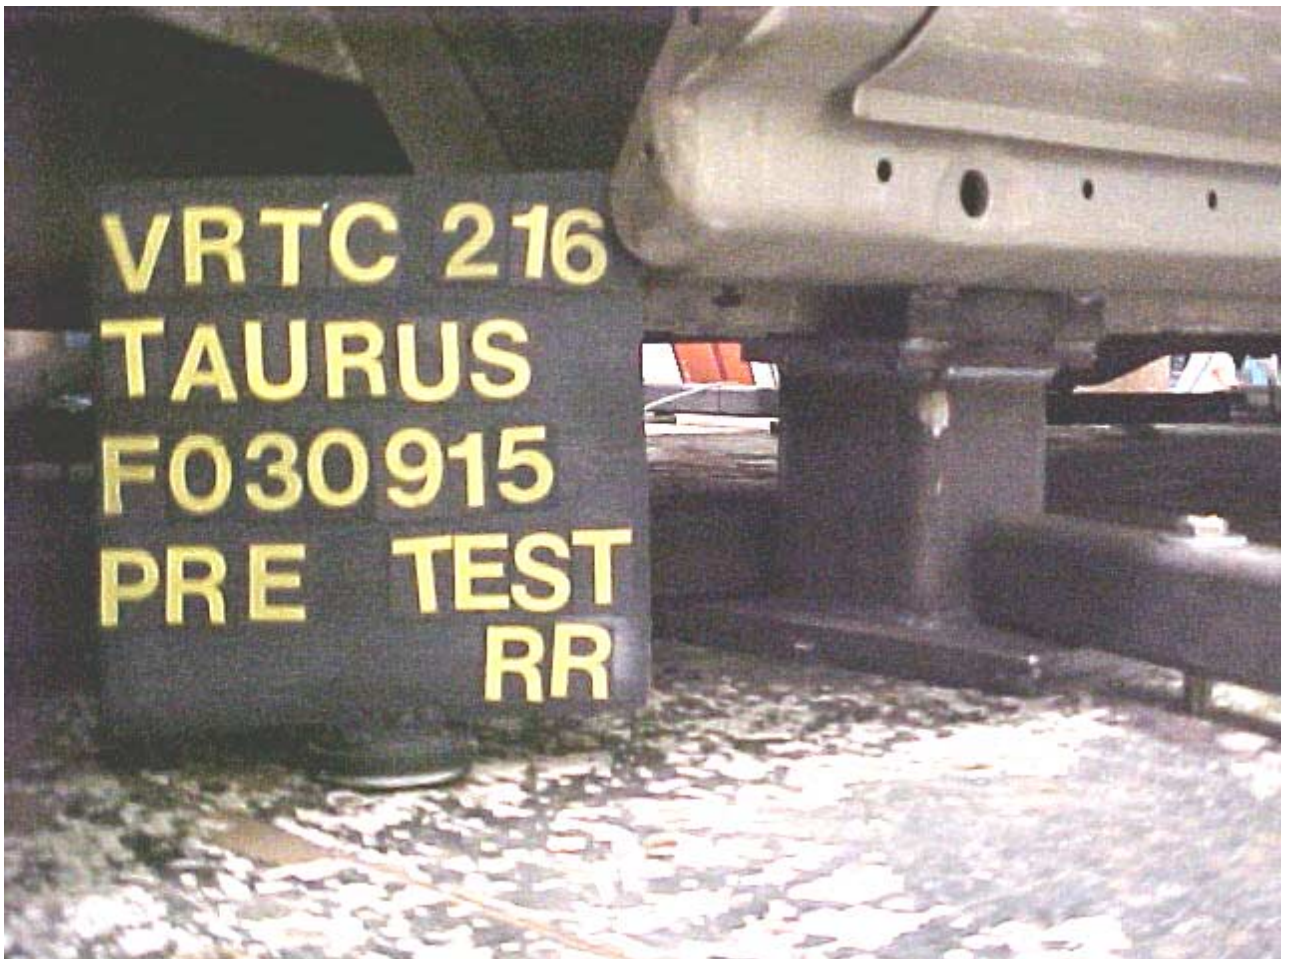
Figure A-16 Pre-Test Right Rear Stand and Reinforcement View

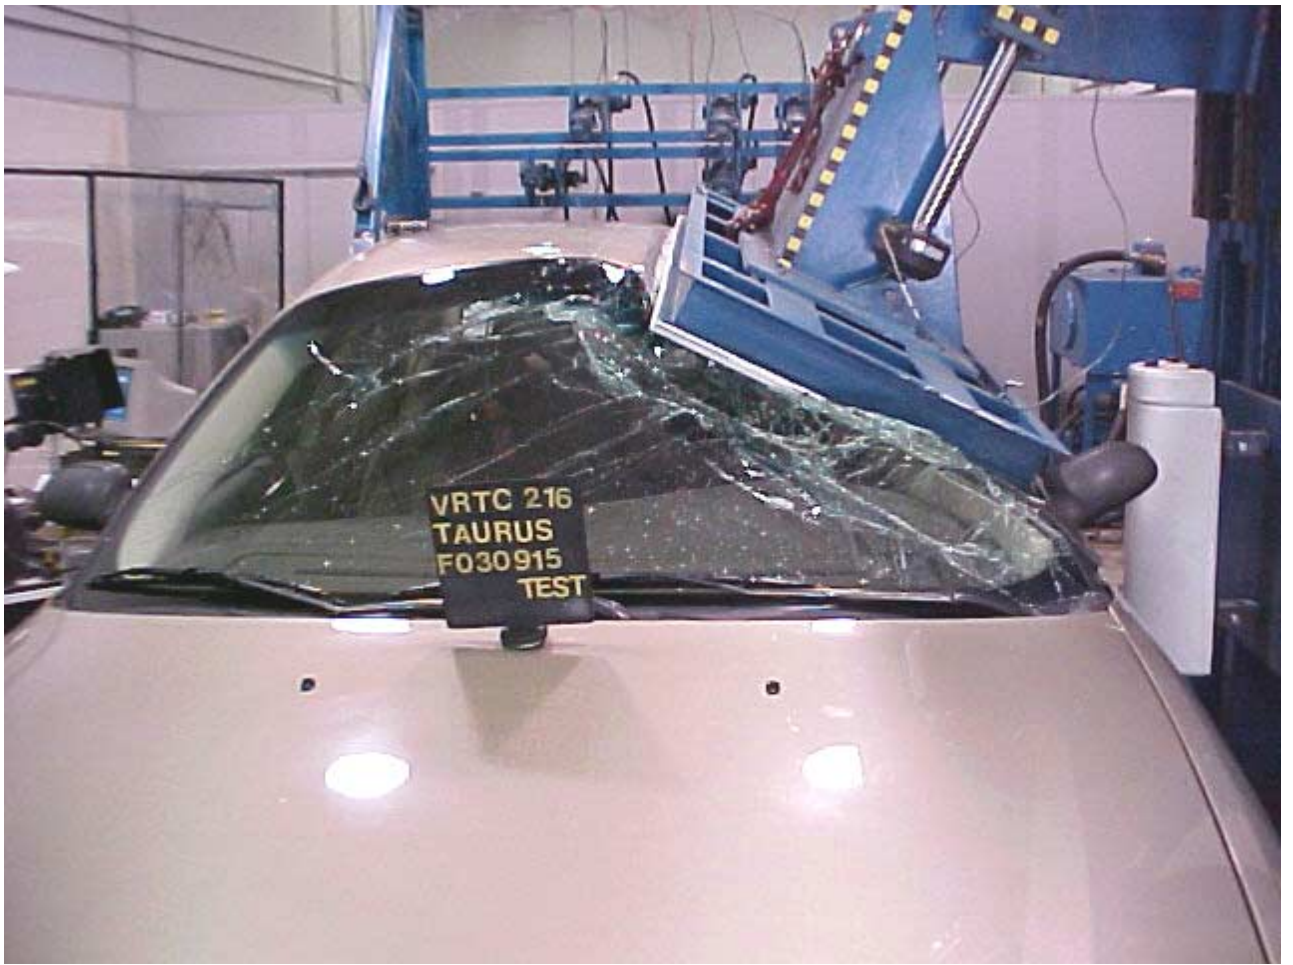
Figure A-23 Post-Test Maximum Stroke Front View

The test vehicle, a 2001 Ford Taurus, was subjected to 254 millimeters (10.0 inches) of crush by the loading device on the left front roof edge.

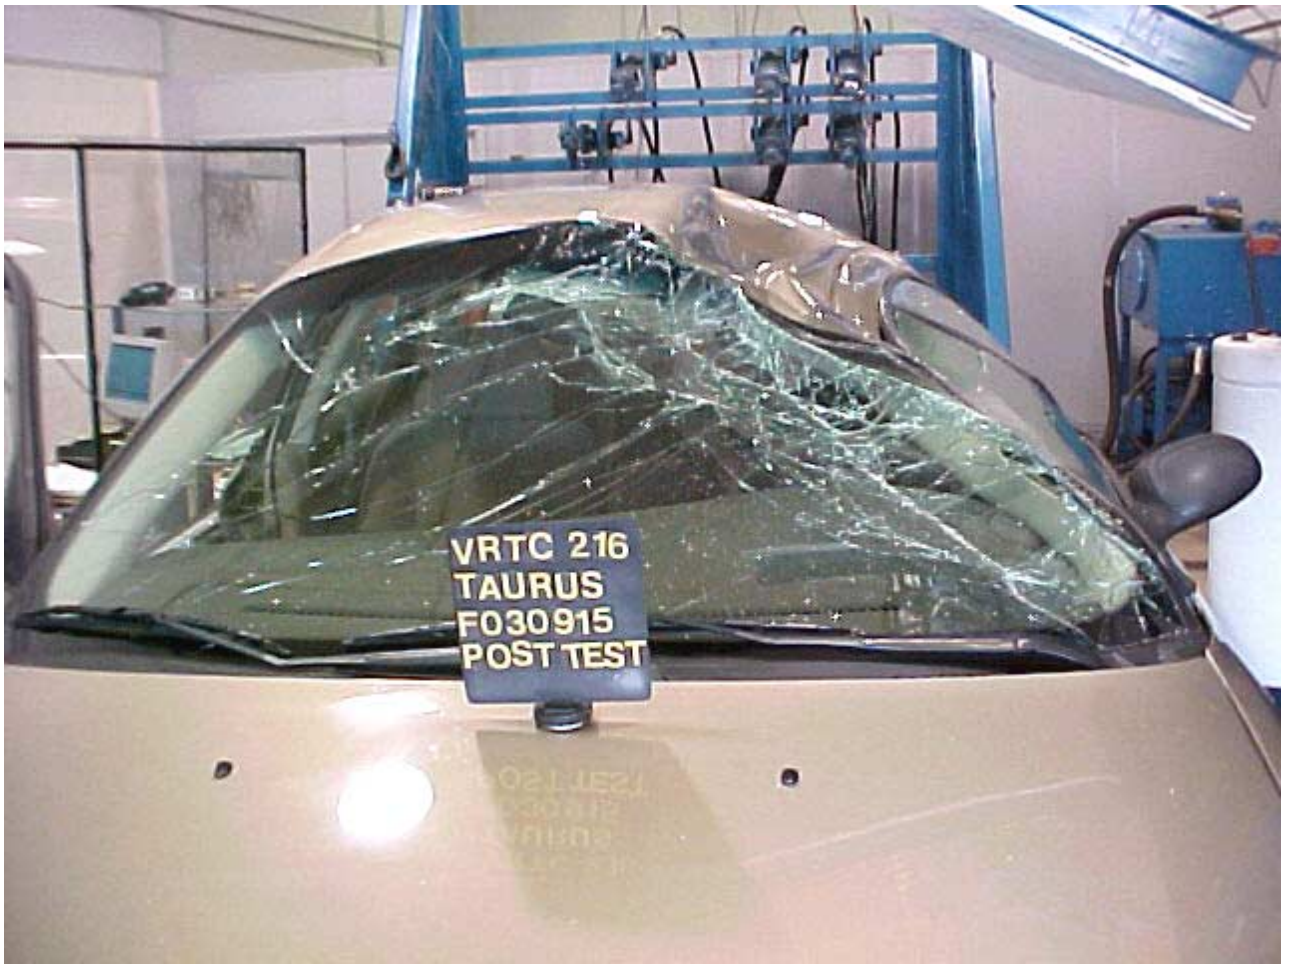
Figure A-35 Post-Test Vehicle Damage - View 1

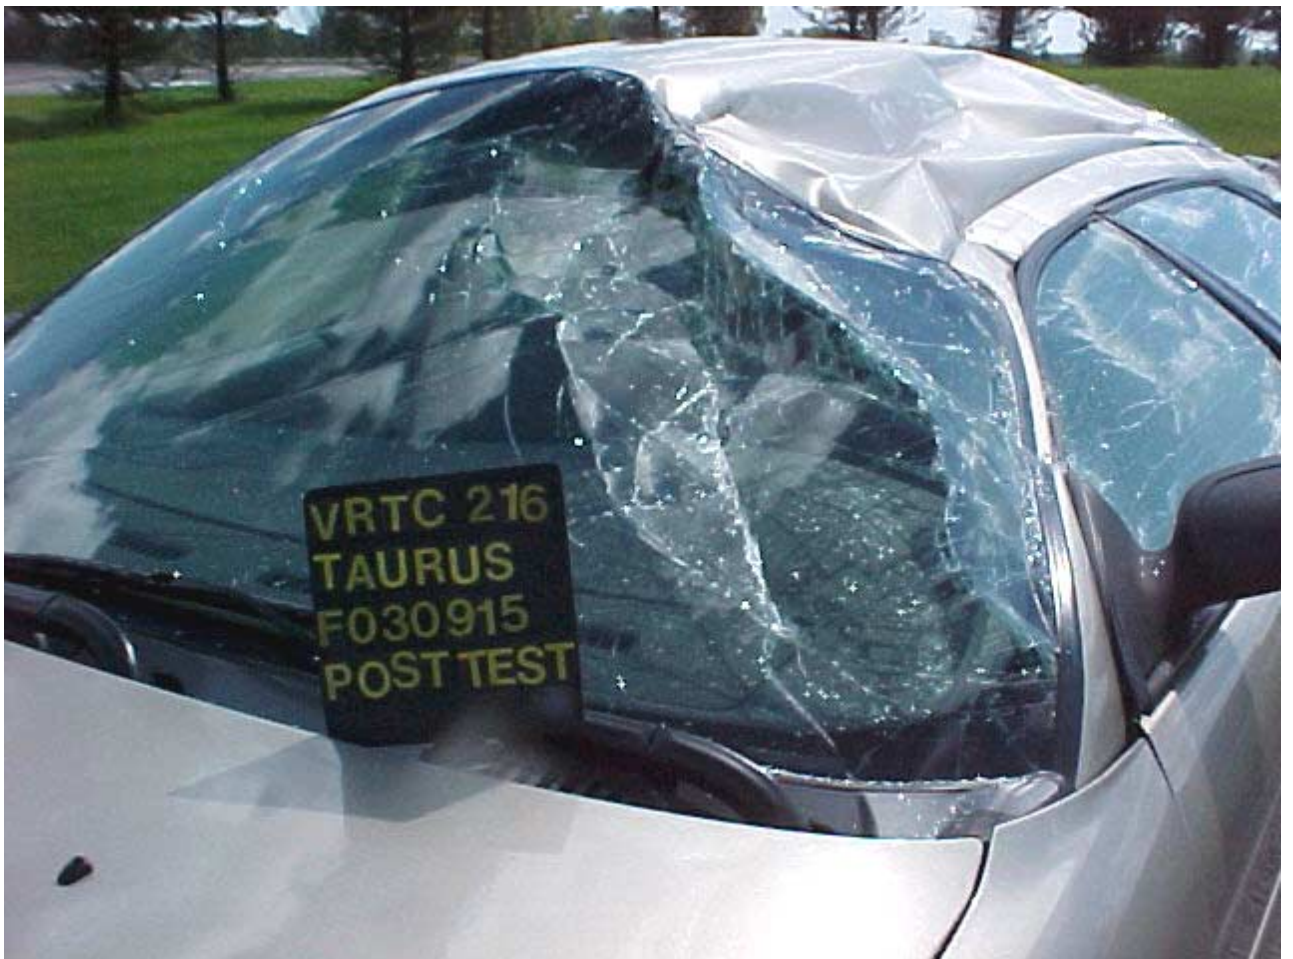
Figure A-36 Post-Test Vehicle Damage - View 2

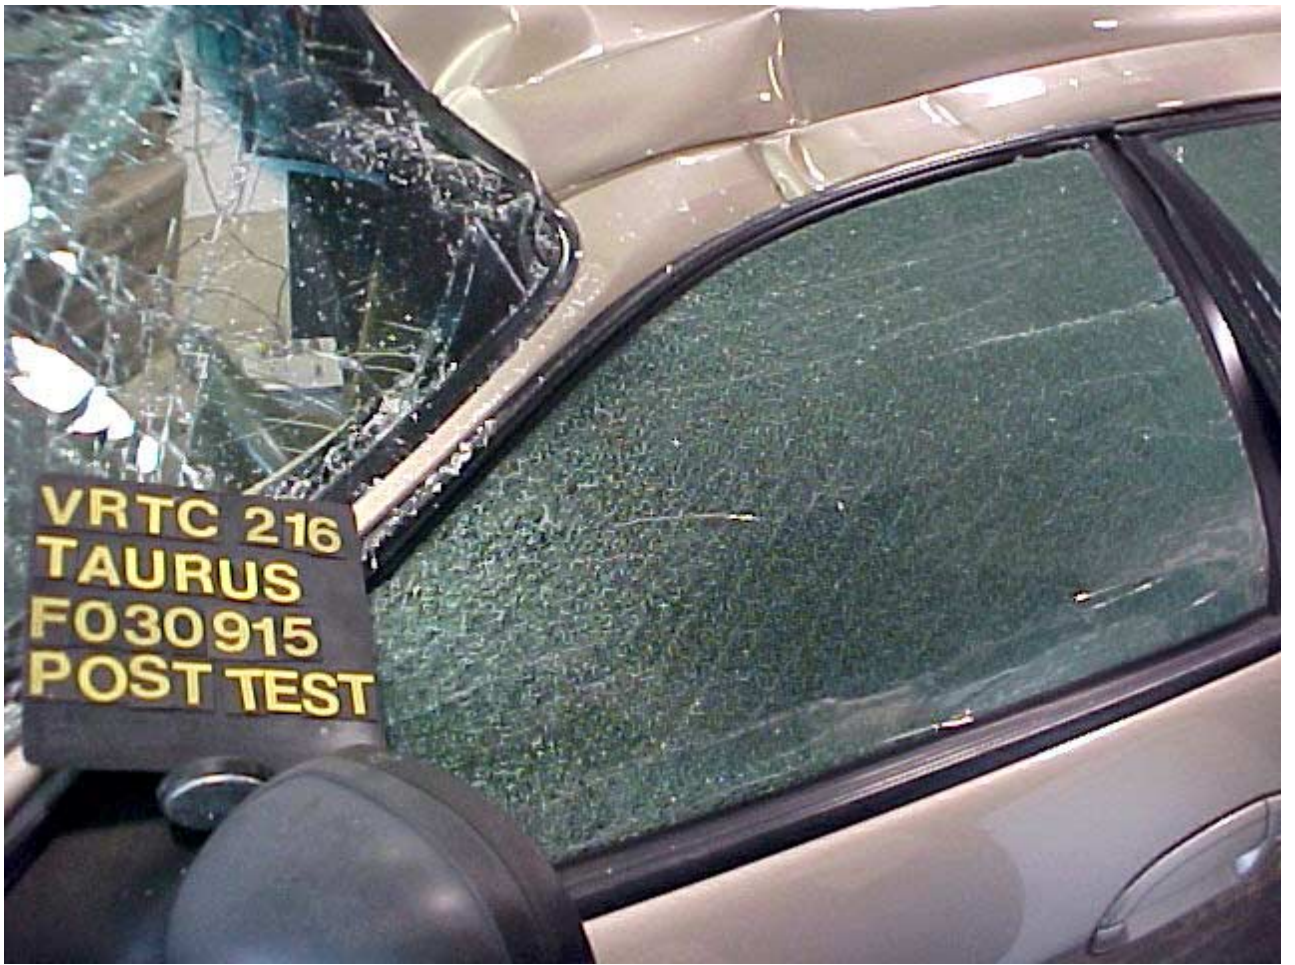
Figure A-37 Post-Test Vehicle Damage - View 3

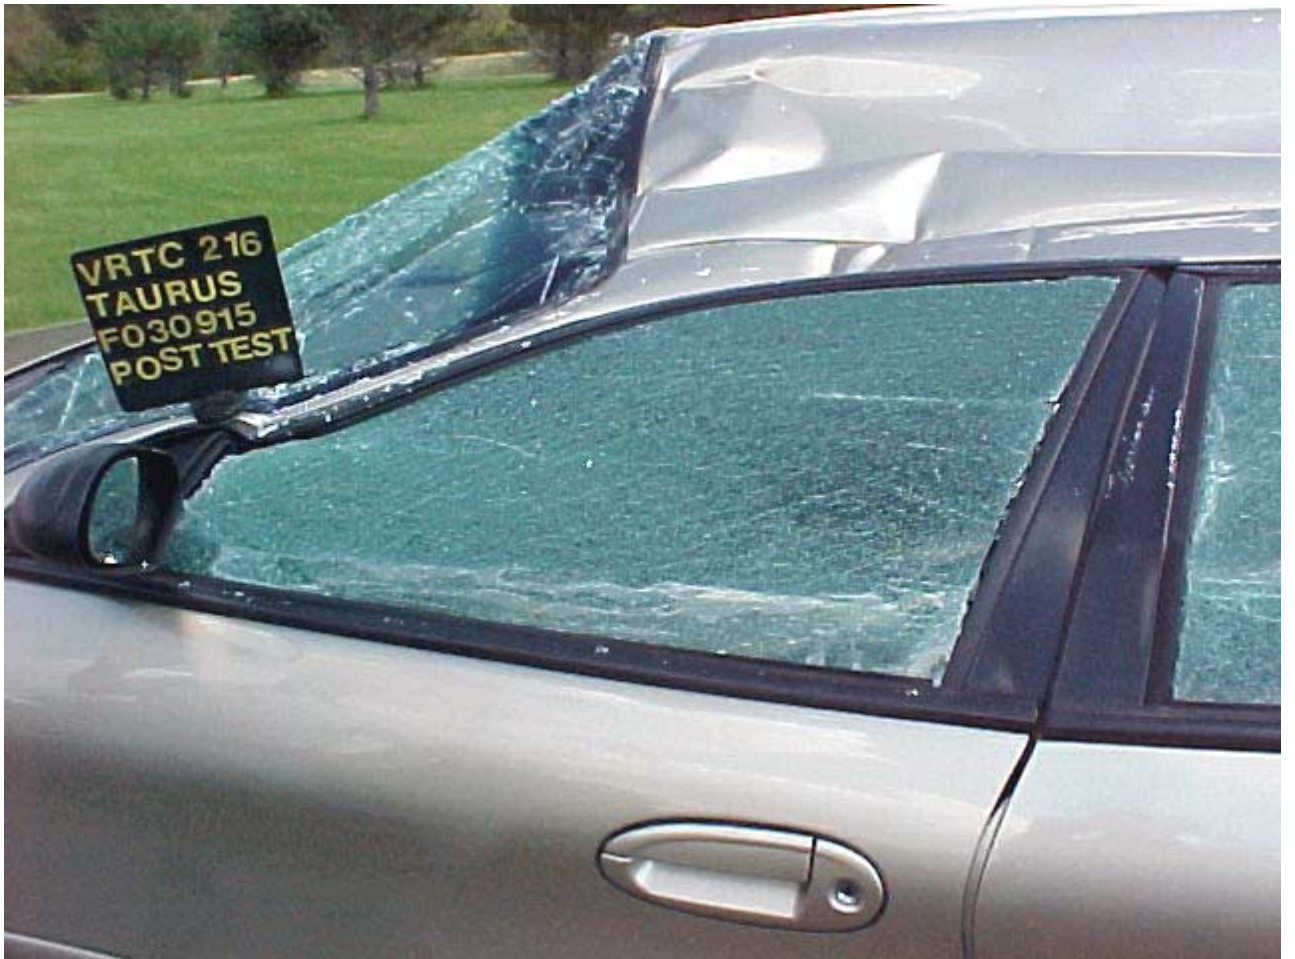
Figure A-38 Post-Test Vehicle Damage - View 4

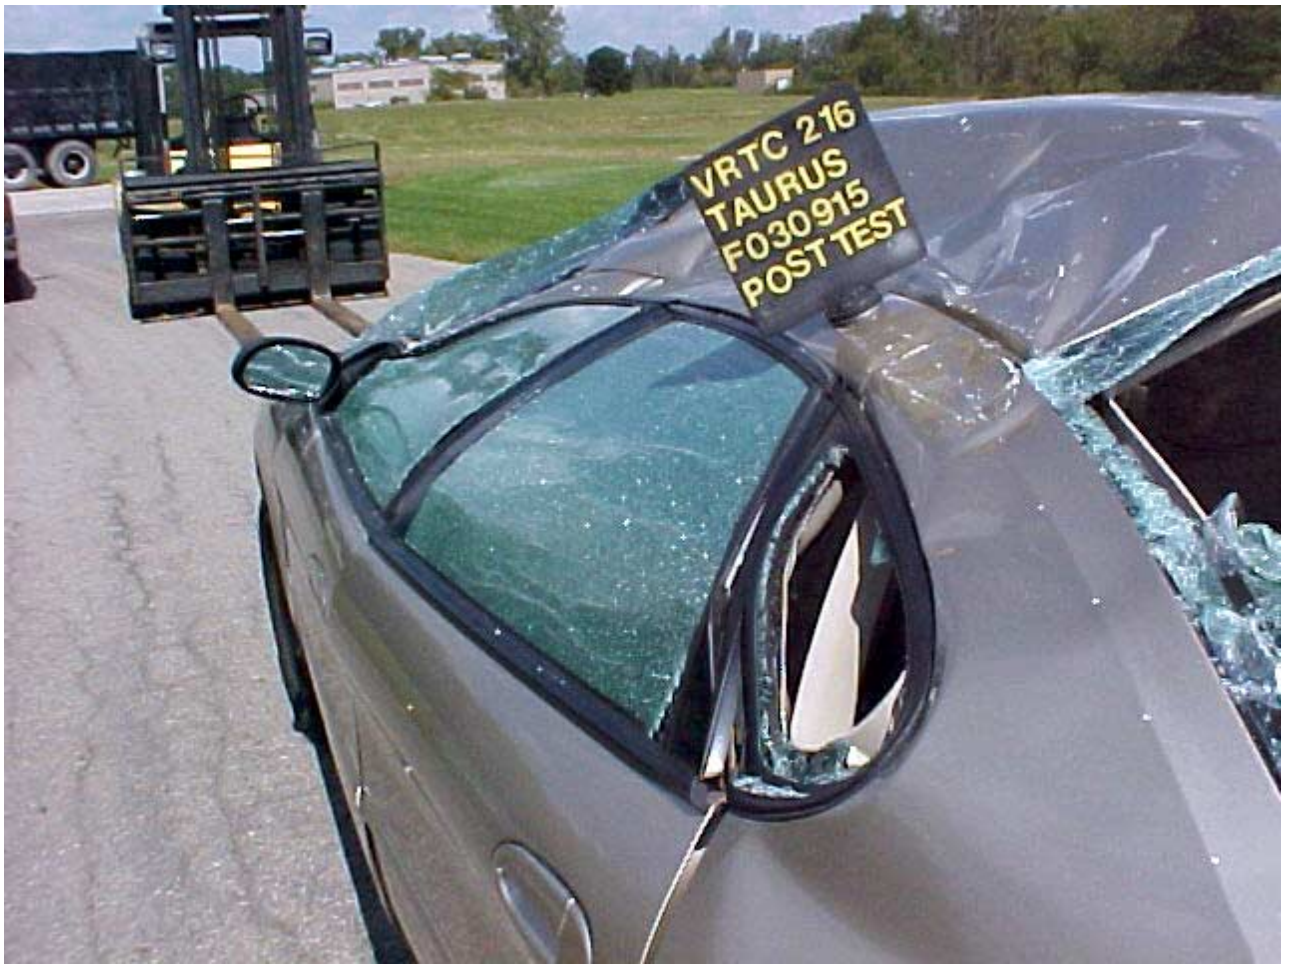
Figure A-39 Post-Test Vehicle Damage - View 5

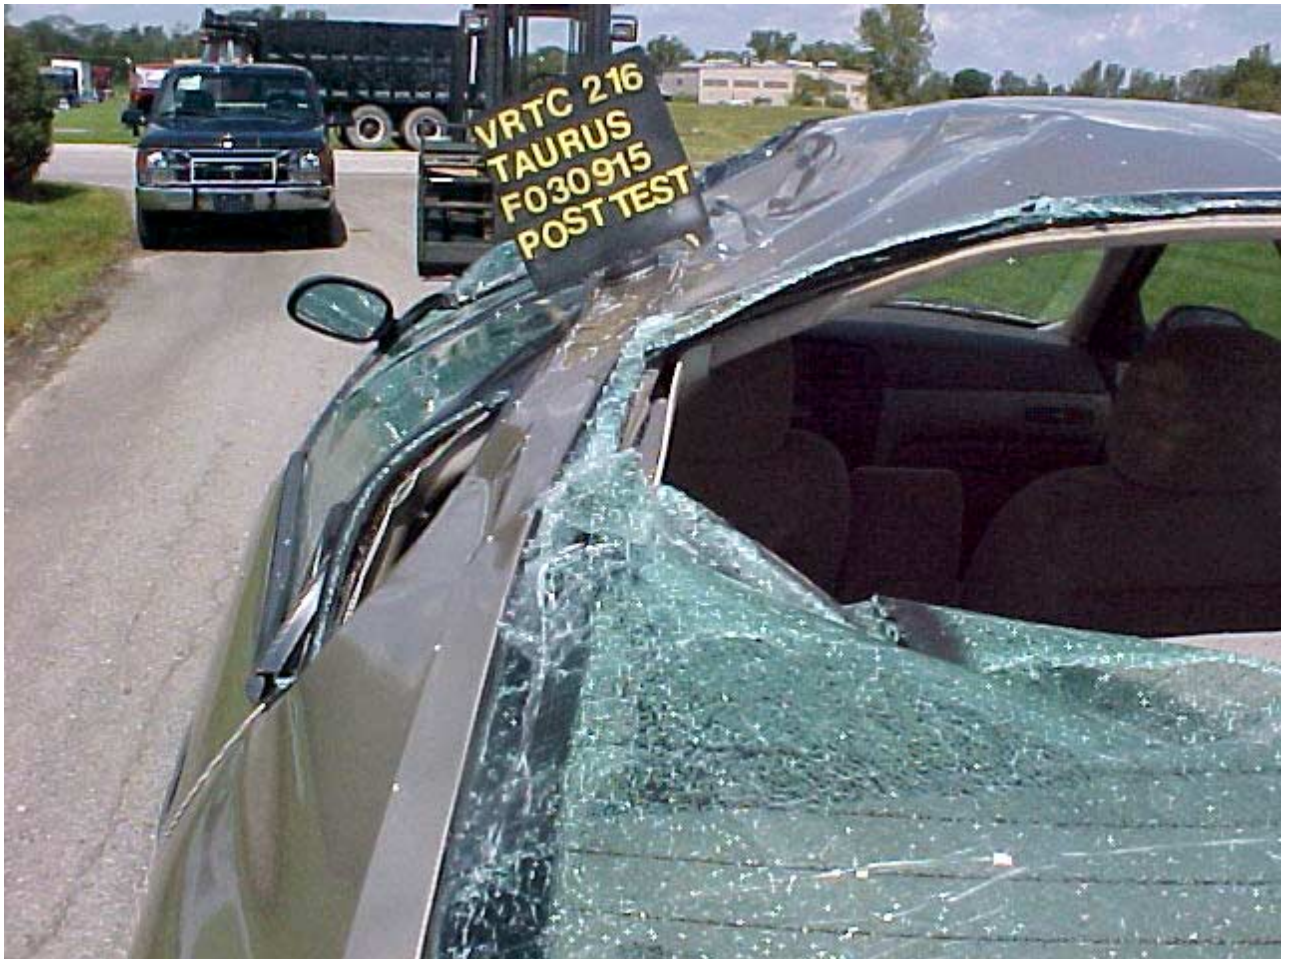
Figure A-40 Post-Test Vehicle Damage - View 6

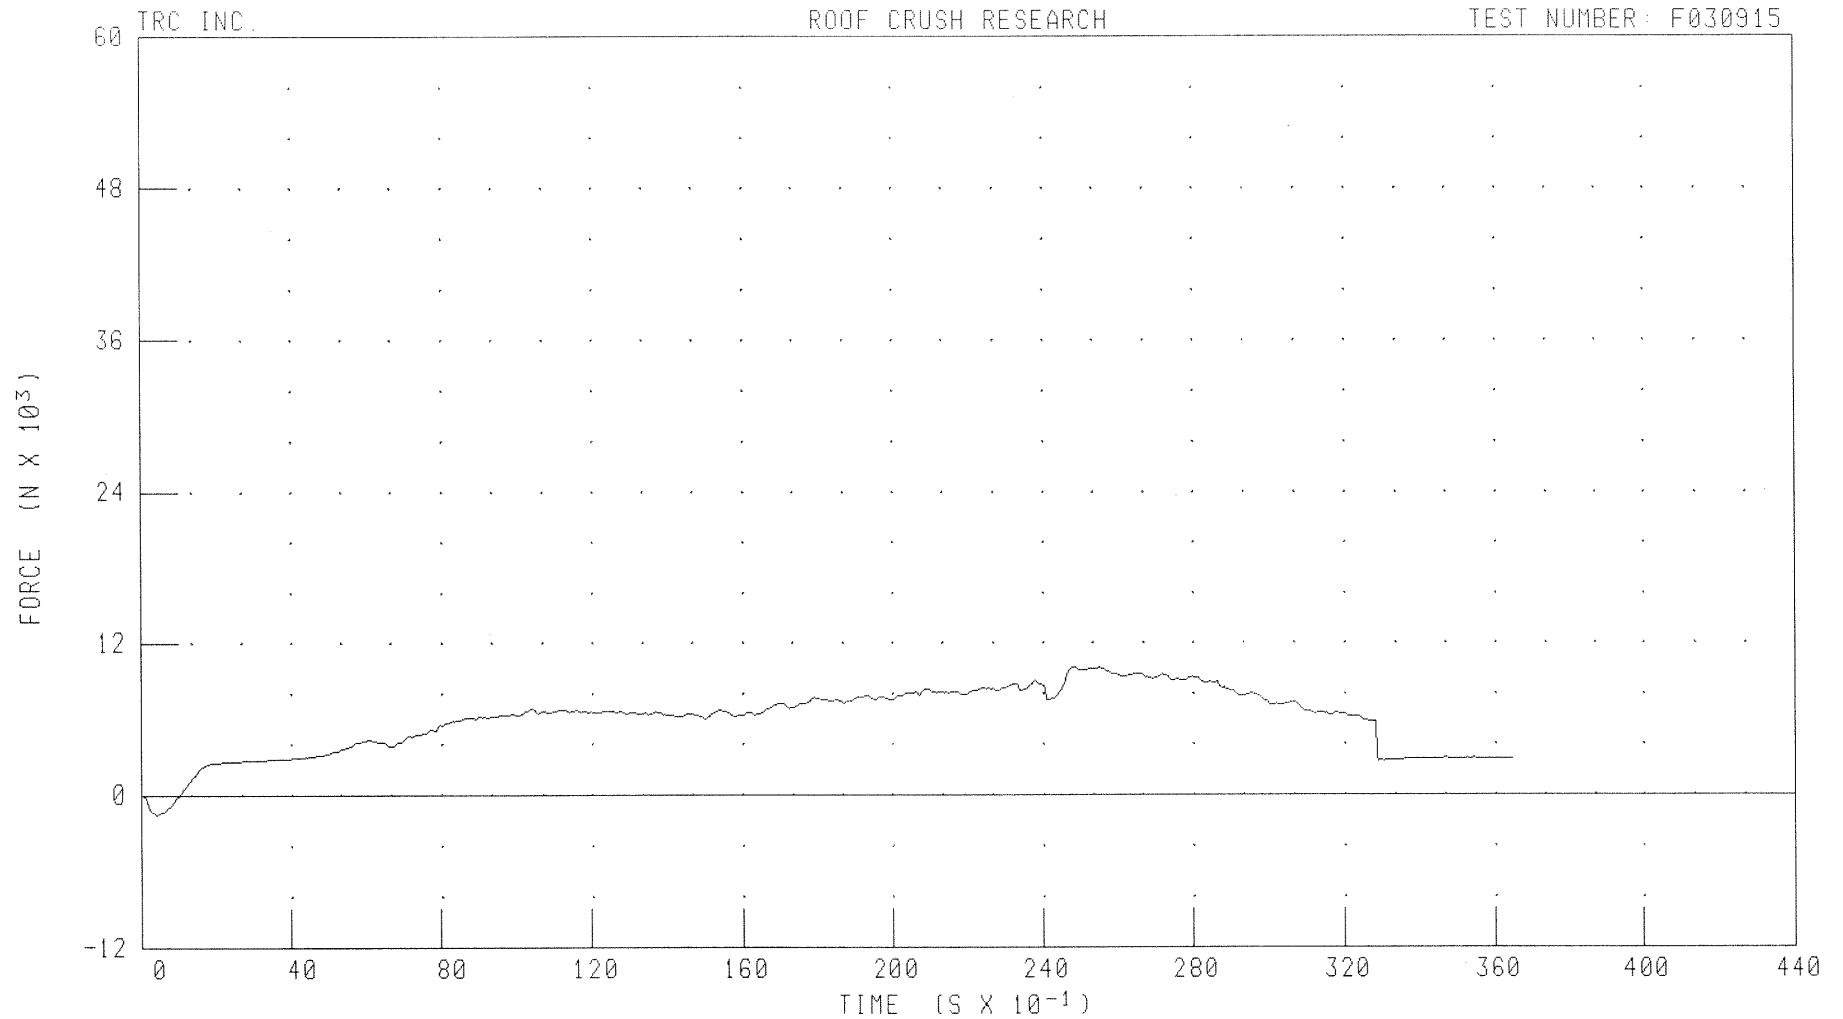
LOAD CELL 1 FORCE

CHANNEL: LC1

PEAK DATA: 10026.66 N @ 24.84 S; -1507.67 N @ 0.44 S

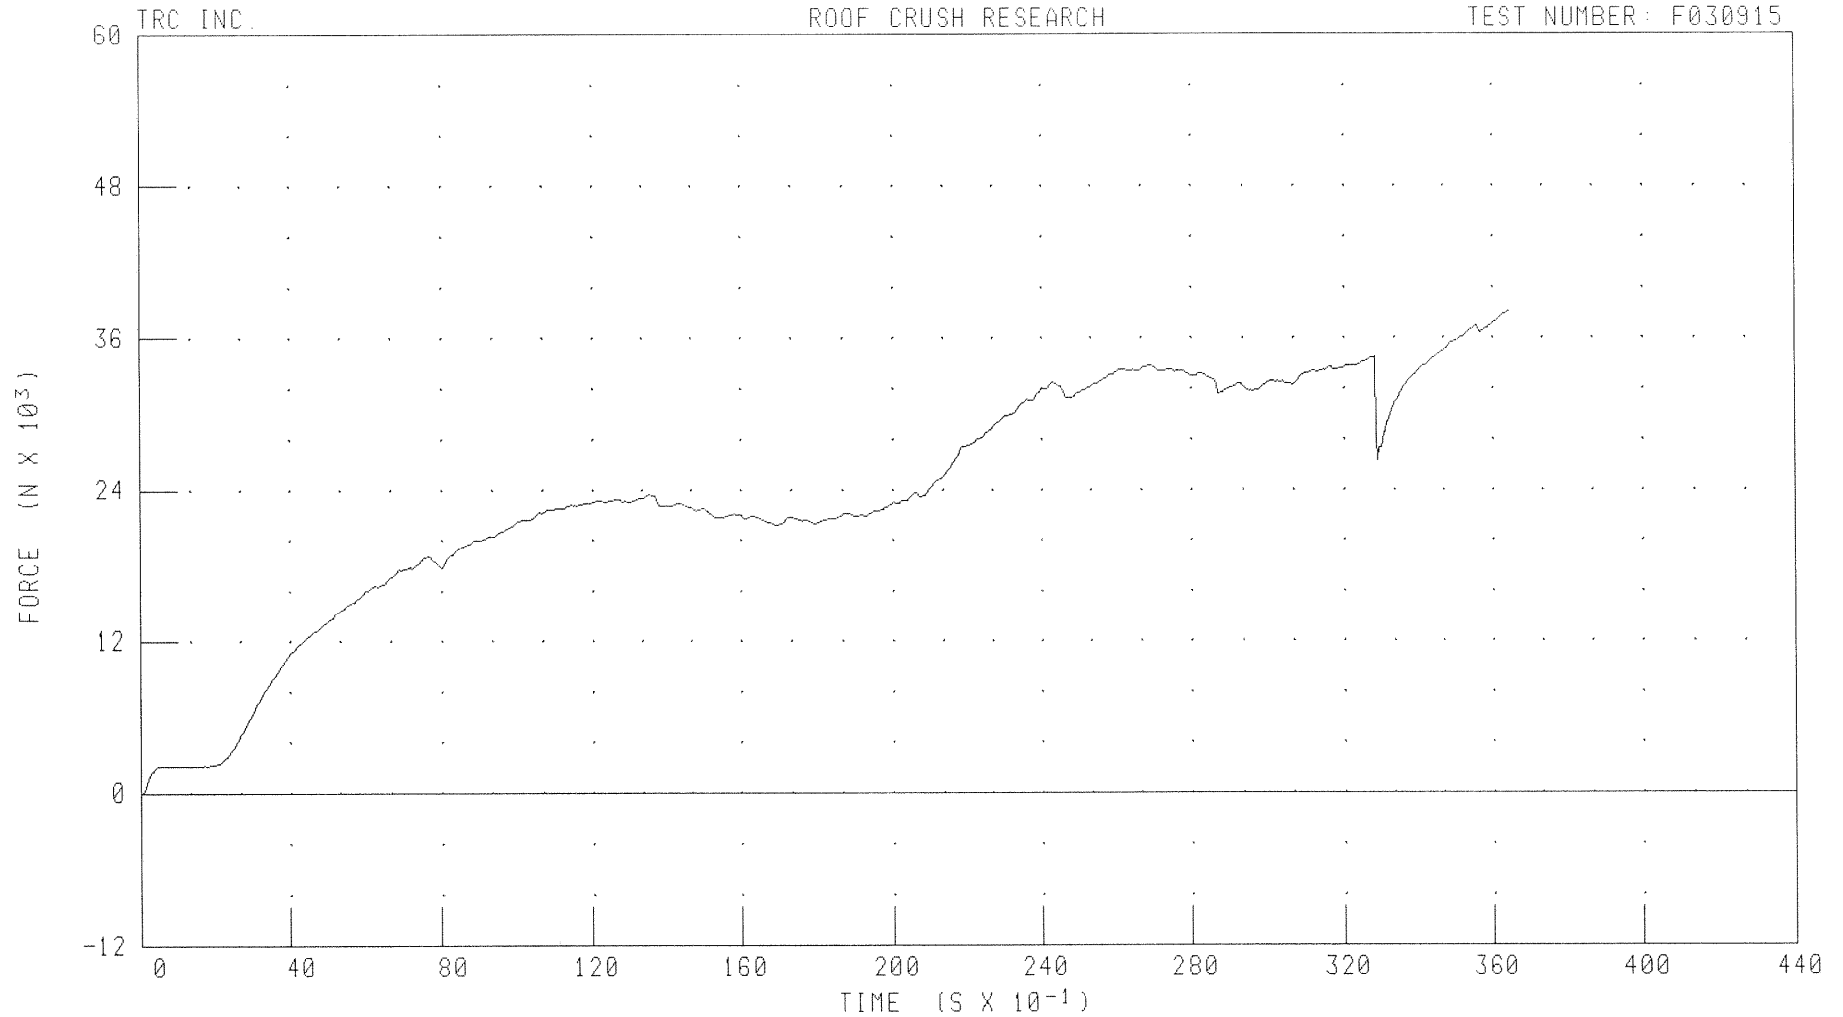
LOAD CELL 2 FORCE

CHANNEL: LC2

PEAK DATA: 38075.46 N @ 36.48 S; 9.53 N @ 0.00 S

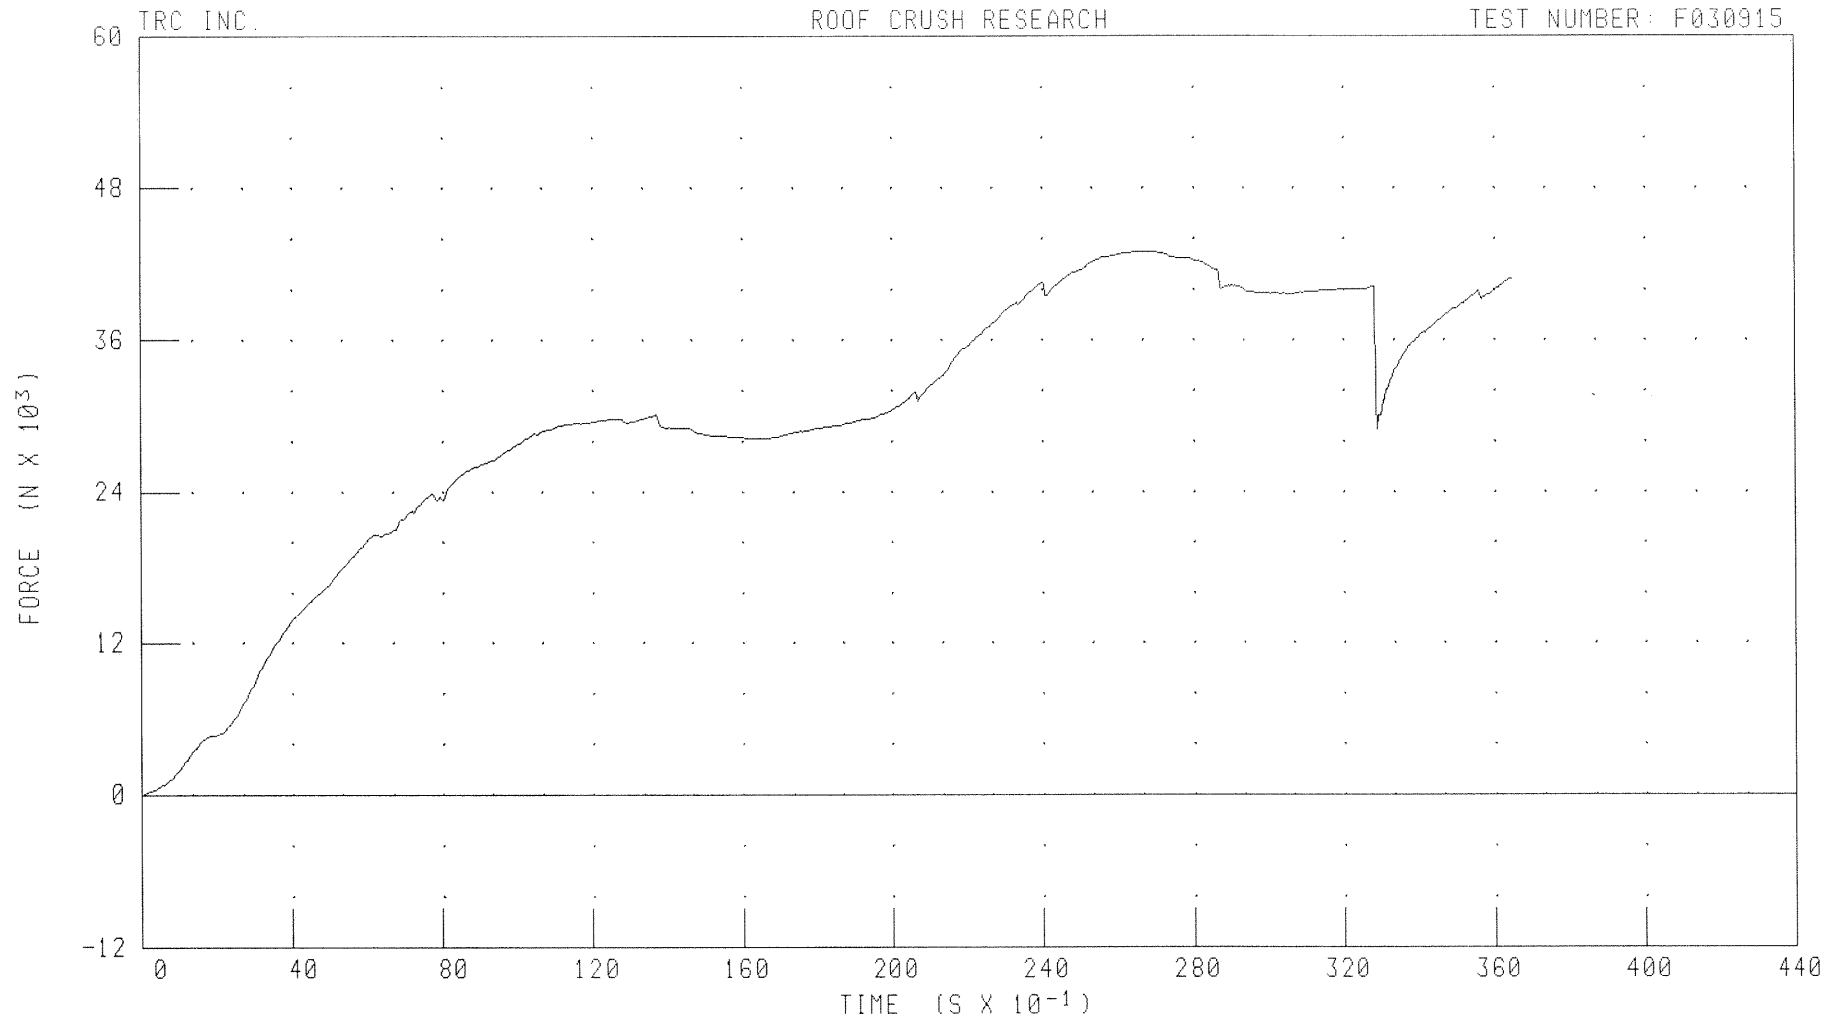
TOTAL LOAD CELL FORCE

CHANNEL: TOT

PEAK DATA: 42999.97 N @ 27.00 S; -19.25 N @ 0.04 S

The test vehicle sustained a peak load of 43000 Newtons at 186.5 millimeters of test device displacement. The test was completed in approximately 36.48 seconds.
