**Vehicle Research and Test Center
2001 Ford Taurus
Roof Crush Research
with 5° Pitch, 25° Roll
TRC Inc. Test Number: F030915**

**Prepared By:
Transportation Research Center Inc.
10820 State Route 347
East Liberty, OH 43319**

**Final Report
September - October 2003**

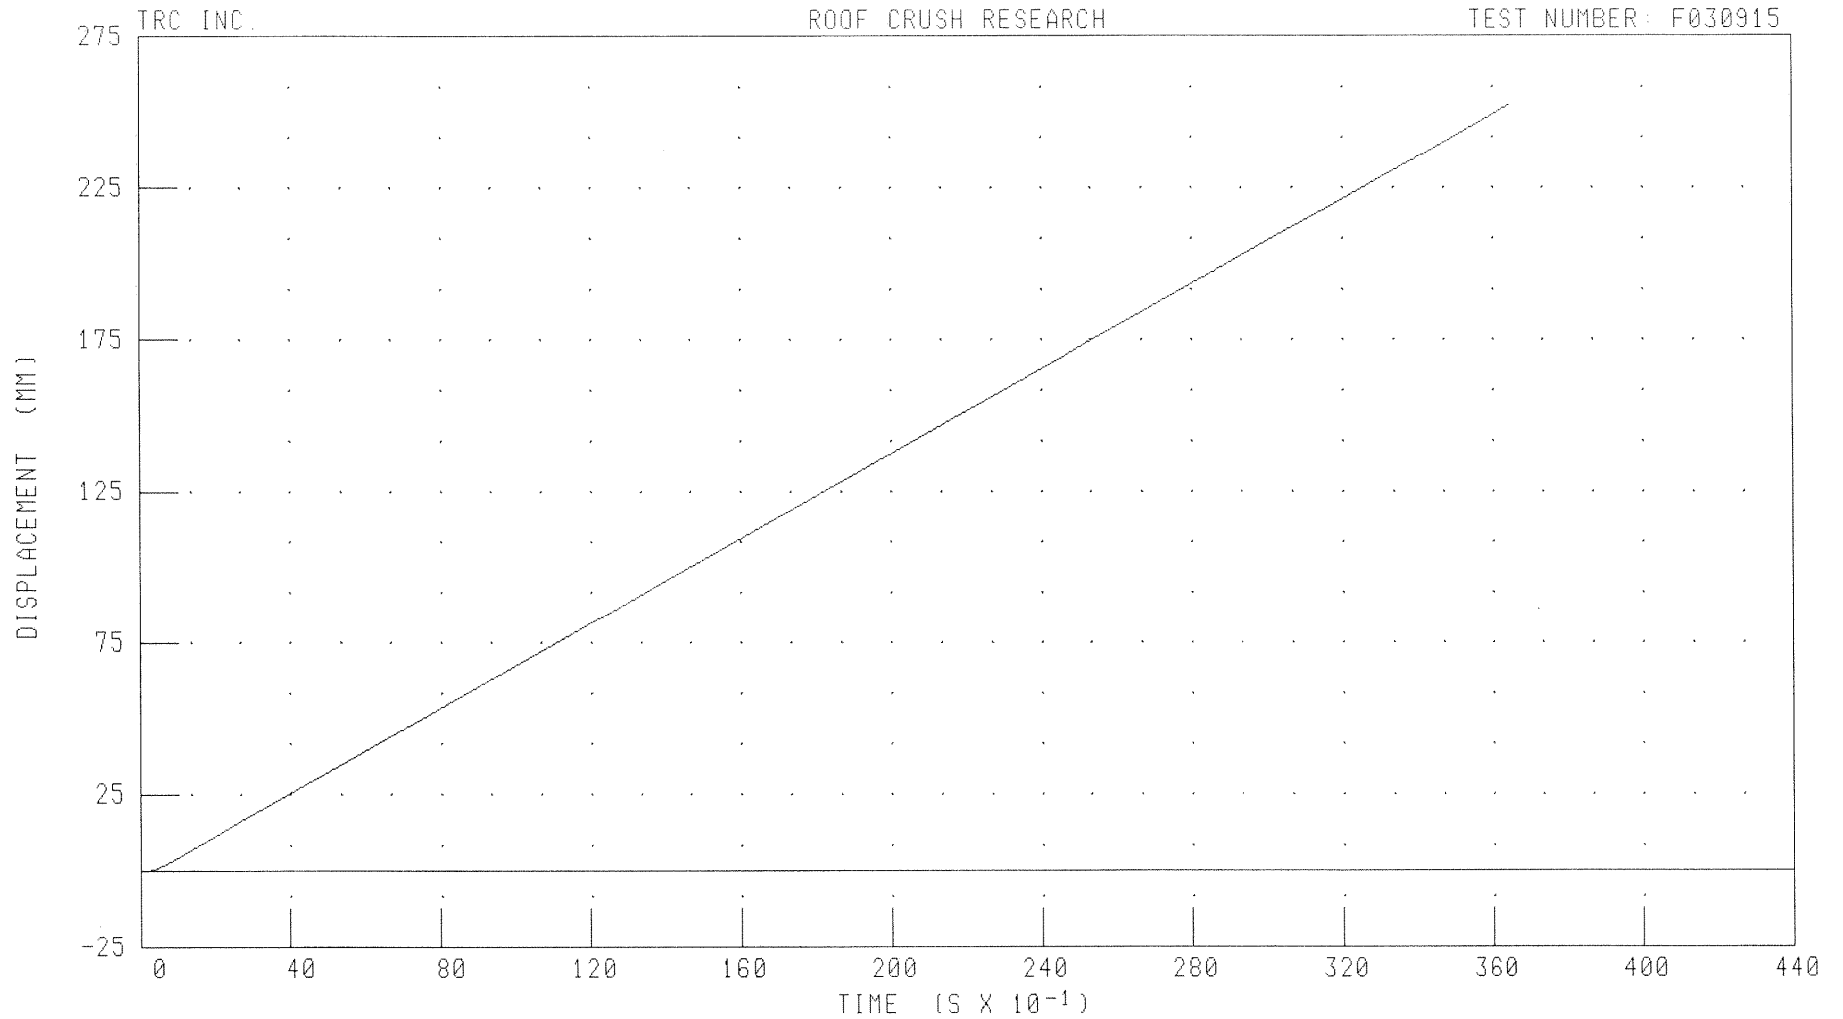
CYLINDER 1 DISPLACEMENT

CHANNEL: DISP1 FILTER: CH. CLASS 1000

PEAK DATA: 252.11 MM @ 36.48 S; -0.08 MM @ 0.08 S

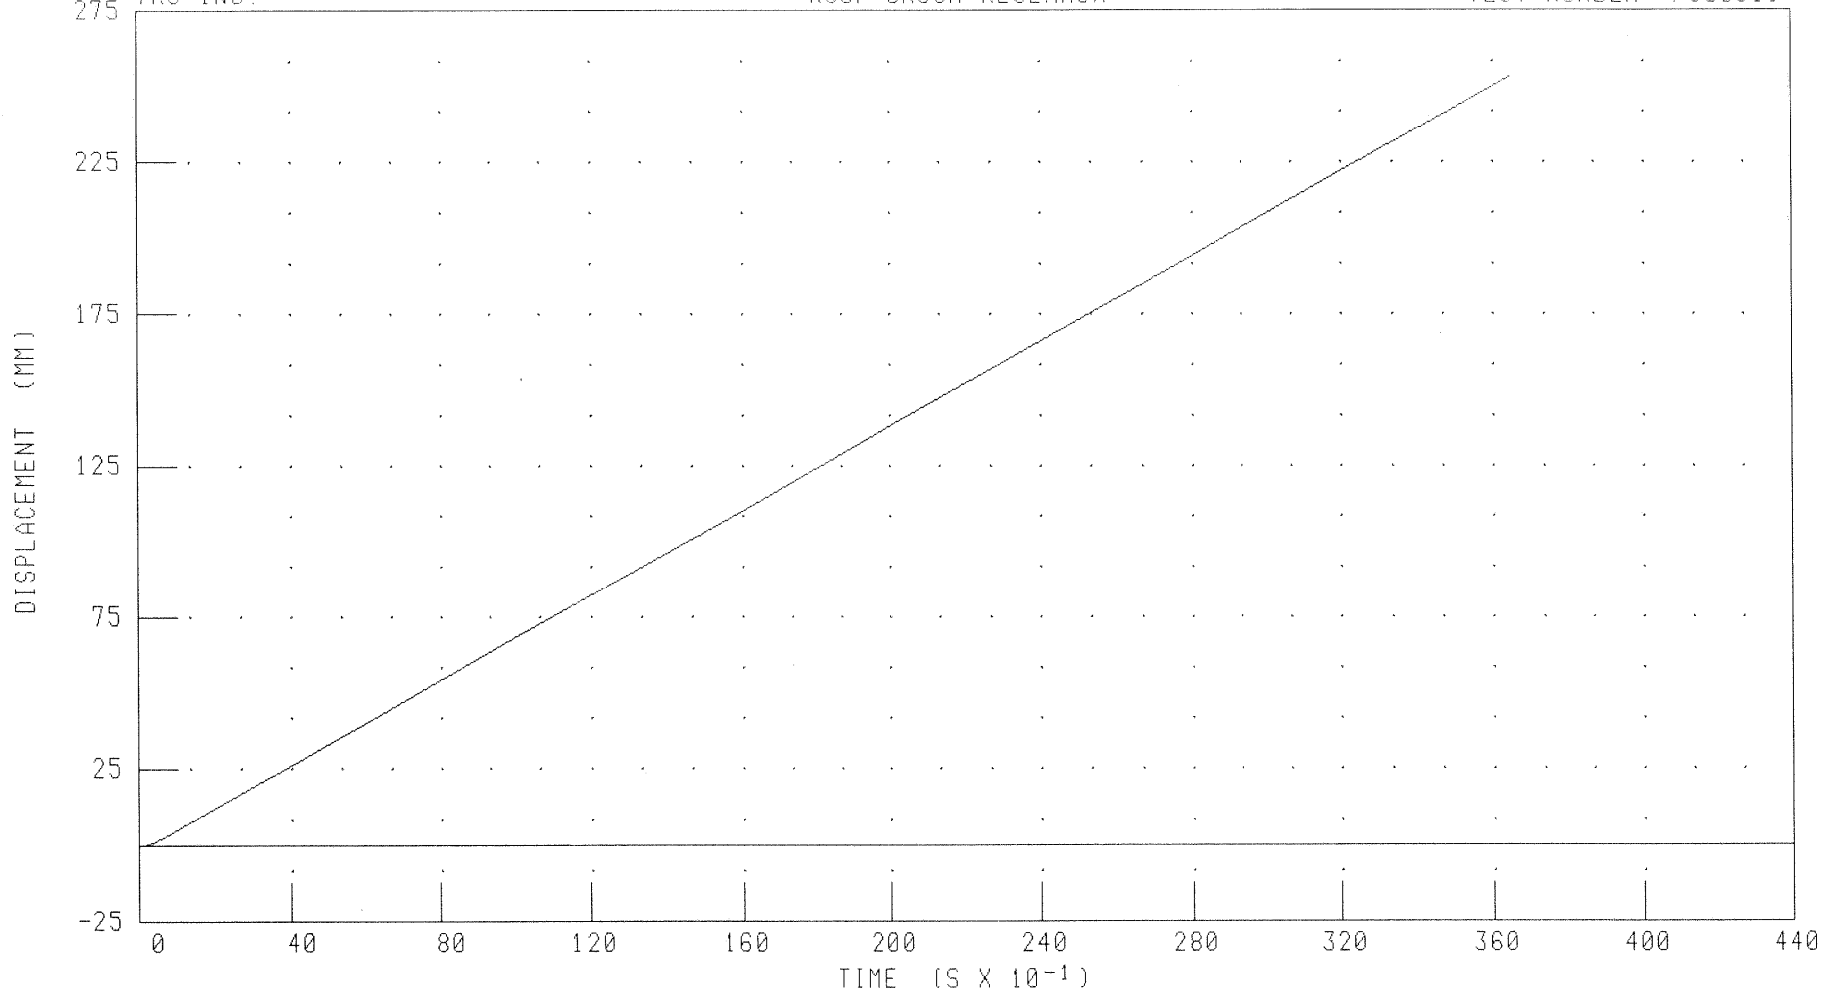
CYLINDER 2 DISPLACEMENT

CHANNEL: DISP2

PEAK DATA: 252.88 MM @ 36.48 S, -0.02 MM @ 0.00 S

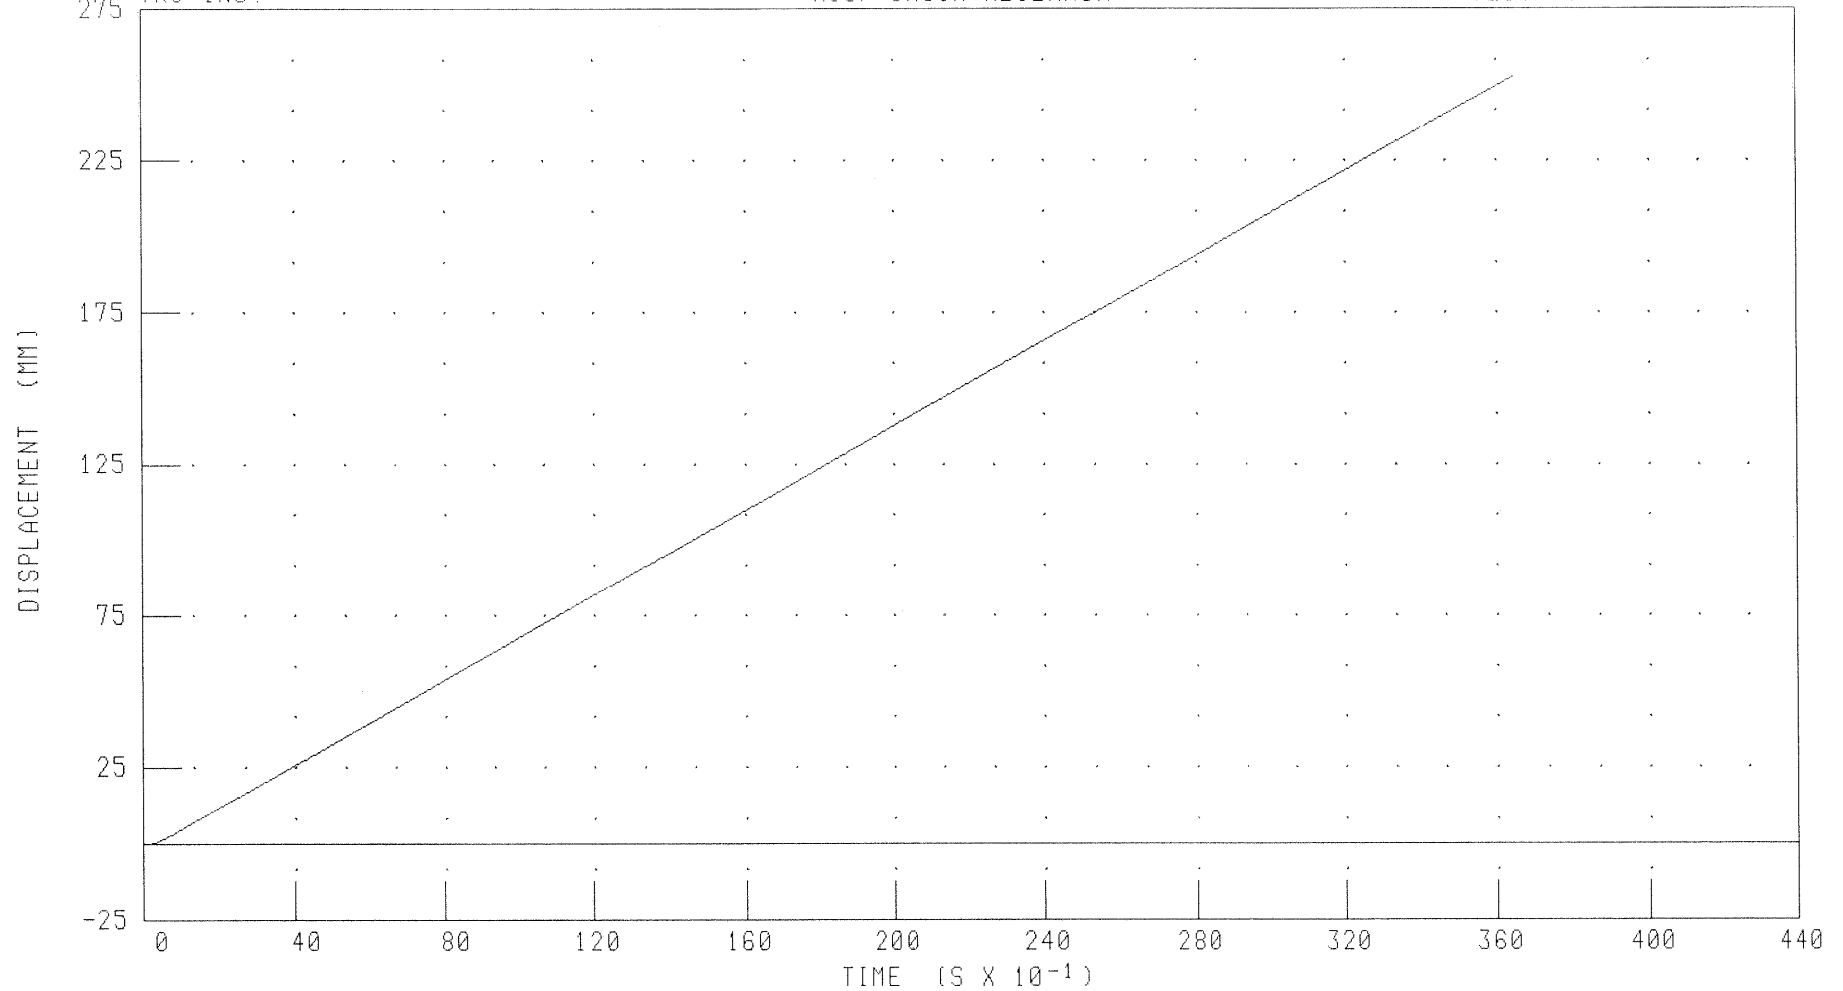
AVERAGE CYLINDER DISPLACEMENT

CHANNEL: AVG

PEAK DATA: 252.50 MM @ 36.48 S; -0.01 MM @ 0.04 S

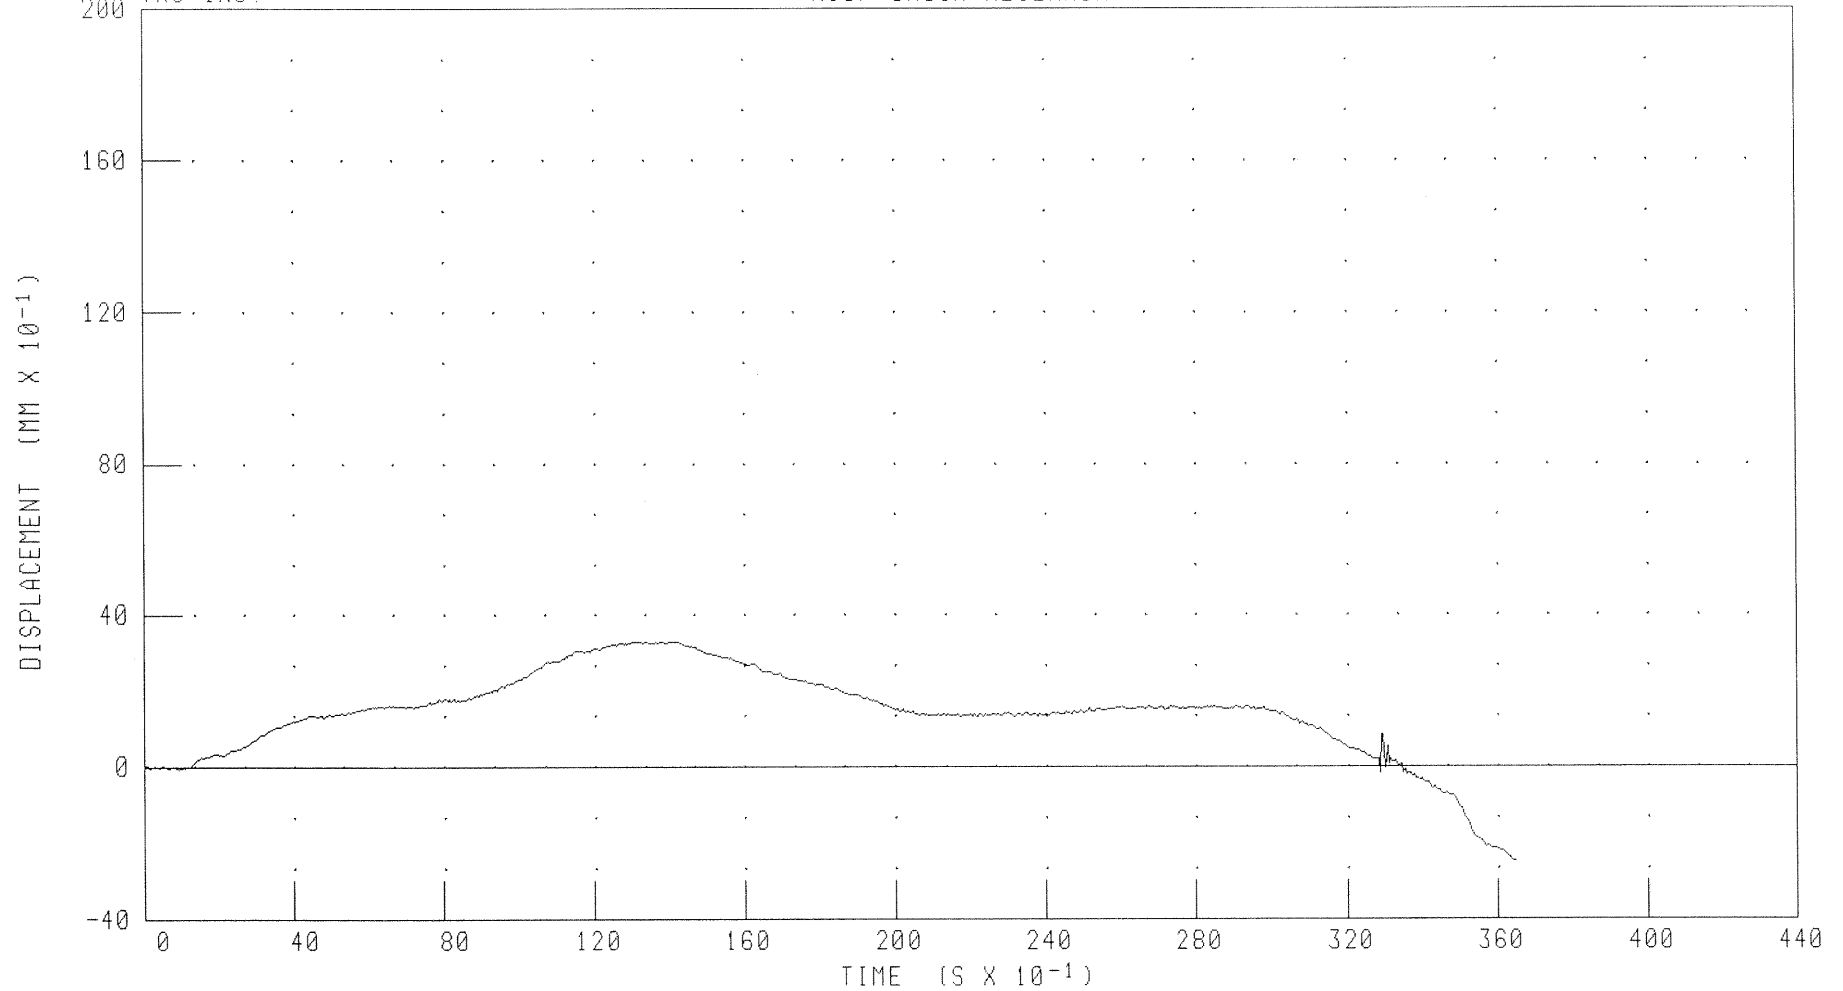
2001 FORD TAURUS - ROOF CRUSH AT 5 DEGREE PITCH / 25 DEGREE ROLL
LEFT FRONT VEHICLE VERTICAL DISPLACEMENT

CHANNEL: BMLFZD FILTER: CH. CLASS 1000

PEAK DATA: 3.27 MM @ 13.00 S; -2.47 MM @ 36.40 S

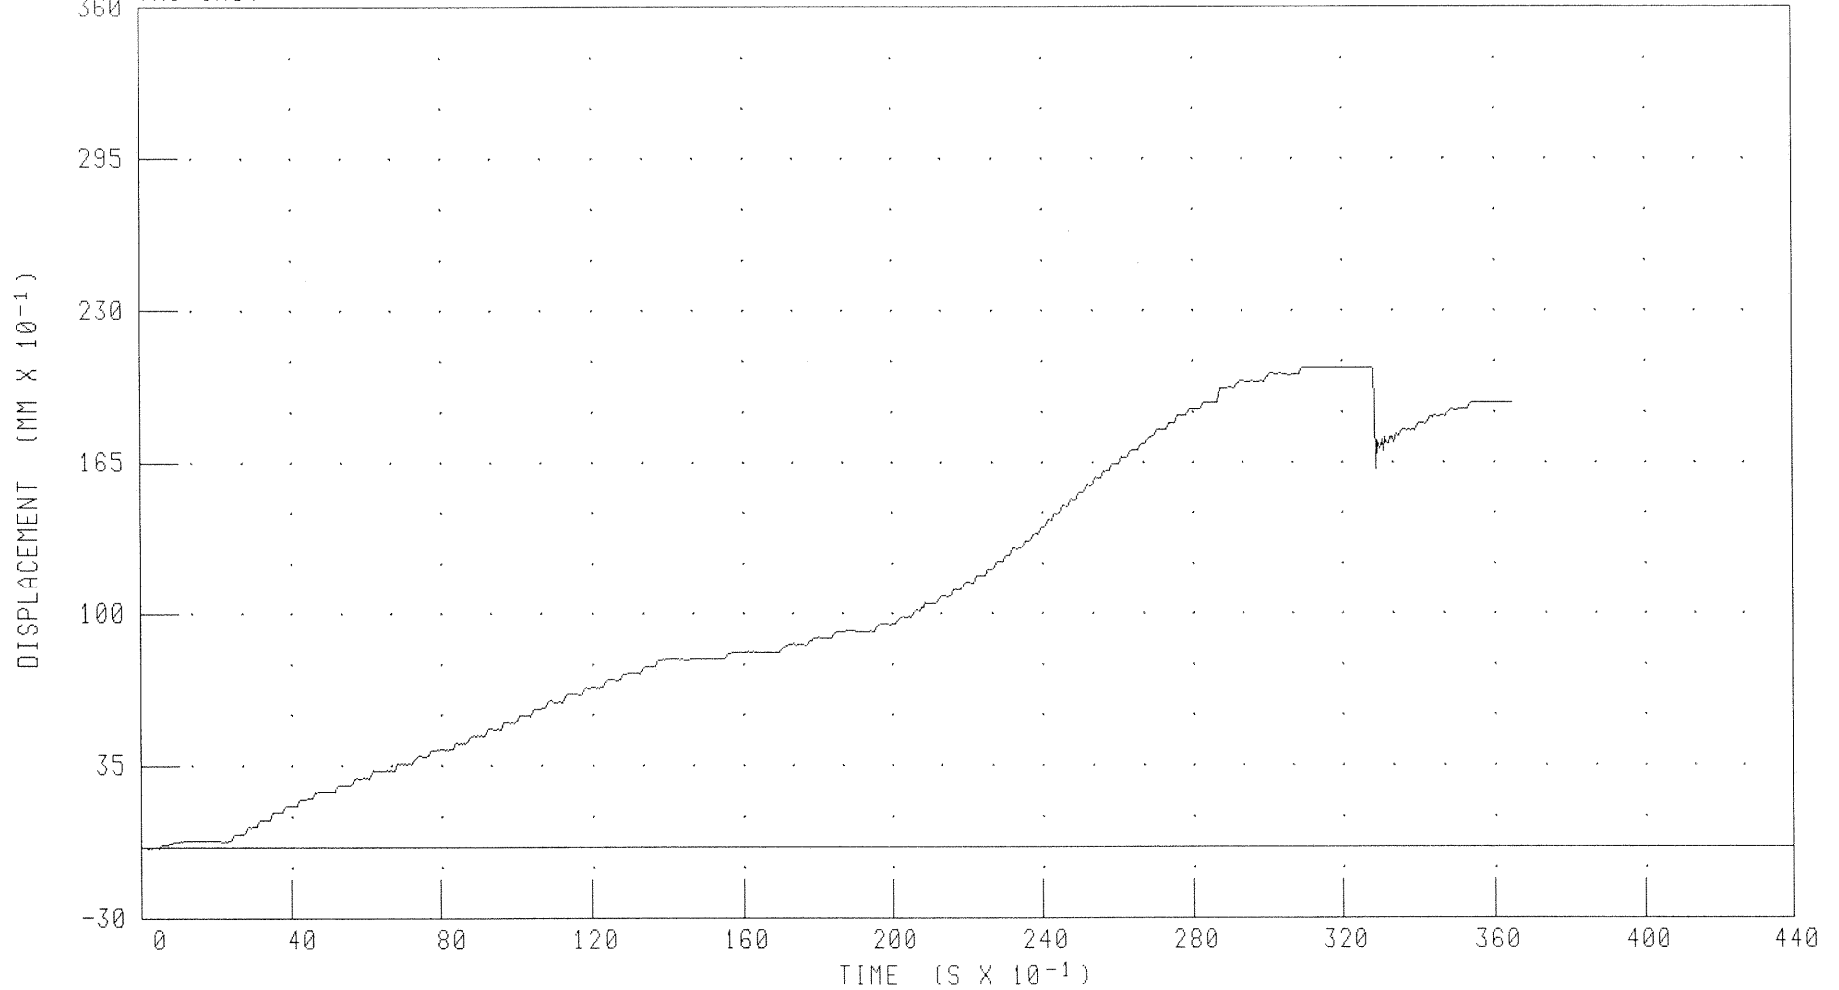
2001 FORD TAURUS - ROOF CRUSH AT 5 DEGREE PITCH / 25 DEGREE ROLL
LEFT REAR VEHICLE VERTICAL DISPLACEMENT

CHANNEL: BMLRZD FILTER: CH. CLASS 1000

PEAK DATA: 20.57 MM @ 30.96 S; -0.03 MM @ 0.16 S

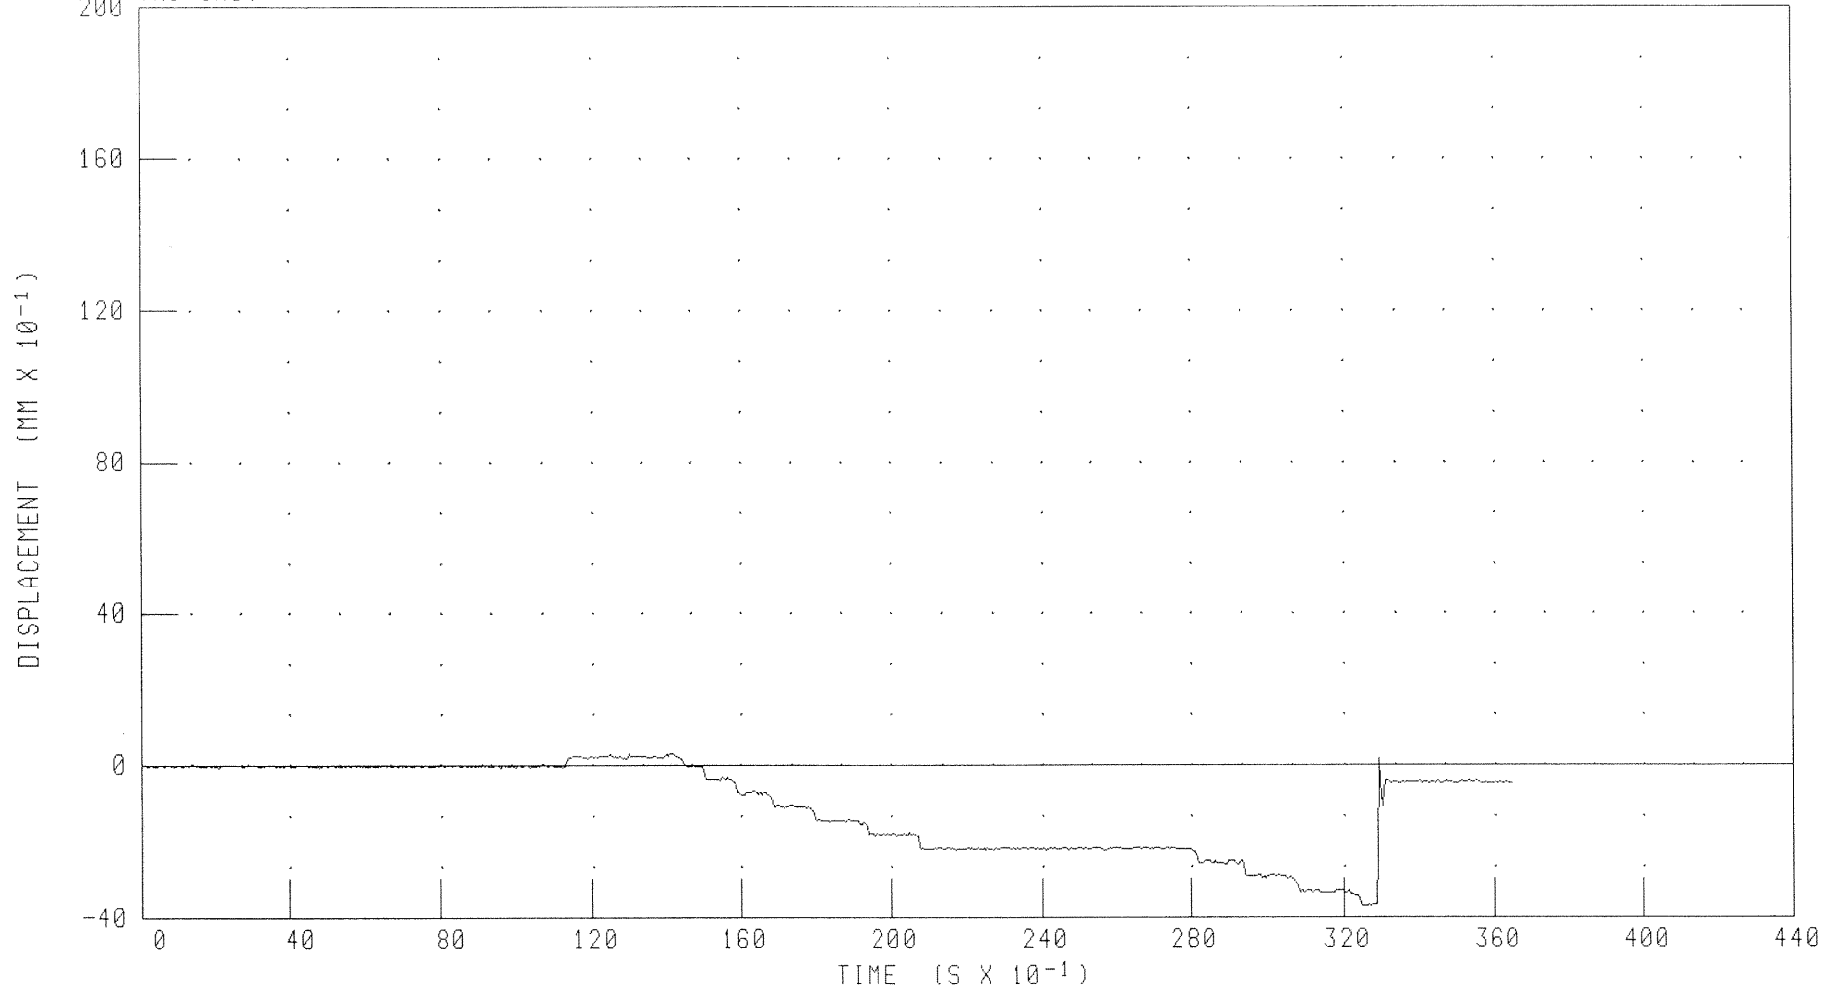
2001 FORD TAURUS - ROOF CRUSH AT 5 DEGREE PITCH / 25 DEGREE ROLL
RIGHT FRONT VEHICLE VERTICAL DISPLACEMENT

CHANNEL: BMRFZD FILTER: CH. CLASS 1000

PEAK DATA: 0.29 MM @ 12.48 S; -3.71 MM @ 32.48 S

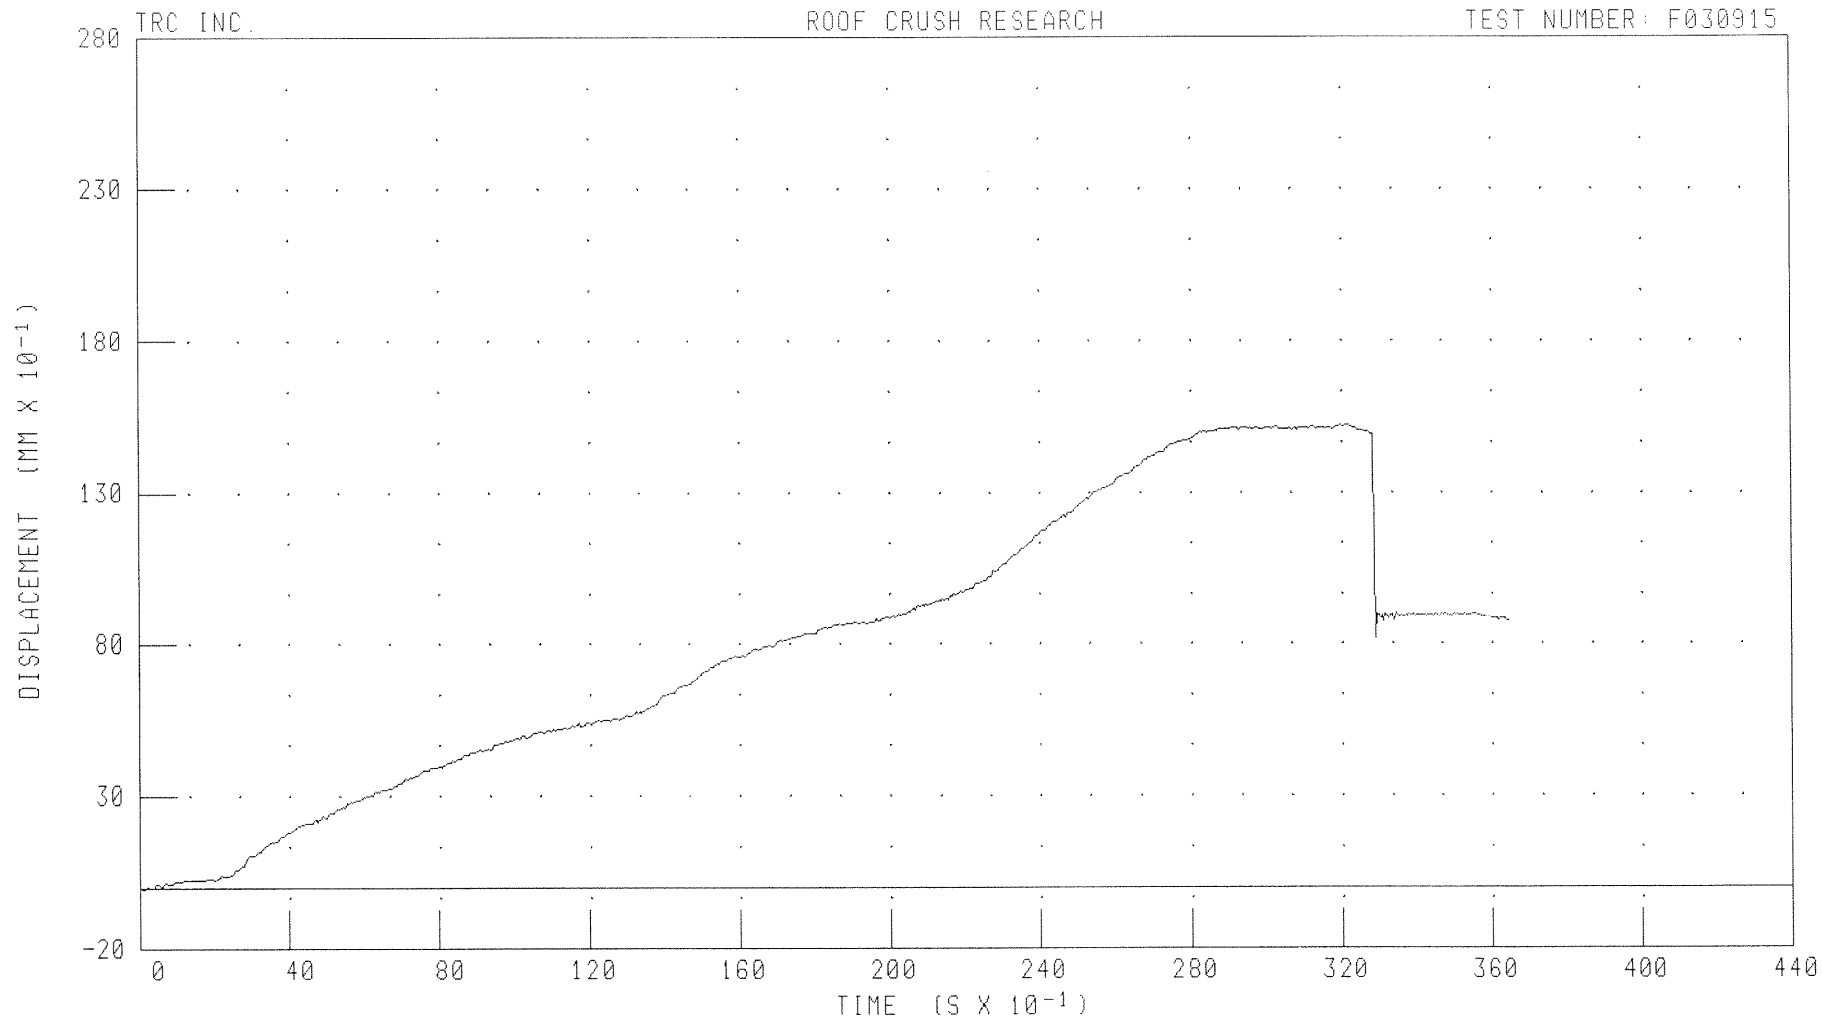
2001 FORD TAURUS - ROOF CRUSH AT 5 DEGREE PITCH / 25 DEGREE ROLL
RIGHT REAR VEHICLE VERTICAL DISPLACEMENT

CHANNEL: BMRRZD FILTER: CH. CLASS 1000

PEAK DATA: 15.24 MM @ 31.96 S; -0.05 MM @ 0.08 S

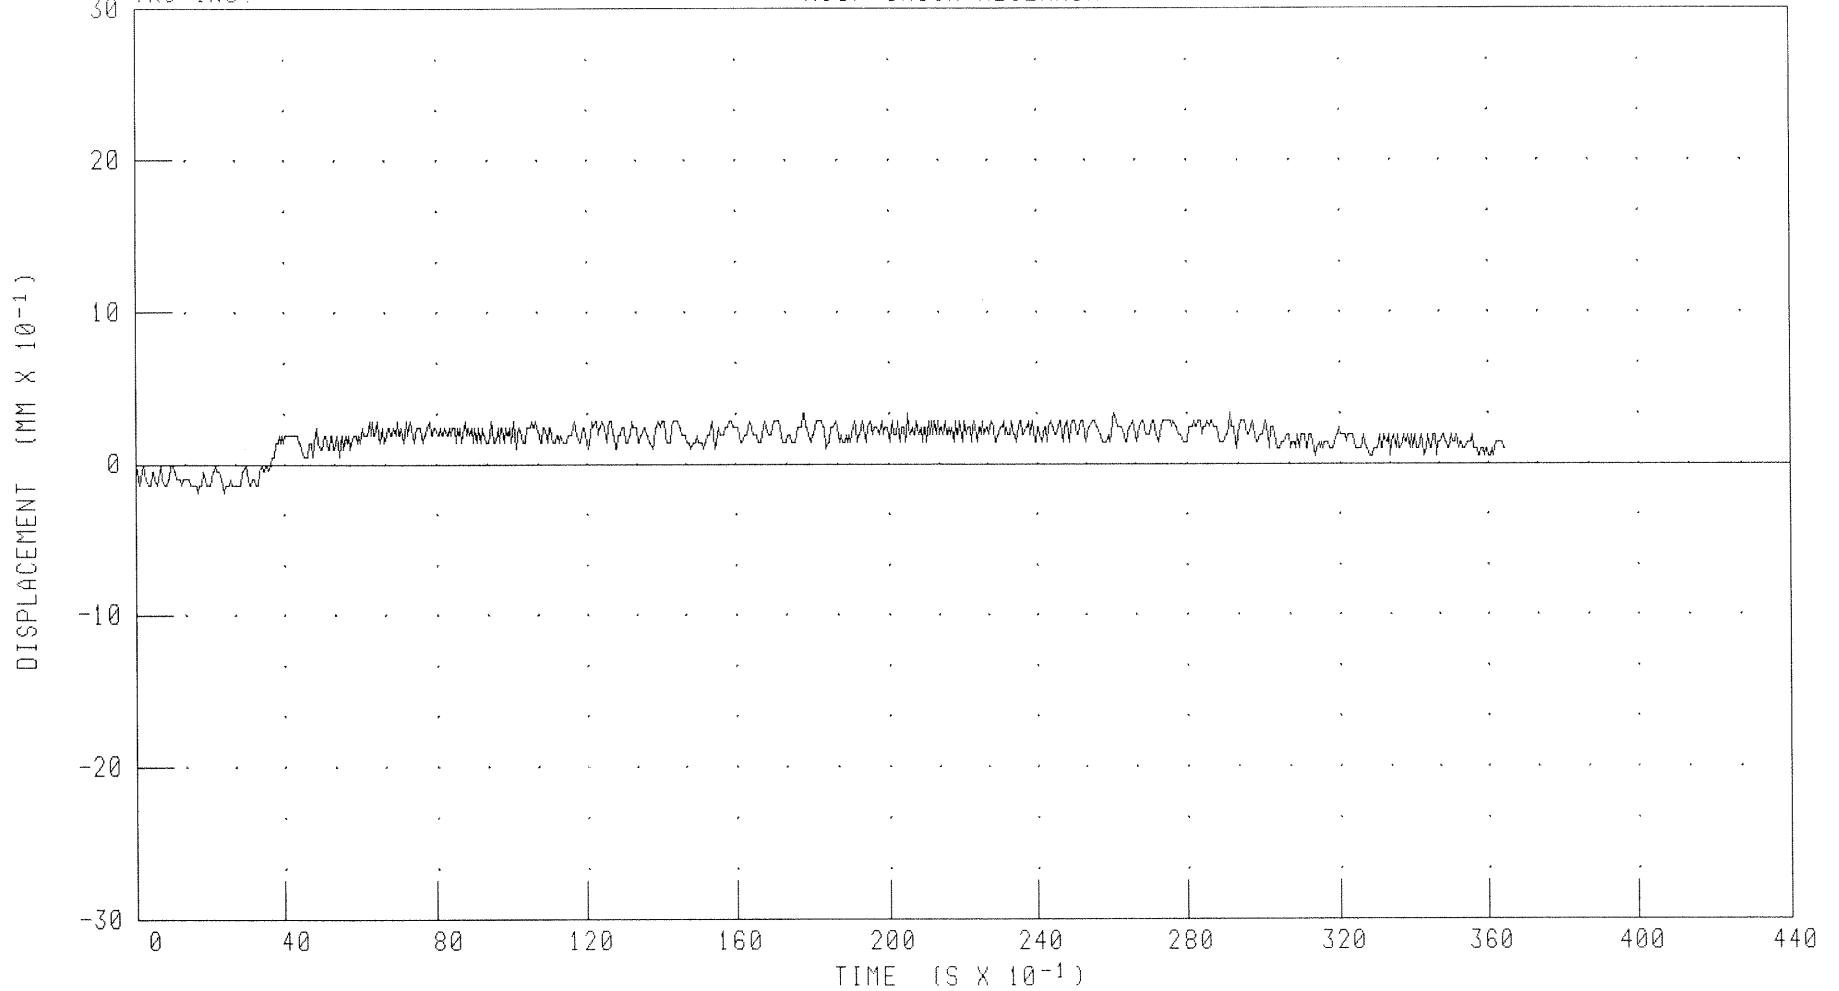
2001 FORD TAURUS - ROOF CRUSH AT 5 DEGREE PITCH / 25 DEGREE ROLL
OPPOSITE SIDE SILL LATERAL DISPLACEMENT

CHANNEL: DSRFYD FILTER: CH. CLASS 1000

PEAK DATA: 0.33 MM @ 17.80 S; -0.19 MM @ 1.68 S

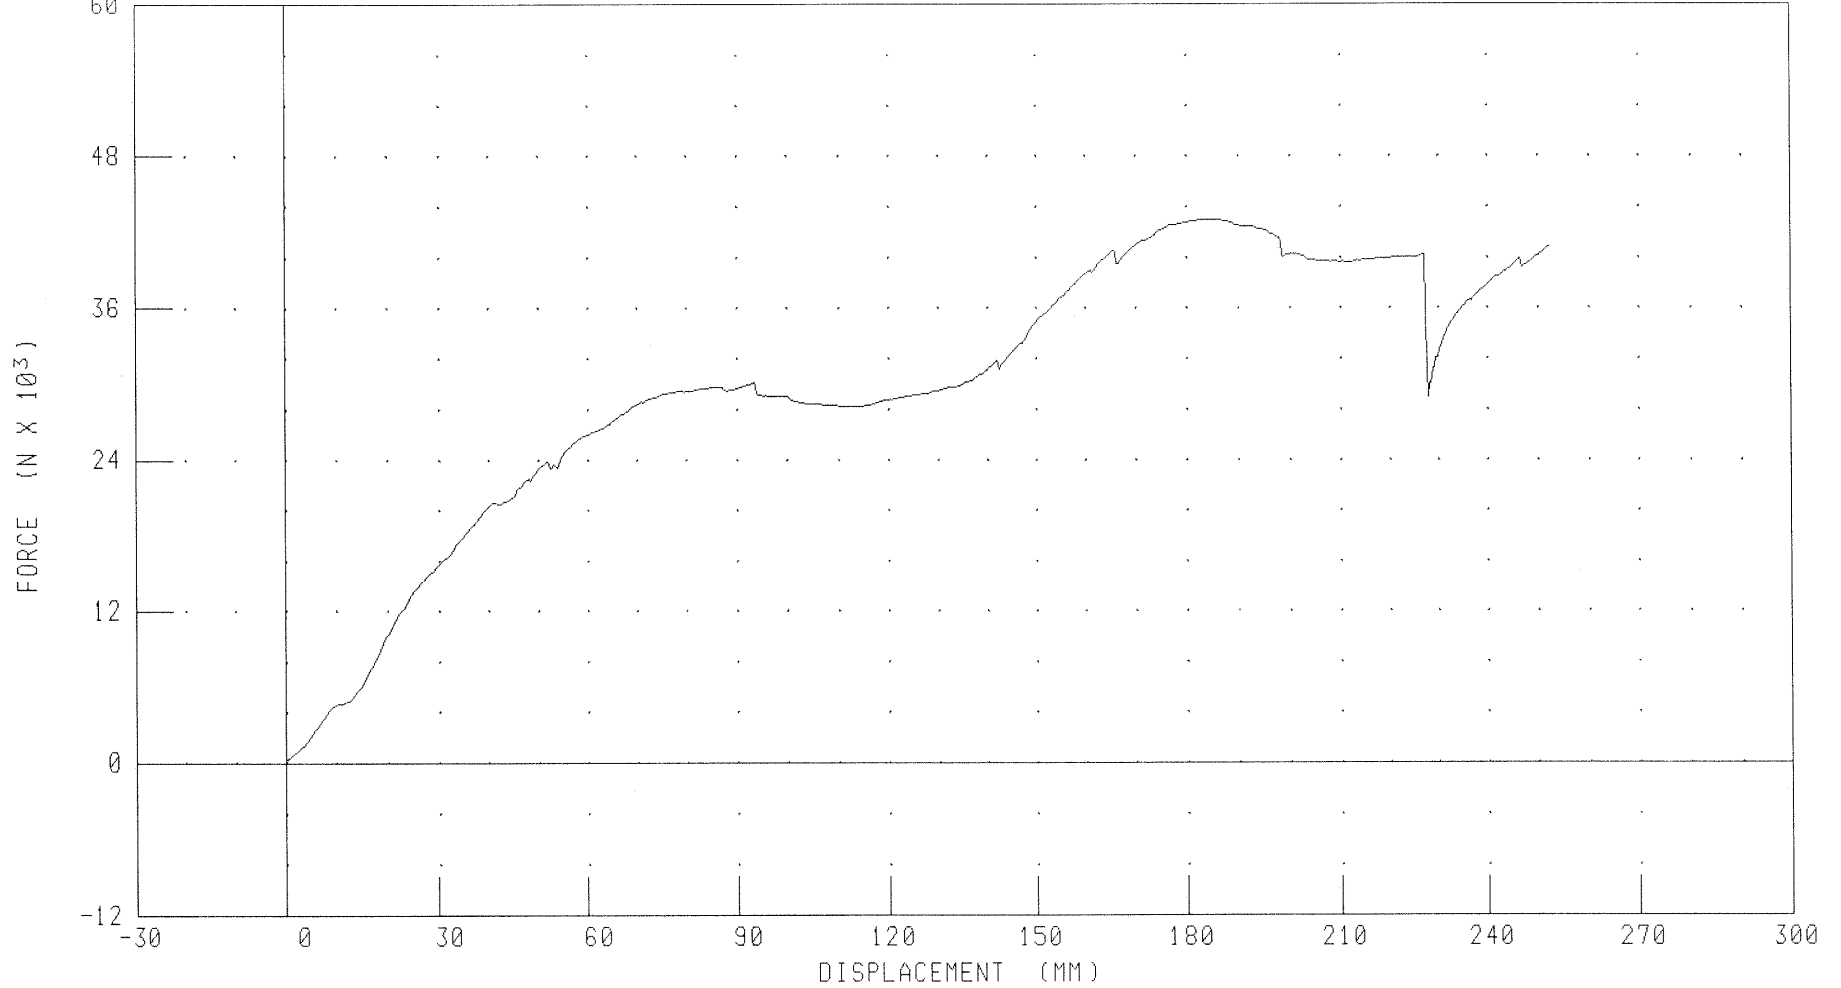
2001 FORD TAURUS - ROOF CRUSH AT 5 DEGREE PITCH / 25 DEGREE ROLL
TOTAL FORCE VS AVERAGE CYLINDER DISPLACEMENT

CHANNEL: AVG
TOT

PEAK DATA: 252.50 MM @ 36.48 S; -0.01 MM @ 0.04 S
42999.97 N @ 27.00 S; -19.25 N @ 0.04 S

The test vehicle sustained a peak load of 43000 Newtons at 186.5 millimeters of test device displacement. The test was completed in approximately 36.48 seconds.

Description	Maximum Force	Displacement at Time of Maximum Force
Total Force vs. Displacement	43000 N	186.5 mm
