### 6.10.5 Weatherstripping

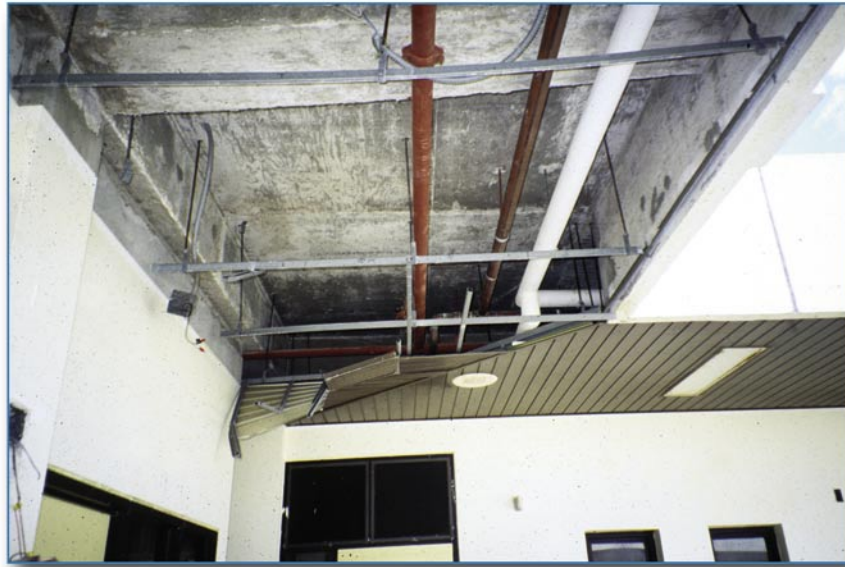
Figure 6-33  
This suspended metal soffit was not designed for upward-acting wind pressure.

Depending upon wind direction, soffits can experience either positive or negative pressure. Besides the cost of repairing damaged soffits, wind-borne soffit debris can cause property damage and injuries.

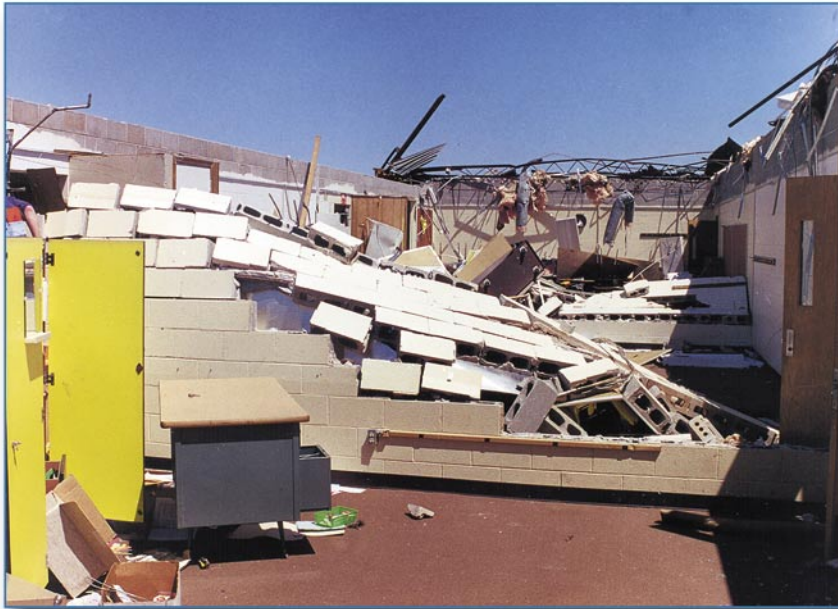
Figure 6-34  
The interior walls of this classroom wing were constructed of unreinforced CMU.

Special consideration should also be given to interior non-load bearing masonry walls. Although these walls are not required by building codes to be designed to resist wind loads, if glazing is broken, the interior walls could be subjected to significant load as the school rapidly becomes fully pressurized. To avoid occupant injury (see Figure 6-34), it is recommended that interior non-load bearing masonry walls that are adjacent to student areas be designed to accommodate loads exerted by a design wind event, using the partially enclosed pressure coefficient. By doing so, wall collapse may be prevented if the building envelope is breached. This recommen-

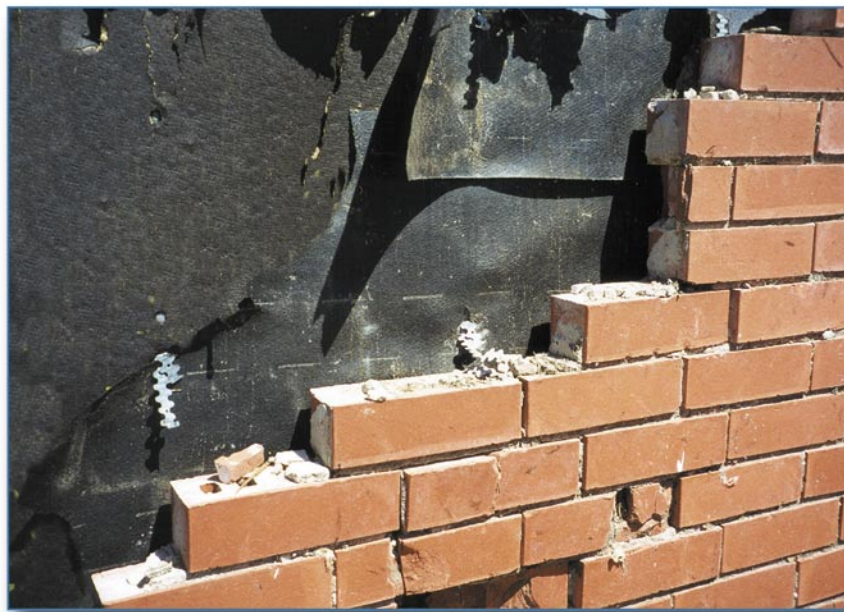
Figure 6-35  
Failure of brick veneer

Figure 6-35 shows brick veneer that was blown off. The bricks were attached to the back-up wall with corrugated metal ties. All of the following failure modes are commonly found in the vicinity of this type of common failure: 1) The nails pull out of the studs (smooth shank nails are typically used, hence they have limited withdrawal resistance; 2) The ties do not extend far enough into the mortar joint (i.e., the tie is not long enough); 3) Although the ties make contact with the mortar, they are not well-bonded to it; 4) The ties are spaced too far apart; and 5) The ties provide essentially no resistance to compression. Hence, when a great amount of positive pressure is applied to the bricks, the brick joints flex. This flexing weakens the mortar joint. Walls that have not had bricks blown away have been found to be capable of being deflected with hand pressure. Although they look sound, in this condition they are very vulnerable to failure. Good reliable wind performance of brick veneer is very demanding on the designer and applicator.

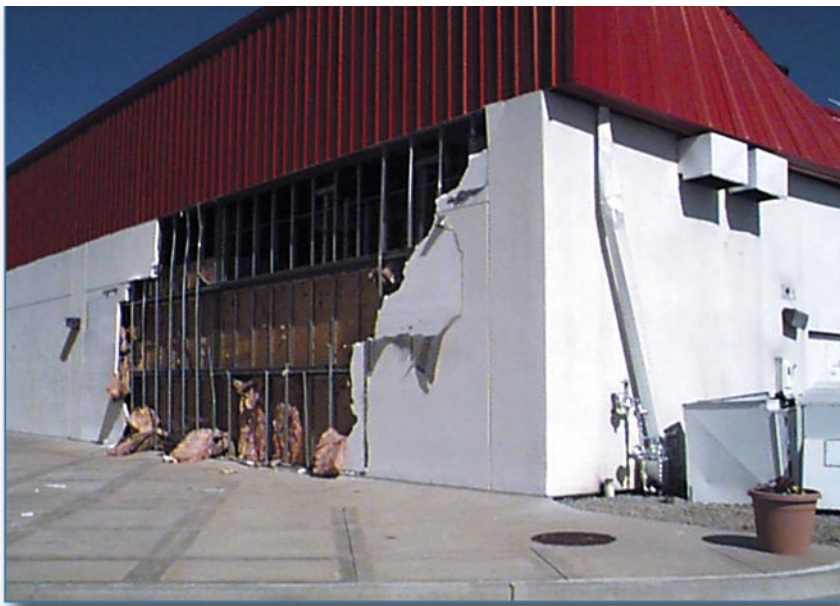
Figure 6-36  
EIFS blow-off near a wall corner. At one area, the metal fascia was also blown in.

Figure 6-36 shows EIFS blow-off. In this case, the expanded polystyrene (EPS) was attached to gypsum board, which was attached to metal studs. The gypsum board detached from the studs, which is a common EIFS failure mode. When the gypsum board on the exterior side of the studs is blown away, it is common for gypsum board on the interior side to also be blown off. This then allows the school to become fully pressurized and allows entrance of wind-driven rain. Other common failure modes include separation of the EPS from its substrate and separation of the synthetic stucco from the EPS. Good reliable wind performance of EIFS is very demanding on the designer and applicator. Maintenance of EIFS and associated sealant joints is also demanding in order to minimize reduction of EIFS' wind resistance due to water infiltration.

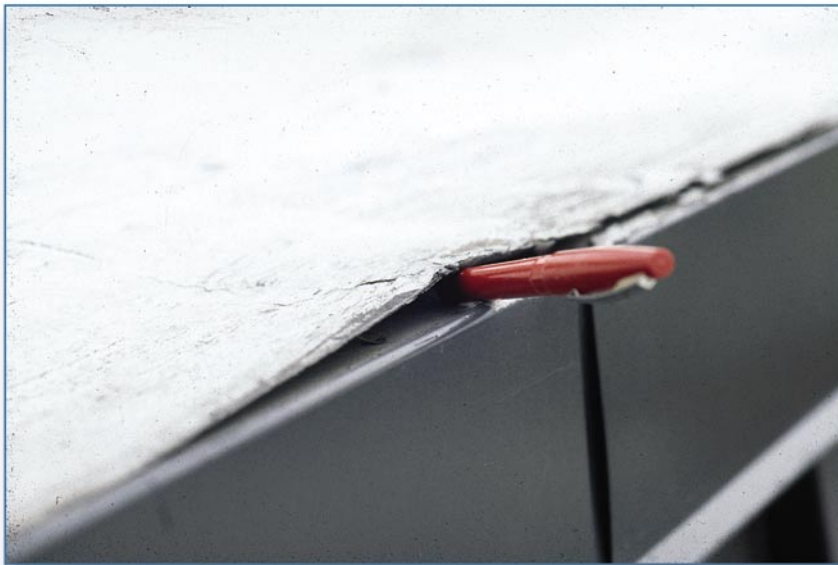
Figure 6-37  
The metal edge flashing on this modified bitumen membrane roof was installed underneath the membrane, rather than on top of it and then stripped in. In this location, the edge flashing is unable to clamp the membrane down. At one area, the membrane was not sealed to the flashing (an ink pen was inserted into the opening prior to photographing). Wind can catch the opening and lift and peel the membrane.

**Edge Flashings and Copings.** Roof membrane blow-off is almost always a result of lifting and peeling of the metal edge flashing or coping, which serves to clamp down the membrane at the roof edge (see Figure 6-37). Therefore, it is important for the architect to carefully consider the design of metal edge flashings, copings, and the nailers to which they are attached. ANSI/SPRI ES-1, *Wind Design Standard for Edge Systems Used in Low Slope Roofing Systems* provides general design guidance, including a methodology for determining the outward-acting load on the vertical flange of the flashing/coping (ASCE 7 does not provide this guidance).

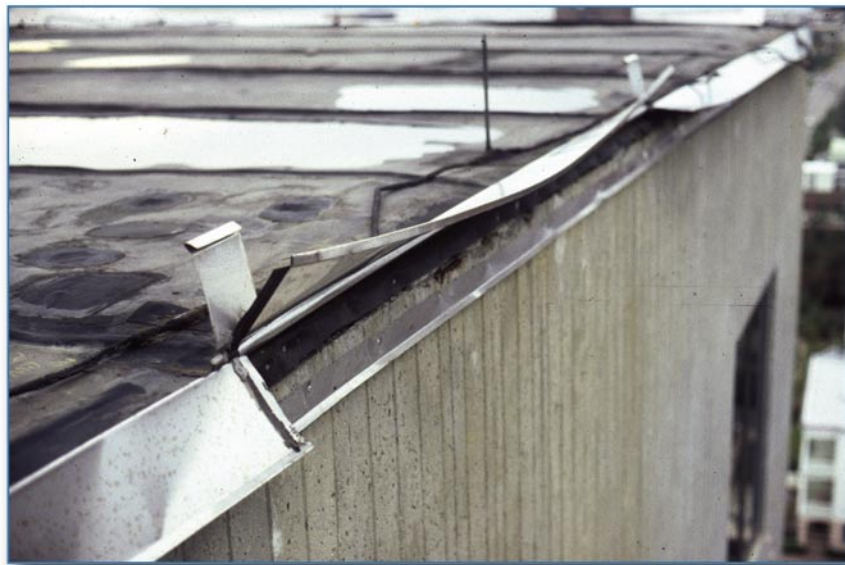
Figure 6-38  
This metal edge flashing had a continuous cleat, but the flashing disengaged from the cleat and the vertical flange lifted up. However, the horizontal flange of the flashing did not lift.

The traditional edge flashing/coping attachment method relies on concealed cleats that can deform under wind load and lead to disengagement of the flashing/coping (see Figure 6-38) and subsequent lifting and peeling of the roof membrane (as shown in Figure 6-11). When a vertical flange disengages and lifts up (as shown in Figure 6-38), the edge flashing and membrane are very susceptible to failure. Normally, when a flange lifts such as shown in Figure 6-38, the failure continues to propagate and the metal edge flashing and roof membrane blow off.

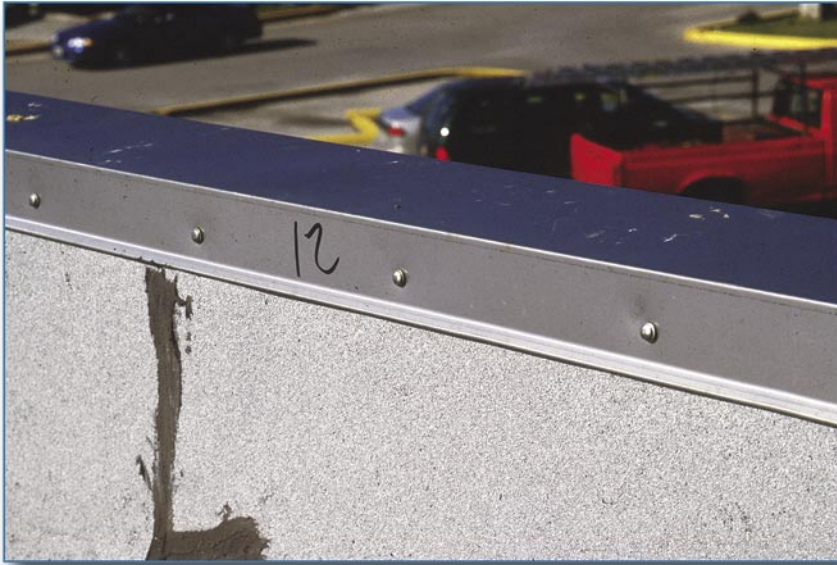
Figure 6-39  
 This coping was attached with ¼-inch diameter stainless steel concrete spikes at 12 inches on center. When the fastener is placed in wood, #14 stainless steel screws with stainless steel washers are recommended. Also, in the corner areas, the fasteners should be more closely spaced (the spacing will depend upon the design wind loads). ANSI/SPRI ES-1 provides guidance on fastener spacing and thickness of the coping/edge flashing.

Storm-damage research has revealed that, in lieu of cleat attachment, use of exposed fasteners to attach the vertical flanges of copings and edge flashings has been found to be a very effective and reliable attachment method (see Figure 6-39).

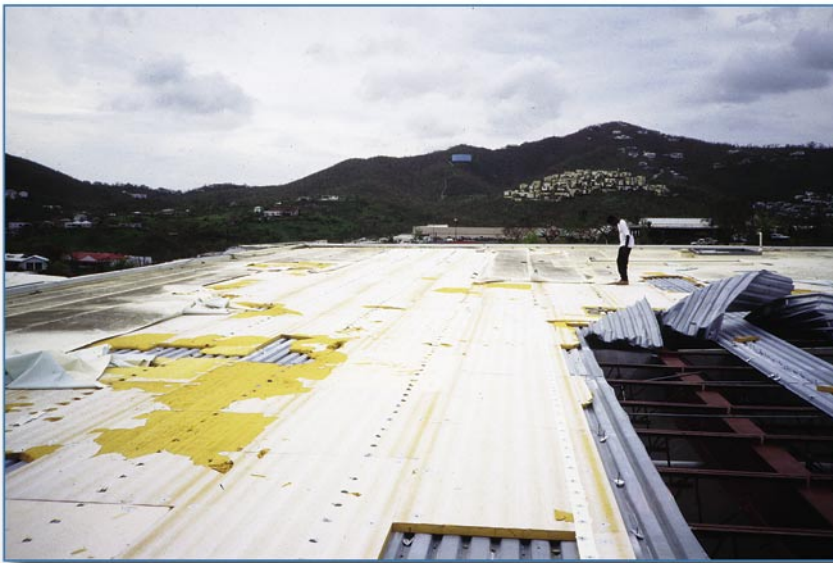
Figure 6-41  
On this school, the fastener rows of the mechanically attached single-ply membrane ran parallel to the top flange of the steel deck. Hence, essentially all of the row's uplift load was transmitted to only two deck fasteners at each joist (as illustrated in Figure 6-42). Because the deck fasteners were overstressed, a portion of the deck blew off and the membrane progressively tore.

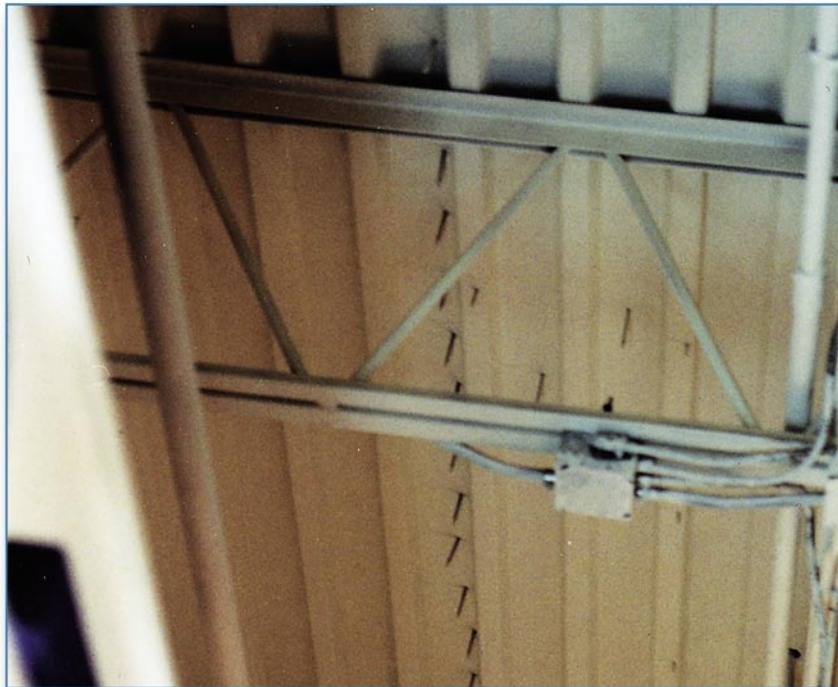
Figure 6-42  
View of the underside  
of a steel deck. The  
mechanically attached  
single-ply membrane  
fastener rows ran parallel  
to the top flange of the steel  
deck.

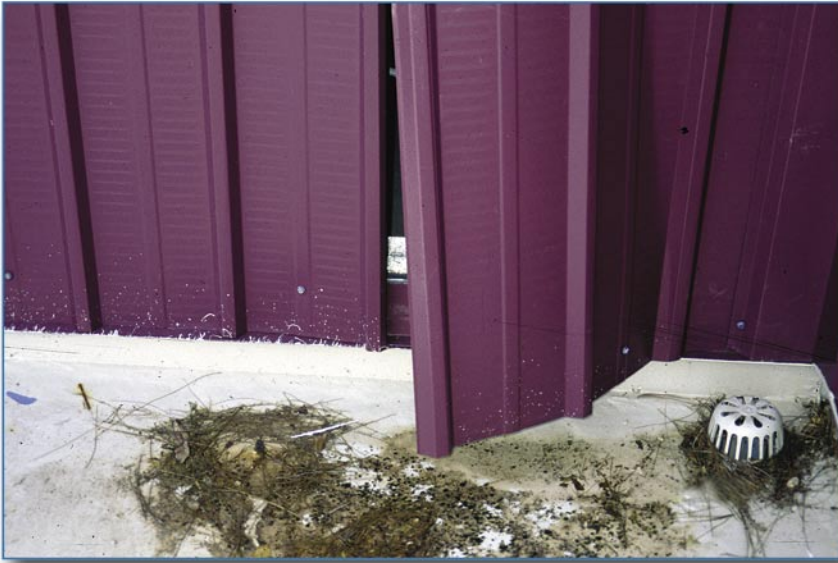
Figure 6-43  
The parapet on this school was sheathed with metal wall panels. The panels were fastened at 2 feet on center along their bottom edge, which was inadequate to resist the wind load.

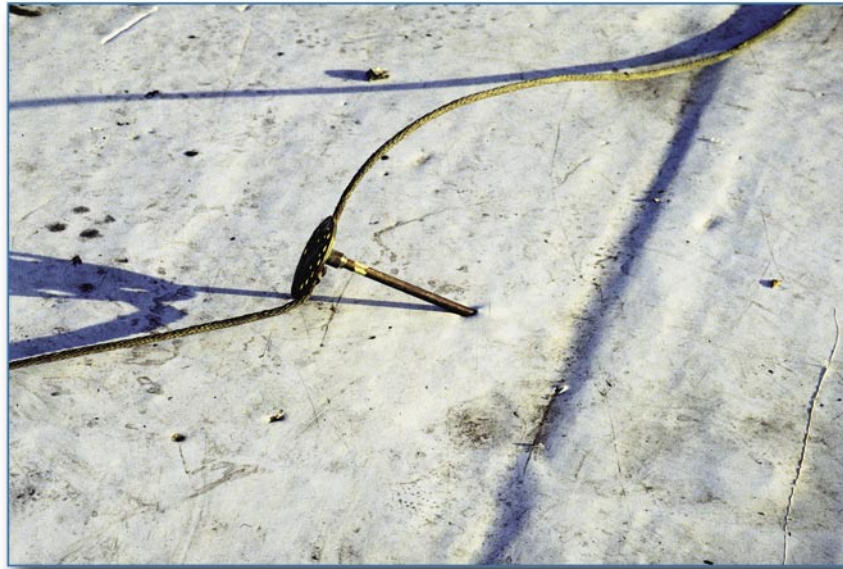
This air terminal (“lightning rod”) was dislodged and whipped around during a windstorm. The single-ply membrane was punctured by the sharp tip in several locations.

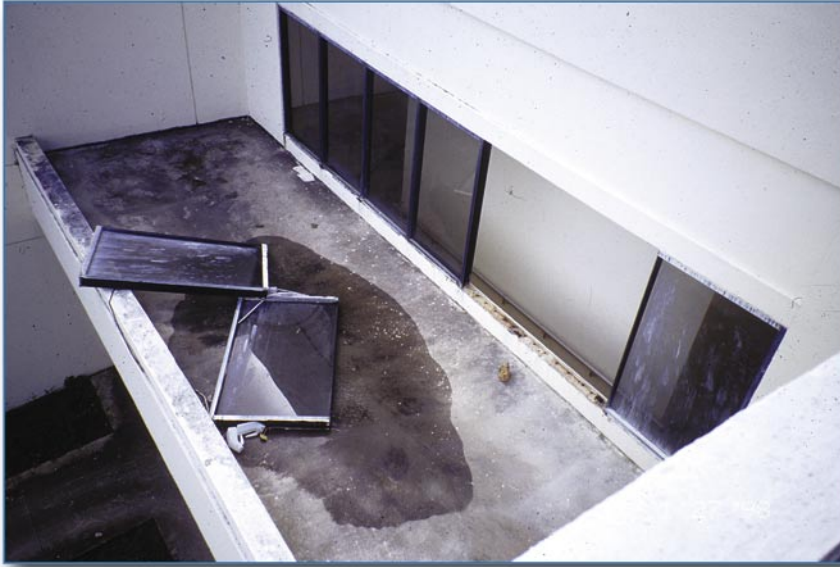
Figure 6-45  
Two complete windows, including their frames, blew out. The frames were attached with an inadequate number of fasteners, which were somewhat corroded.

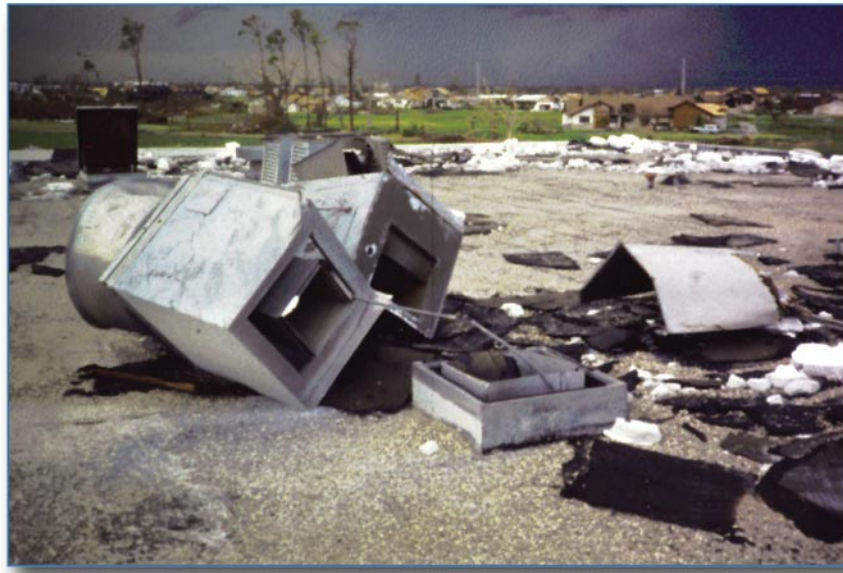
Figure 6-48

The rooftop mechanical equipment on this school was blown over. The displaced equipment can puncture the roof membrane and, as in this case, rain can enter the school through the large opening that is no longer protected by the equipment.

Exterior-mounted mechanical (e.g., exhaust fans, HVAC units, relief air hoods, boiler stacks), electrical, and communications equipment (e.g., light fixtures, antennae, satellite dishes) are often damaged during high winds. Damaged equipment can impair the use of the school, the equipment can become missiles, and water can enter the facility where equipment was displaced (see Figures 6-19 and 6-48).

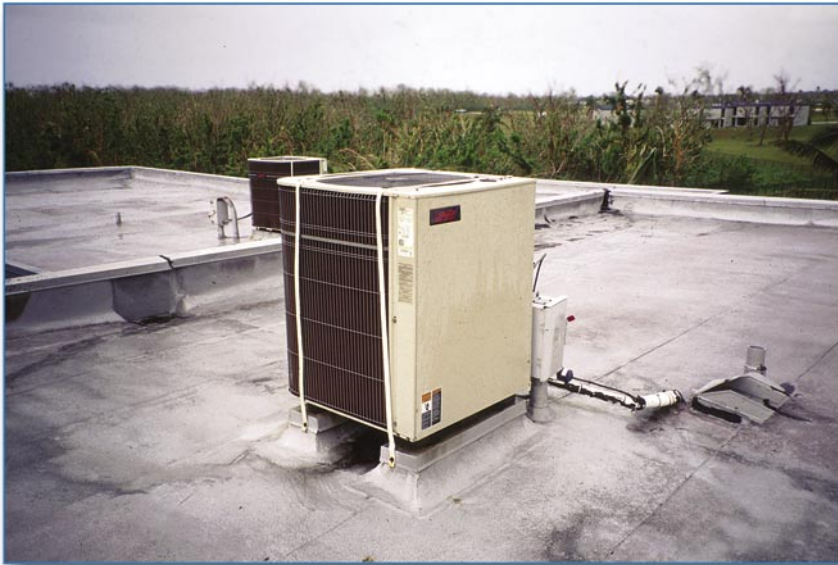
Figure 6-49  
This HVAC equipment had two supplemental securement straps. Both straps are still on this unit, but some of the other units on the roof had broken straps.

Figure 6-49 illustrates the use of supplemental securement straps to anchor equipment. The supplemental attachment was marginal; the straps were too light and the fasteners used to secure them were corroded. This illustrates the validity of the supplemental securement, and it also illustrates the need to execute the securement with attention to detail. In lieu of one screw at each end of the strap, two side-by-side screws offer a stronger and more reliable connection (this of course requires a slightly wider strap).

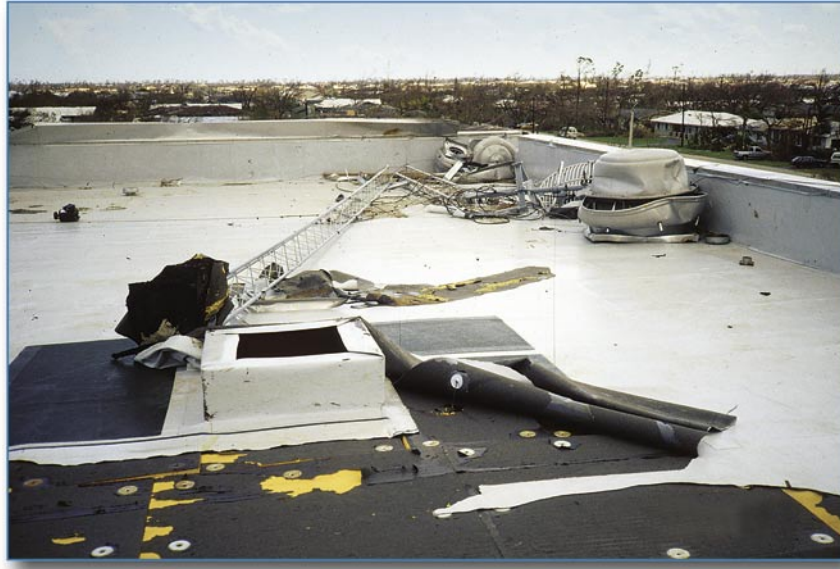
The communications mast on this school was pulled out of the deck, resulting in a progressive peeling failure of the fully adhered single-ply membrane. There are several exhaust fans in the background that were blown off their curbs, but were retained on the roof by the parapet.

**Electrical and Communications Equipment.** Damage to exterior-mounted electrical equipment is infrequent, in large part, because of the small size of most equipment (e.g., disconnect switches). Exceptions are communication masts (see Figure 6-50), surveillance cameras, service masts, and satellite dishes. These failures are typically caused by failure to perform wind load calculations and anchorage design. Service mast failure is typically caused by collapse of overhead power lines; this can be avoided by underground service. Where overhead service is provided, it is recommended that the service mast not penetrate the roof. Otherwise, a downed service line could pull the mast and rupture the roof membrane.

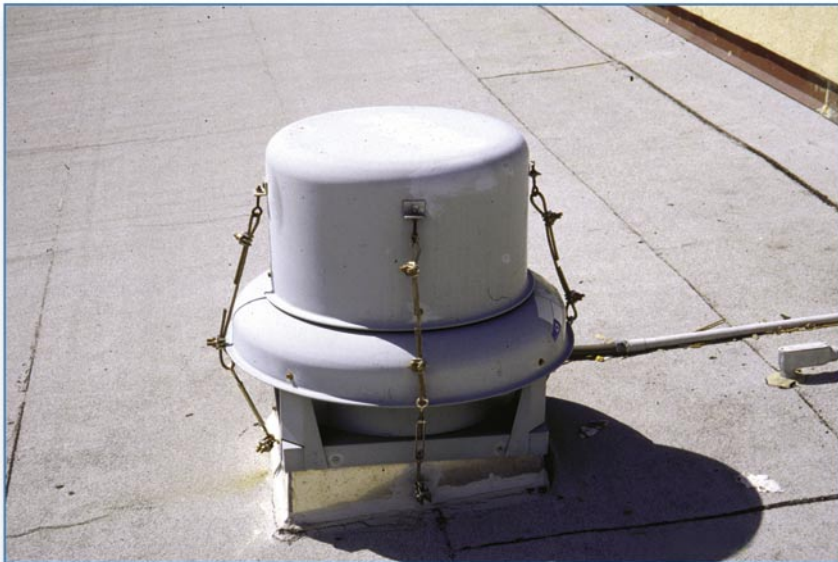
Figure 6-51  
To overcome blow-off of the fan cowling, which is a common problem, this cowling was attached to the curb with cables. The curb needs to be adequately attached to carry the wind load exerted on the fan.

Damage investigations have revealed that cable tie-downs have been effective in securing fan cowlings when a sufficiently strong cable and anchor details were used (see Figure 6-51). For fan cowlings less than 4 feet in diameter, 1/8-inch diameter stainless steel cables are recommended. For larger cowlings, use 3/16-inch diameter cables. When the basic wind speed is 120 mph or less, specify two cables. Where the basic wind speed is greater than 120 mph, specify four cables. (As an alternative to cables, heavy stainless steel straps could be screwed to the cowling and curb.) To minimize leakage potential at the anchor point, it is recommended that the cables be anchored to the equipment curb (rather than anchored to the roof deck). The attachment of the curb itself also needs to be designed and specified.

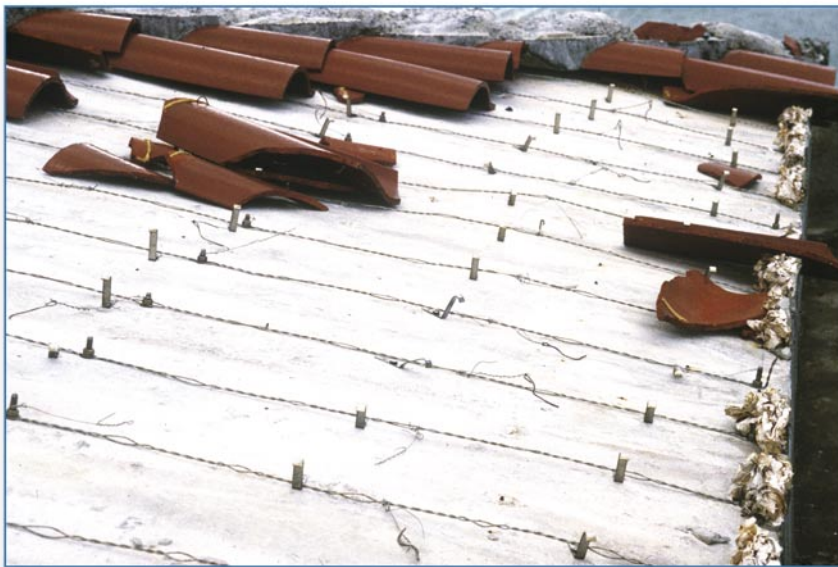
Figure 6-52  
These wire-tied tiles were installed over a concrete deck. They were attached with stainless steel clips at the perimeter rows and all of the tiles had tail hooks. Adhesive was also used between the tail and head of the tiles.

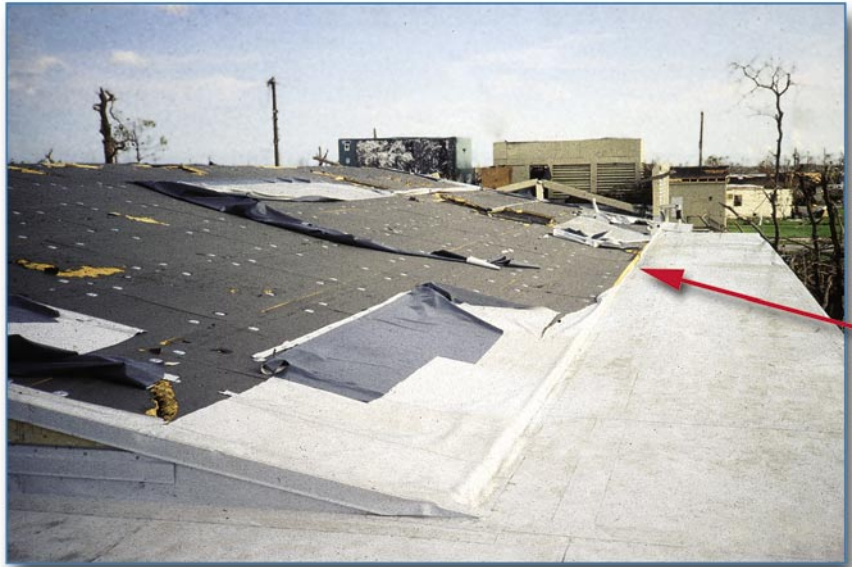
At this school, a missile struck the fully adhered low-sloped roof (see arrow) and slid into the steep-sloped reinforced mechanically attached single-ply membrane. A large area of the mechanically attached membrane was blown away due to progressive membrane tearing.

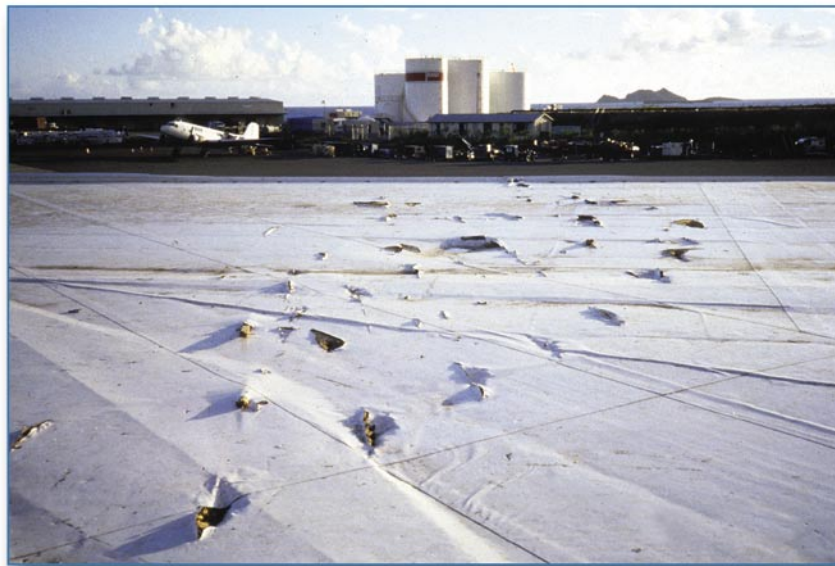
Figure 6-54

This fully adhered single-ply membrane was struck by a large number of missiles during a hurricane.

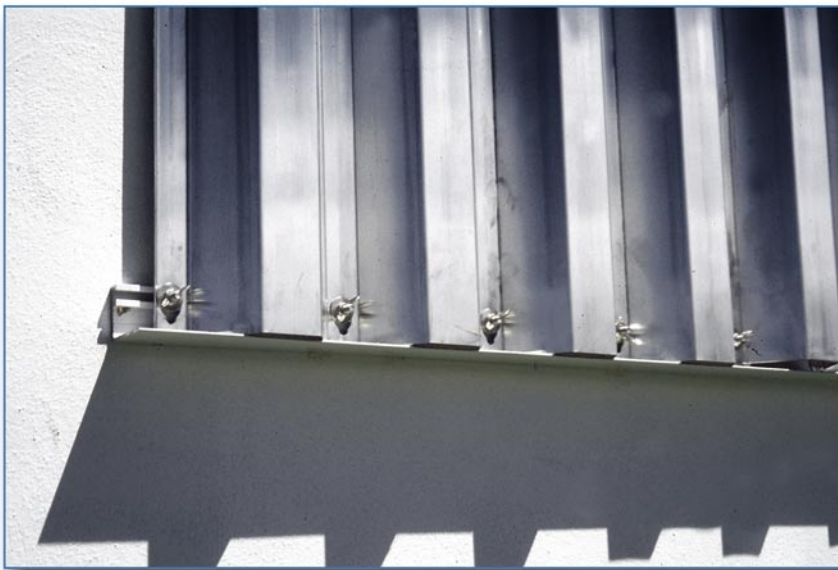
Figure 6-55  
View of a metal shutter  
designed to provide missile  
protection for windows

With the advent of building codes requiring glazing protection in wind-borne debris regions, a variety of shutter designs have entered the market. Figure 6-55 illustrates an effective shutter. A metal track was permanently mounted to the wall above and below the window frame. Upon notification of an approaching hurricane, the metal shutter panels were inserted into the frame and locked into position with wing nuts.

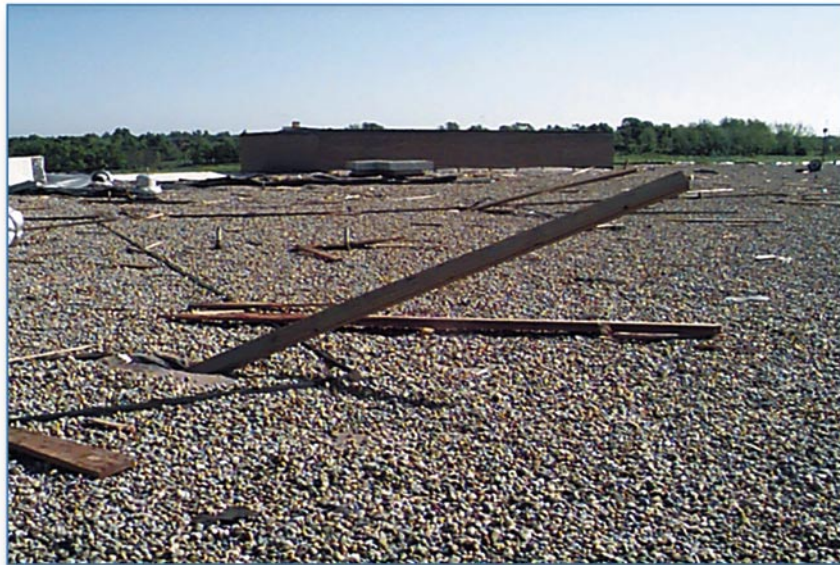
A violent tornado passed by this high school and showered the roof with missiles.

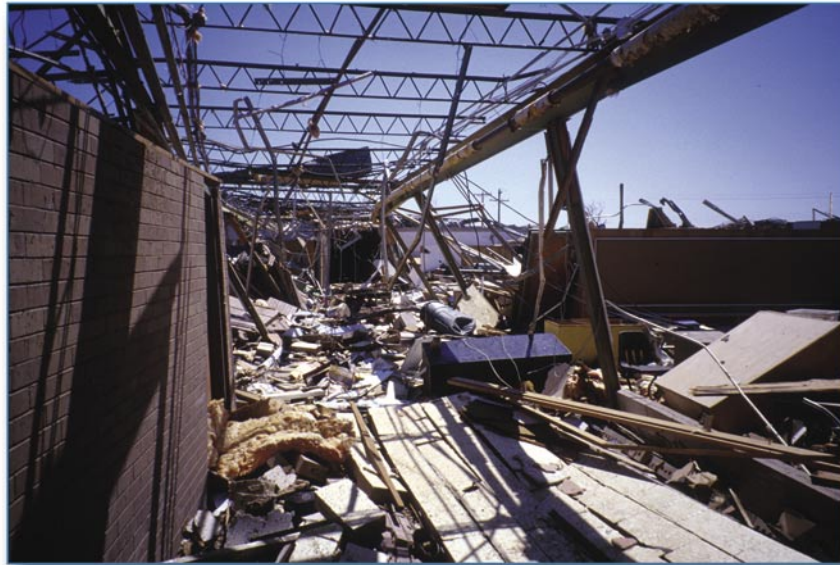
View of an elementary school corridor after passage of a violent tornado. Although corridors sometimes offer protection, they can be death traps as illustrated in this figure (fortunately the school was not occupied when it was struck).

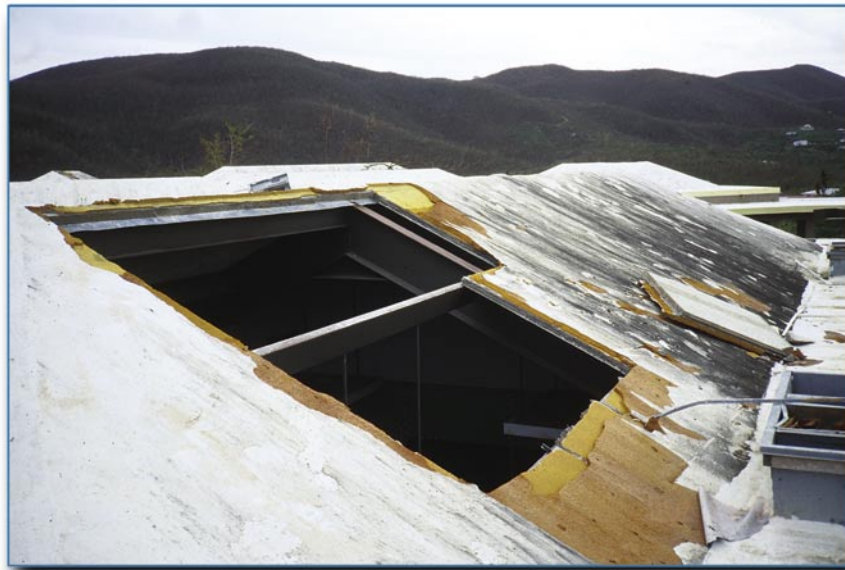
Figure 6-58  
This school had a cementitious wood-fiber deck (commonly referred to by the proprietary name “Tectum”).
