# Seagrass Management Plan for Big Lagoon and Santa Rosa Sound

Dec 2001

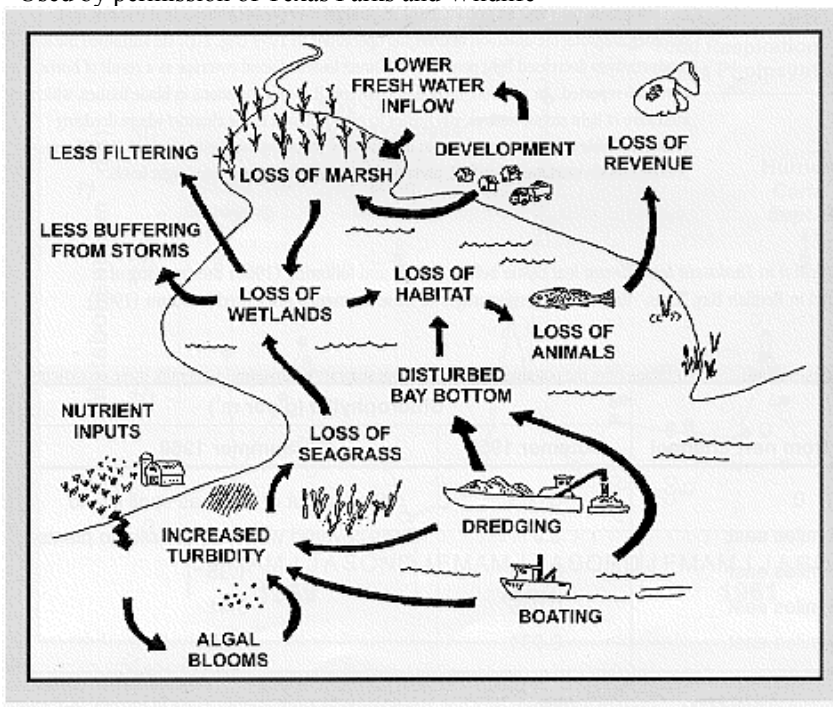
Figure 2-6. The major factors that contribute to loss of seagrass habitat are primarily from human induced impacts and include dredging, excessive nutrient inputs, and boating activities.

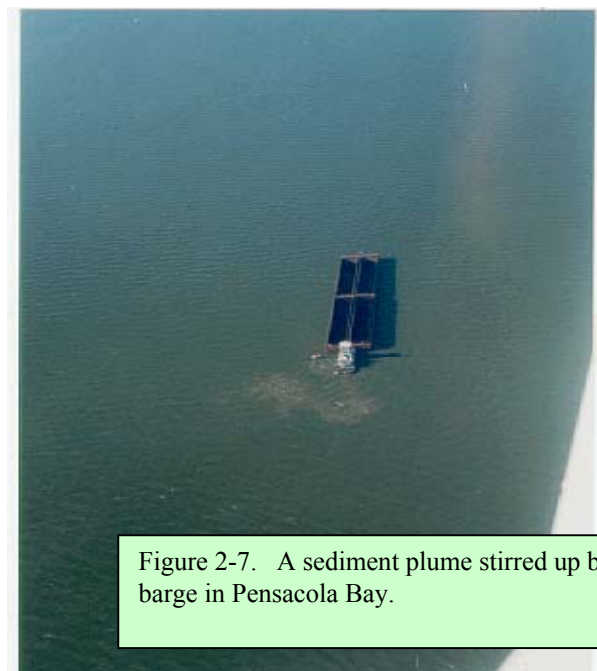
Figure 2-7. A sediment plume stirred up by a barge in Pensacola Bay.

One way to decrease the frequency of this form of resuspension is proper and timely channel maintenance. Keeping the channels adequately marked and at proper depth is crucial to the minimization of excessive turbidity. And responsible use of BMP’s during channel dredging is just as important (i.e. use of turbidity controls).

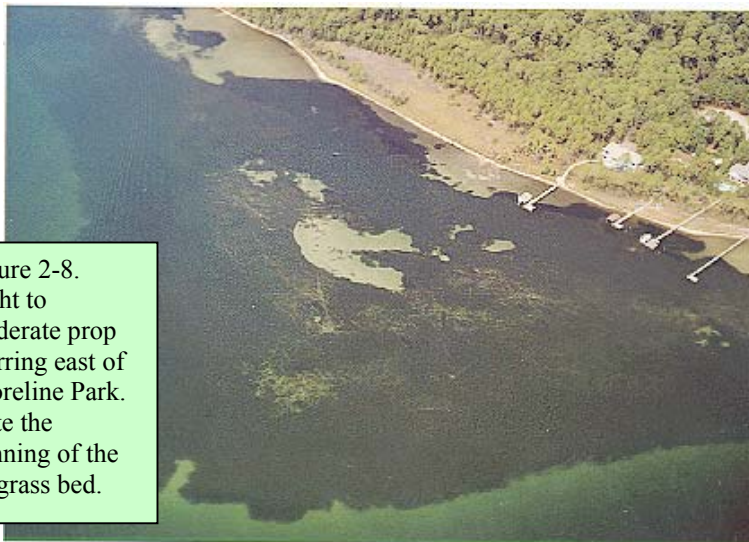
Figure 2-8. Light to moderate prop scarring east of Shoreline Park. Note the thinning of the seagrass bed.

Tourism and recreational boating have been on the rise over the last decade. The main effects of these industries are related to boat operations, marina construction, and small localized oil spills in marinas. Careless boating activities can have a distinct impact on shallow grass beds through propeller scarring (Figure 2-10). This scarring results in direct damage to seagrasses

through the physical destruction of seagrass leaves and below ground tissue (roots and rhizomes) by boat propellers. These scars are then subject to erosion, leading to further damage.

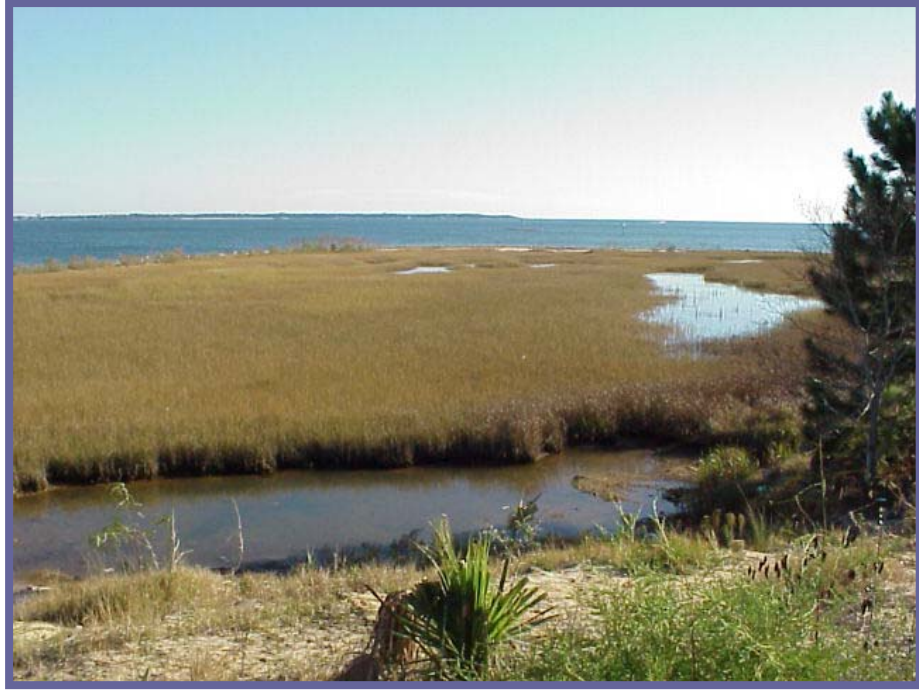
Figure 3-1. Bruce Beach marsh. A mitigation marsh planted in 1991 by the FDEP Ecosystem Restoration Section. This photo was taken approximately 10 years after initial planting.

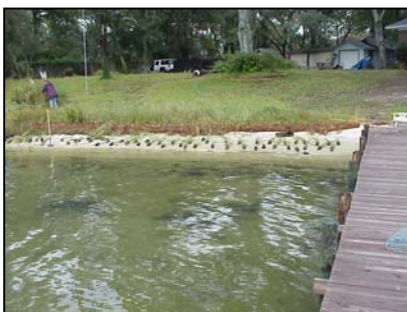
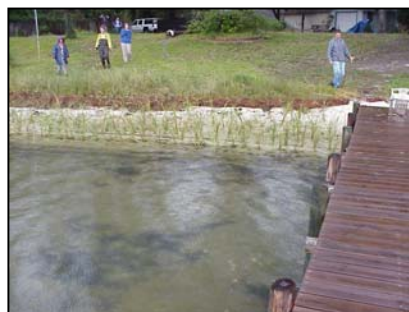
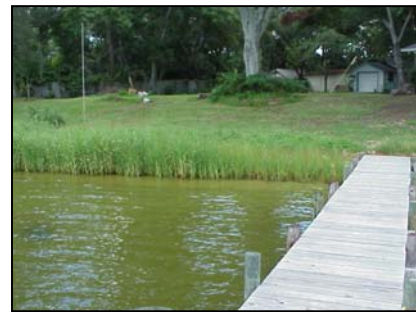
Figure 3-2.

FDEP volunteers prepare to vegetate a residential shoreline. Nov 17, 2000

Shoreline is planted. Nov 17<sup>th</sup>, 2000

Mature buffer zone after approx. one year of growth. Aug 1, 2001

Urban development has altered the natural shoreline leading to a significant decline in intertidal marshes, replacing them with “seawalls”. Seawalls, though they stabilize the immediate shoreline, offer no buffering treatment to stormwater runoff and may cause excessive erosion to neighboring shorelines by interruption of a natural process known as “long shore drift”. The natural alternative to seawall construction is maintaining and restoring intertidal marshes or other shoreline vegetation. These submerged and emergent marshes, directly surrounding the coast’s edge, are referred to as buffer zones. Buffer zones provide food and shelter for marine life, stabilize sediments preventing erosion, and filter pollutants from runoff.

Vegetation also absorbs energy from falling rain, which prevents erosion, and allows for more percolation of water into the ground. Waterbodies without buffer zone protection receive pollutants directly, with no treatment, producing significant impacts on water and sediment quality (FDEP 1998). For this reason,

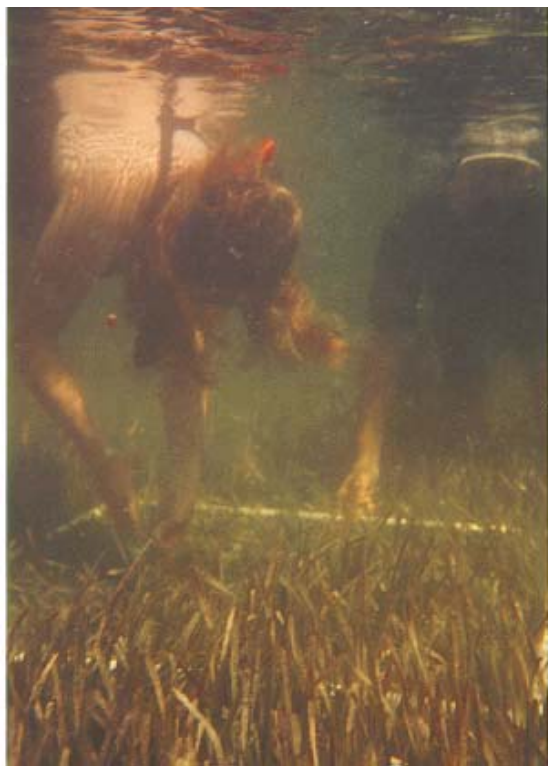
Figure 3-4. Seagrass Monitoring

Detailed monitoring of the twenty transects involves physically measuring water depth, blade height, percent coverage, density, and species composition of the seagrass (Figure 3-3). This monitoring takes place twice a year; once at the beginning of the growing season (April), and once again near the end of the growing season (September). In addition to seagrass monitoring, porewater sulfide is sampled bi-monthly, water quality is monitored monthly, and PAR is monitored bi-weekly. For accuracy in establishing baseline data, monitoring was performed the same time each year for 1999, 2000, and 2001.

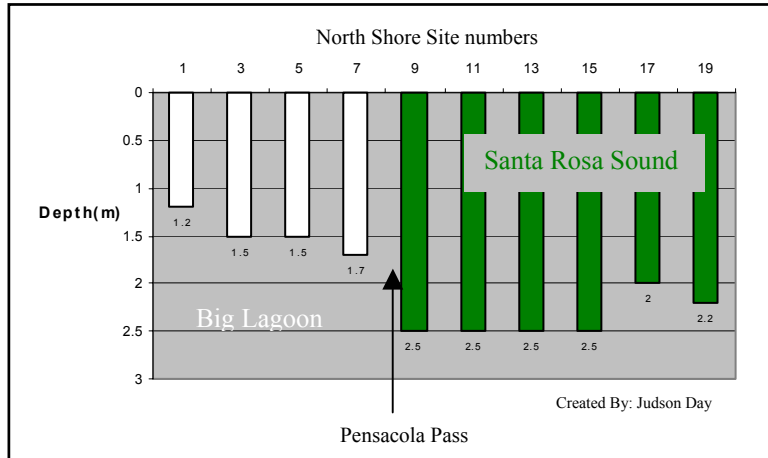
Figure 3-5. Depth of the deep edges of seagrass on the north shores of Big Lagoon and Santa Rosa Sound.

Along the north shore, seagrass grows to a deeper depth in Santa Rosa Sound (approximately 2.5m) than in Big Lagoon (approximately 1.5 meters) (Figure 3-5). The white bars indicate the water depth at the deep edge of the grass beds on the north shore of Big Lagoon. The green bars indicate the depth at the deep edge of the grass beds on the north shore of Santa Rosa Sound. Refer to Figure 3-2 for exact site location.

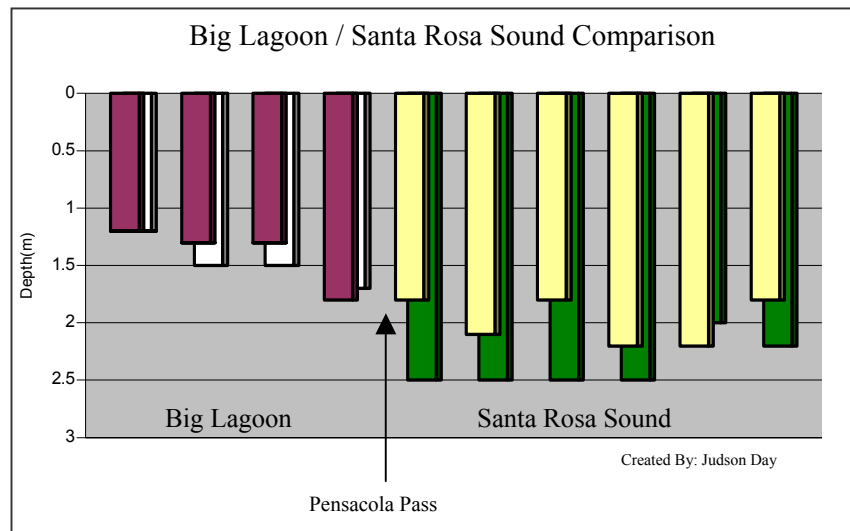
Figure 3-7. A 4-way comparison between the deep edge depths on the north and south shores, and between Big Lagoon and Santa Rosa Sound.

White = Big Lagoon North Shore  
 Red = Big Lagoon South Shore  
 Green = Santa Rosa Sound North Shore  
 Yellow = Santa Rosa Sound South Shore

On a larger scale, seagrass grows to a deeper depth on both shores of Santa Rosa Sound than in Big Lagoon. The average depth for growth in Big Lagoon is 1.4 meters, with the most shallow at the far west end (around Big Lagoon State Park) and slowly increasing in depth eastward toward the pass. The average depth in Santa Rosa Sound is 2.2 meters, with one of the most shallow sites at UWF Beach (site 20) and slowly increasing westward toward the pass on the north shore. The south shore remains, on average, constant westward (Figure 3-7). Figure 3-7 was created by an overlay of Figure 3-5 onto figure 3-4.

The results show that as you move toward the pass, the grass beds grow increasingly deeper. This, and the fact that Santa Rosa Sound has a deeper average depth, may be due to increased flushing, and an overall better water quality (i.e. lower light availability in Big Lagoon caused by excessive turbidity and stormwater impacts).
