**GEOPHYSICAL INVESTIGATION REPORT**

***ELECTRICAL RESISTIVITY INVESTIGATIONS***

**Pimmit Run & Minnehaha Creek Trail Bridges  
Brookmont, Virginia & Glen Echo, Maryland**

**October 12, 2005**

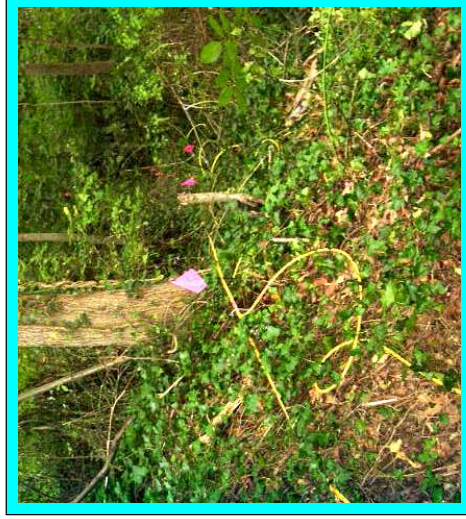
THE PHOTO SHOWS A PORTION OF THE RESISTIVITY CABLE ALONG THE SURVEY LINE. THE CABLES ARE ATTACHED TO STEEL STAKES SPACED AT 10-FOOT INTERVALS (RED FLAGS).

Prior to conducting the geophysical electrical resistivity investigation at each site, 28 stainless steel stakes were driven into the ground at 10-foot intervals along the survey line, resulting in a 270-foot long resistivity array. The passive electrode cables were then attached to the metal stakes and connected to the Advanced Geosciences Inc. (AGI) SuperSting R1 resistivity meter and associated switch box. A brine solution was poured around each of the steel stakes to enhance ground contact with stakes.

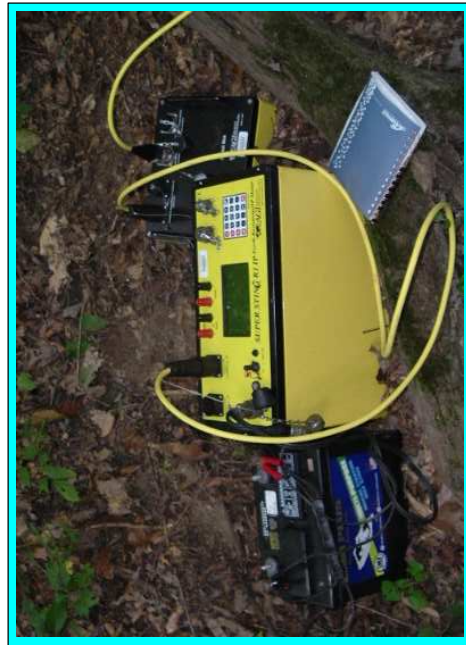
THE PHOTO SHOWS THE AGI SUPERSTRING R1 RESISTIVITY METER ALONG WITH THE SWITCH BOX AND 12-VOLT BATTERY USED TO CONDUCT THE GEOPHYSICAL SURVEYS.

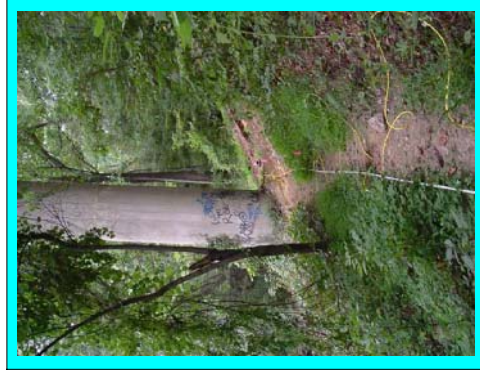
SOUTHWESTWARD LOOKING VIEW OF THE BRIDGE PIER NO. 2, SHOWING A PORTION OF THE RESISTIVITY LINE
