# Damage Delineation in Structures Using Laser Vibrometry And Remote Excitation

Peter Swanson<sup>1</sup> and John Rettkowski<sup>2</sup>

National Institute for Occupational Safety and Health  
Spokane Research Laboratory  
315 E. Montgomery Ave.  
Spokane, WA 99207  
USA

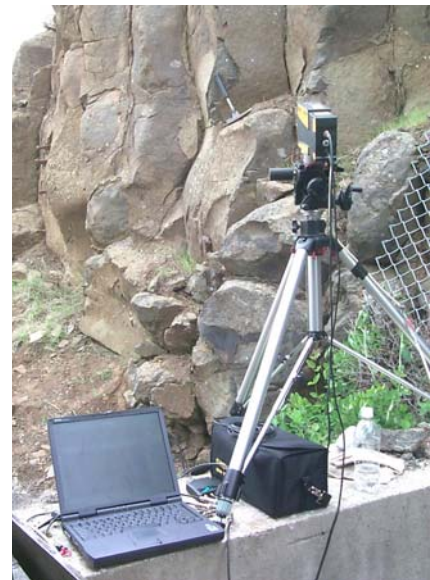
Figure 1.—Portable laser vibrometer, dynamic signal analyzer, battery pack, and data collection computer.

Vibration response was measured with a portable, battery-powered, laser Doppler vibrometer (Figure 1). The vibrometer (LDV) is an optical interferometer that measures relative motion between the LDV and target via a Doppler shift carried by the scattered return signal. The unit outputs analog and digital measures of ground velocity over a frequency range of 0 to 22 kHz with a resolution of 0.05 mm/s. Unlike automated scanning vibrometers, the portable LDV does not have a speckle tracking feature to help compensate for the poor reflective qualities of rough surfaces. Speckle tracking helps maintain high signal-to-noise ratios to reduce momentary signal dropouts [6]. To minimize the time required to collect suitable time periods of dropout-free data, each target site was given a small area of retro-reflective treatment.

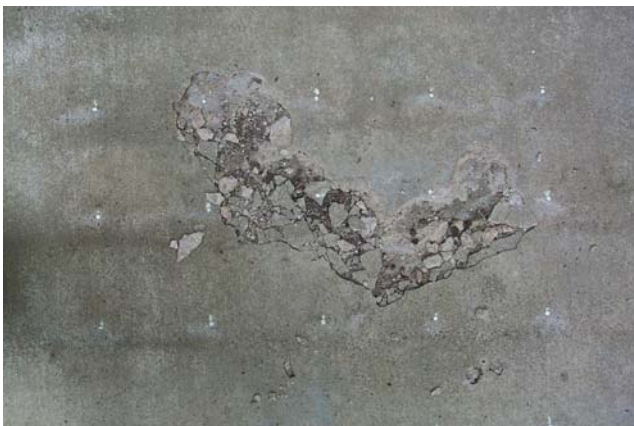
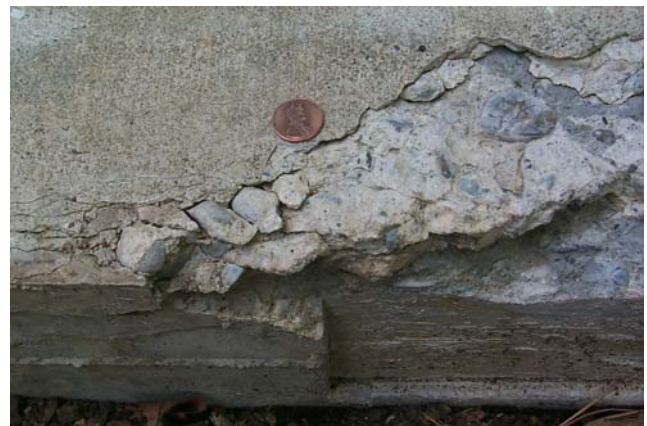
Figure 2.—(a) Concrete damage that has penetrated through to the slab's surface, exposing more-competent material (field of view is 90 cm across). (b) Near-surface damage and aggregate characteristics exposed at edge of slab (penny for scale)

had become completely detached from the bulk of the slab (Figure 2a) and exposed a deeper, more-competent, rough concrete surface. The thickness of the detached layer in the exposed area was up to one to two aggregate particle diameters. Figure 2b shows a closeup of similar damage on the edge of the slab outside the measurement array.
