# **OPTICAL NONDESTRUCTIVE EVALUATION TECHNIQUES FOR ENVIRONMENTAL BARRIER COATINGS**

**ENERGY TECHNOLOGY DIVISION  
ARGONNE NATIONAL LABORATORY**

**Presented to:  
Environmental Barrier Coatings  
Workshop 2005**

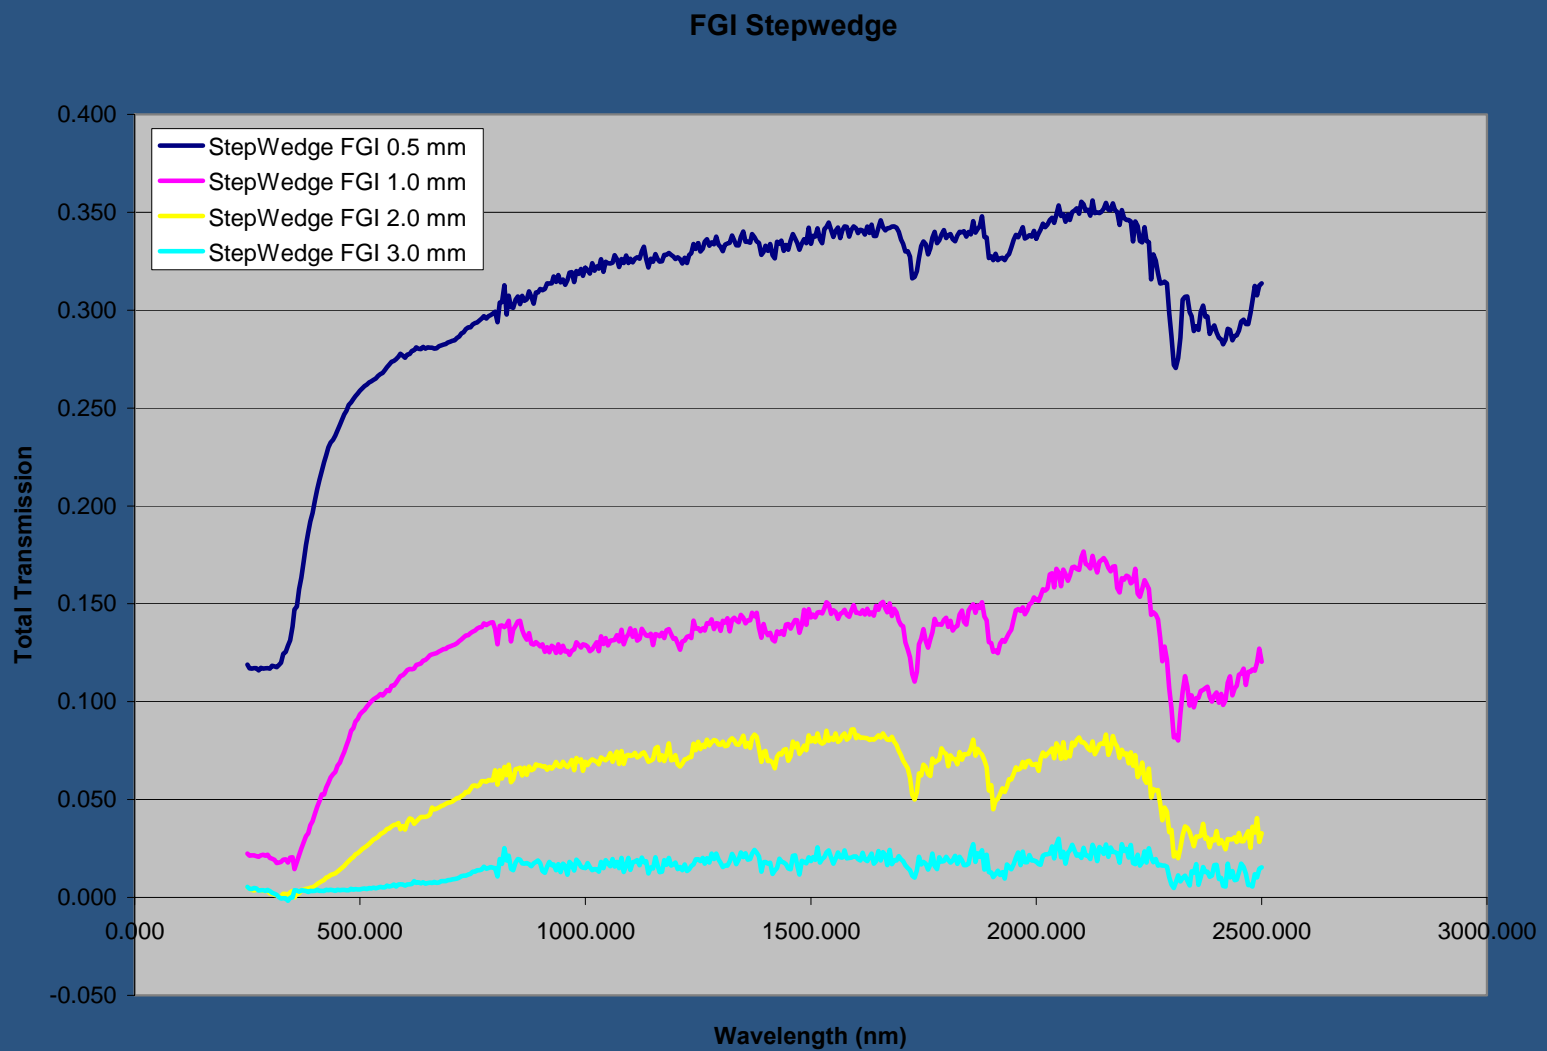
# Optical transmission characteristics of one EBC for Oxide/Oxide composite

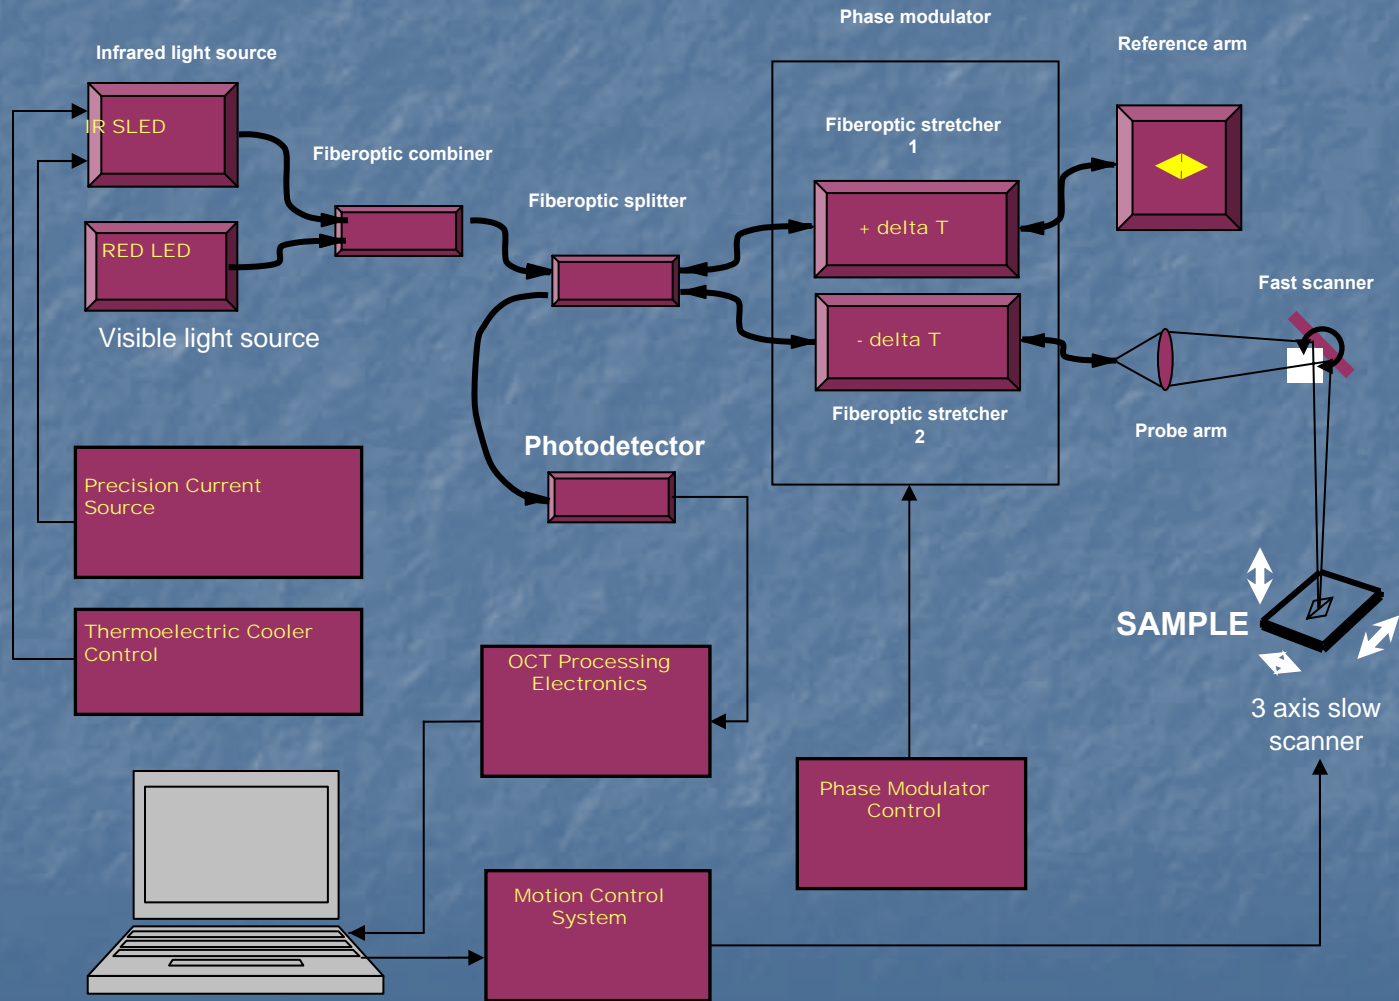
# Diagram of Optical Coherence Tomography System

## THEORETICAL SPATIAL RESOLUTION LIMITS FOR OCT SYSTEM

**$\Delta x \approx 10 \mu\text{m}$  (theory suggests  $\sim 2-5 \mu\text{m}$ )**

**$\Delta z \approx 18 \mu\text{m}$  (theory suggests  $\sim 10 \mu\text{m}$ )**

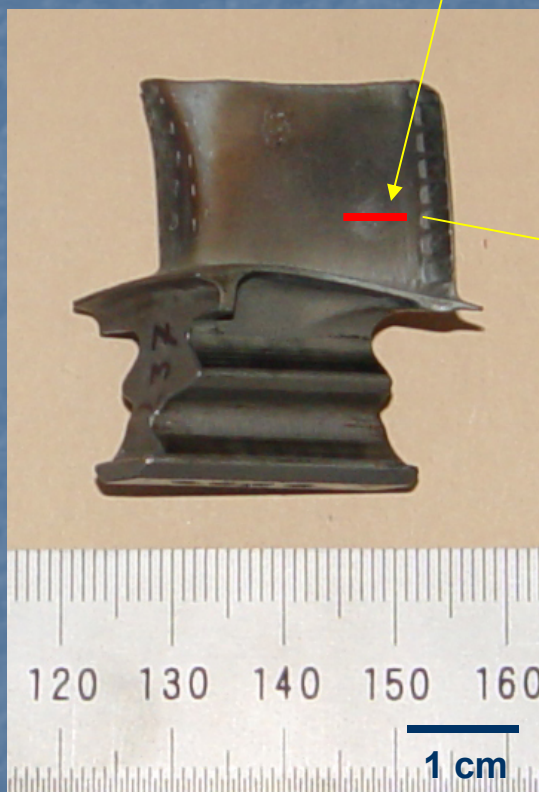
OCT Scan taken  
along red line  
perpendicular to the  
surface

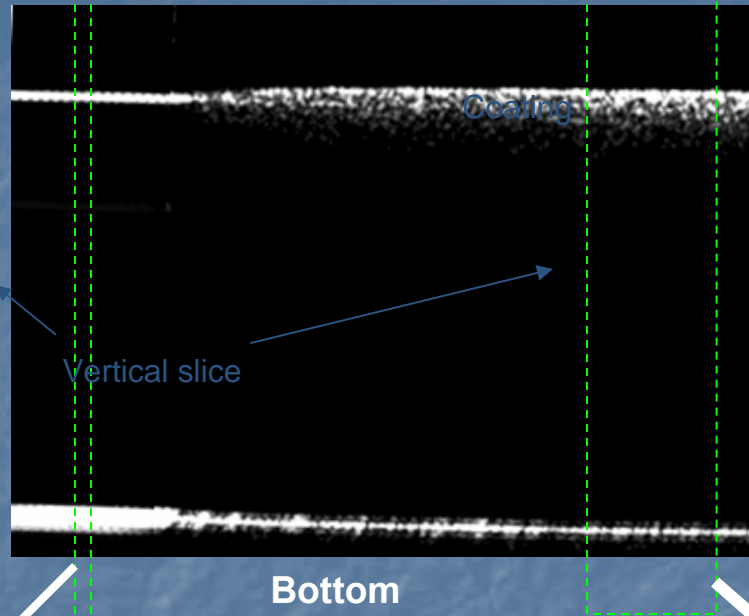
# Optical Coherence Tomography data for thick\* slurry cast green-state oxide EBC

6.3  $\mu\text{m}/\text{pixel}$  for a scan set at 2.8mm.

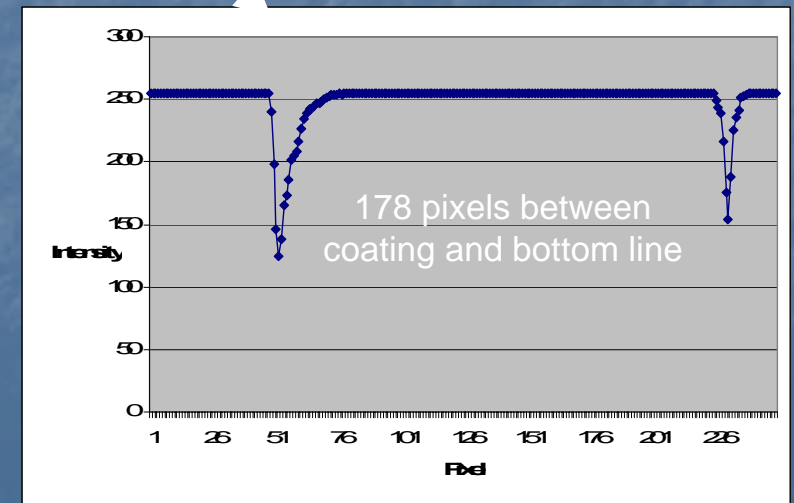
Plot profile of coating

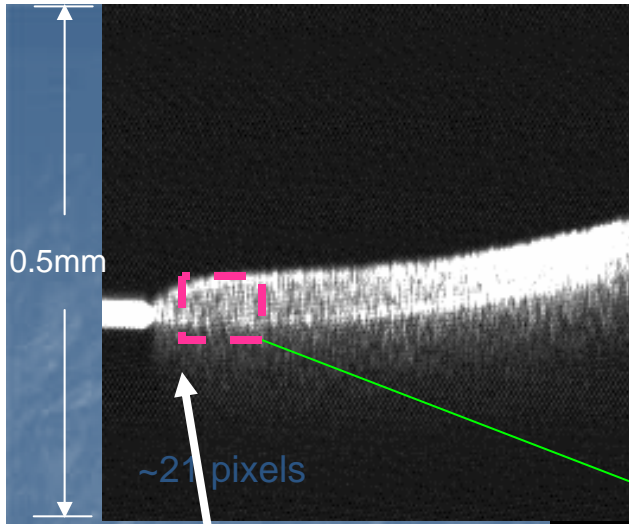
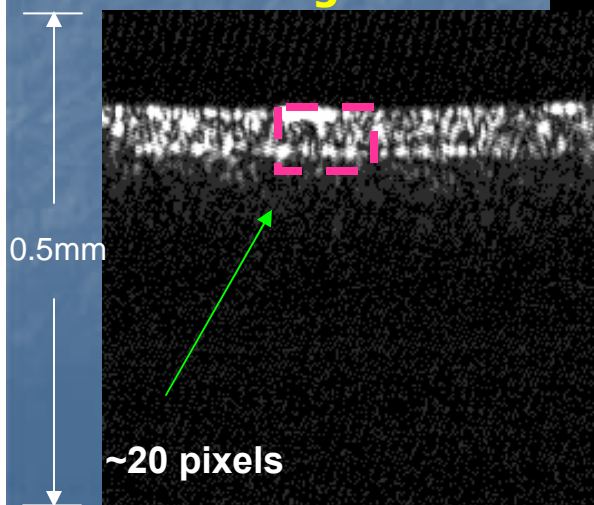
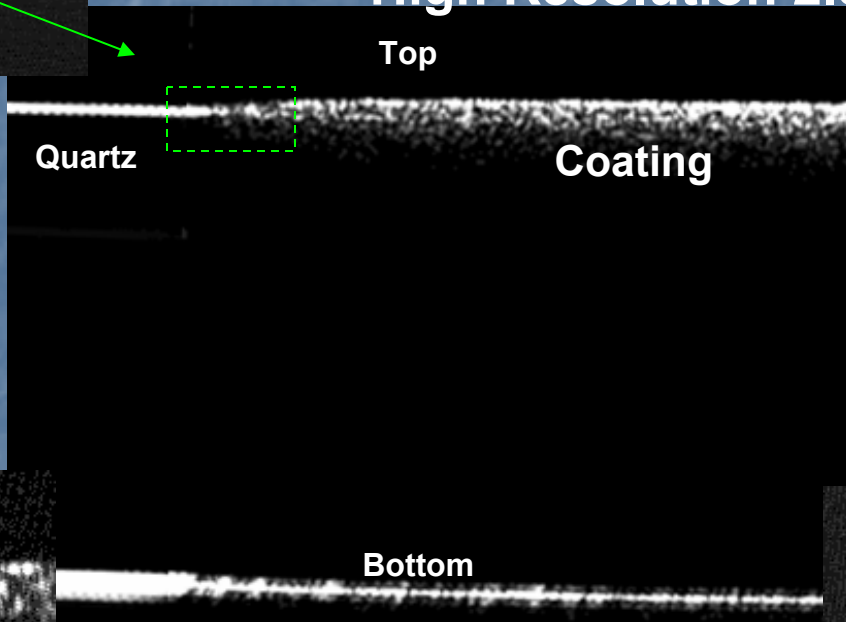
Vertical Cross Section Scans

High Resolution 2.3  $\mu\text{m}/\text{pixel}$

Note  
detection of  
taper

~20 pixels  
again suggests  
thickness in the  
46  $\mu\text{m}$  range
