Highway Safety Challenges on Low-Volume Rural Roads

Jerome W. Hall, Elizabeth W. Rutman, James D. Brogan

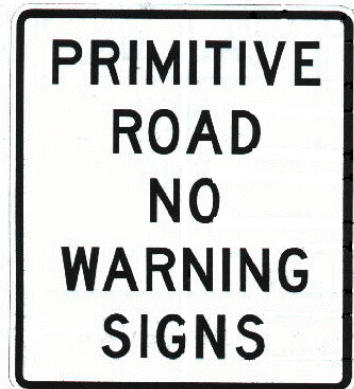
Figure 2. Washington Sign

Idaho (14) and New York (15) have similar manuals for low-volume roads. New York, for example, permits the use of a "MINIMUM MAINTANCE ROAD" sign on an unpaved, low-volume road. The Washington State Modifications to the MUTCD (16) includes a provision to use the "PRIMITIVE ROAD" (see Figure 2) sign on a portion of a county road that:

- Is not classified as part of the county primary road system,
- Has a gravel or earth driving surface, and
- Has an average annual daily traffic of one hundred or fewer vehicles

An accompanying "CAUTION – NO WARNING SIGNS" sign may also be posted, with or without a "NEXT XX MILES" plaque.

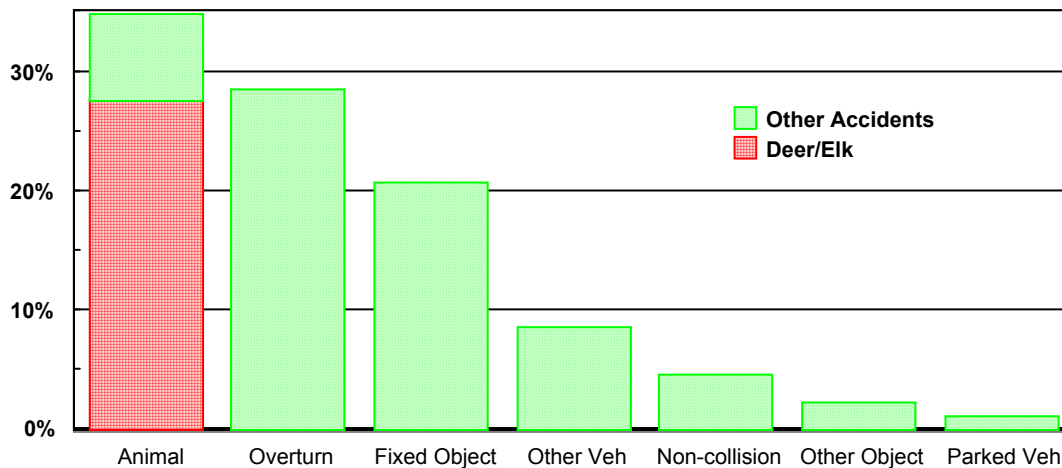
Figure 4. NM LVRR Crash Type Distribution, 1998-2001

Figure 4 shows the distribution of NM LVRR accidents by collision classification. Over one-third of the accidents involve an animal struck by a vehicle, and 80% of these animals are either deer or elk. There were no reported accidents involving a pedestrian on any of these LVRR.

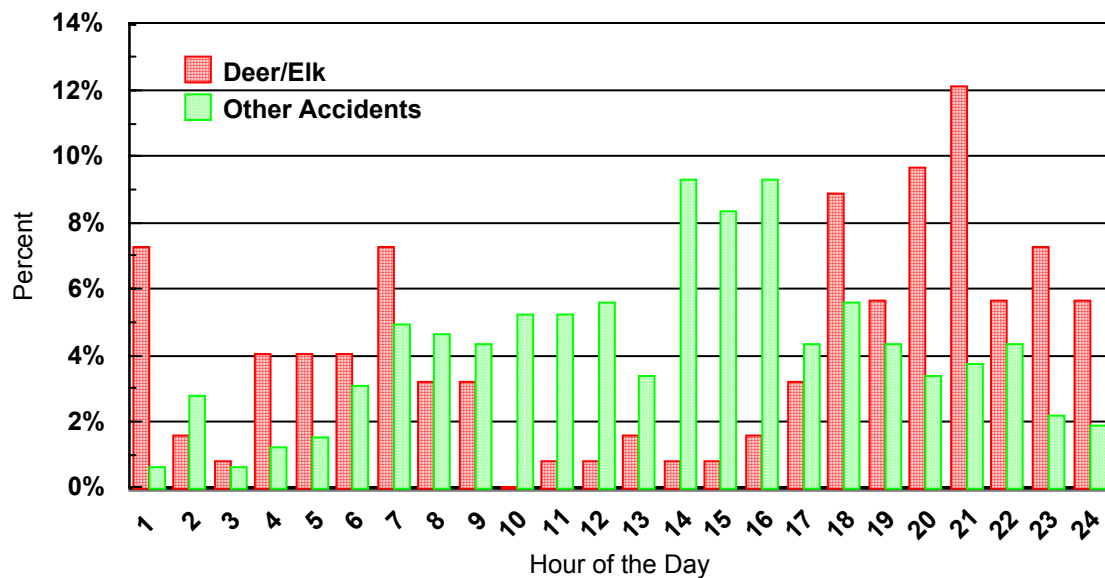
Figure 5. Hourly Distribution of NM LVRR Accidents, 1998-2001

Figure 5 shows the hourly distribution of 124 deer/elk accidents and 323 other accidents on New Mexico’s LVRR. The most troublesome time for deer/elk impacts is between 6 pm and 2 am with 62% of the crashes. Other accidents show a peak between 2 and 5 pm, which accounts for 25% of the crashes. The period from 7 am to 1 pm accounts for another 30% of the LVRR accidents. Approximately 44% New Mexico’s LVRR accidents occurred between 6:00 pm and 6:00 am; according to TSF 2000, only 31% of all accidents nationwide occur during this time span.

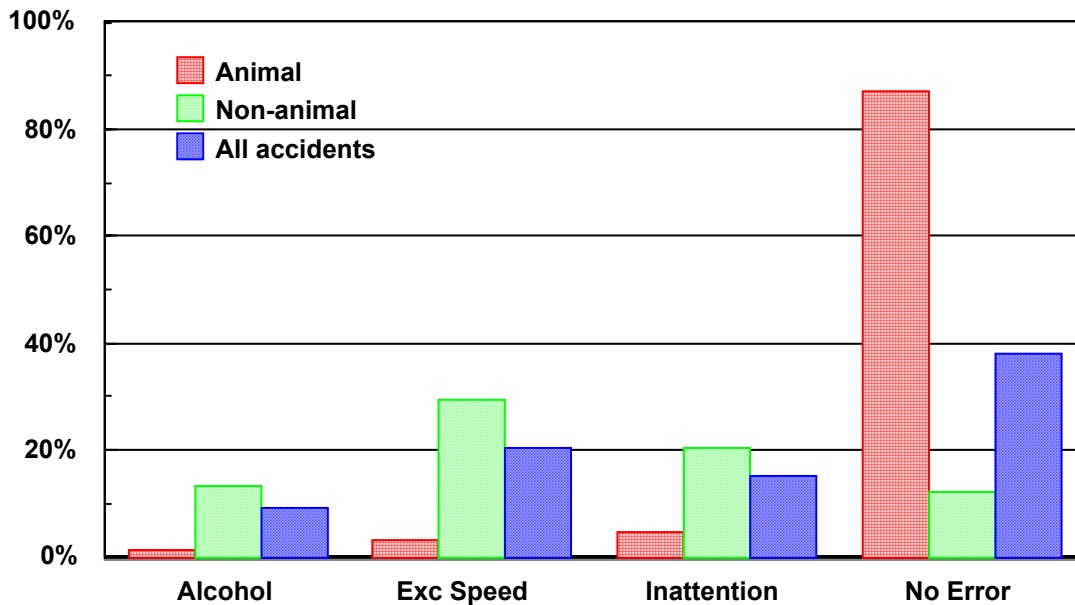
Figure 6 Highest Contributing Factor to NM LVRR Accidents, 1998-2001

Over 90% of New Mexico’s reported accidents on LVRR occurred on dry pavement; this figure, which obviously depends on weather conditions, is virtually identical to the pavement condition reported for all of the state’s traffic accidents. On the New Mexico traffic accident form, the investigating officer is asked to identify the factors that contributed to the accident. This is a challenge because 90% of the crashes involve a single vehicle, so the officer probably didn’t witness the accident and the chances are high that there are no witnesses besides the motorist involved. In the process of developing computerized accident files, factors cited by the officer are evaluated on an importance scale (e.g., driving while intoxicated is more serious than speed to fast for conditions, which in turn is more serious than driver inattention), with the most serious defect selected as the “highest contributing factor.” Figure 6 plots the highest contributing factor for three crash types on New Mexico’s LVRR for 1998-2001:

- all accidents
- all animal accidents (includes deer, elk, cattle, and others)
- all non-animal accidents

Alcohol, excessive speed, driver inattention, and no driver error account for 82% of the highest contributing factors to the accidents on these roads. The importance of speed as a contributing factor reinforces previous work on higher volume roads showing a relationship between speed and single vehicle accidents. Although no driver error was reported for 87% of the animal impacts, it is quite possible that driver inattention or excessive speed could have been involved in these collisions. Alcohol was cited in 9% of the crashes.

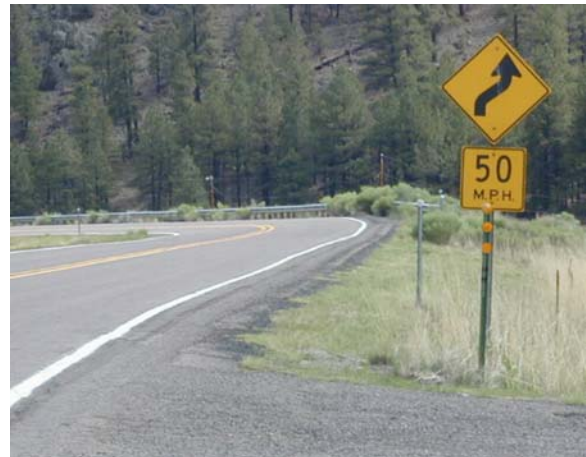
Figure 7. Sign inconsistent with roadway

- lack of certain warning signs and object markers
- existing warning signs inconsistent with roadway features (see Figure 7)
- signs in need of maintenance
- need for larger STOP and Stop Ahead signs
- problems with signing isolated, low-speed curves on 55-mph highway
- concentrations of deer/elk accidents with no nearby signing
- excessive vegetation in ROW attracts animals
- cattle on the ROW (see Figure 8)
- travel lanes less than 10 feet wide
- absence of any shoulders
- overturning and fixed object accidents on the outside of horizontal curves
- excessive superelevation on roads with the potential for ice
- steep sideslopes without guardrail
- need for guardrail maintenance

- Ensure the accuracy of all signs: signs must be consistent with what the driver sees on the road. Remove signs that are no longer applicable.
- Require that Stop Ahead signs be placed in advance of all STOP signs on these routes with approach segment lengths greater than 10 miles.

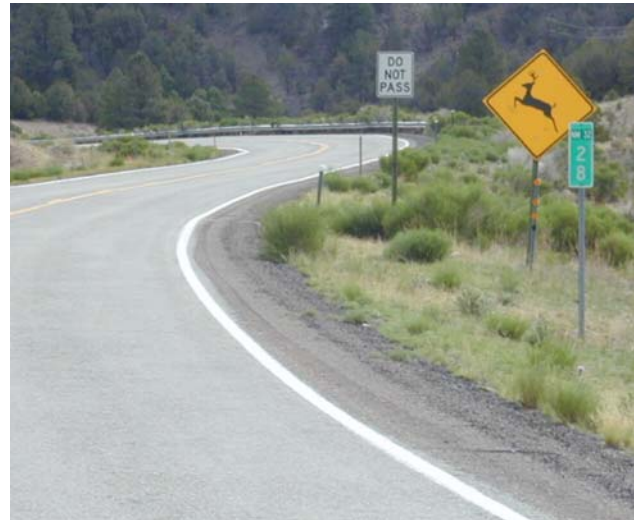
Figure 9. Typical Deer Warning Application

Deer-vehicle collisions are a national problem, amounting to more than \$1 billion in property damage and more than 200 human deaths per year (18). On NM LVRR, animal-vehicle collisions account for nearly 35% of all accidents; 80% of the animals struck are deer and elk. The typical safety treatment is to install warning signs (see Figure 9) occasionally with distance plaques (“Next XX Miles”). Game animals (e.g., deer, elk and moose) are more active at night, an added challenge for motorists due to the decreased visibility. Human instinct causes motorists to attempt to avoid hitting a large animal, though predicting which direction the animal will go is difficult. Swerving to miss an animal can cause a more severe accident than simply hitting the animal.

- Use animal crossing signs judiciously; distance plaques are helpful, but limit distances to less than 7 miles lest the motorists forget.
- To discourage grazing by animals, keep the ROW mowed. Repair damaged fencing promptly. Report deficient cattle guards and gates to land owners.
