NUREG/CR-6931/V1 SAND2007-600/V1

***CAROLFIRE Test Report Volume 1:***  
**General Test Descriptions and the Analysis of Circuit Response  
Data**

Steven P. Nowlen and Francis J. Wyant  
Risk and Reliability Analysis Department 6761  
Sandia National Laboratories  
Albuquerque, New Mexico

Project Manager: Hugh W. Woods  
Fire Research Branch  
Division of Fuels, Engineering, and Radiological Research  
Office of Nuclear Regulatory Research  
U.S. Nuclear Regulatory Commission  
Under JCN N6125

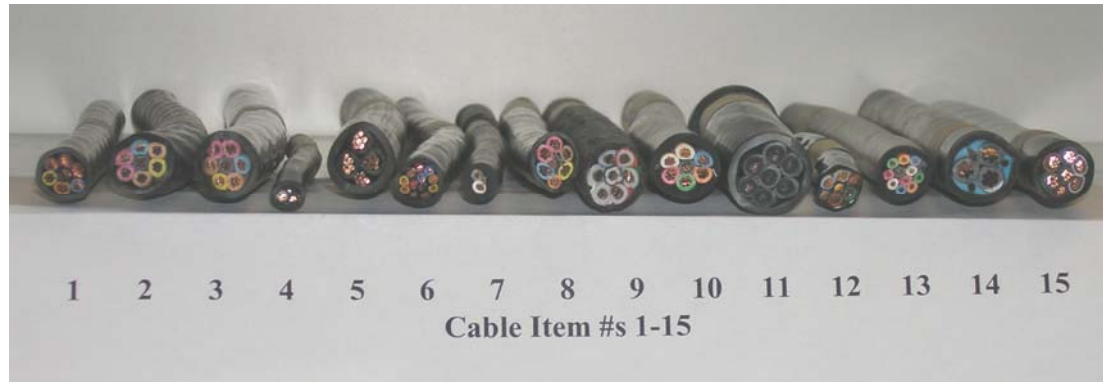
**Figure 3.8: Photograph of the 15 different cables tested in CAROLFIRE.**

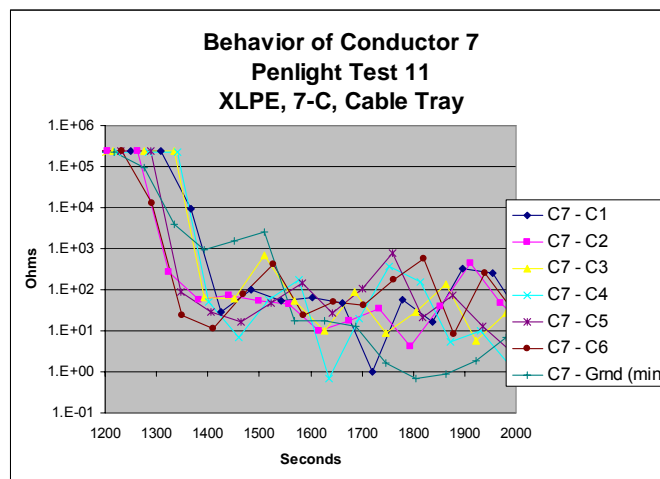
Figure 4.1: Example of a typical IRMS data plot taken from *Penlight* Test 11.

A typical cable response plot for the IRMS is illustrated in Figure 4.1. This example was taken from *Penlight* Test 11 which involved the ‘core’ 7-conductor 12 AWG XLPE-insulated cable (item #10). The numbering of the conductors for this test is illustrated in Figure 4.2.

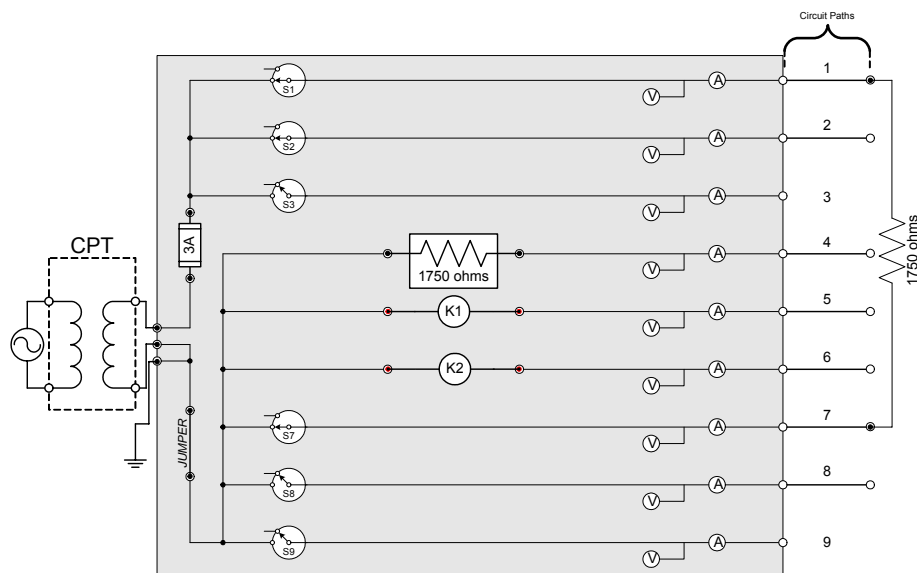
**Figure 4.4: MOV-1 SCDU circuit configuration with two active targets (paths 5&6) and one passive target (path 4). Paths 1 and 2 are the energized sources, path 7 is grounded, and path 8 monitors a spare conductor. Note that circuit paths 3 and 9 are not used.**

For most tests, the SCDUs were used to obtain circuit behavior data in a manner essentially identical to the motor operated valve (MOV) surrogate test circuits utilized during the EPRI/NEI tests and the more recent Duke Energy (2006) tests. This is the configuration that is referred to in this report as the ‘MOV-1’ configuration. Figure 4.4 illustrates this configuration.

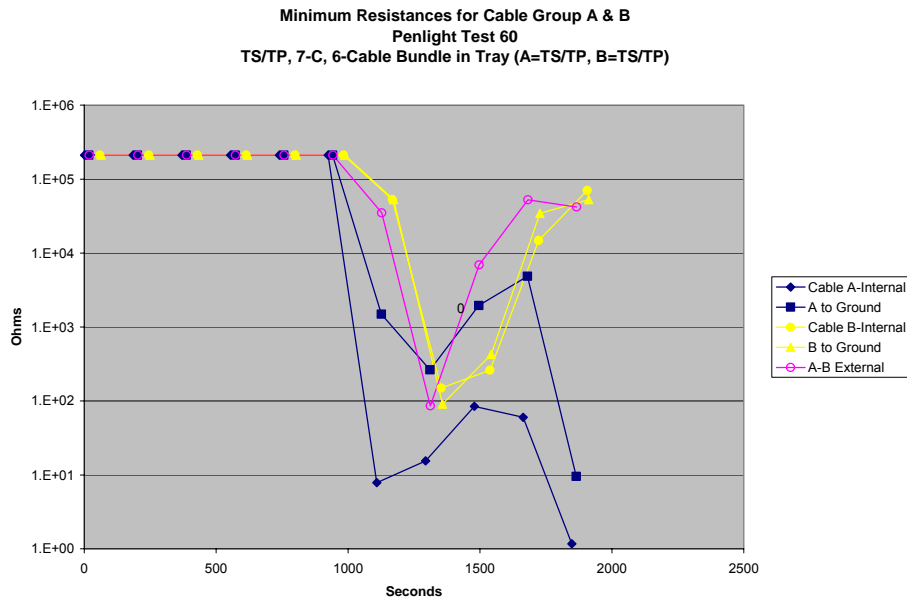
Figure 6.2: Shorting results for Cables A&B in Test PT-60.

The second most significant inter-cable faults were observed in Tests PT-60, one of the later *Penlight* tests, and in IT-7, one of the intermediate-scale tests. In both cases, TS-to-TS inter-cable shorting was observed as a secondary fault mode for one cable (i.e., after intra-cable faulting of this first cable had been detected) and as the primary fault mode in the second cable (the first detected fault for the second cable). These faults could have led to a spurious operation in practice if the proper combination of conductors were involved, a matter that appears to be essentially random.

the primary failure mode for cable B. This particular case is taken as a possible indication that inter-cable shorting between two TS-insulated cables is plausible.

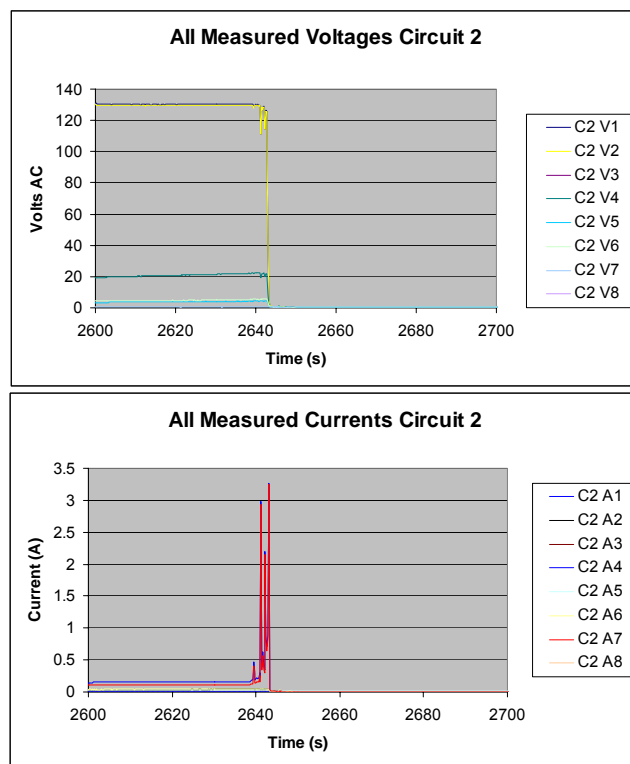
**Figure 7.3: Illustration of the Fuse Blow failure on Circuit 2 in Test IT-1.**

Fuse blow failures can be caused by a short between one of the energized conductors (Circuit Paths 1 and 2 for the MOV-1 configuration) and the power supply return side conductor (Circuit Path 7 for the MOV-1 configuration). In conjunction with this behavior there will also be a current spike (sharp rise and sharp fall) on one of the two source conductors and on the return path conductor. For the grounded circuits (i.e., for all but SCDU-1) a fuse blow can also result from shorts between an energized conductor (Paths 1 or 2) and the external ground. Note that the mode of ground faulting can be distinguished (at least nominally) because a short to external ground does not cause a current spike on the return path conductor (Path 7) whereas an intra-cable short to the grounded conductor on path 7 does cause a current spike on Path 7.

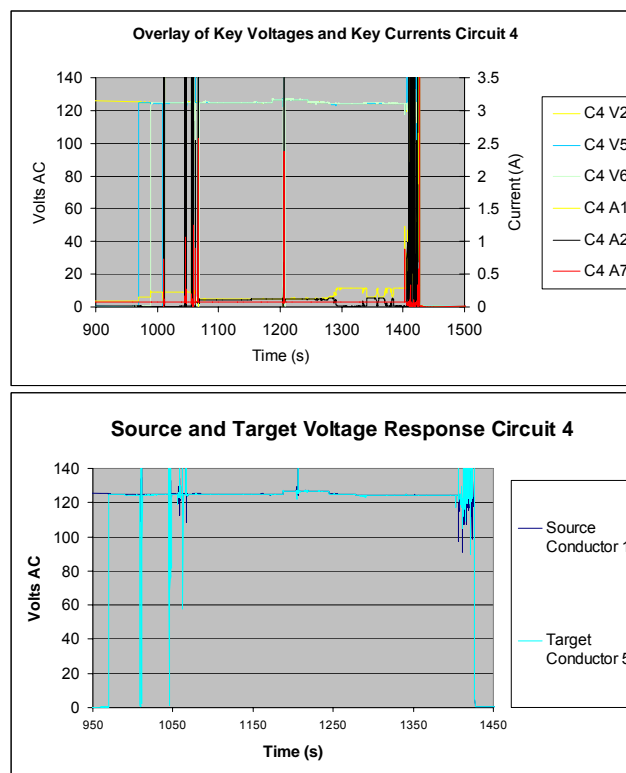
**Figure 7.4: Results for SCDU-4 in Test IT-9.**

As indicated in Table 7.2, there were many cases of spurious actuations of the active targets (the motor contactors) for both TP and TS cables. Figure 7.4 illustrates the single longest duration spurious actuation observed; namely, Circuit 4 in Test IT-9, 457s duration. This was, again, a MOV-1 configuration on a 100VA CPT and connected to a TP (PE 7/C 12AWG ID #15) cable.

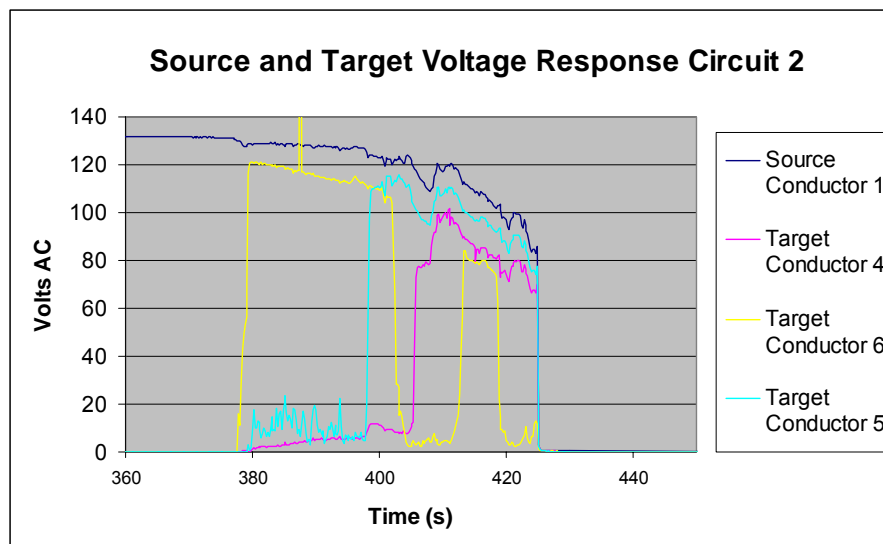
**Figure 7.5: Spurious actuation failure on SCDU Circuit 2 in Test IT-7.**

A second example is shown in Figure 7.5. This is taken from SCDU Circuit 2 during Test IT-7. In this case the circuit does experience a spurious actuation and also sees significant degradation of the source circuit voltage prior to a fuse blow.

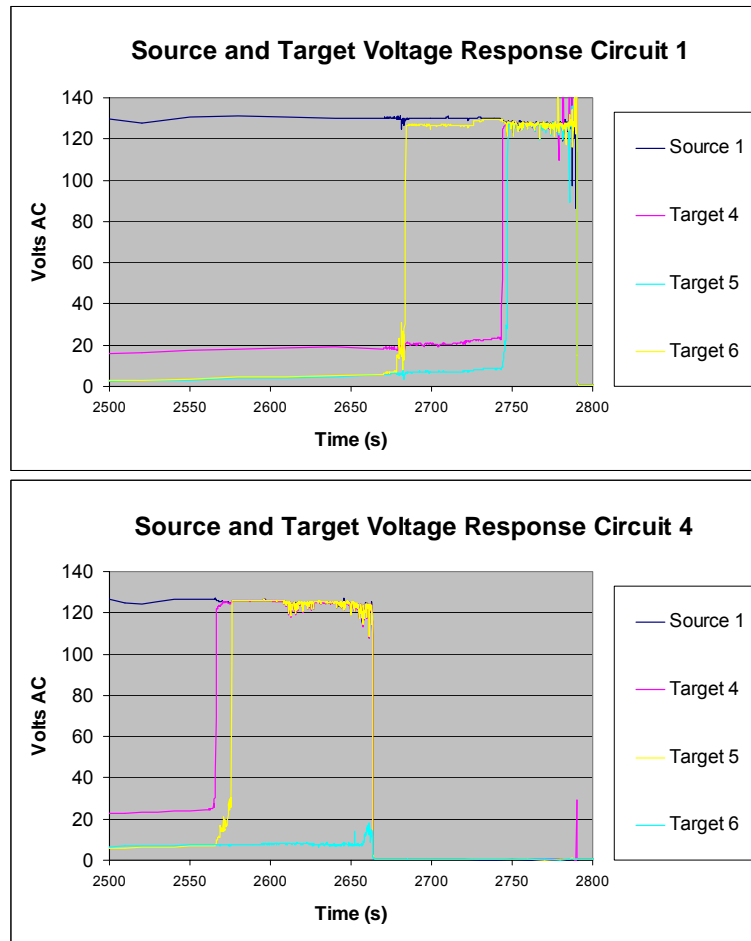
**Figure 7.6: Illustration of the inter-cable interactions observed between circuits 1 and 4 in Test IT-1. Note the voltage spike to Target 4 in Circuit 4 after that circuit had experienced a fuse blow.**

This particular case is actually quite typical of the inter-cable interactions that were detected with the SCDU. Similar momentary inter-cable shorts were also observed in Tests IT-3 (with two of the three IC configurations present) and IT-7 (between two MOV-1 configurations). In the case of the IT-3 interactions, it is apparent that one of the cables had shorted to ground and subsequently shorted to an energized conductor in the second circuit creating a momentary voltage/current spike. In Test IT-7, the behavior is essentially identical to that described above for Test IT-1. That is, one circuit had already shorted to ground and experienced a fuse blow. The second circuit then hit the cable for the first circuit with a momentary voltage/current spike as the second circuit was itself cascading to failure. Neither case led to a spurious actuation due to insufficient current/voltage.

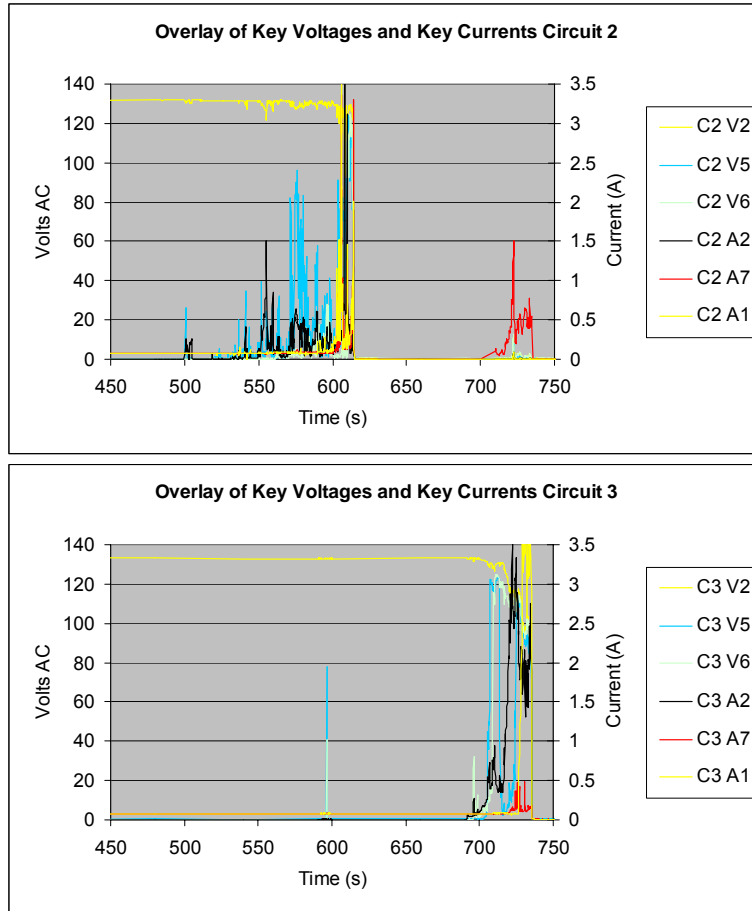
**Figure 7.7: Illustration of the interactions between Circuits 2 and 3 in Test IT-8. Note the current increase on Circuit 2 Path 7 (C2 A7) in the upper plot concurrent with failure of Circuit 3.**

The most notable case occurred during Test IT-8 between a PE (TP) cable and an XLPE (TS) cable. The TP cable failed first causing a fuse blow failure for that SCDU. Subsequent to this, a hot short from the TS cable impacted the TP cable as evidenced by a current increase on one of the TP cable conductors lasting for about 10 seconds. In this case, the hot short impacted the grounded conductor in the TP cable rather than a target conductor. It is not clear whether or not a hot short to a target conductor could have caused a spurious operation in this case because the exact extent of faulting in the TP cable is not known (only that a fuse blow had occurred).

There was only one case that did not follow this pattern exactly, but rather, led to more than a momentary inter-cable shorting behavior as shown in Figure 7.7. This was Circuits 2 and 3 in Test IT-8. In this case, a short between two MOV-1 circuits persisted for approximately 13s. In this case the energizing source cable was that connected to Circuit 3 which was a TS cable (XLPE). The target was the cable on Circuit 2 and that was a TP cable (PE). About 100s after the fuse blows on Circuit 2, there is an increase in current to Circuit 2 Path 7, the grounded return conductor, concurrent with the failure of Circuit 4. This current flow can only be explained by inter-cable shorting. The potential for a spurious actuation in the target circuit (Circuit 2) cannot be definitively assessed. If the two target conductors (i.e., those on Circuit 2 Paths 5 and 6) were both shorted to ground, then a spurious actuation was not possible. However, all that can be stated for certain in this case is that at least one of the two energized conductors in Circuit 2 had shorted either to an external ground or to the grounded conductor on Path 7. Hence, there is some potential that this interaction could have led to a spurious actuation in Circuit 2 had the hot-short impacted either of the two target conductors.

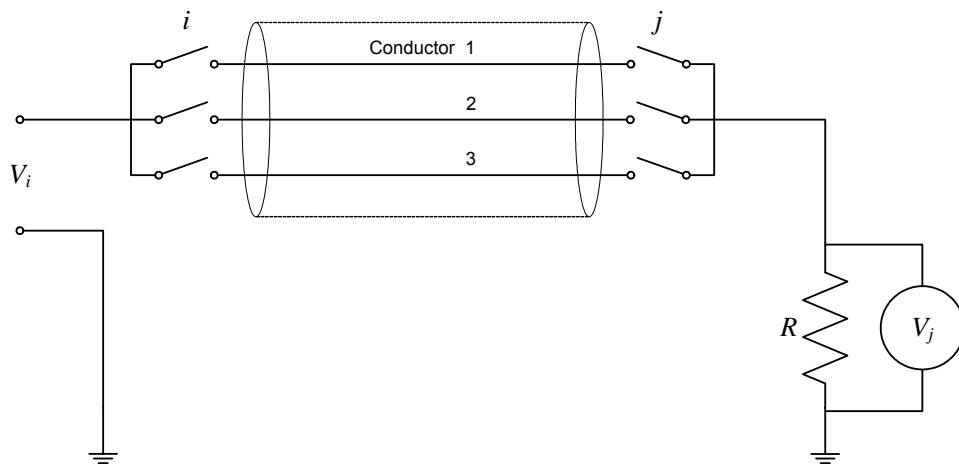
**Figure B.2 Circuit for measuring insulation resistance between any conductor pair in a cable.**

This concept evolved to include the two sets of controlled switches, one set on the input side (i) and one on the output side (j) of the circuit. One switch on the voltage input side is closed (thereby energizing one conductor) followed by the sequential closing-measurement-opening of each measurement side switch. Each sequential switching configuration measures leakage currents between one energized "source" conductor and one non-energized "target" conductor, and the various pairs are systematically evaluated in sequence.

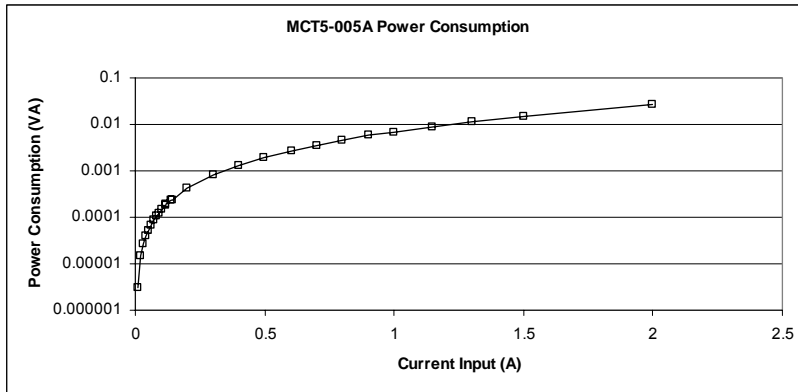
Figure D.10: Power consumption behavior for the NEI/EPRI style current transducers.

In both cases, the transducer output, which by design is a 0-1 mA signal proportional to the input, was shunted through a 470Ω resistor. A third multi-meter was connected across the shunt resistor to ensure that a valid output signal was being generated. (The experiment was also repeated for several measurement points using a 940 Ω shunt resistor with little change in the results.)

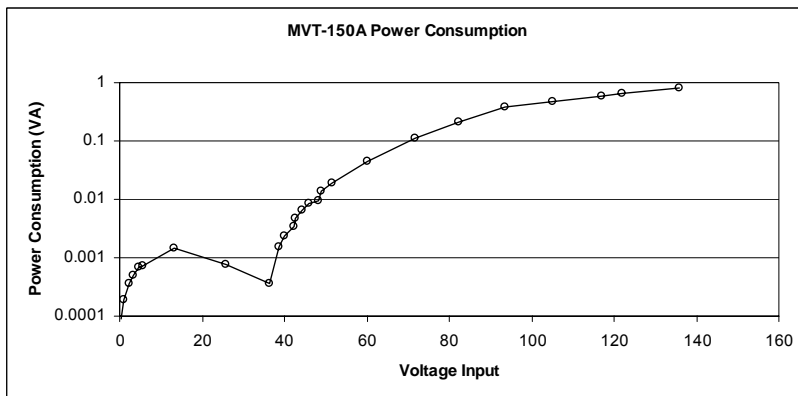
Figure D.11: Power consumption behavior for the NEI/EPRI style voltage transducers.

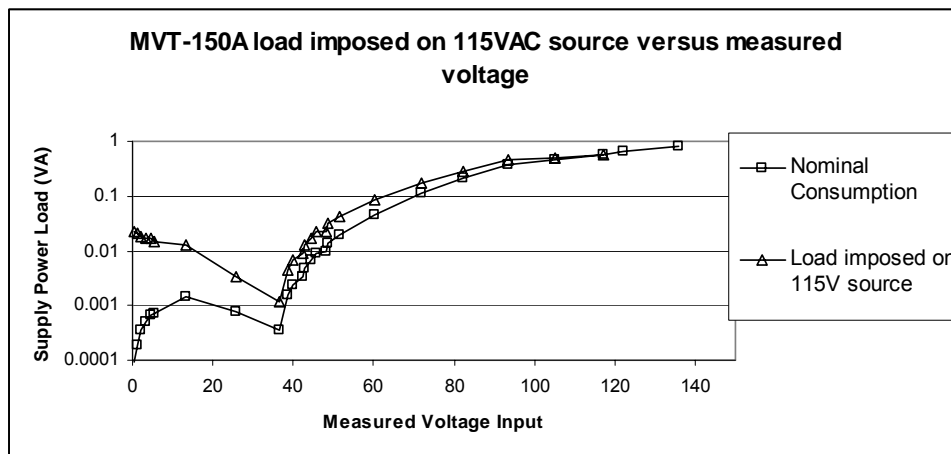
Figure D.12: Power consumption imposed on the CPT by the NEI/EPRI style voltage transducers.

Assuming a nominal 115 VAC supply voltage, the power imposed on the circuit supply transformer (e.g., the CPT) can be recalculated as shown in the final figure below. Note that the percentage differences are most pronounced at the lowest voltage levels where the power consumption is also at its lowest. In this case, the maximum effect in absolute terms is seen at higher voltages. The worst case load increase is in the 80-90 V input range where the supply power required is about 0.09 VA higher than the nominal power requirement of the transducer. The overall effect at all voltage levels is relatively small, but may need to be considered in assessing the effect that up to nine such transducers might have had on a monitored circuit.
