## One of the Iowa Watershed Cooperative Agreement Program sites

The Roozeboom AML/AMD Site was disturbed by past coal mining practices in the 1960's, and left in an unreclaimed state. The site is located near Oskaloosa in Mahaska County, Iowa and lies adjacent to the Little Muchakinock Creek, which empties directly into Muchakinock Creek.

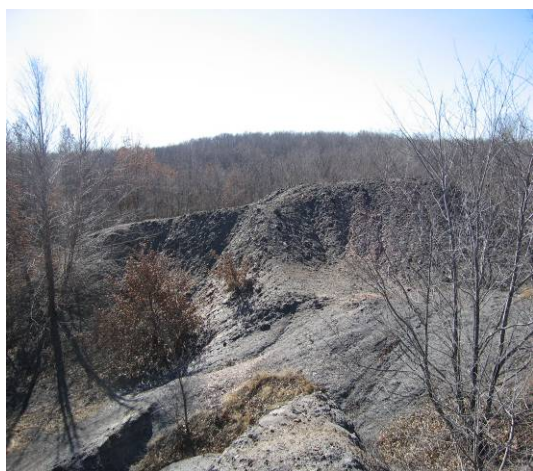
Figure 1. Acidic spoil piles.

Reclamation activities included the clearing of existing vegetation, filling and grading the erosion gullies, smoothing out uneven grades to approximately contours, and neutralizing acid/ and toxic material in the subgrade. Soil was tested to determine lime and fertilizer application rates prior to establishing a successful vegetative cover. This vegetative cover consisted of warm/cool season grass mixture and trees planted in selected areas.

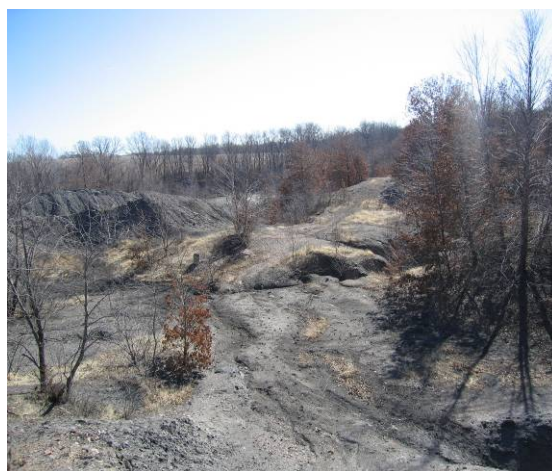
Figure 2. Acidic spoil piles with pond in background .

The two ponds were backfilled in the grading process. Prior to this backfilling, any acidic waters were neutralized and discharged. A new larger 2 ½ acre pond and wetlands were created to mitigate the loss with equal waters. Two of the existing ponds were enhanced. The wetlands and waters of the U.S. mitigation area were seeded above and below the waterline.

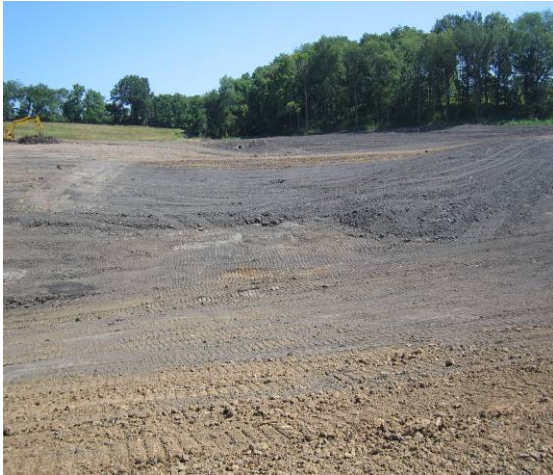
Figure 3. Pond being reconstructed.

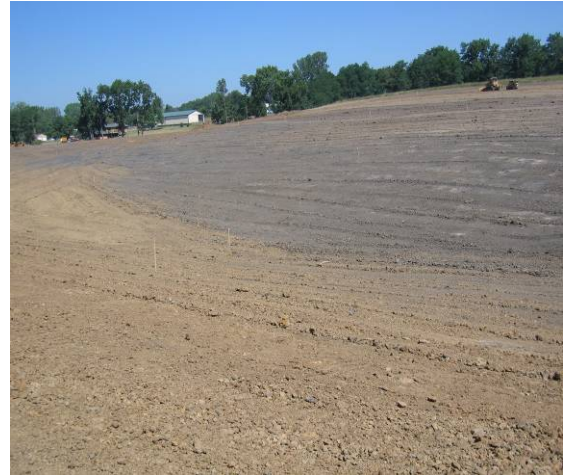
Figure 4. Pond and terraces being reconstructed.

Terraces and outlet structures were sited to reduce erosion. Multiple wetlands were built to capture surface runoff and create seasonal pools that will be used by local wildlife. Riprap and permanent reinforced turf mat were used to stabilize the wetland discharge points.

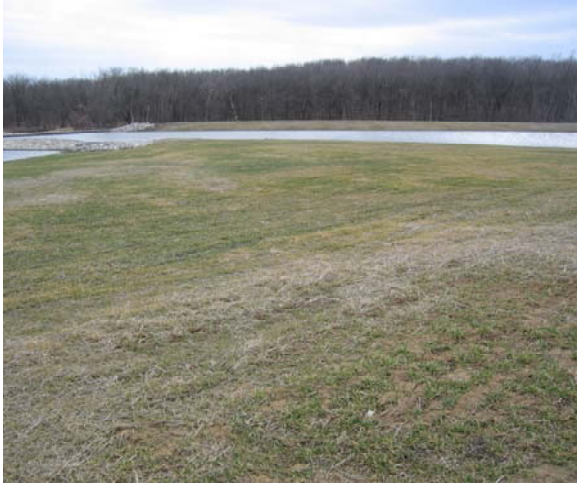
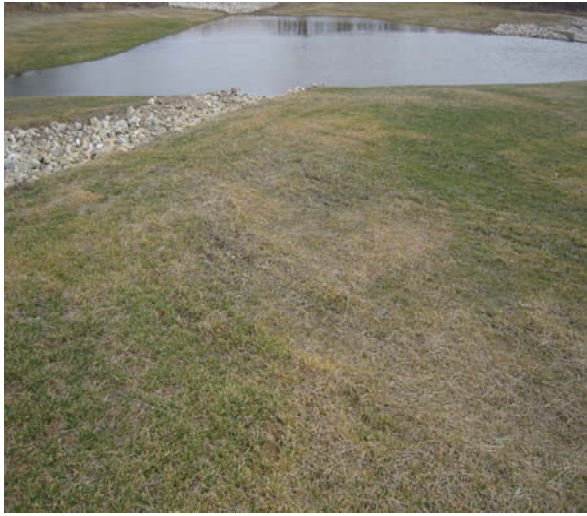
This reclamation has enhanced the wildlife habitat as shown in the next two photographs taken in March 200t. The pond is approximately 2 ½ acres with over 1 ½ acres of deep water to support fish habitat.
