Effects of Removing Good Hope Mill Dam on Selected Physical, Chemical, and Biological Characteristics of Conodoguinet Creek, Cumberland County, Pennsylvania

Scientific Investigations Report 2005-5226

U.S. Department of the Interior
U.S. Geological Survey

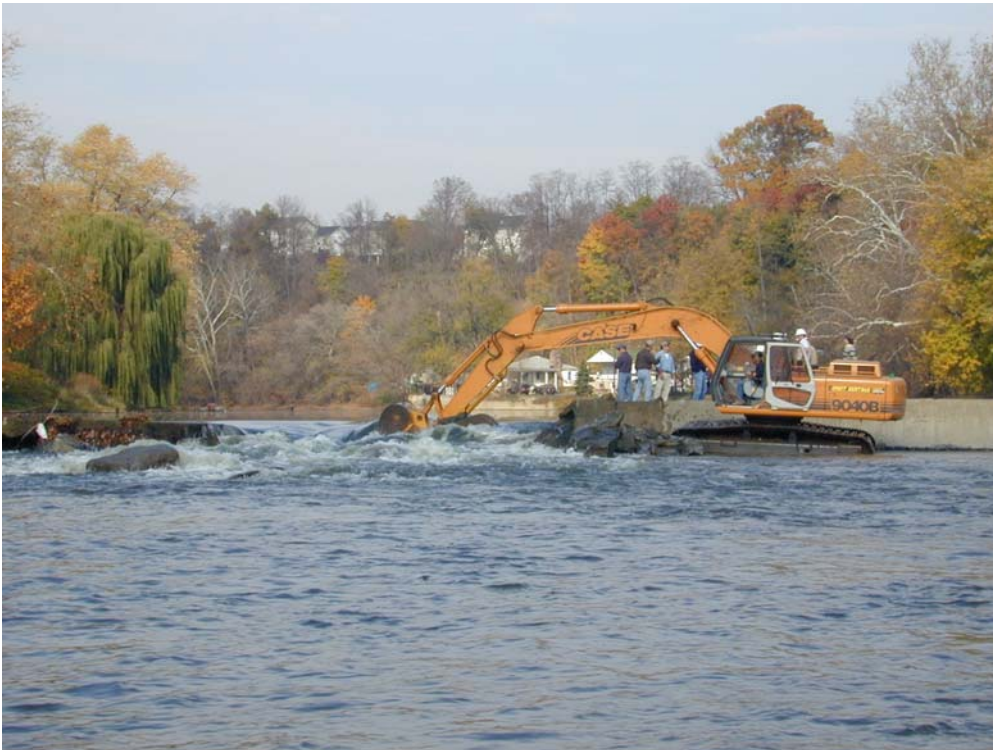
Cover photograph:
View looking upstream at the initial breach of Good Hope Mill Dam on November 2, 2001.
Photographed by J. Chaplin, U.S. Geological Survey.

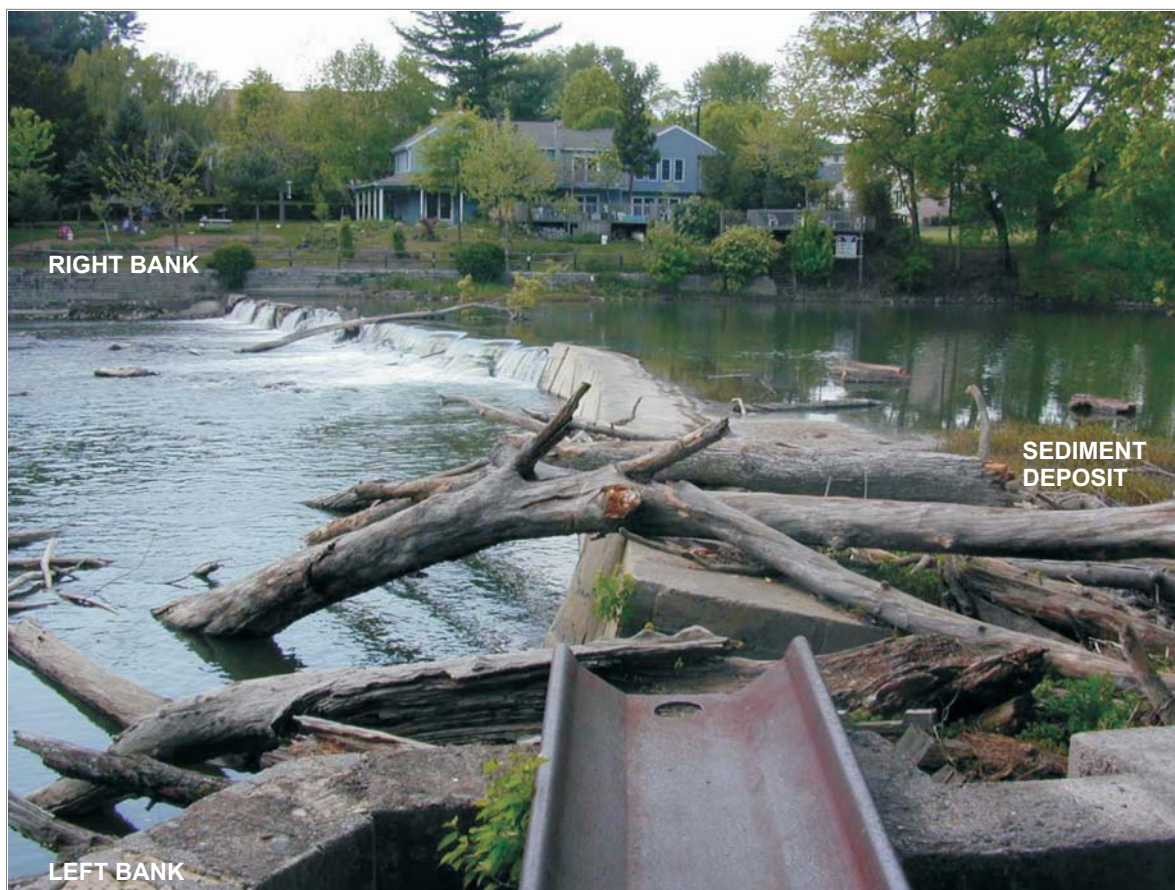
Figure 2. Conodoguinet Creek flowing over Good Hope Mill Dam, a 6-foot high, 220-foot wide concrete structure constructed on bedrock over 100 years ago to power a former mill, Cumberland County, Pennsylvania. (Photographed by J. Kent Crawford, U.S. Geological Survey, on May 21, 2001).

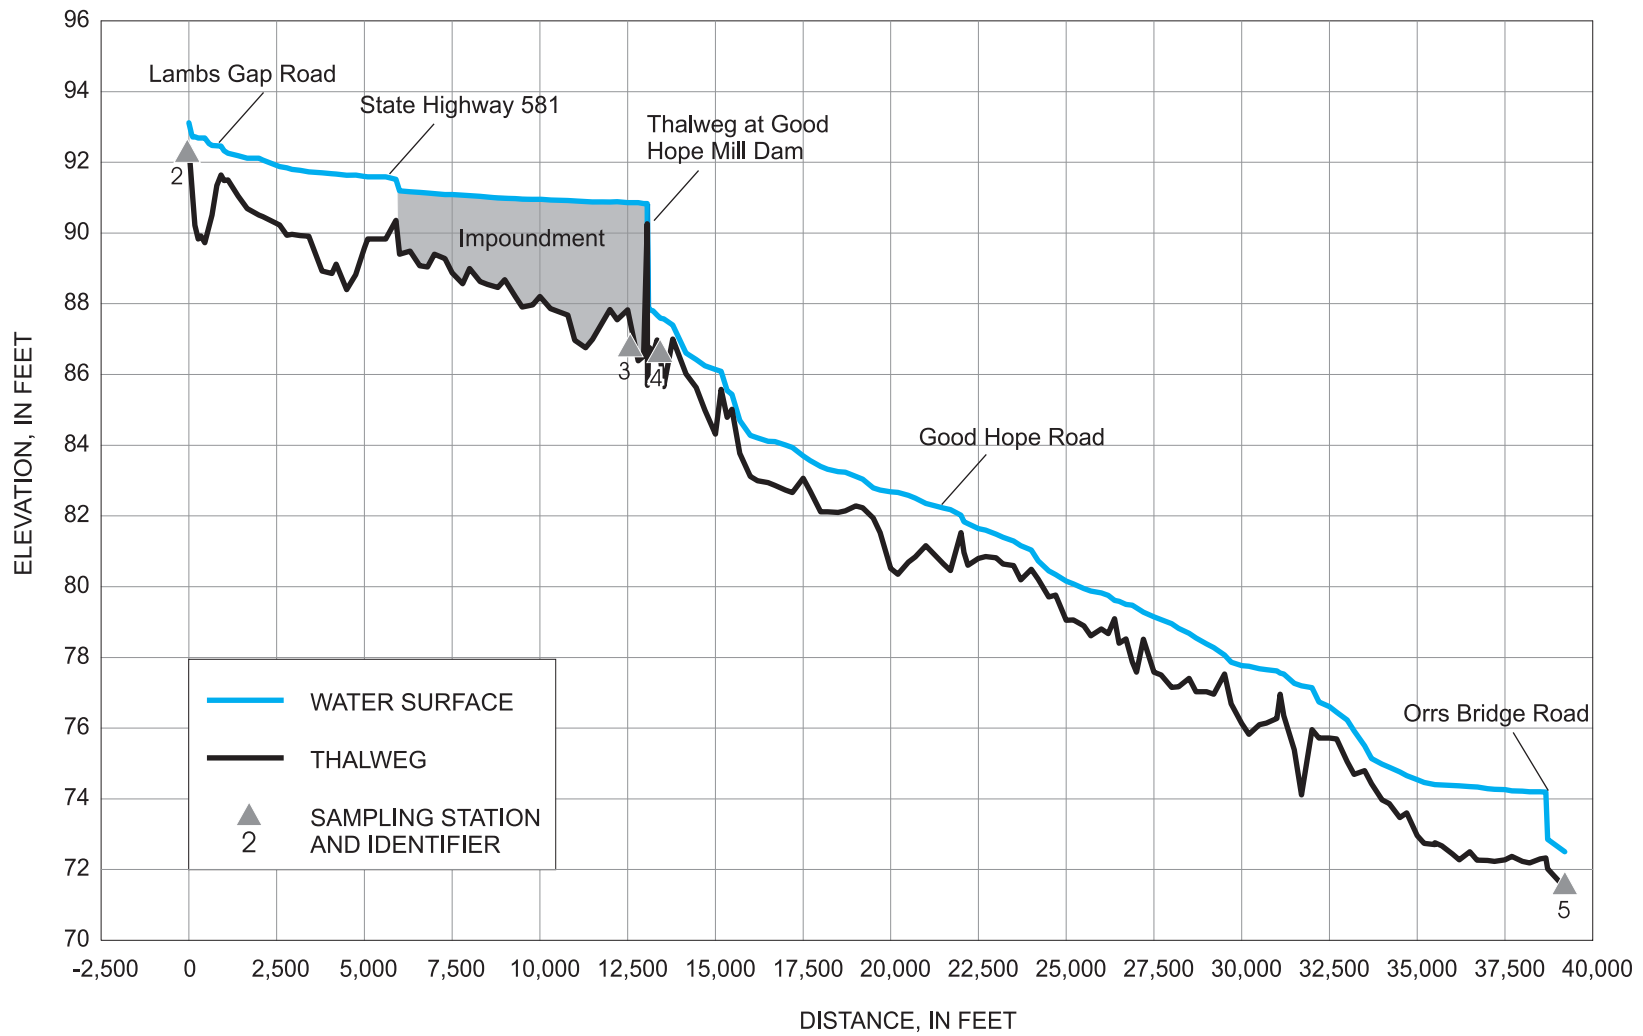
Figure 3. Longitudinal profile of the water surface and thalweg of Conodoguinet Creek as measured July–August 2001 before removal of Good Hope Mill Dam, Cumberland County, Pennsylvania.

Surveyed elevations of the thalweg through the impoundment (fig. 3) indicate Good Hope Mill Dam was not an effective barrier to sediment transport. Dams that are effective barriers cause aggradation of the impounded reach through entrapment of bedload and (or) deposition of suspended sediment resulting in a thalweg slope that approximates the water-surface slope of the impoundment. The slope of the thalweg within the impoundment of Good Hope Mill Dam is an order of magnitude greater than the water-surface slope (5.5×10^{-4} ft/ft compared to 5.1×10^{-5} ft/ft) and is similar to the slope of the entire surveyed reach (6.4×10^{-4} ft/ft) as illustrated in figure 3. These observations indicate the majority of bedload and suspended sediment carried by Conodoguinet Creek was transported over the dam.

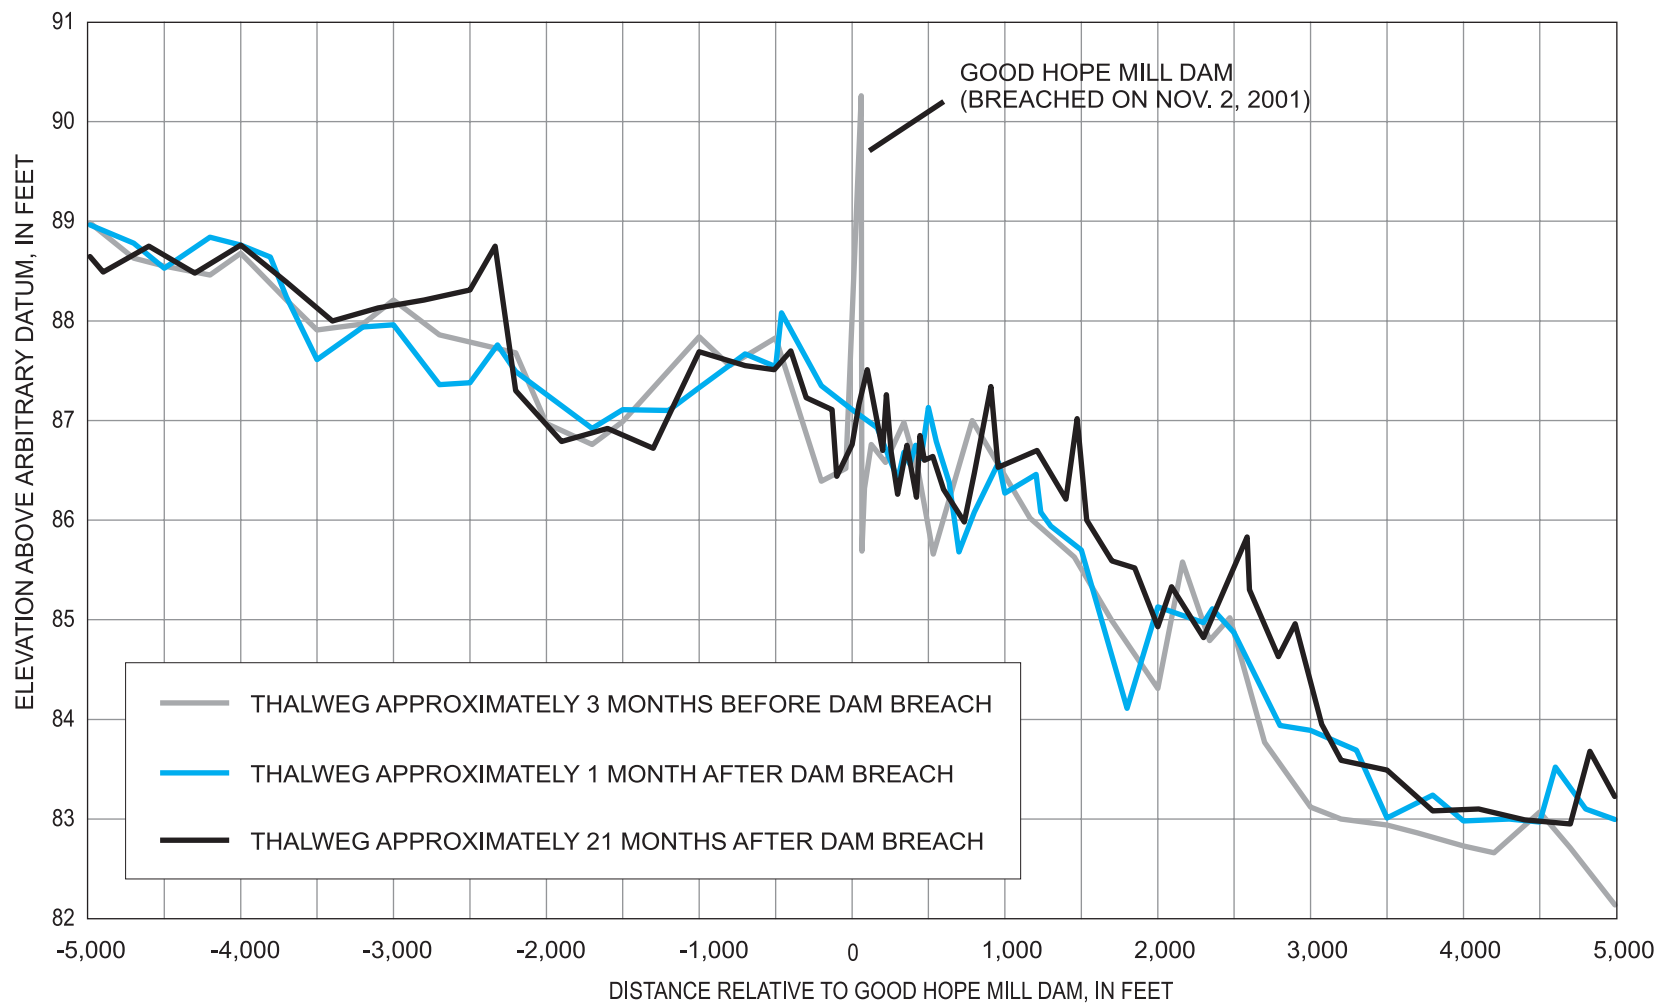
Figure 4. Longitudinal profile of the thalweg of Conodoguinet Creek in the vicinity of Good Hope Mill Dam, Cumberland County, Pennsylvania.

The thalweg within the impoundment and in the downstream reach was unchanged as a result of dam removal, other than demolition of the dam structure itself (fig. 4). Erosion-resistant bedrock throughout the impoundment was not subject to degradation during or after removal. Large-scale aggradation in the reach downstream of Good Hope Mill Dam, a commonly reported result of other dam removals (Bushaw-Newton and others, 2002), did not occur because little sediment was available for transport (fig. 4).

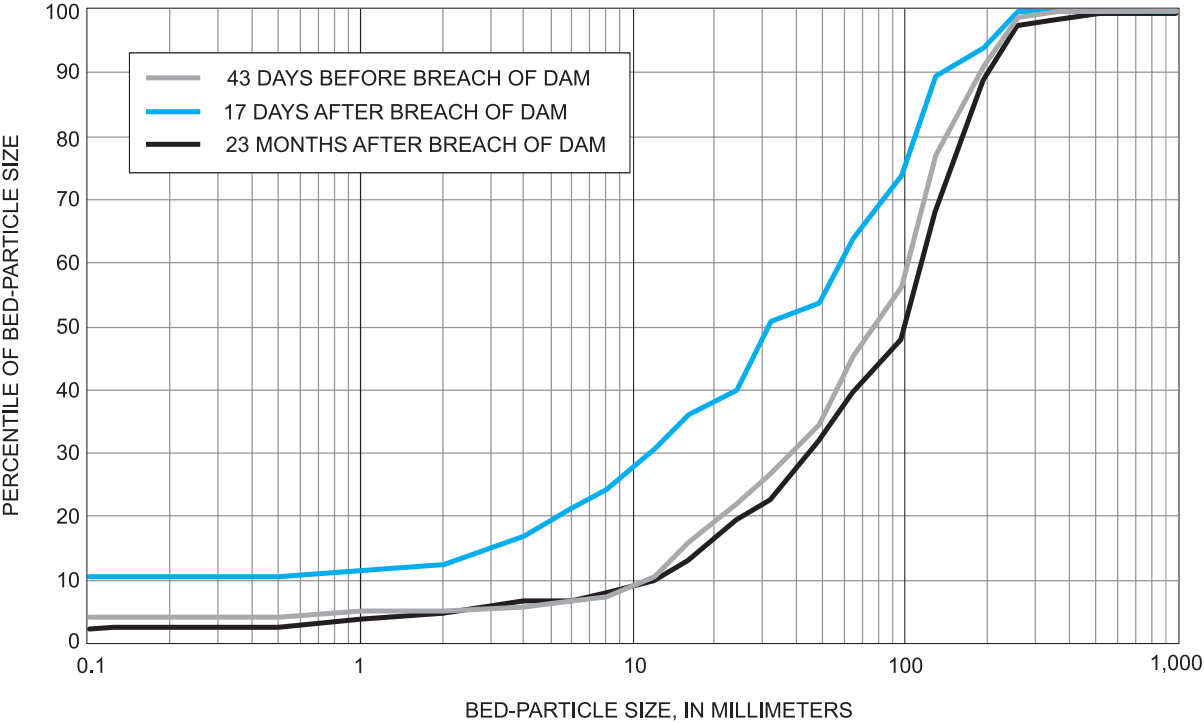
Figure 5. Bed-particle-size distribution in Conodoguinet Creek at station 4, 126 feet downstream of Good Hope Mill Dam, Cumberland County, Pennsylvania.

Pebble-count data collected after the dam removal indicate silt/clay bed particles were initially entrained and deposited on the substrate at station 4 (fig. 5; table 3), the first riffle downstream of the dam. The source of fine material was a combination of silt/clay that coated bedrock within the impoundment and sediment mobilized by heavy equipment operating between the dam and station 4. The range of flows between November 19, 2000, and October 3, 2003 (daily mean ranged from 38 to 5,810 ft³/s), transported the silt/clay at stations 3 (fig. 6) and 4 (fig. 5) downstream. As a result, the particle distribution at station 3 became coarser (median bed-particle size 17 days after removal was 2.9 mm, compared to 35 mm 23 months after removal; table 3), and the distribution at station 4 reverted to pre-removal conditions (fig. 5). Pebble-count data collected at station 5 indicate sediment mobilized from within the impoundment was most likely transported downstream of the study reach or deposited in a location that was not sampled. The distribution at station 5 was coarser 23 months after removal than before removal (table 3).

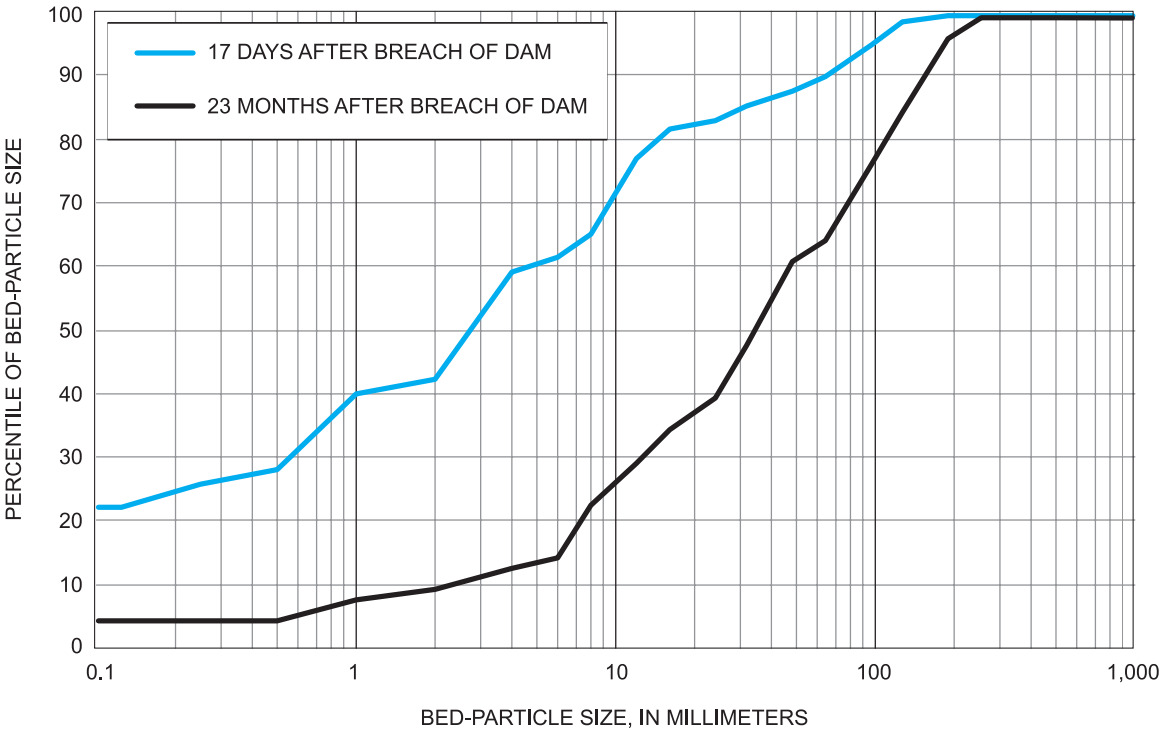
Figure 6. Bed-particle-size distribution in Conodoguinet Creek at station 3, 115 feet upstream of Good Hope Mill Dam, Cumberland County, Pennsylvania.

removal transported silt/clay from the impoundment (fig. 6), resulting in a 3.0-percent increase in cross-sectional area at station 3 and essentially no change at station 4. Cross-sectional area at control stations 2 (fig. 9) and 5 (fig. 10) changed less than 1 percent between the initial and final surveys (table 3).

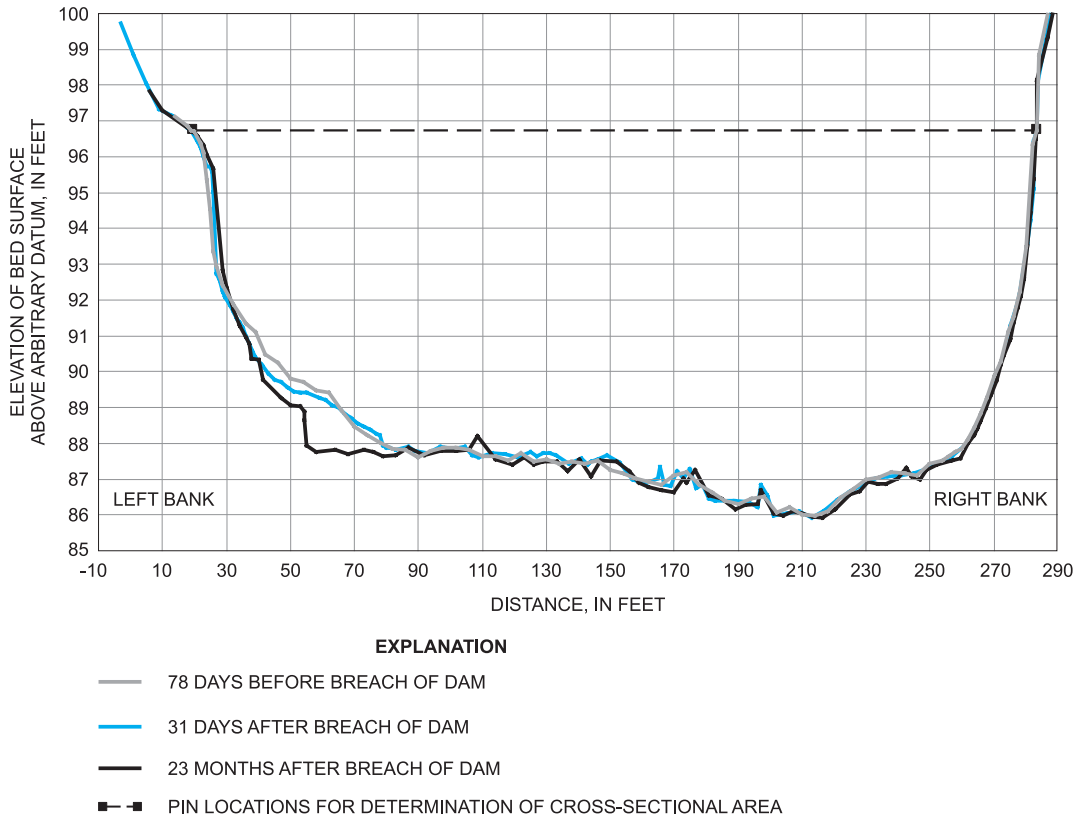
Figure 7. Cross-sectional channel surveys of Conodoguinet Creek at station 3, 115 feet upstream of Good Hope Mill Dam, Cumberland County, Pennsylvania.

Cross-sectional dimensions at stations 3 and 4 remained similar throughout the study (figs. 7 and 8). The difference in cross-sectional area before removal and 17 days after removal was only 0.9 percent at station 3 and -0.4 percent at station 4 (table 3). Streamflows occurring within 23 months of dam

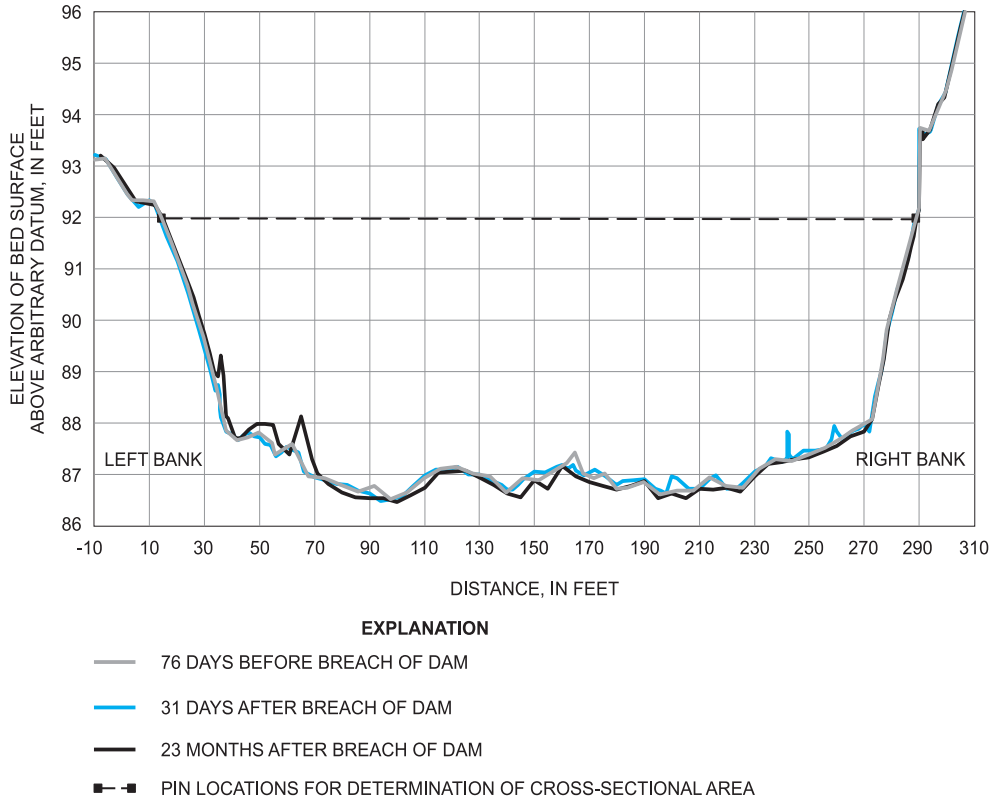
Figure 8. Cross-sectional channel surveys of Conodoguinet Creek at station 4, 126 feet downstream of Good Hope Mill Dam, Cumberland County, Pennsylvania.

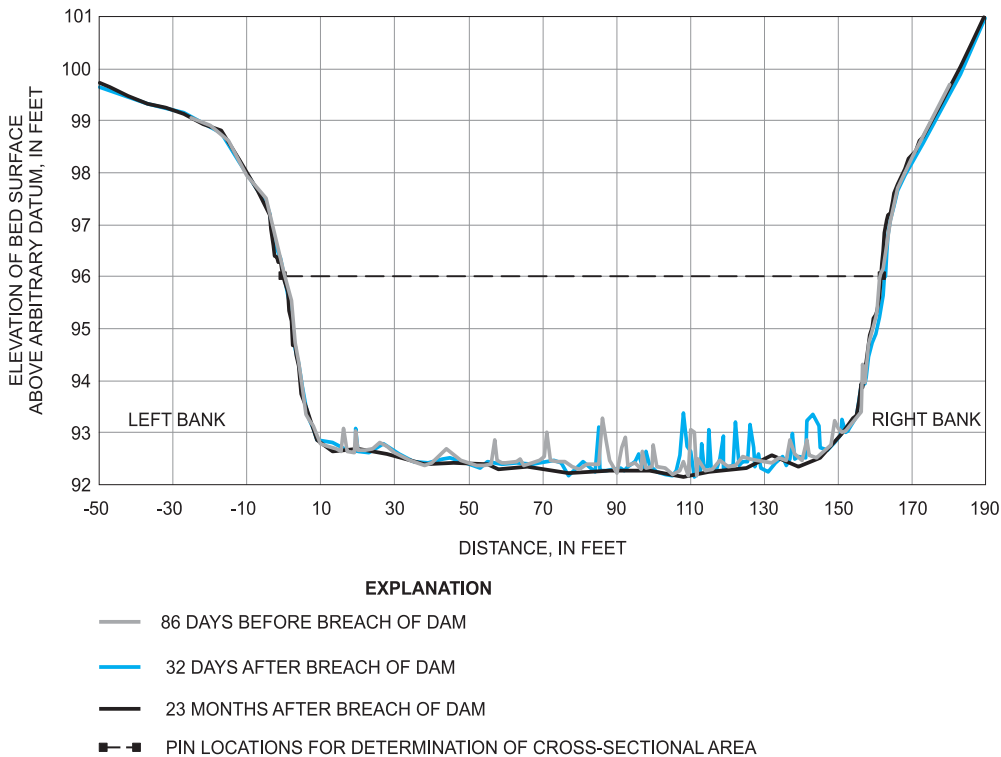
Figure 9. Cross-sectional channel surveys of Conodoguinet Creek at station 2, 2.5 miles upstream of Good Hope Mill Dam, Cumberland County, Pennsylvania.

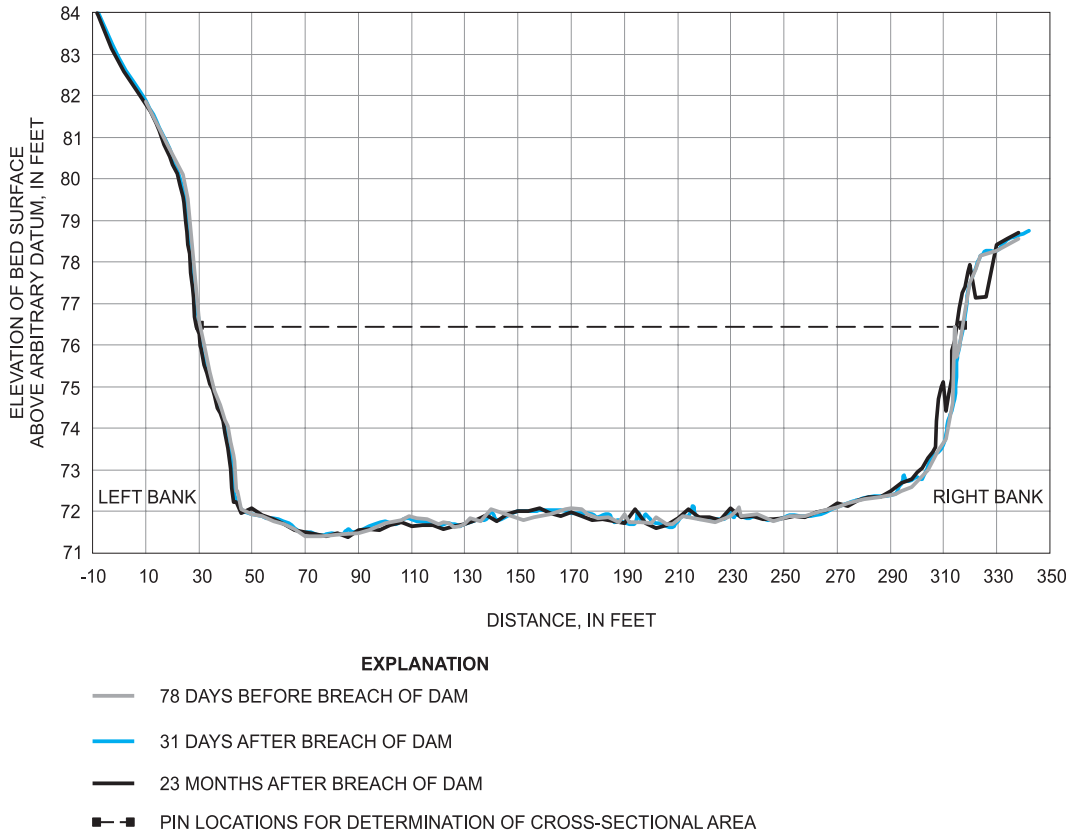
Figure 10. Cross-sectional channel surveys of Conodoguinet Creek at station 5, approximately 5 miles downstream of Good Hope Mill Dam, Cumberland County, Pennsylvania.

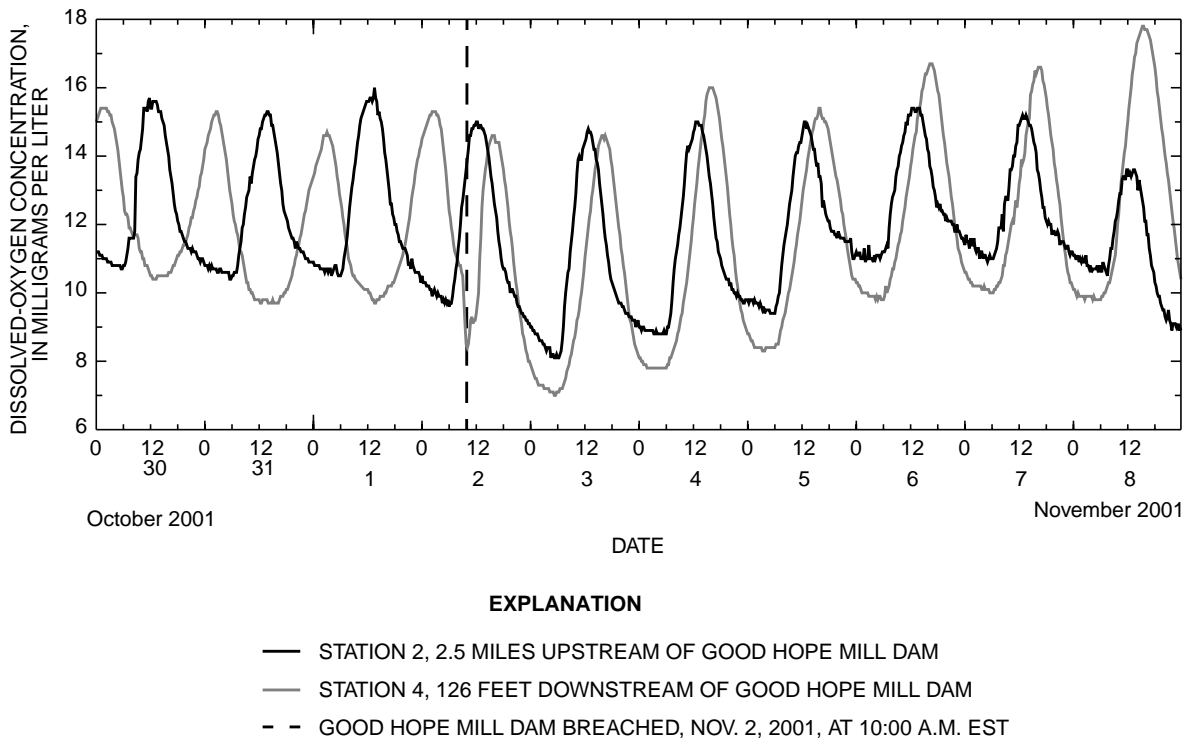
Figure 15. Dissolved-oxygen concentration in Conodoguinet Creek at station 2, 2.5 miles upstream of Good Hope Mill Dam, and station 3, 126 feet downstream of the dam, Cumberland County, Pennsylvania. (EST, Eastern Standard Time)
