New PLC for Turbines and Commission of PAT Refrigerator

K. C. Wu 12/23/03

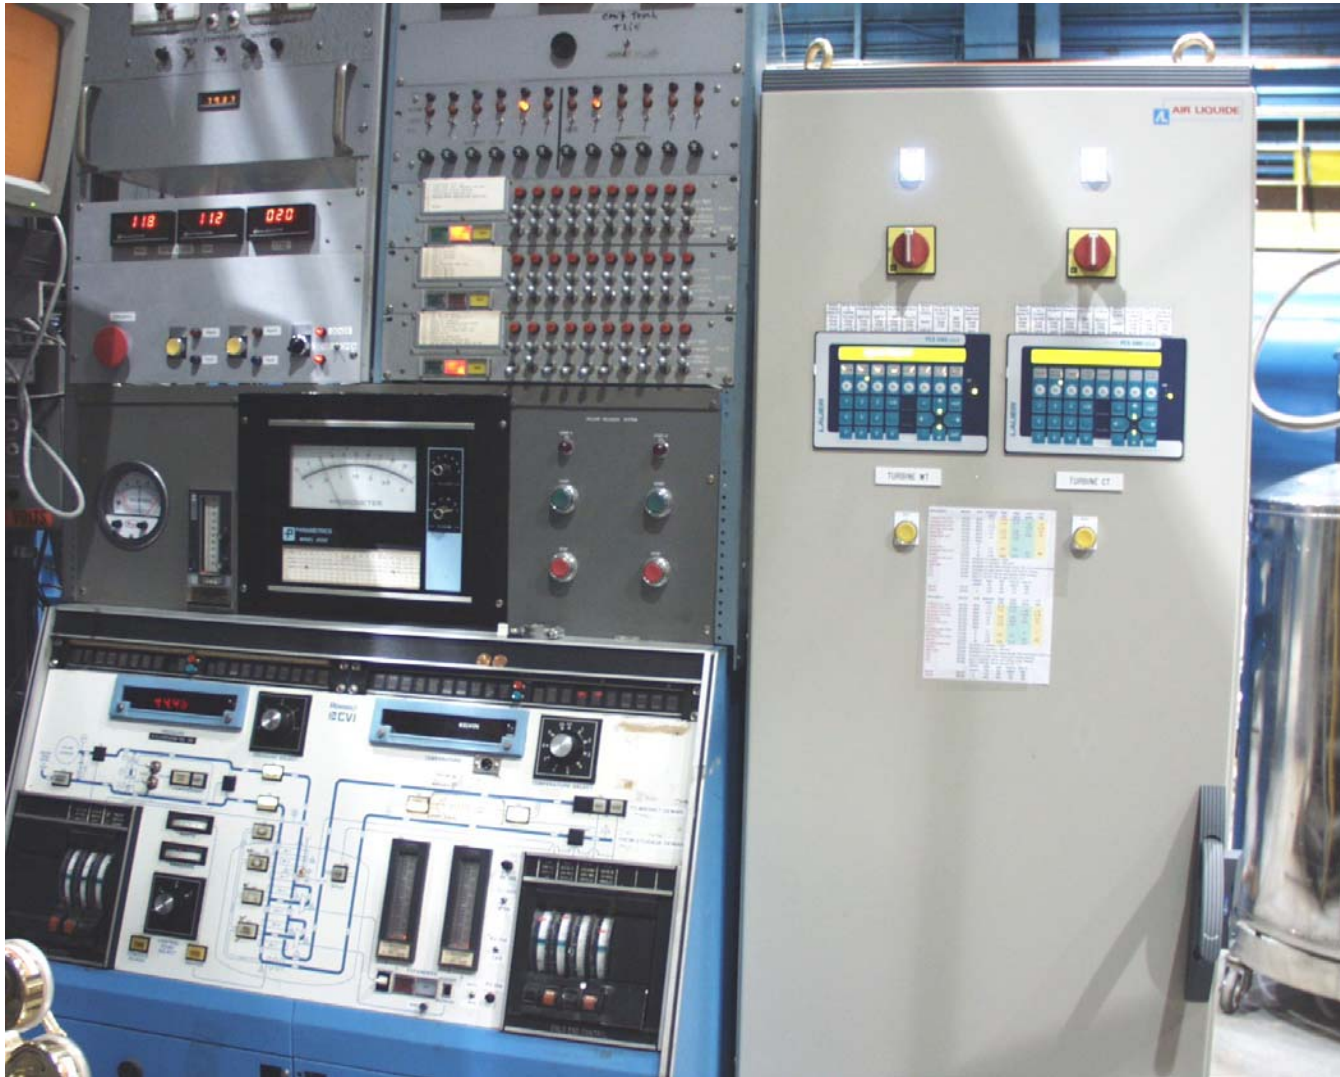
PLC controller and original control console of PAT refrigerator

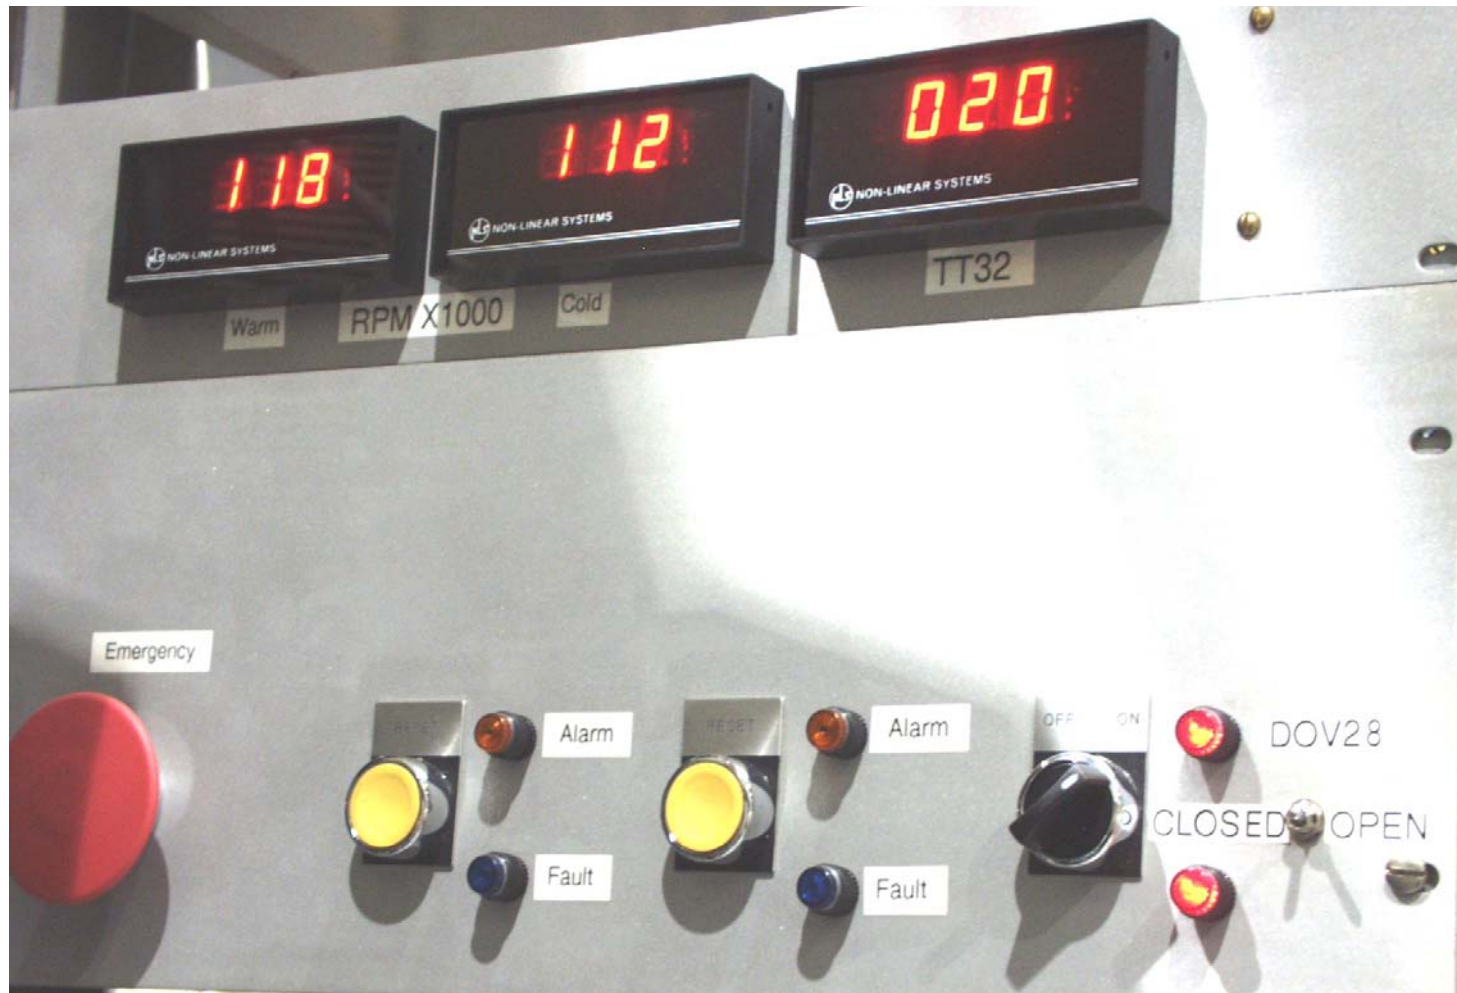
New Start/Stop control for the turbines

Right button for start and stop, Yellow buttons for reset, Crash button on the left. Upper displays are for speed and temperature.

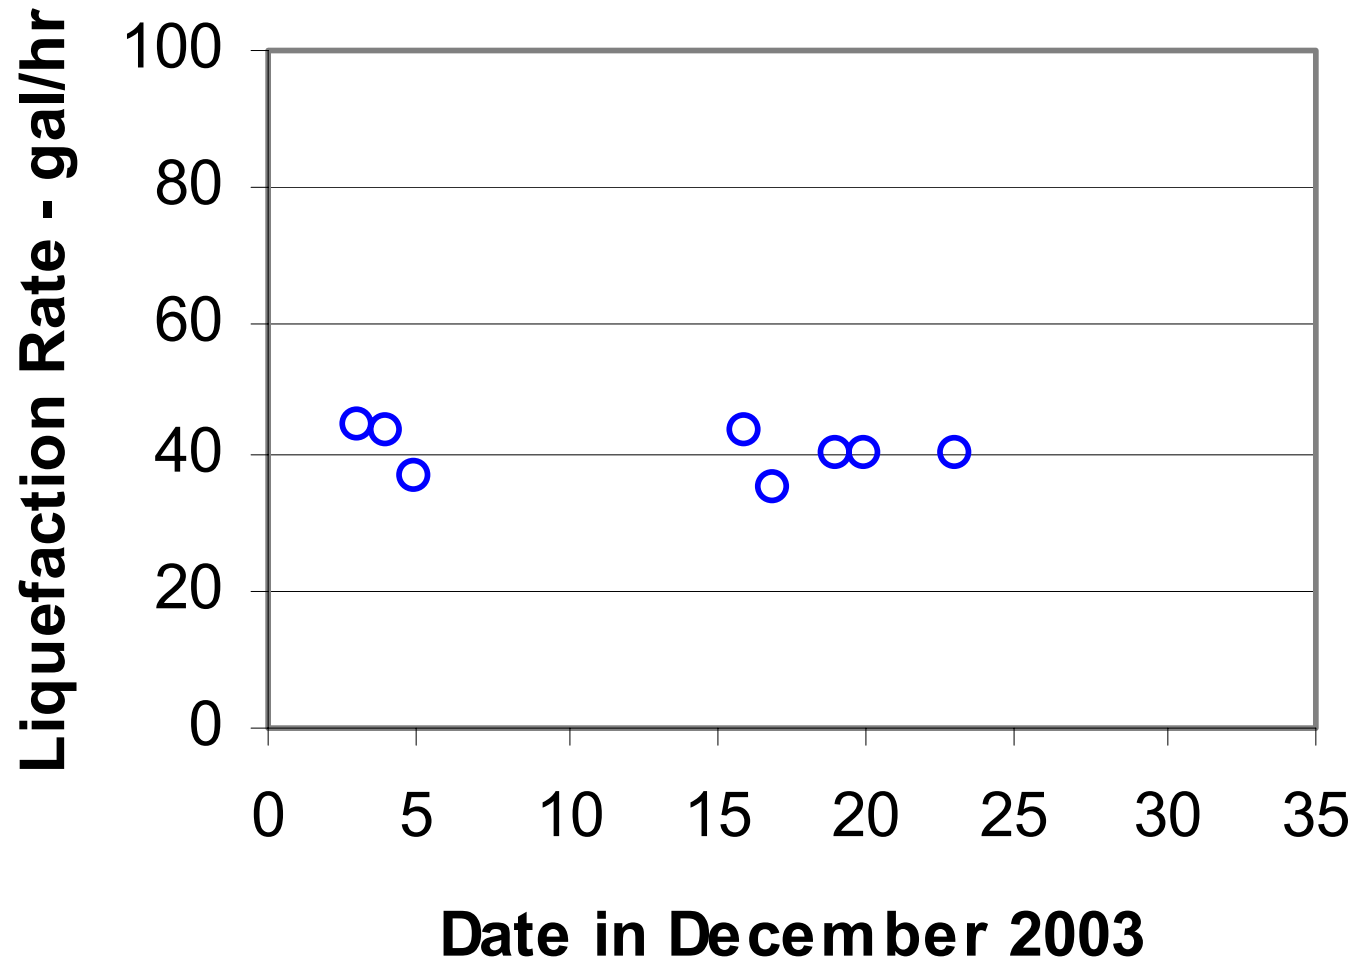
Overnight liquefaction rate of PAT

- Very stable
- No abnormally high temperature on brake housing
- No ice on bearing gas outlet
- No need to disable any interlock
- No leak of helium from bearing gas system to ambient
- No unreliable solenoid for Start/Stop control
- All parameters within Air Liquide specification
- Liquefy ~ 40 gallon per hour overnight

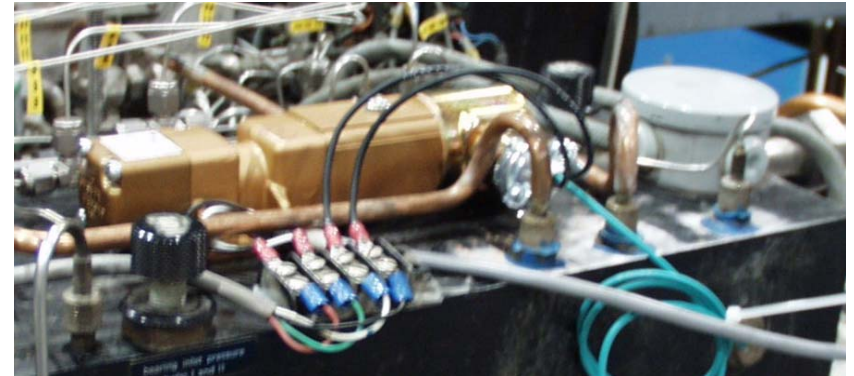
Manifold on PAT Turbine Pod with new Start/Stop control solenoid and blue epoxy sealed joints to prevent helium leakage

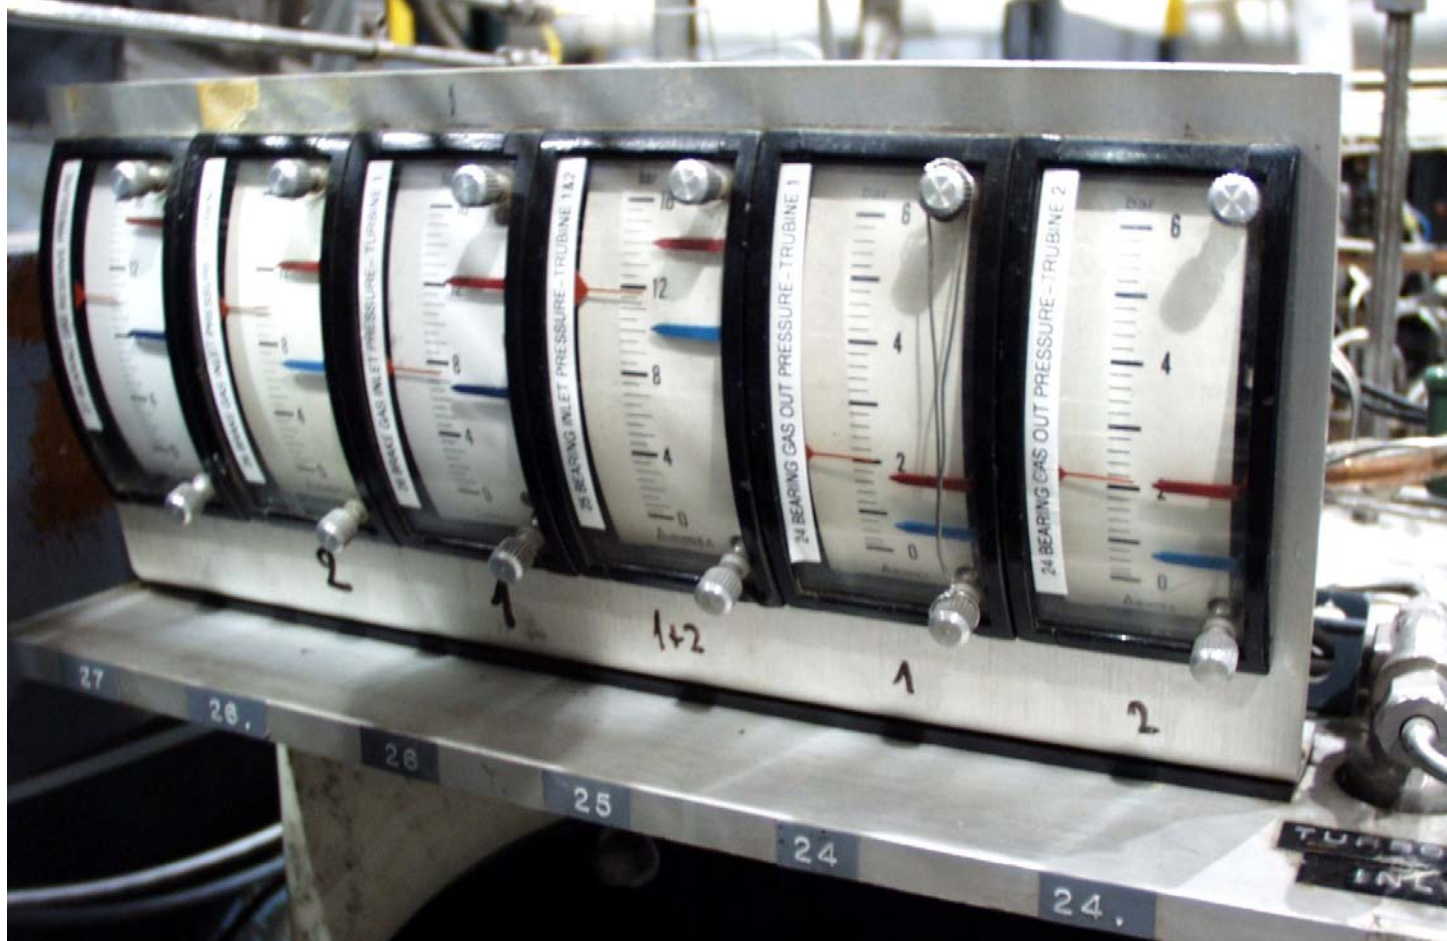
Left side old controller for PAT turbine

Pressures for bearing inlet and brake are within old ranges

Pressures for bearing outlet are set slightly above old values

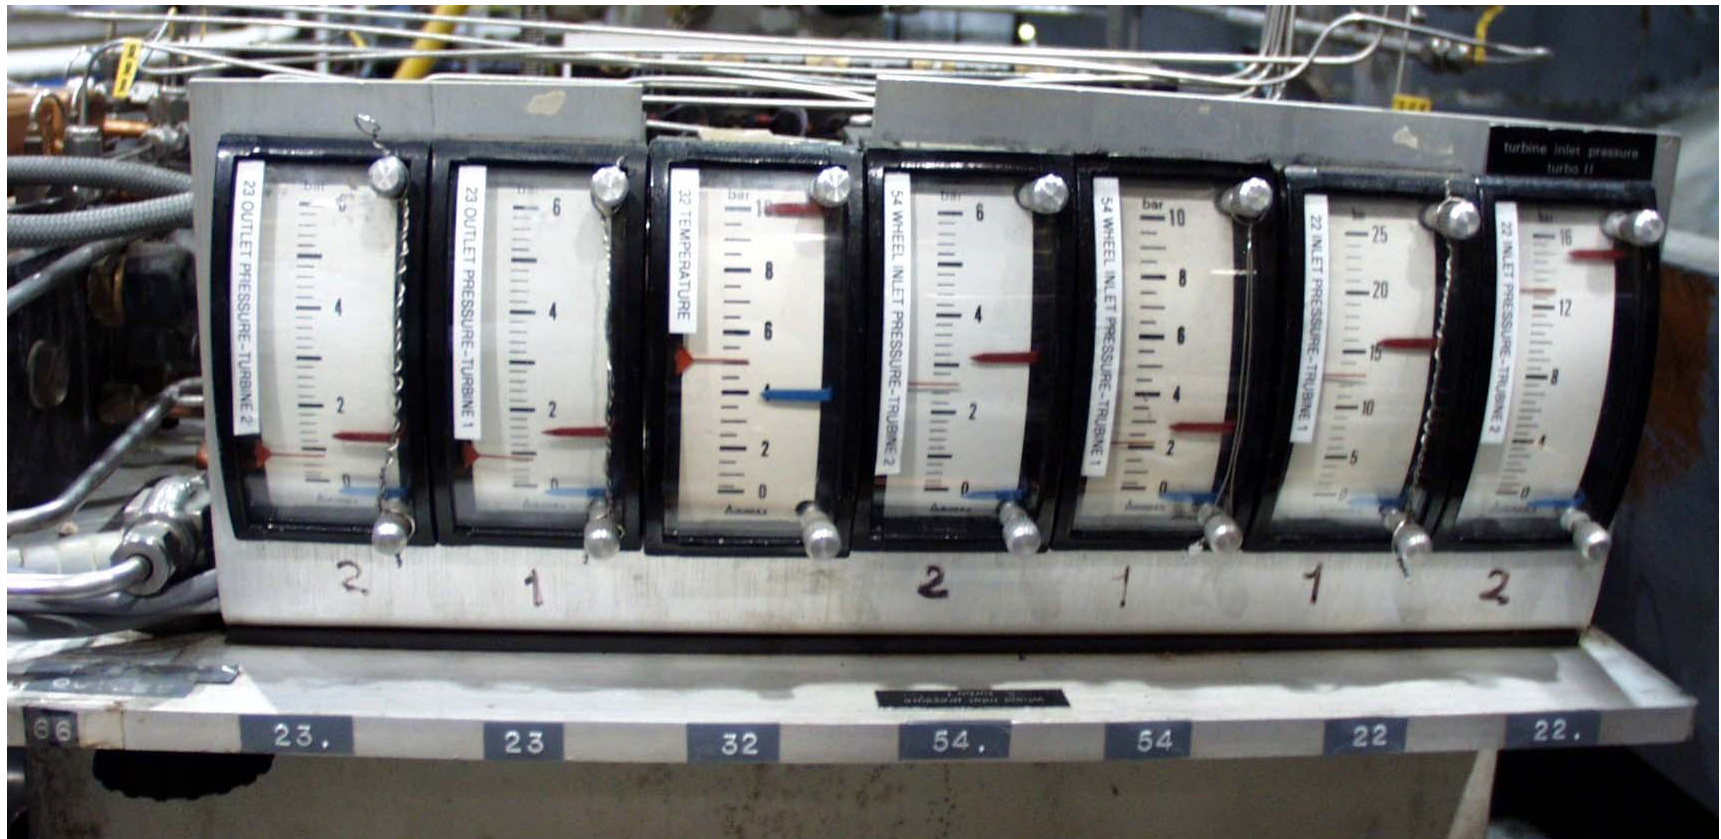
Right side old controller for PAT turbine

All pressures for turbine inlet, outlet, wheel are within old ranges
Pressures for temperature is also within old range

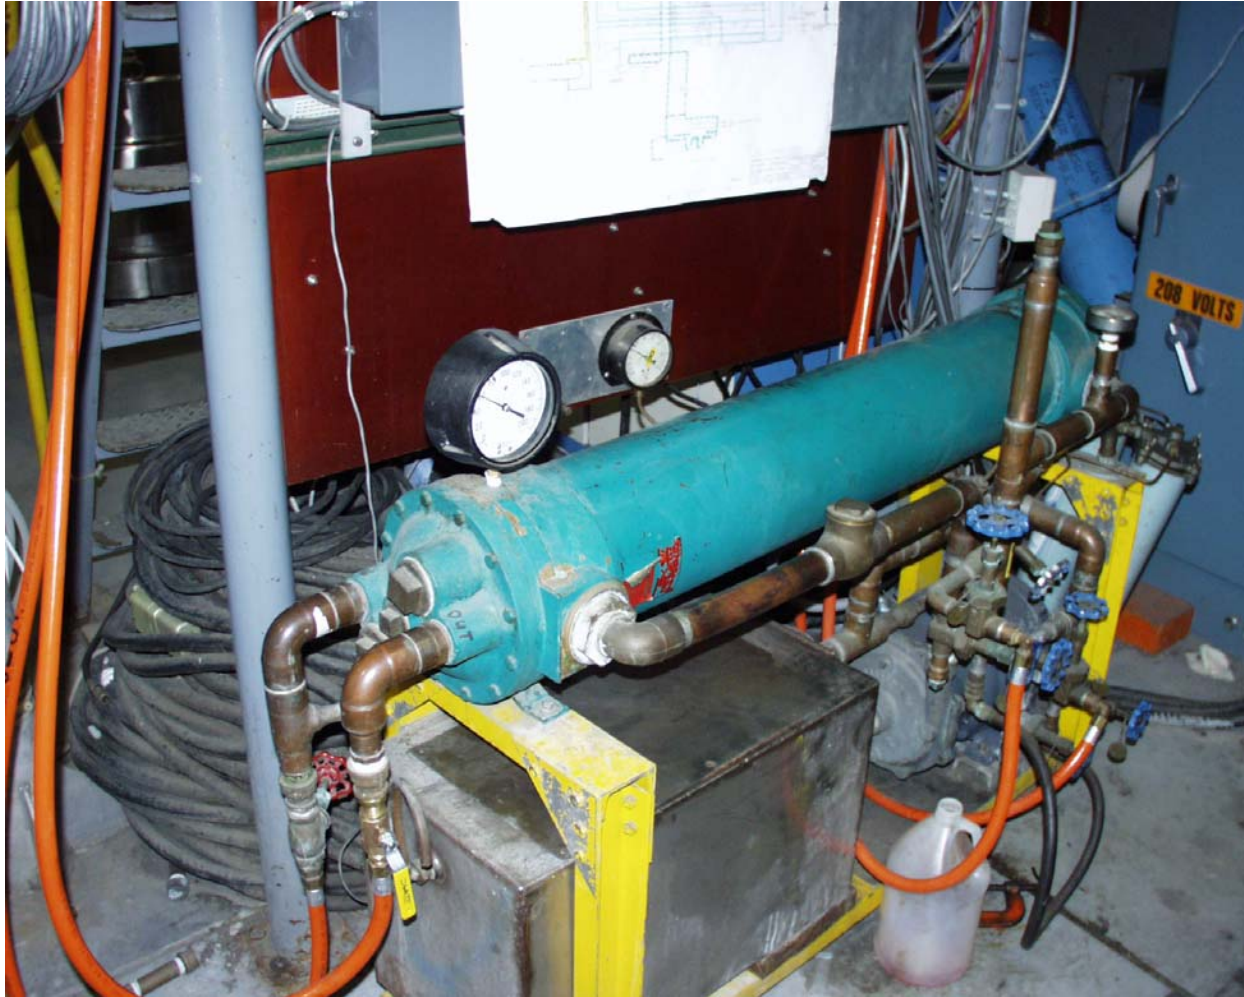
Water cooler has been cleaned to keep
brake housing cool

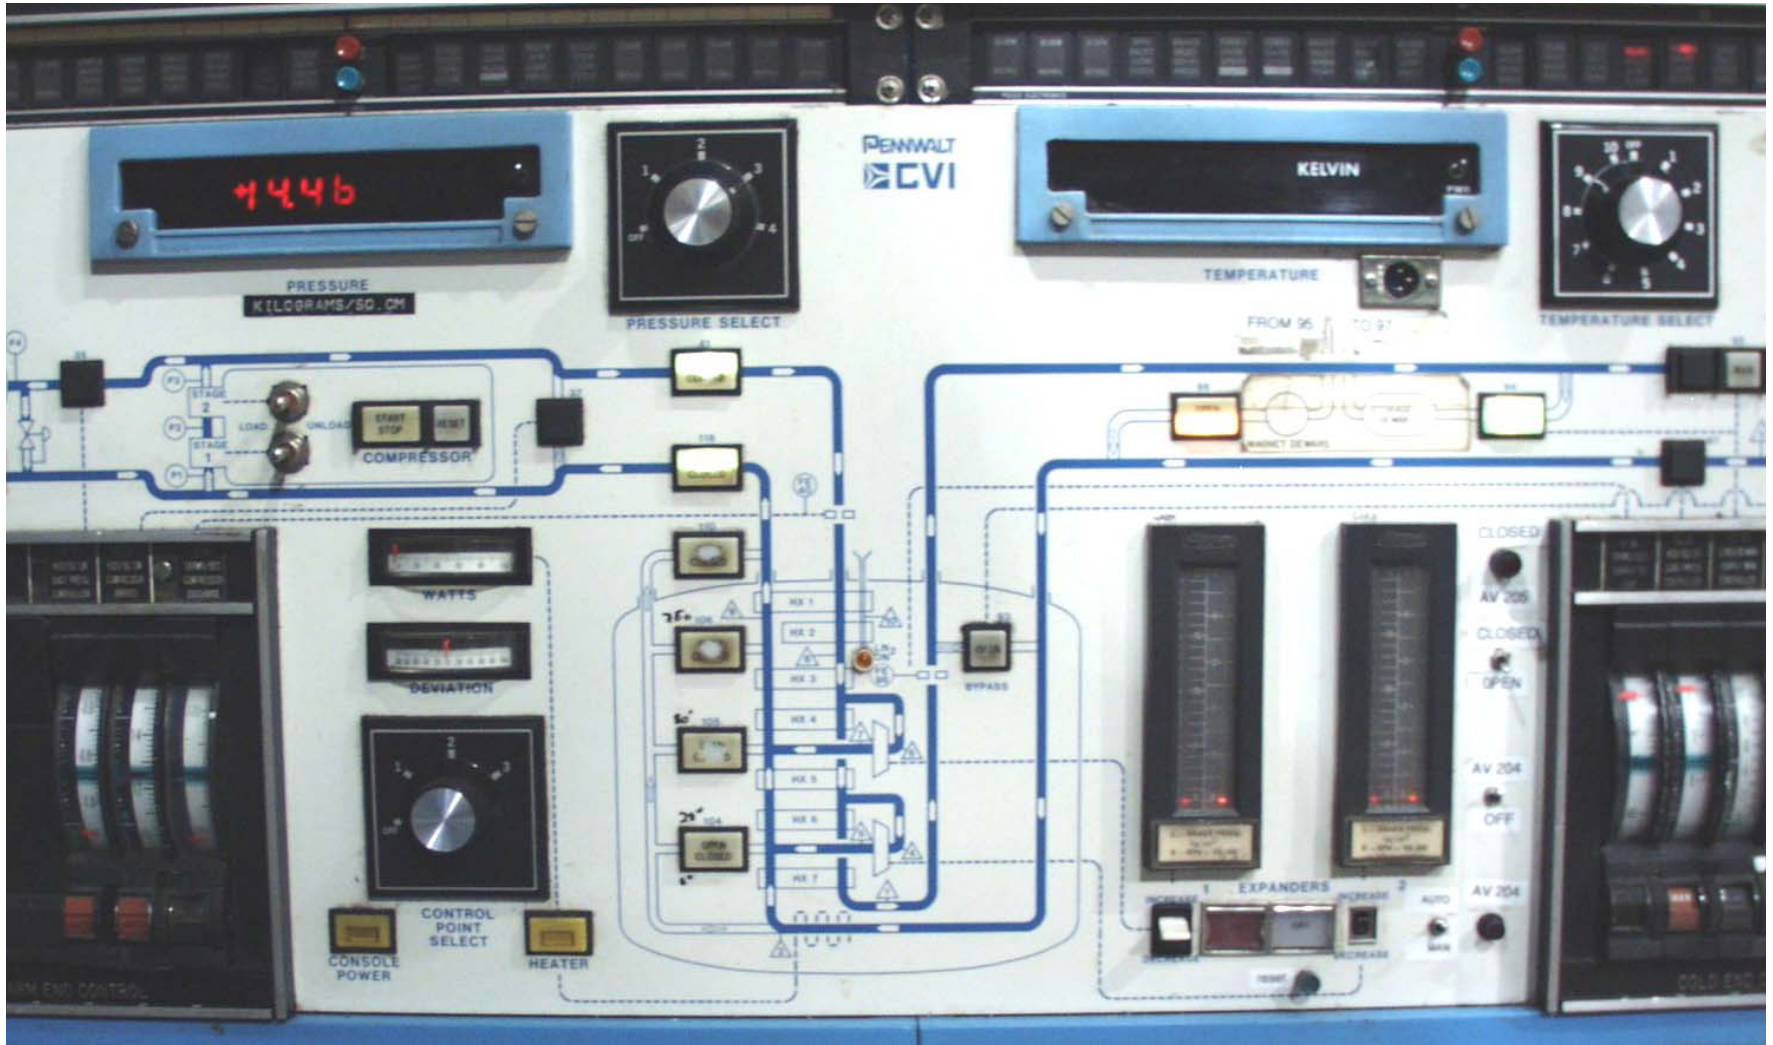
By-pass control on PAT console
