Watershed Partnership Protects World-Class Trout Stream

EPA Region 3
Philadelphia, PA 19103
EPA/903/F-02/007
November 2002

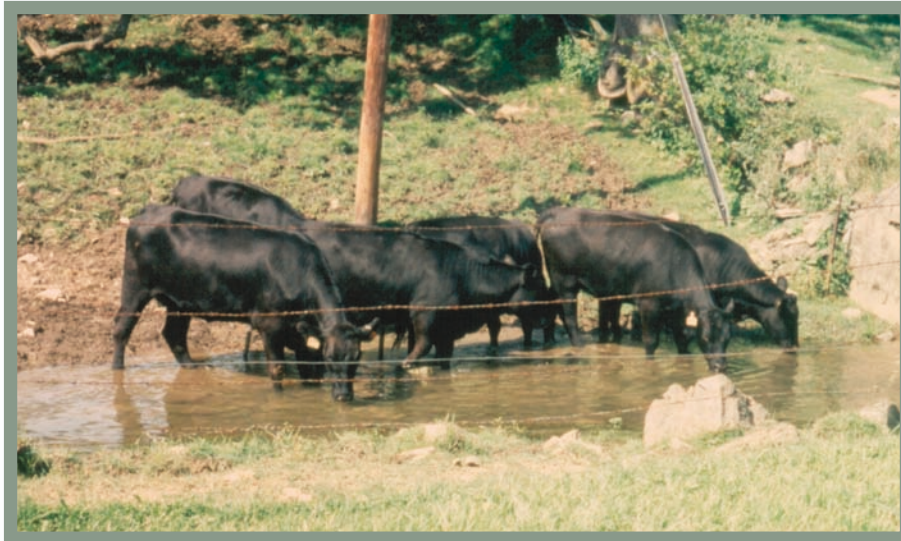
Figure 1. An unfenced pasture along Slab Cabin Run allowed cattle unlimited access to the stream, producing erosion and pollution problems.

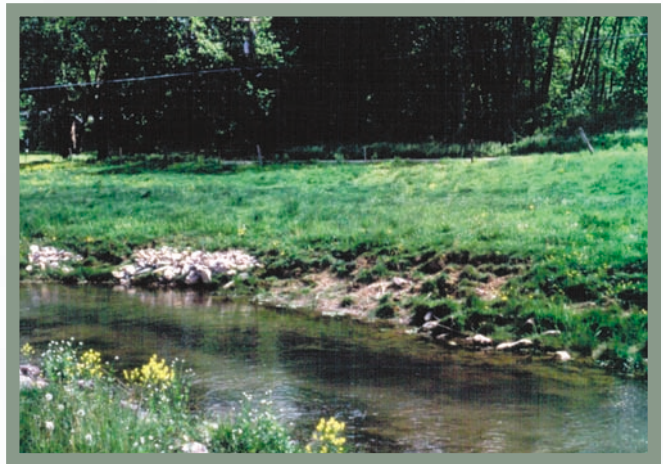
Figure 2. Some landowners put stones that they found on their fields on sections of the streambanks that were becoming eroded.

The majority of the landowners felt that something upstream was responsible for the sediment. The few landowners who did recognize that their cattle contributed to the problem of eroding streambanks placed rocks along the banks (Figure 2). The newly added rock reduced erosion where it was placed, but caused livestock to enter the stream in adjacent areas and the new access points began to erode.

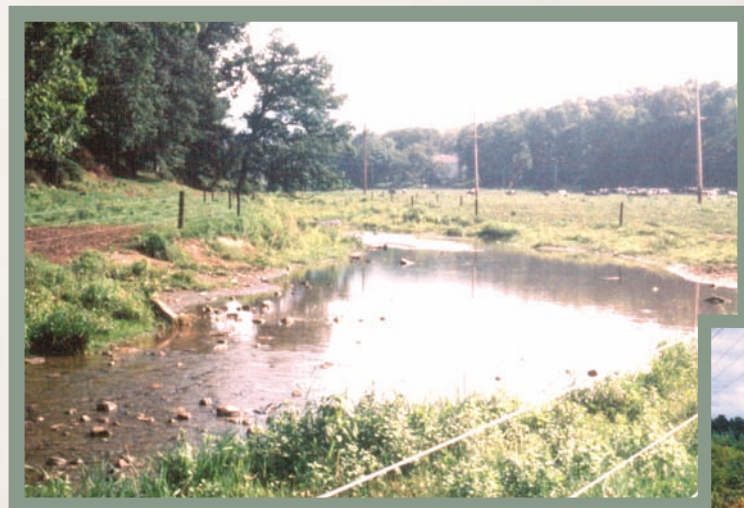
Figure 3. High tensile fencing was installed 3 m on either side of the stream to prevent livestock from trampling down the stream banks and to allow for natural revegetation along the stream.

- By making the riparian areas narrow (only 10 ft (3 m) on either side of the stream), **farmers were required to give up very little pasture.**
- By not requiring planting along the stream, the **cost of maintenance** to the fence (due to branches falling on it, etc.) was **reduced.**

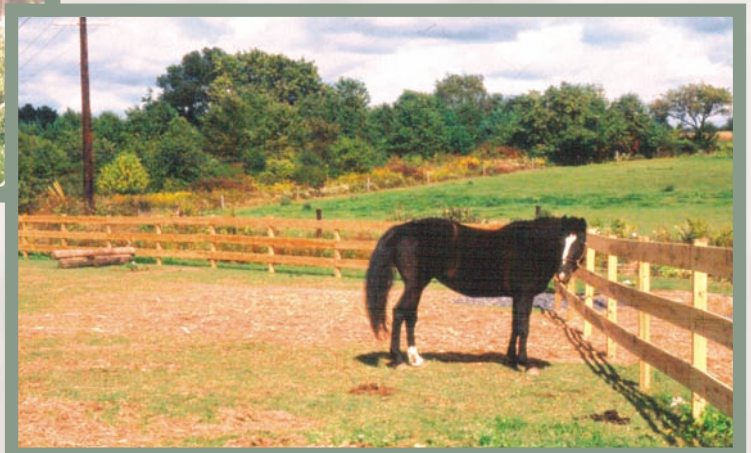
Figure 4. Different fencing was used on horse farms, because horses can injure themselves on wire fencing.

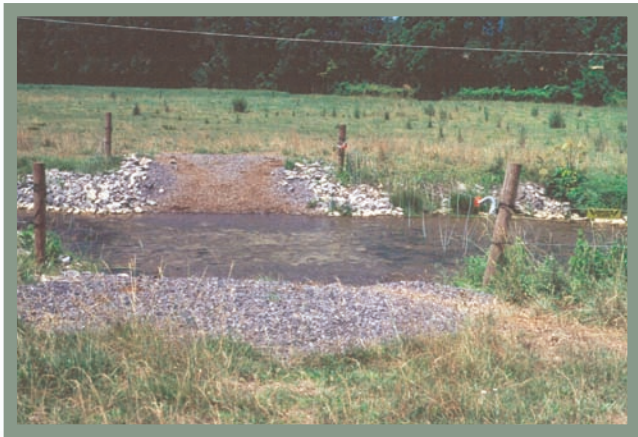
Figure 5. Crossings were installed to allow livestock limited access to the stream.

Construction of streamside fences, installation of rock-lined animal crossings (Figure 5), and stabilization of banks were largely done by private contractors. The U.S. Fish and Wildlife Service (USFWS) installed fencing and stream-access on two projects. The Pennsylvania Fish and Boat Commission and Penn State University also provided heavy equipment for several projects.

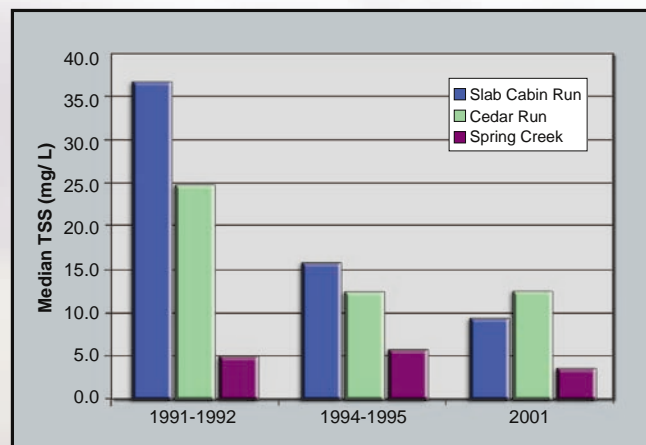
Figure 6. Median range of Total Suspended Solids (TSS) data from 1991-92 (pre-fencing), 1994-95 (partially fenced on Cedar Run; fenced on Slab Cabin Run) and 2001 (post-fencing).

Preliminary results of streambank restorations were published in 1998. It was found that between 1991 and 1998 sediment in Slab Cabin Run decreased by 56.5% and sediment in Cedar Run decreased by 49.6%. Fine substrates were also found to have declined between 1992 and 1997. These preliminary results also suggest that there has been a slight, but statistically significant, decrease in the nitrate concentration in Cedar Run.
