**2005 Operations, Maintenance,
and Monitoring Report**

Sabine Refuge Marsh Creation

State Project Number CS-28
Priority Project List 8

June 2005
Cameron Parish

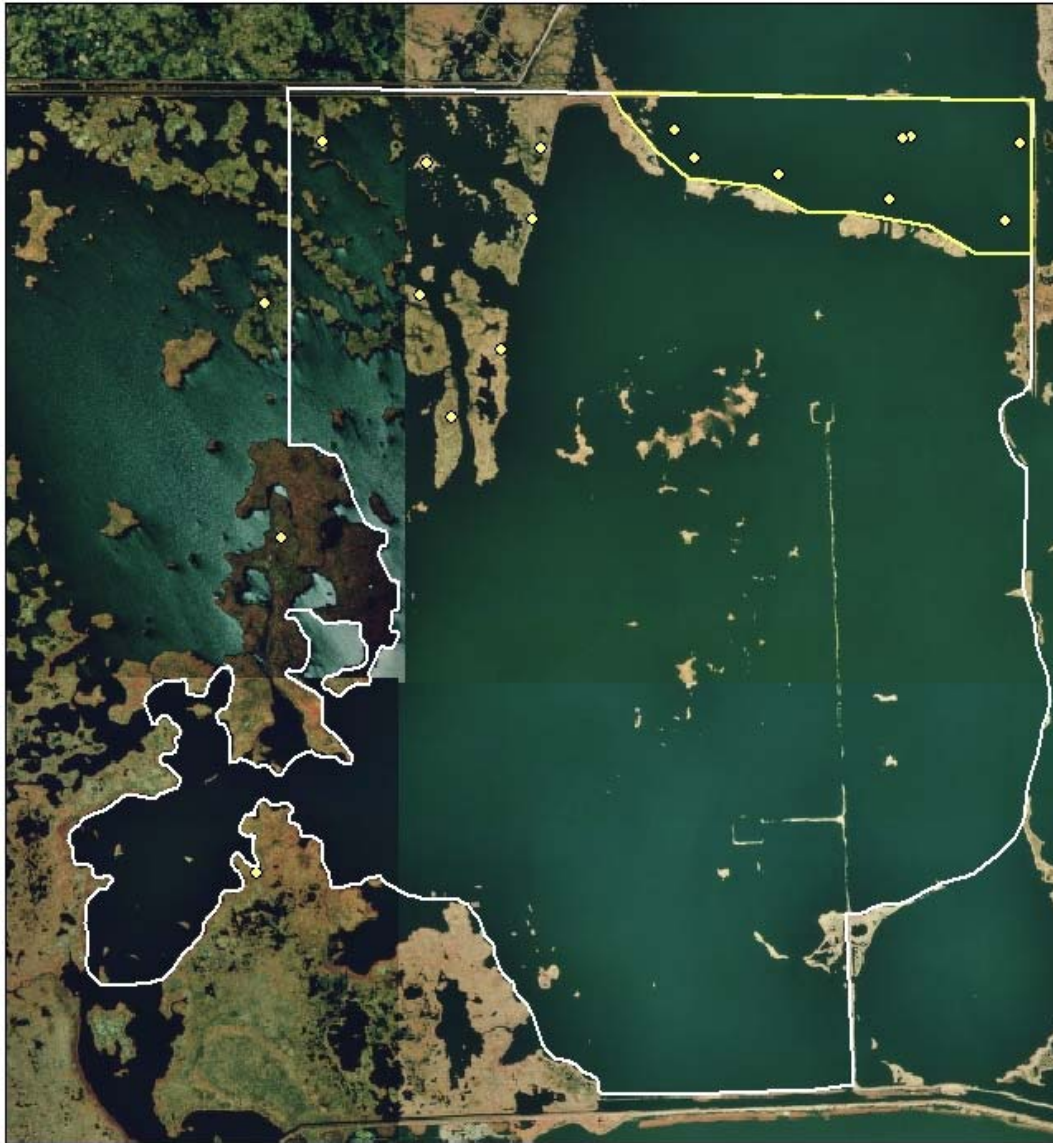
Figure 3. CS-28 project area and vegetation station locations.

To document changes in emergent vegetation due to the project, vegetation was monitored pre-construction in 2001 and post-construction in 2002 and 2004. Ten stations were established in the project area and vicinity in pre-existing marshes (figure 3). Eight stations were also established in the first cycle dredge deposition area after construction, but before vegetation was planted along the edges. Two 2-m² plots were sampled at each of the stations. Percent cover, height of dominant species, and species richness were quantified. Vegetation will be sampled in

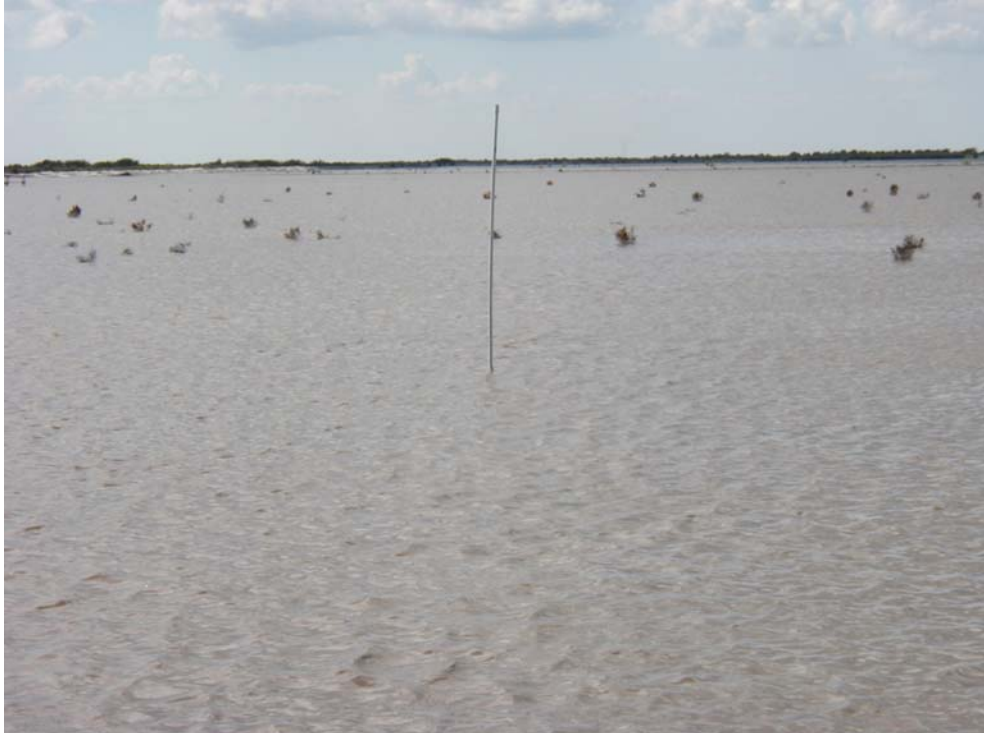
Figure 5. Photograph of vegetation station (CS28-205) in the Cycle 1 deposition area at time of establishment (September 2002). The plants in the background are *Salicornia bigelovii*.

Vegetation stations were established in the dredge cell constructed in 2002 (Cell 1) after construction. At the time of station establishment, the area was still an un-vegetated mudflat (figure 5). The Cell 1 stations were revisited in 2004 and at that time, two species were abundant in the dredge construction area, *Schoenoplectus robustus* and *Spartina alterniflora* (table 1, figure 6). *Spartina alterniflora* had been planted along the edges post-construction in 2002. Total cover had increased from 0 to 52% in the constructed marsh (figure 7). Comparisons to the vegetative assemblages in the adjacent marsh revealed that cover in the constructed marsh was approaching levels found in the natural marsh (figure 7). Height of dominant vegetation in the constructed marsh (*Spartina alterniflora*) was almost twice that of dominant vegetation in the natural marsh (*Distichlis spicata* and *Spartina patens*) (figure 8). Species richness in the constructed marsh was lower than that of the natural marsh but had increased to a maximum of two species in any single plot compared to a maximum of six species in any single natural marsh plot. Mean values for species richness are shown in figure 9.

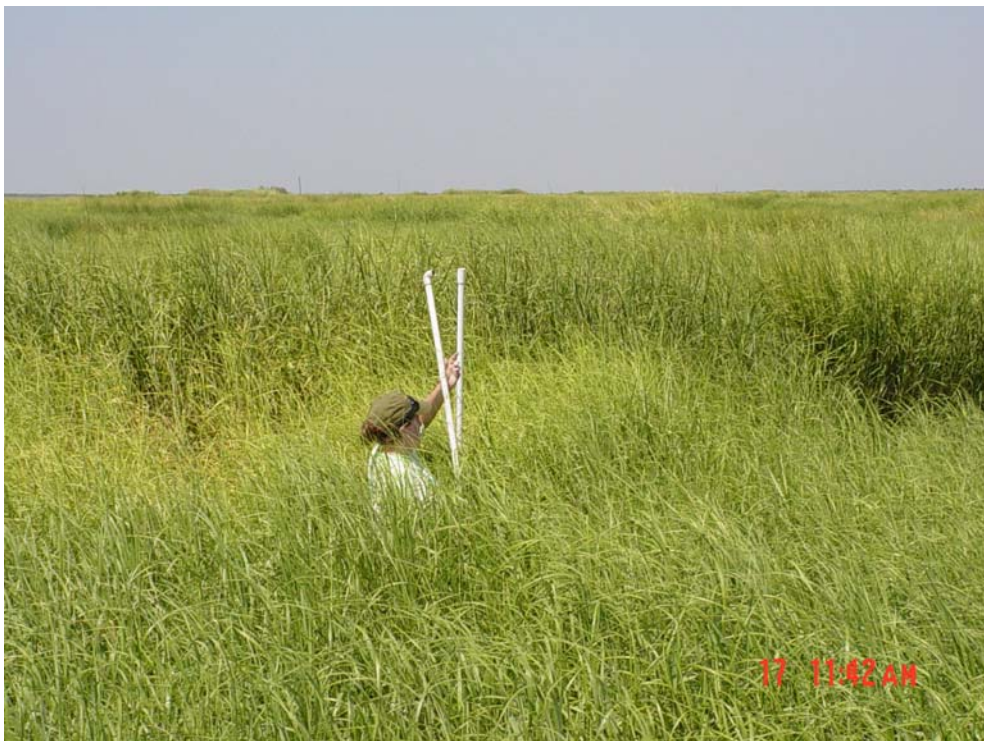
Figure 6. Photograph of vegetation station (CS28-205) in the Cycle 1 deposition area two years after construction (August 2004).

Cell 1 was over 50% vegetated two years after construction and the growth was vigorous. The succession of species on the constructed marsh will be tracked over time. The adjacent marsh does not appear to have been nourished after construction by the suspended dredge sediments, when the southern levee was purposely degraded post-construction (delta formation); the pre-construction cover, height, and richness (2001) were virtually the same as the post-construction values (2002). Cover, height, and richness actually decreased in the adjacent marsh from 2002 to 2004.

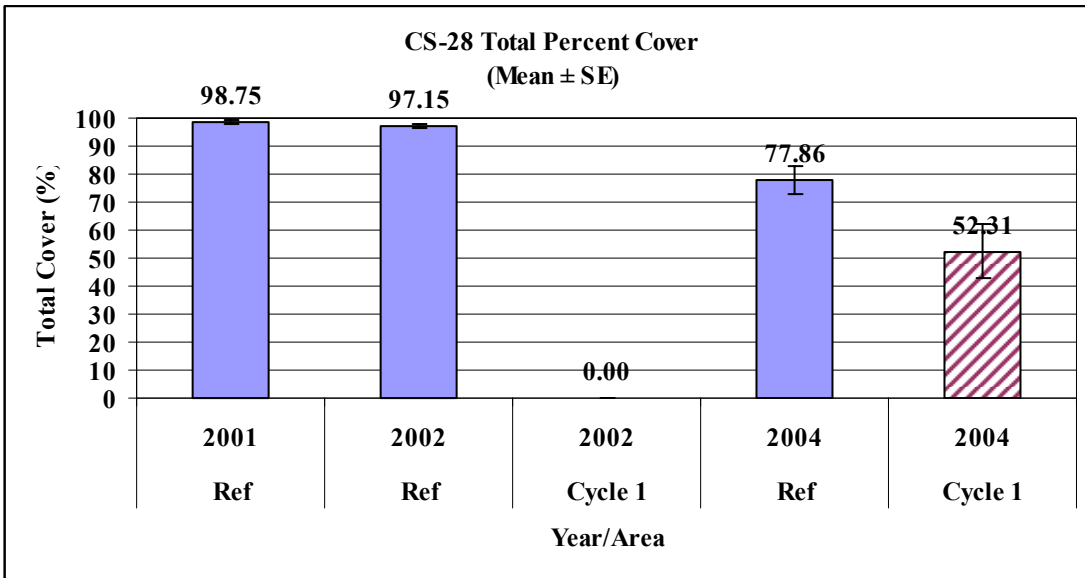
Figure 7. Total % cover of emergent vegetation at sites in pre-existing marsh adjacent to and within the CS-28 Cycle 1 dredge deposition area.

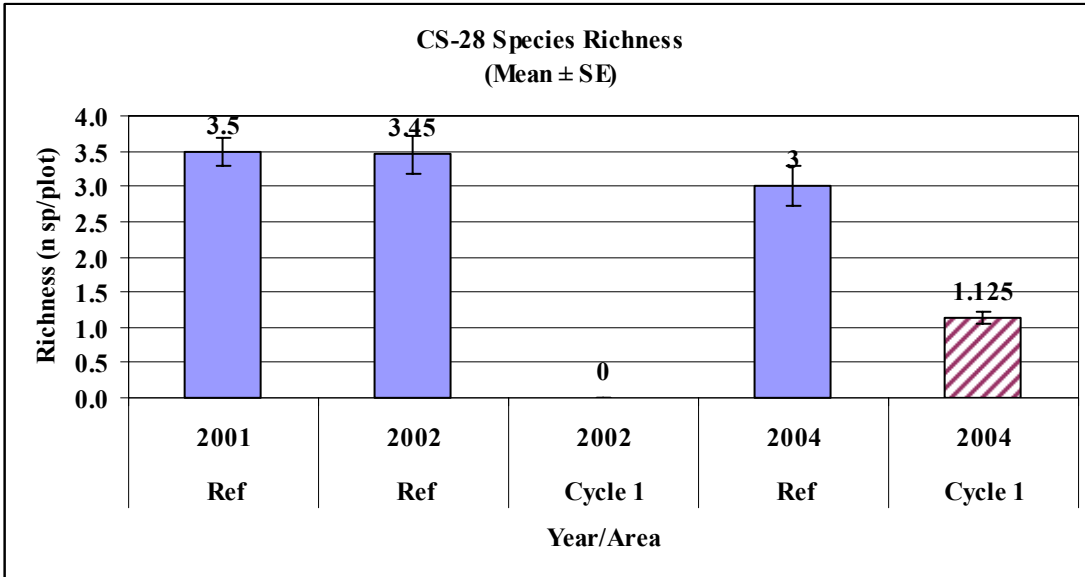
Figure 9. Mean species richness (± 1 standard error) at sites in pre-existing marsh adjacent to and within the CS-28 Cycle 1 dredge deposition area.
