NASA/CR-95- 207617

INTERIM REPORT ON CHEMICAL AND THERMAL ANALYSIS

Prepared for: CAPP International Consortium

Document Number: CAPP/T.3

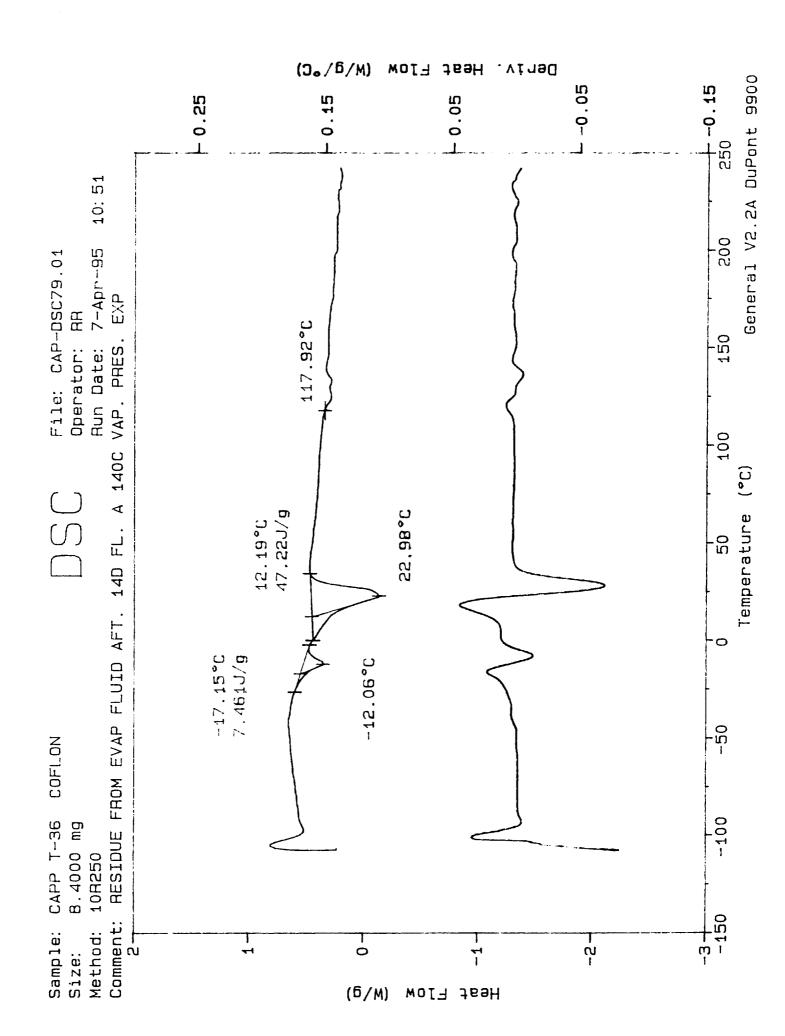
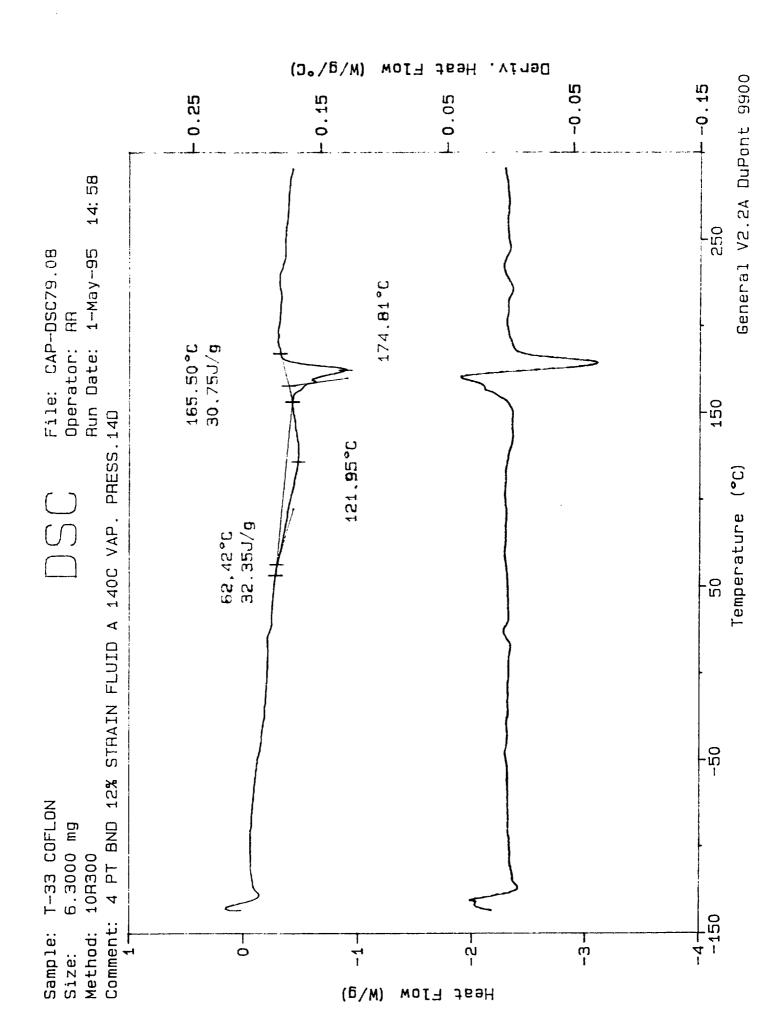
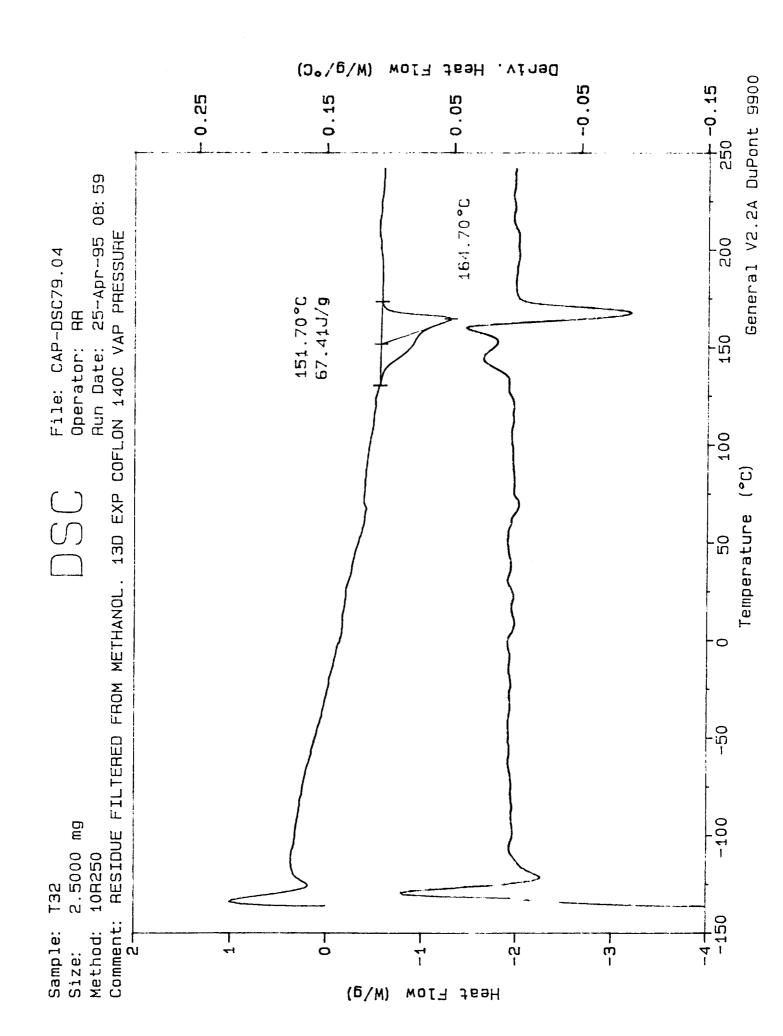
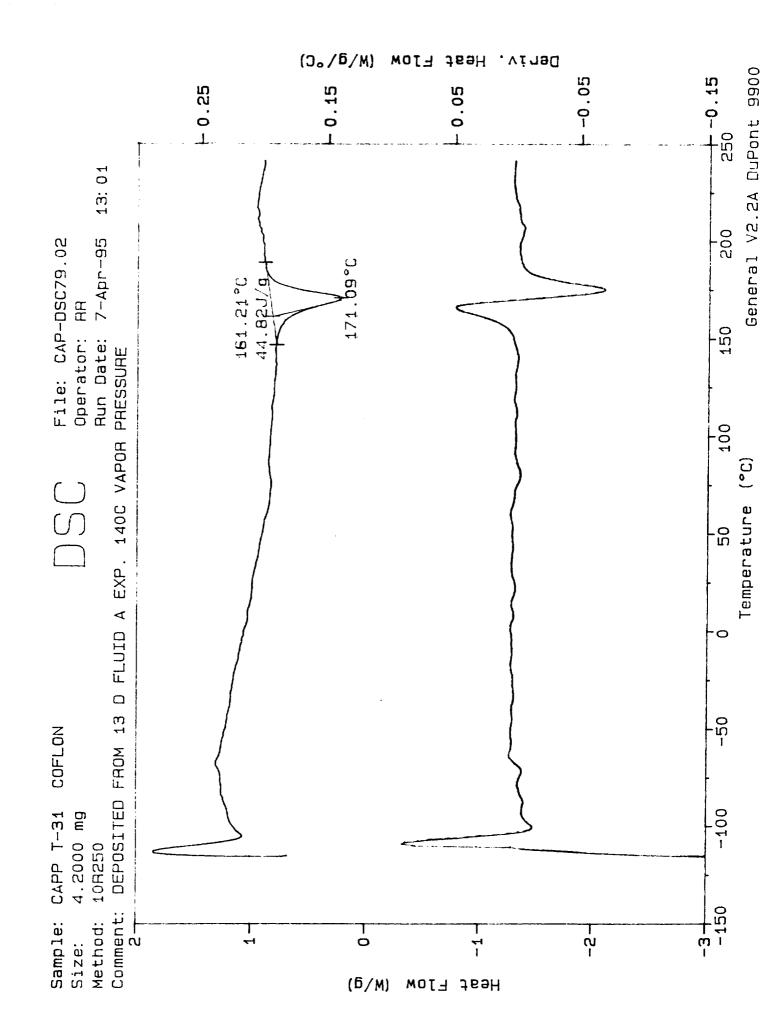
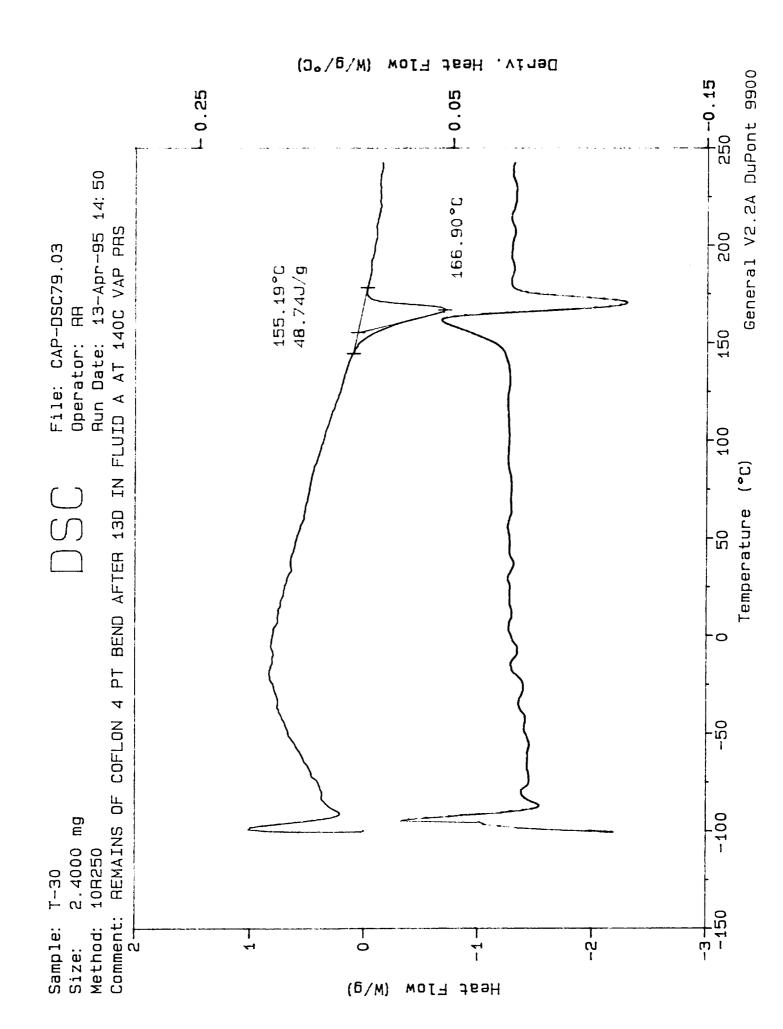
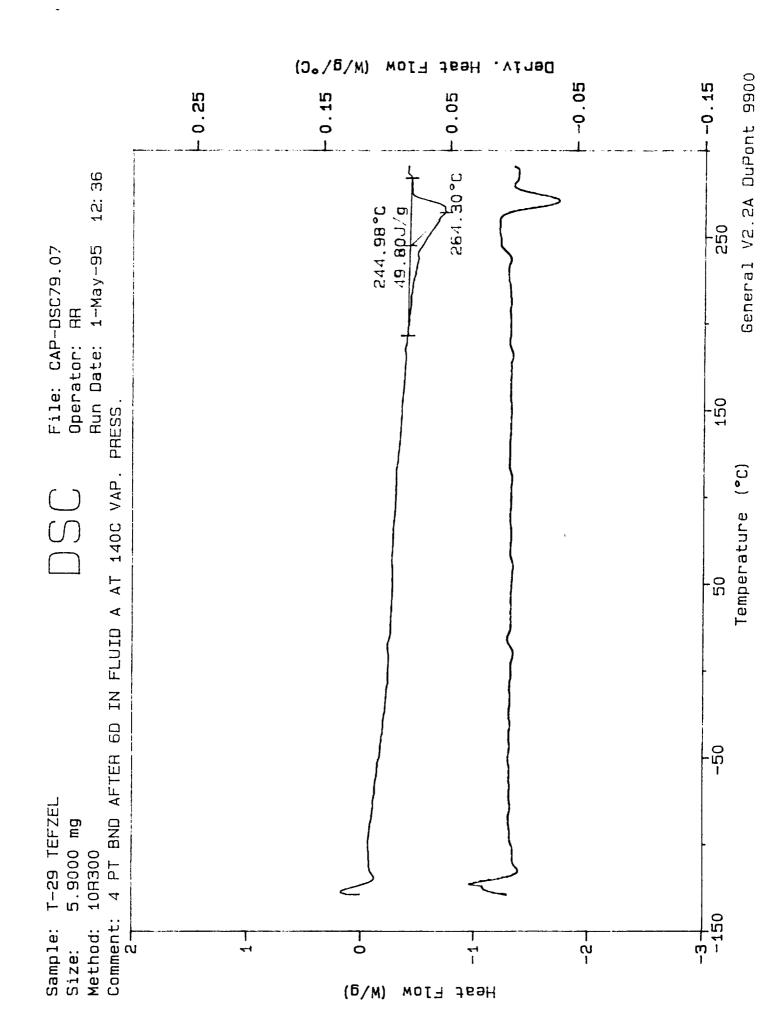
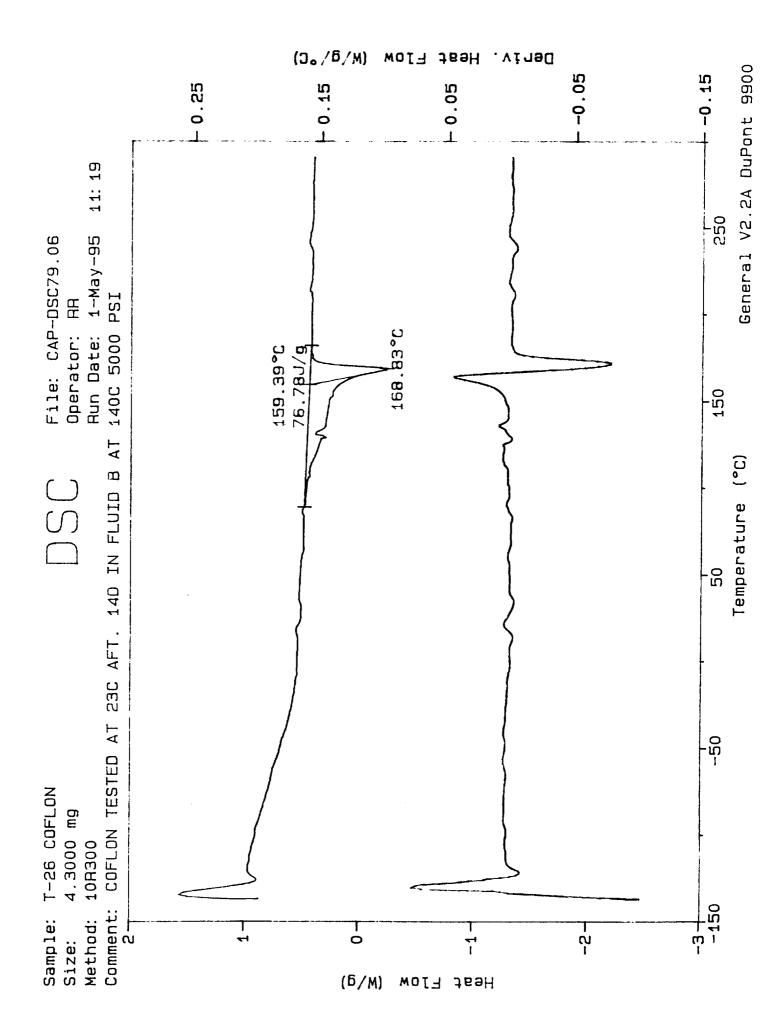
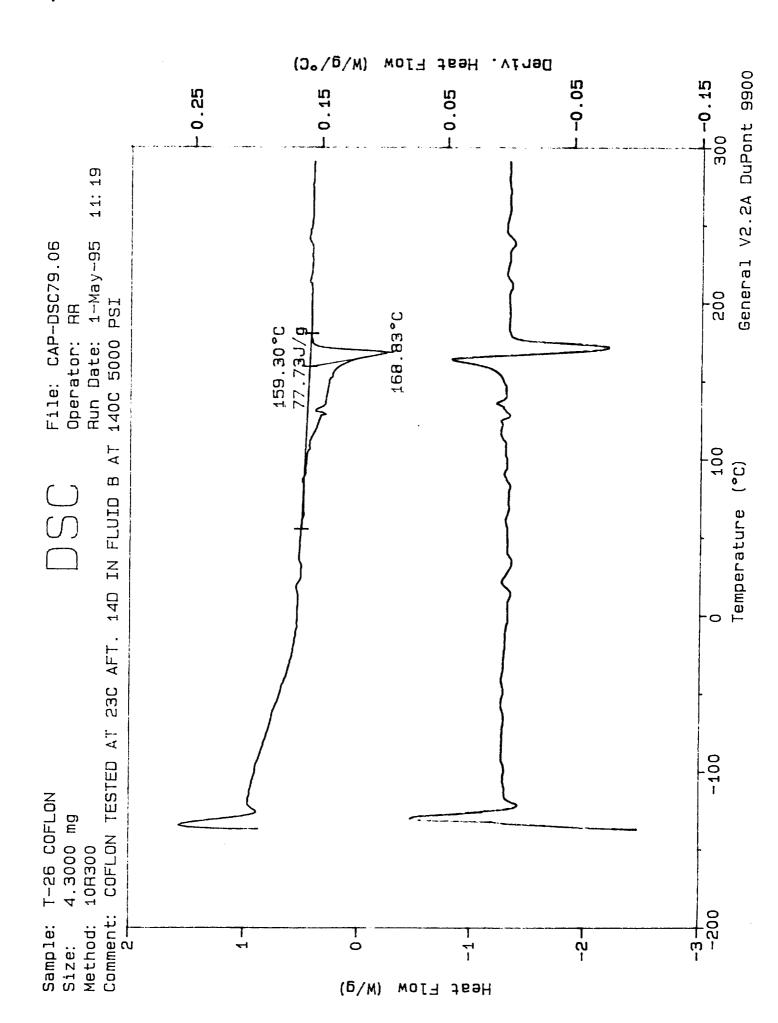
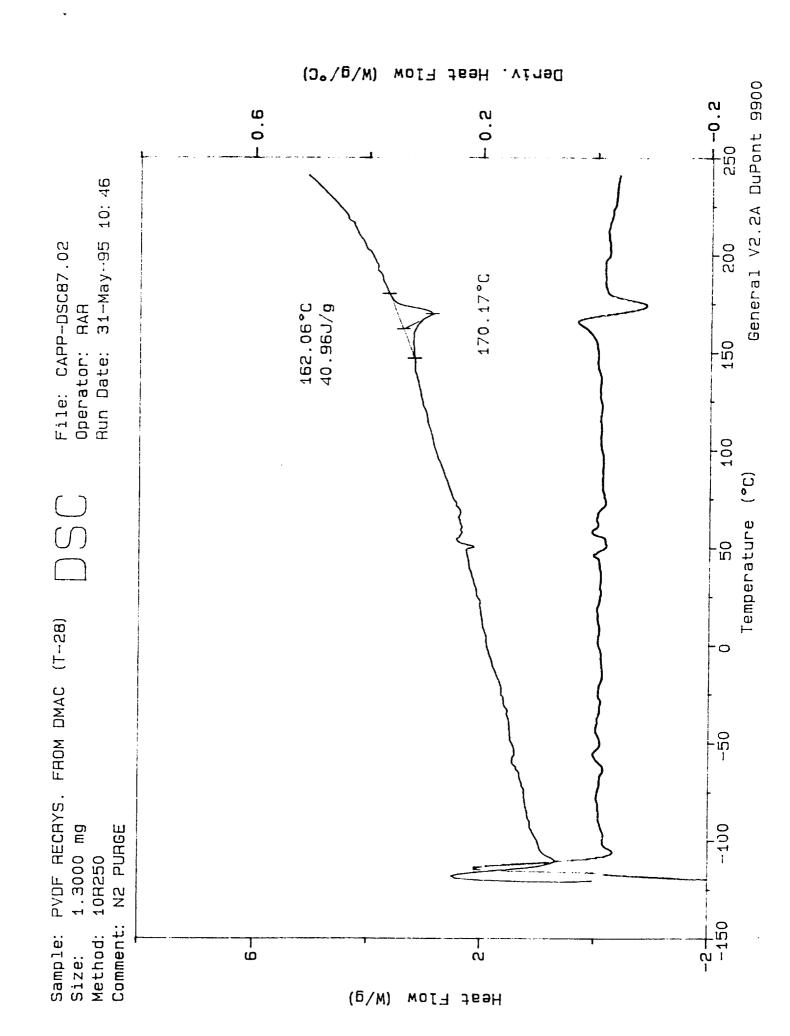
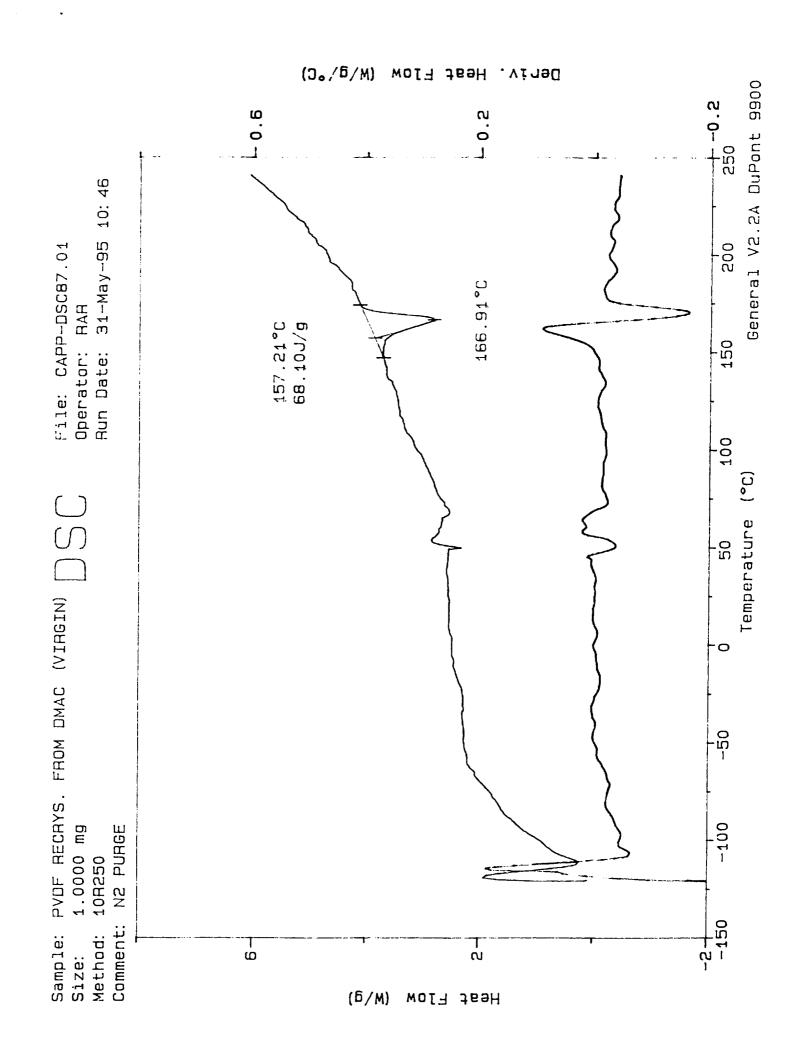
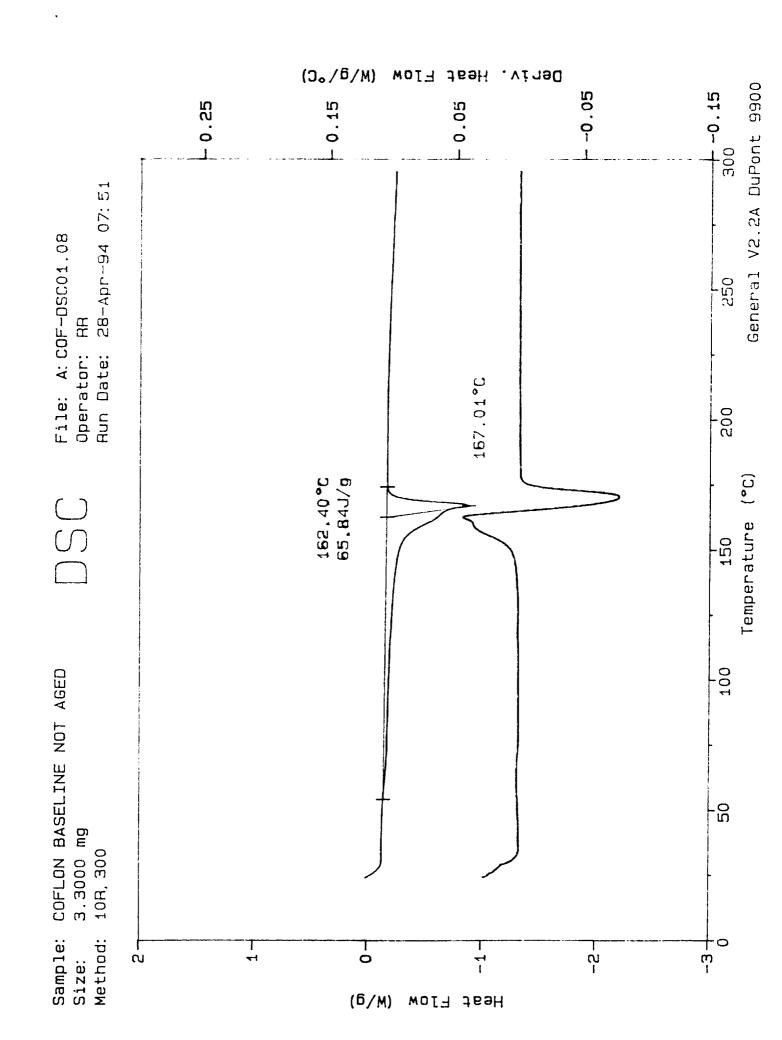
1.5 Appendix One- DSC Results

We conducted DSC on many of the forwarded samples of Tefzel and Coflon. The DSC results of the Coflon materials indicated considerable variability in crystallinity depending on aging conditions. We generally observed an increase in the heat of fusion as a function of heating time and temperature. Some of this effect may be attributable to the loss of plasticizer. The residue from the evaporated fluid after 14 days exposure to fluid A at vapor pressure indicates the presence of three compounds with vastly different melt temperatures from Coflon. The three compounds are possibly plasticizer, the solvent, and the decomposed polymer. Based on the DSC information we are not observing any change from the α form to the β crystalline form. The β form has a melting point of 190 C. We are clearly observing some changes in the relative amount of crystallinity of the Coflon based upon exposure. The DSC results for the samples, the heat of fusion's, the exposure conditions, and percentage crystallinity are given below.

Using the methods cited in the literature we dissolved PVDF in hot dimethylacetamide (DMAC) and cast a film drying the film at ≈70°C for 16 hours. We next performed FTIR and DSC analysis of the resultant film. Films were prepared for virgin PVDF, and aged PVDF (T-28) and compared with a sample of PVDF not dissolved and cast from PVDF. Solution of the PVDF into boiling DMAC was effected within thirty minutes. The DSC analysis (Appendix 1) and the FTIR analysis (Appendix 2) indicate some differences in Tg and the integration areas of the two DSC peaks around 160°C

This could indicate some conversion from the alpha or beta form to the gamma form with resultant permeation and physical property changes. We also performed a derivative analysis of the DSC data in order to clearly resolve the peaks in the analyses.

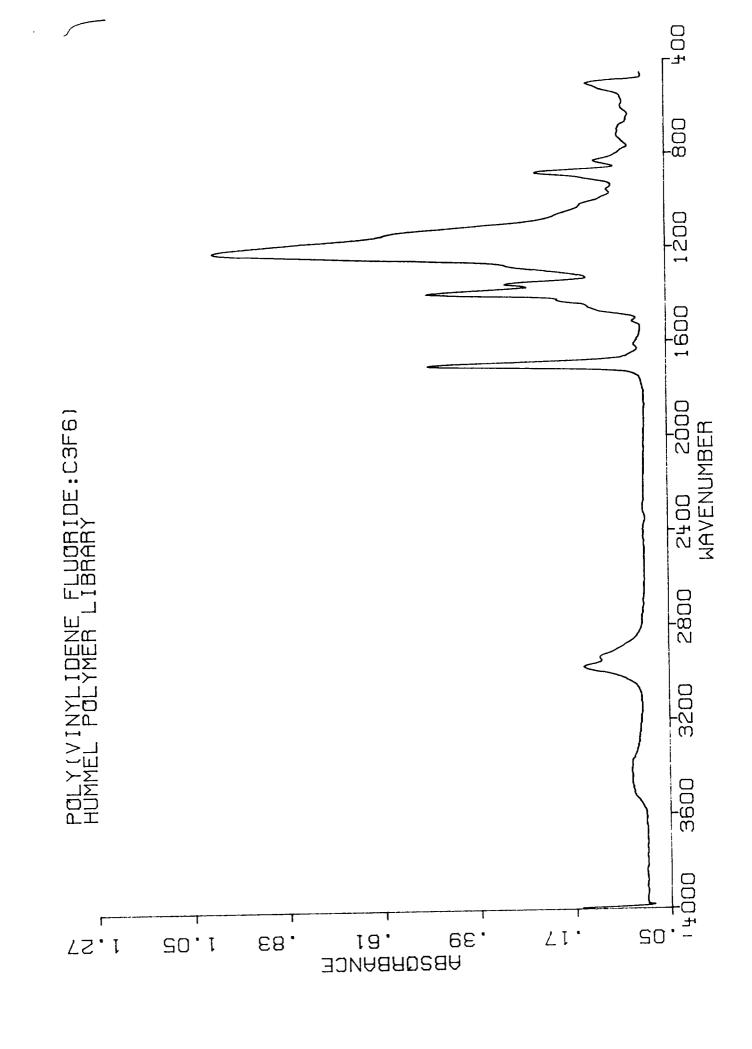
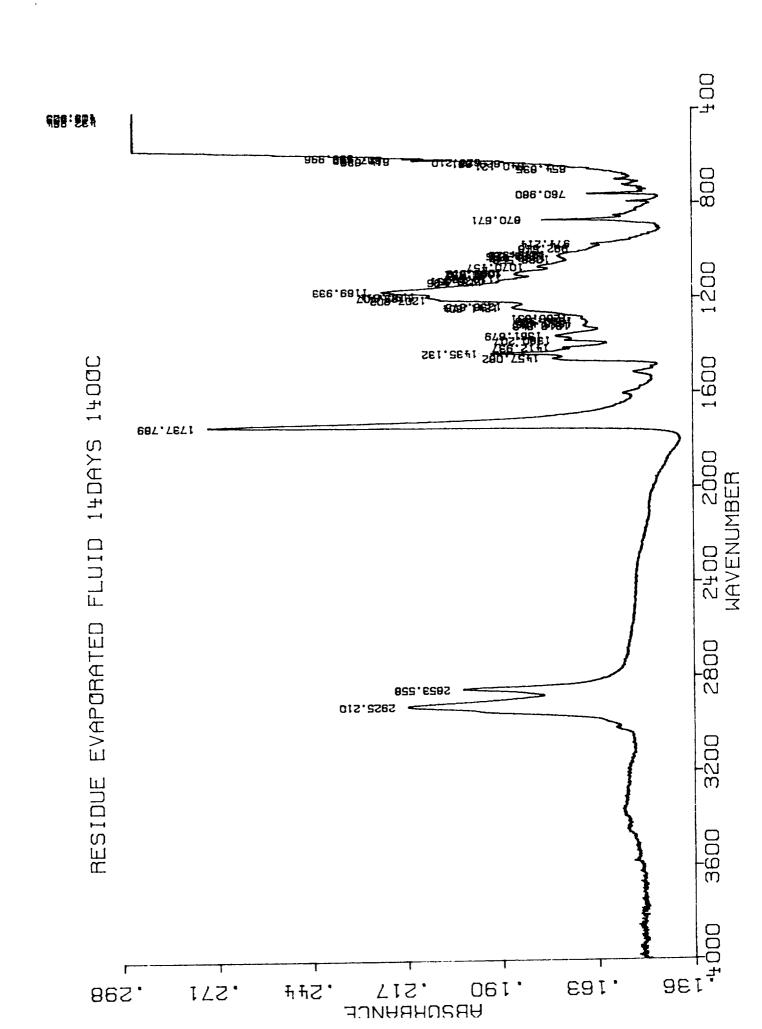
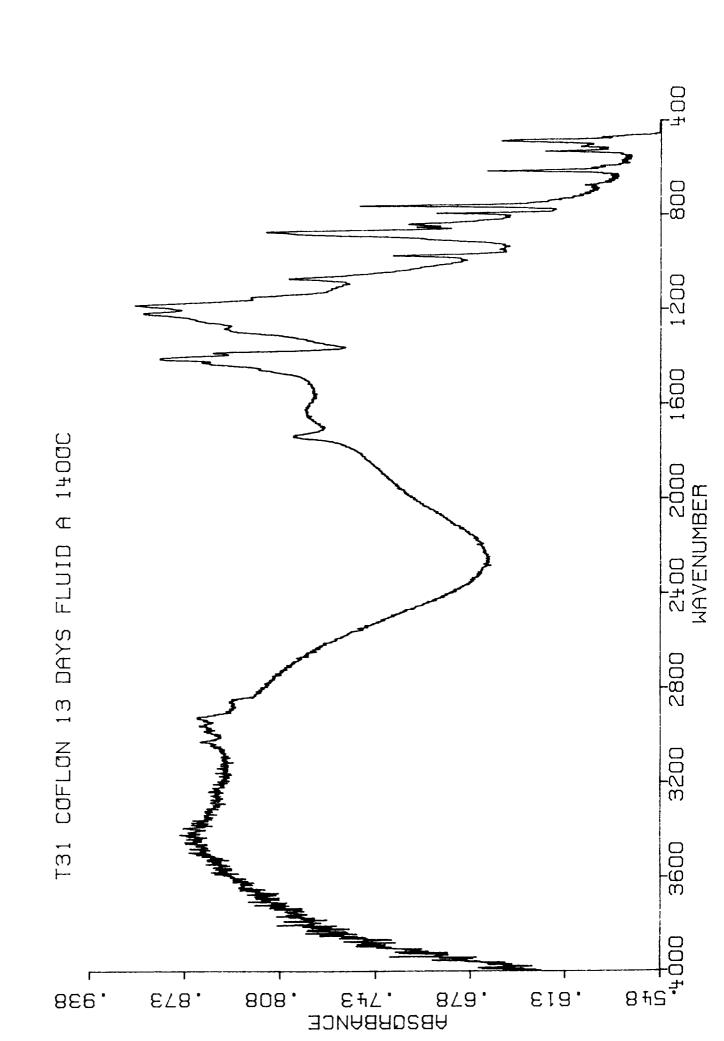
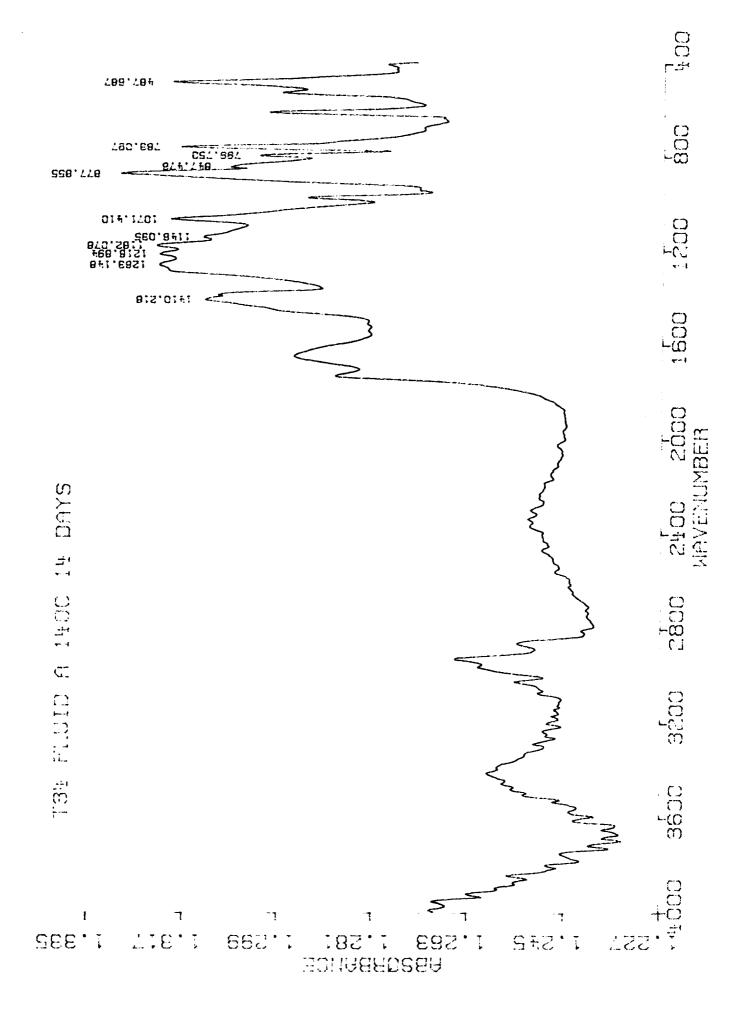
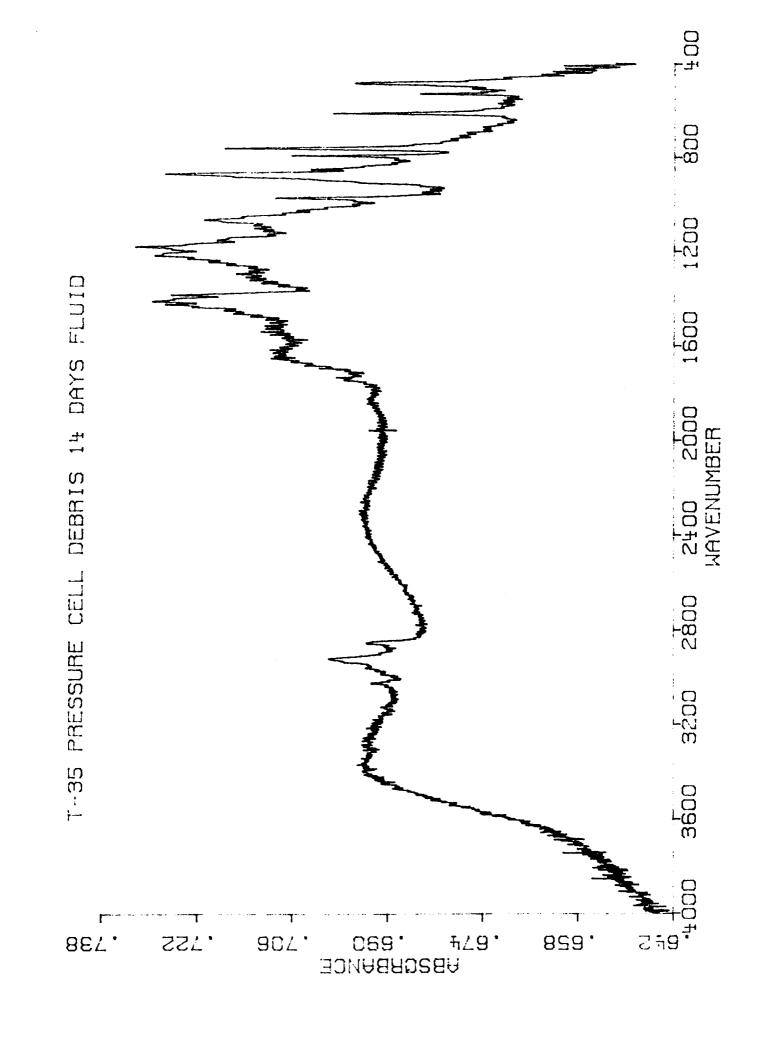
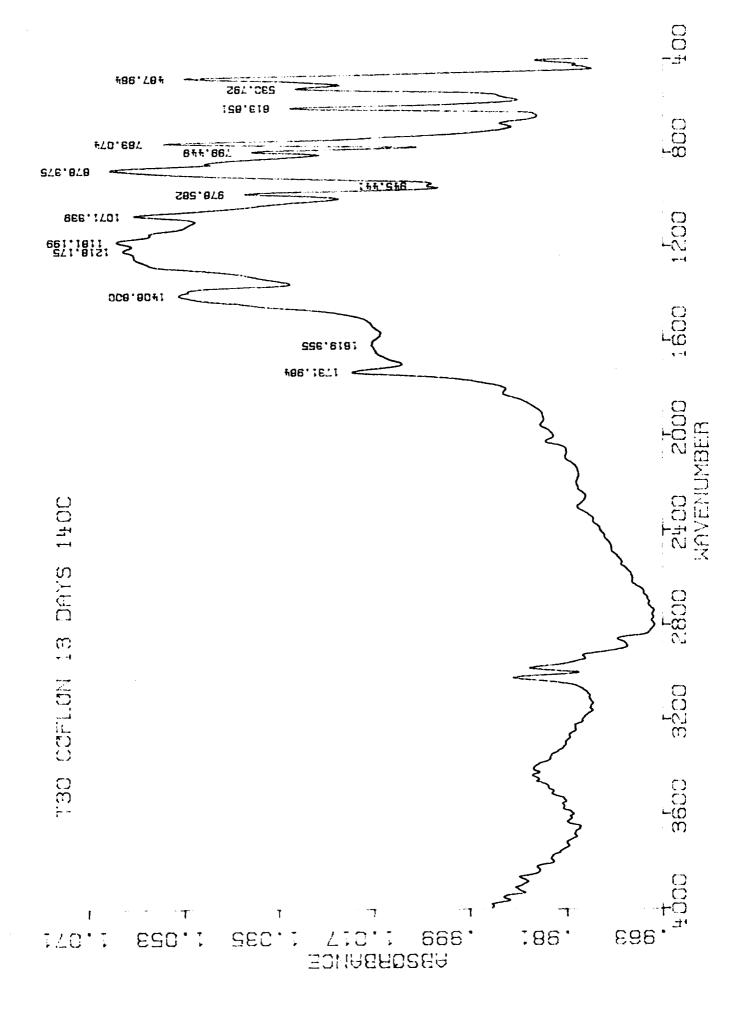
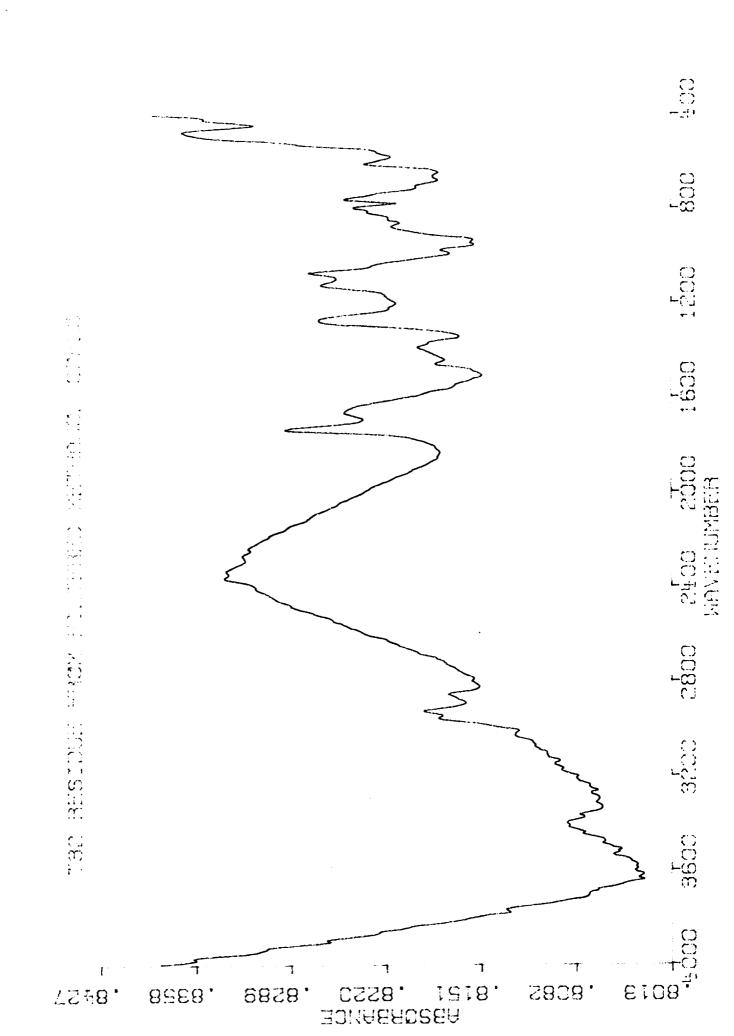
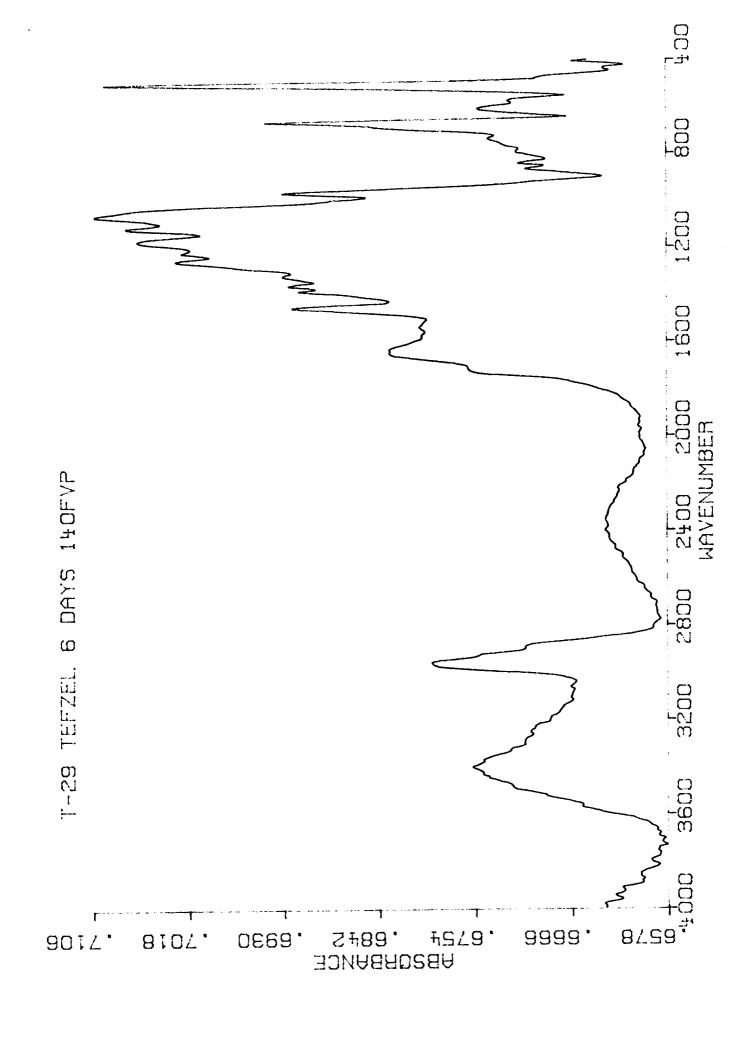
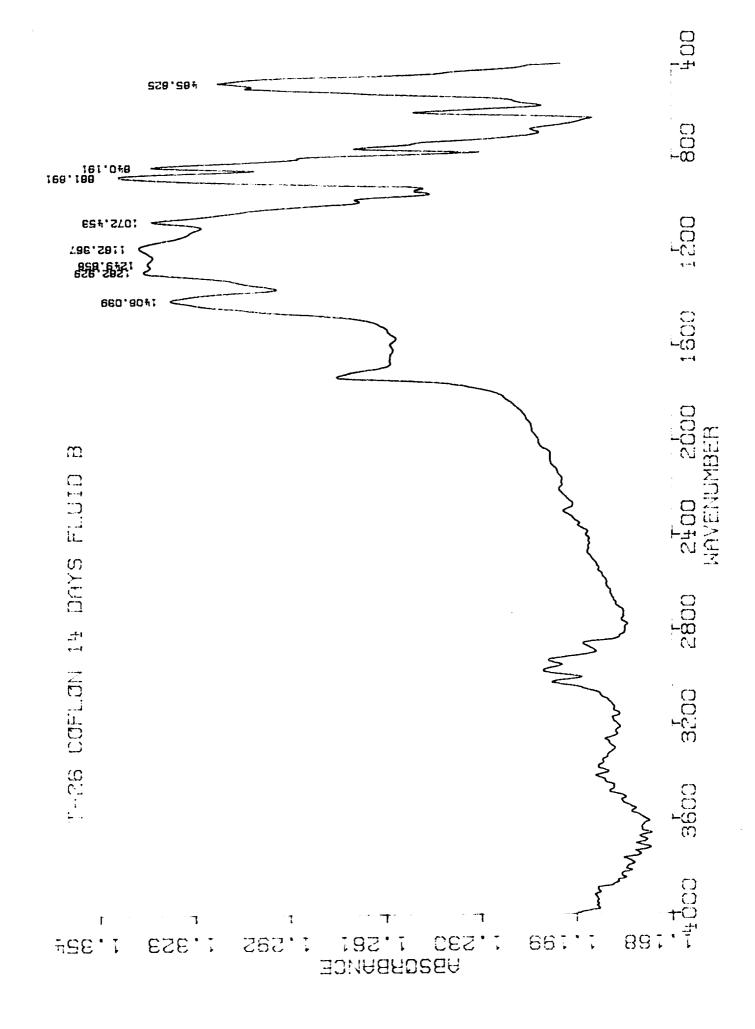
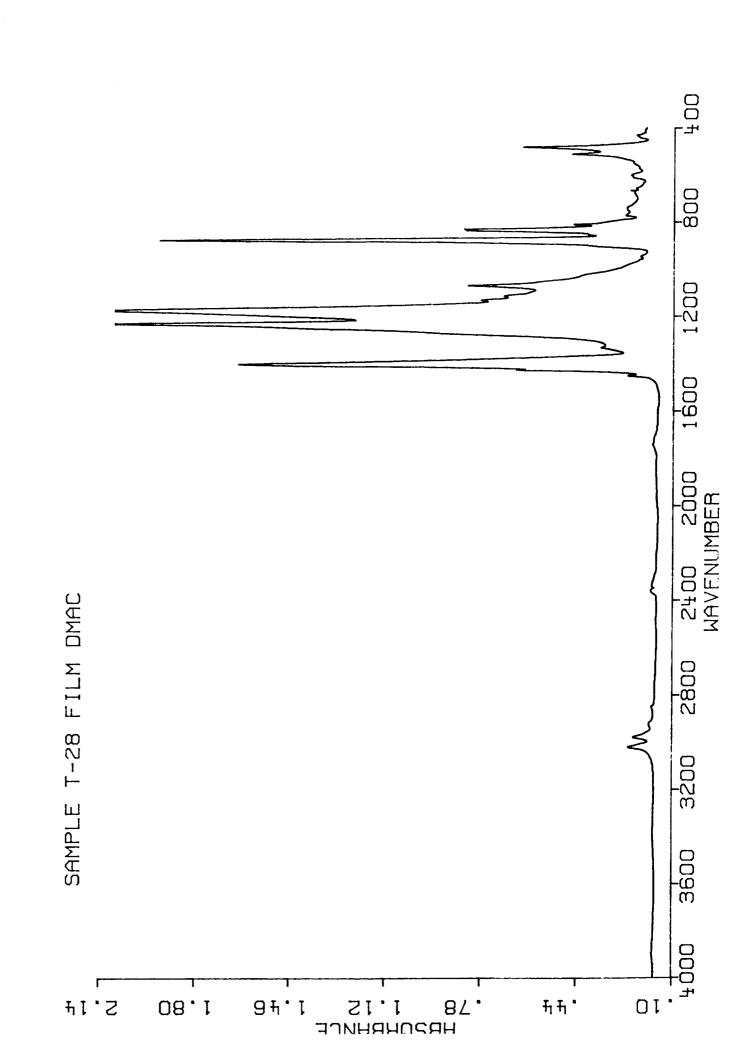
1.6 Appendix Two- FTIR Results

We have conducted FTIR analyses of Coflon and Tefzel test pieces after aging for selected times, temperature, and exposure conditions (Appendix 2). We are interested in the chemical functionality's or changes the samples exhibited upon aging. We were also interested whether the recrystallized PVDF deposits exhibited a change from the α or the type 2 form to the β or type 1 crystalline form when the PVDF dissolved under strain. Below is a table that summarizes the results of the FTIR analyses conducted to date.

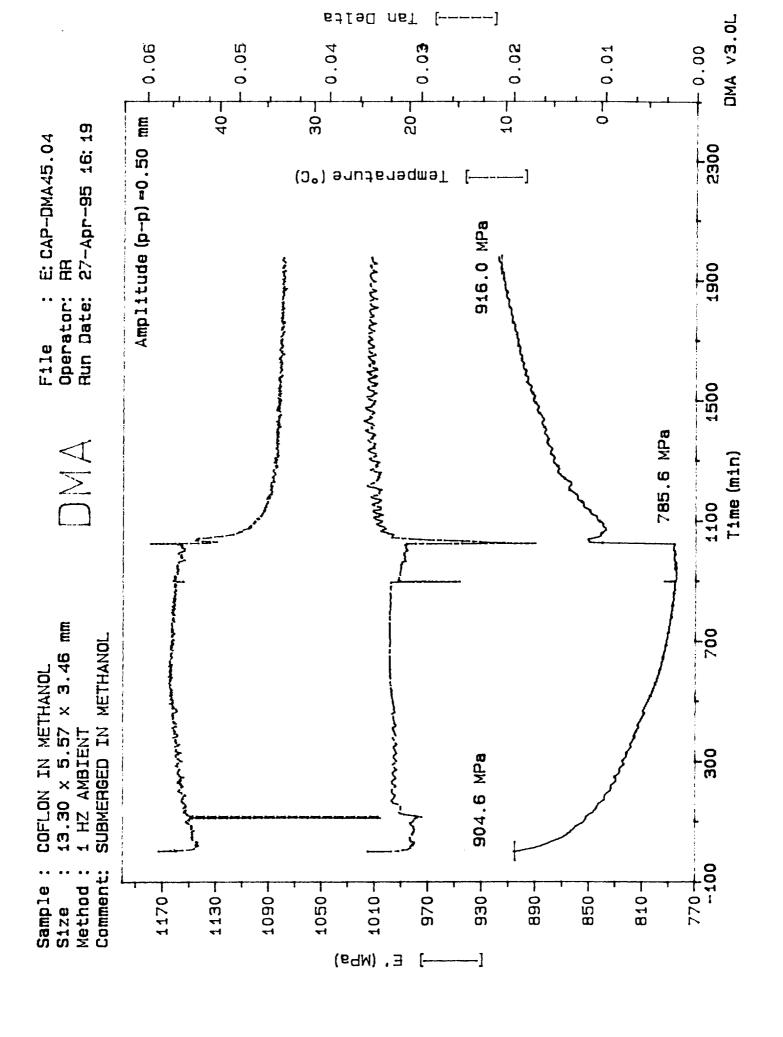
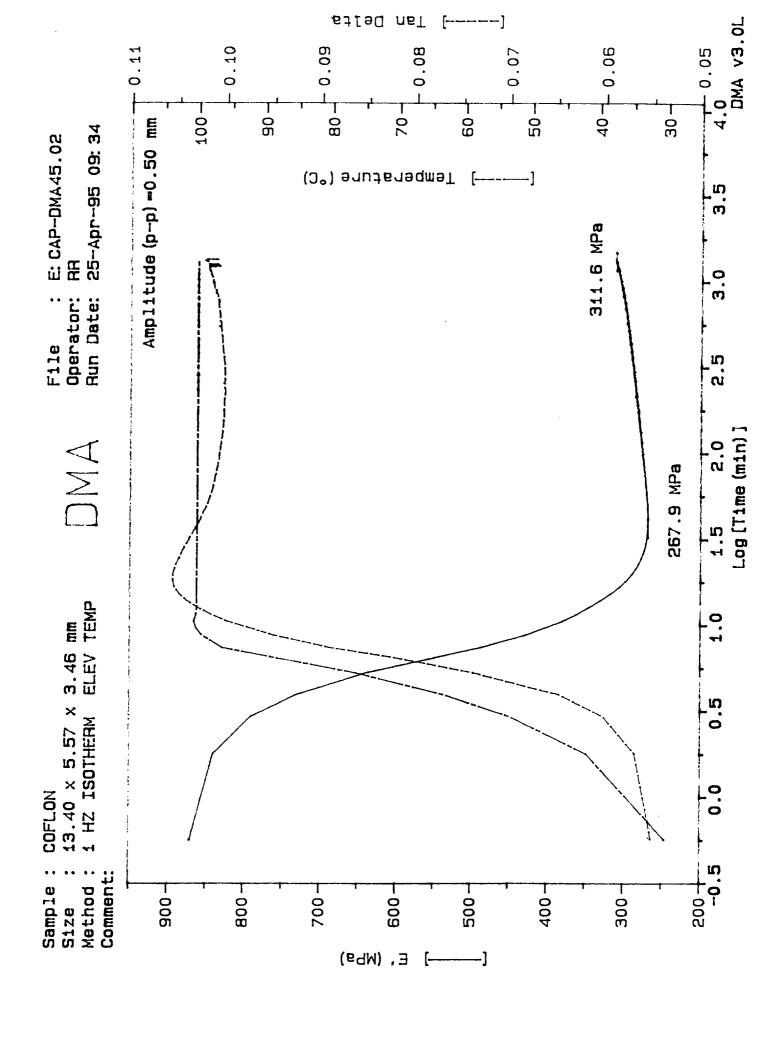
1.7 Appendix Three- DMA Results

Dynamic Mechanical Analysis (DMA) of the Coflon material was carried out and is contained in Appendix 3. The initial flexural modulus was in good agreement with previously published information. Upon heating the flexural modulus drops to a low of 268 MPa. After which it was noted that the flexural modulus increased to 312 MPa. We believe that the increase is due to the deplasticization. We also noted that the tan delta increases (0.105) until the sample reaches 100°C and then decreases to (0.100). After a long period we again see the tan delta rise during deplasticization to (0.102), as the sample becomes more lossy.

We also examined the viscoelastic response of Coflon using DMA while the sample was immersed in methanol at room temperature. During the first eighteen hours of immersion we notice a decrease in the flexural modulus indicating plasticization with methanol had occurred in the Coflon. The flexural modulus of the Coflon decreased over thirteen percent in the initial eighteen hours while immersed in methanol.

The sample was then removed from methanol and the dynamic mechanical analysis was continued in air for the next twenty two hours. We noticed an increase in the flexural modulus to a higher level than the initial value. The initial flexural modulus value had increased 1.3% at the end of twenty-two hours from the initial value. The increase in the flexural modulus at the end of the test could be due to the leaching of the plasticizer, an increase in crystallinity, or both of these processes.

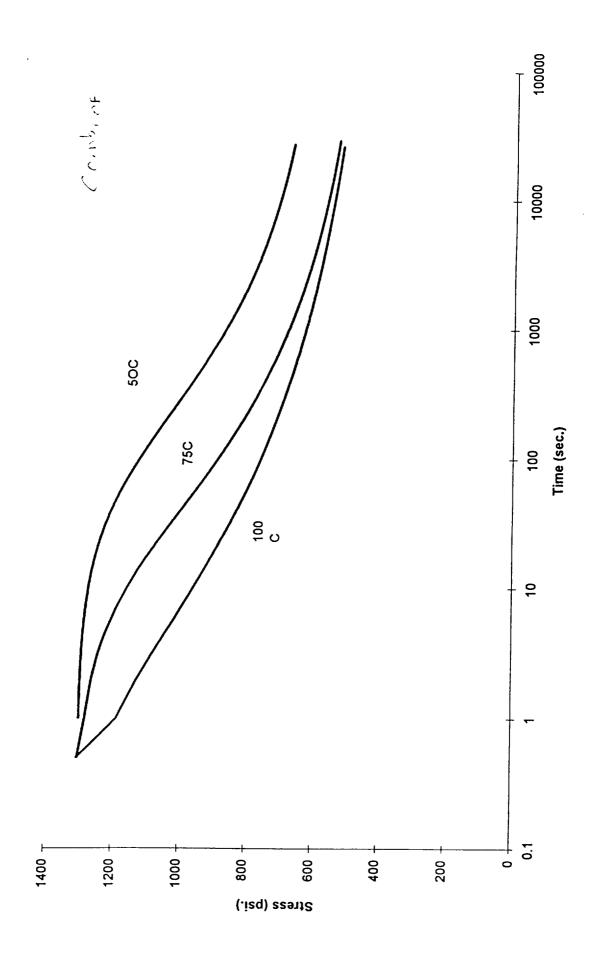
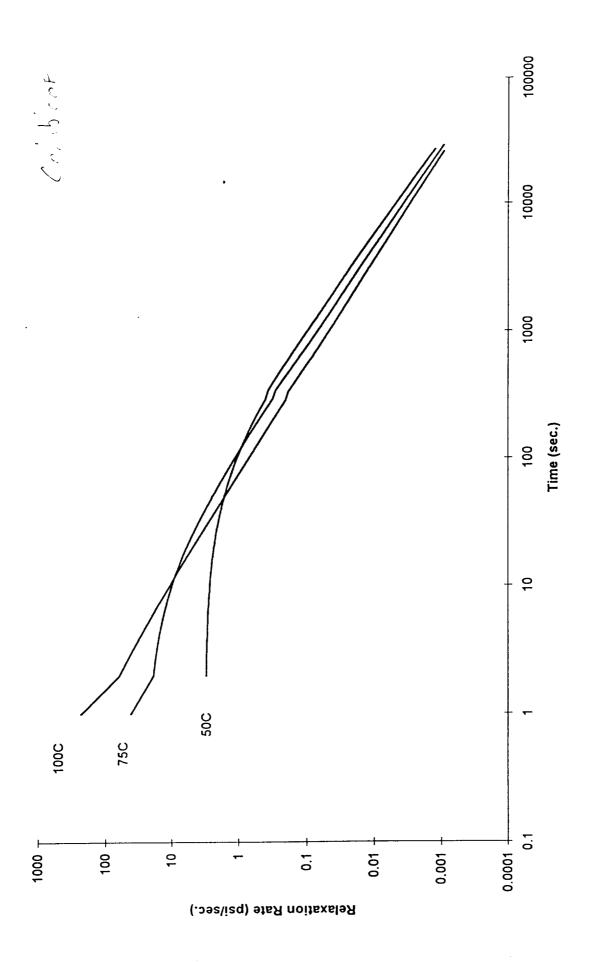
1.8 Appendix Four- Pipe Stress Relaxation Results

We determined the stress relaxation characteristics of Coflon pipe sections in a splitring tension test emulating 200 psi differential internal pressure. The testing was conducted at three temperatures in order to determine the activation energy for the process. An activation energy was determined for the process of 3 Kcal/mol. Any activation below 5 Kcal/mol indicates that no primary bond breaking is occurring. The plots for the stress relaxation experiments are included in Appendix 4.

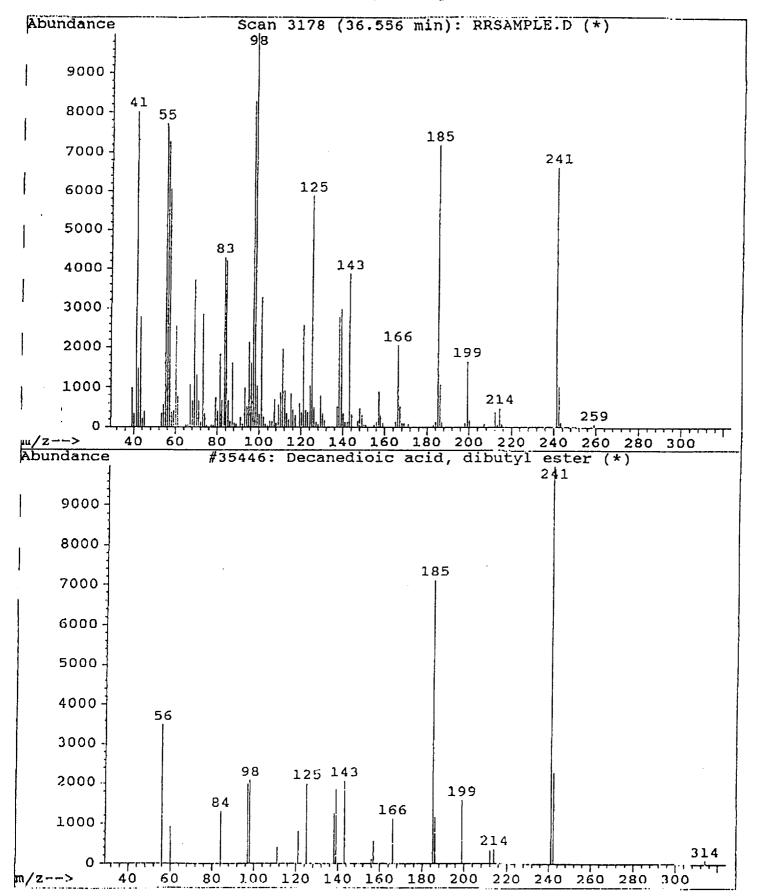
1.9 Appendix Five- Mass Spectra of Exudate From Coflon

We investigated accelerated high temperature aging of the Coflon material and analyzed the liquid exudate using gas chromatography coupled with mass spectrometry. The mass spectrum of the liquid exudate is provided in Appendix 5. The database search base provided the best match with a dibutyl ester of decanedioic acid. The search routine can only match those compounds catalogued in the library that is approximately seven hundred thousand compounds.

ID : Decanedioic acid, dibutyl ester

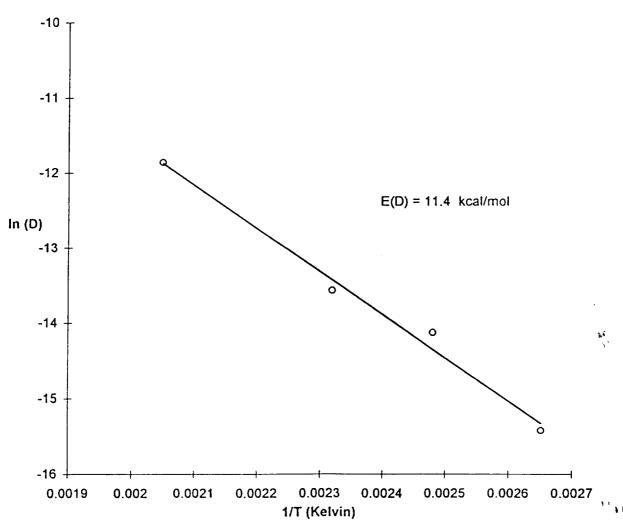
Deplasticization of Coflon

We reanalyzed the thermogravimetric information and recalculated the times associated with deplastization for the Coflon pipe materials at specific temperatures. Below is the information that relates deplasticization of the Coflon to time and temperature.

Additional analysis of thermogravimetric data has been conducted. We are currently developing detailed examination of the deplasticization rates for Coflon. From this information we are calculating this diffusion coefficient of the plasticizer from the Coflon. These rates will be useful in future tests should preconditioning of specimens be required.
