NASA/CR-95- 207617

INTERIM REPORT ON CHEMICAL AND THERMAL ANALYSIS

Prepared for: CAPP International Consortium

Document Number: CAPP/T.3

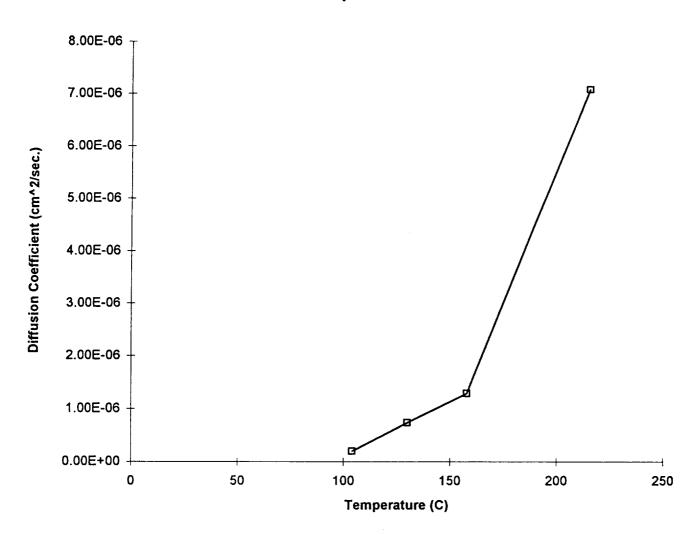
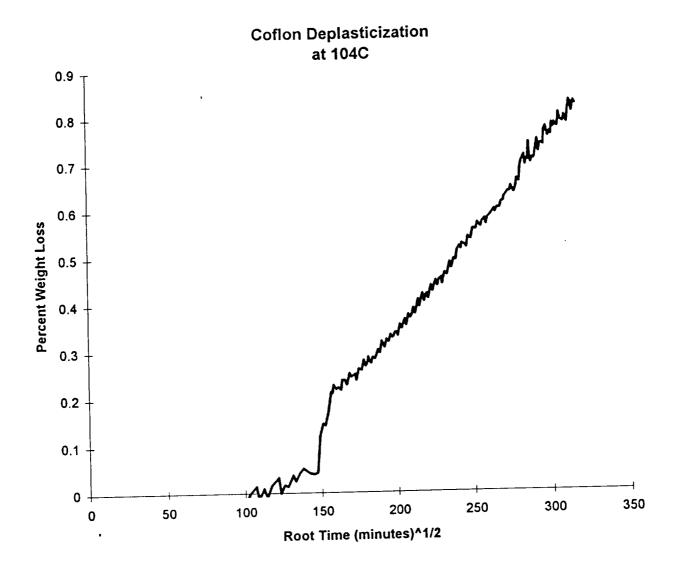
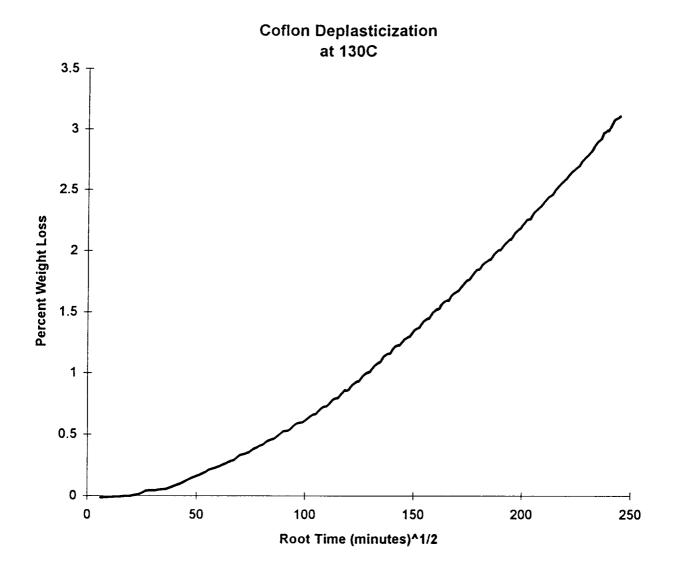
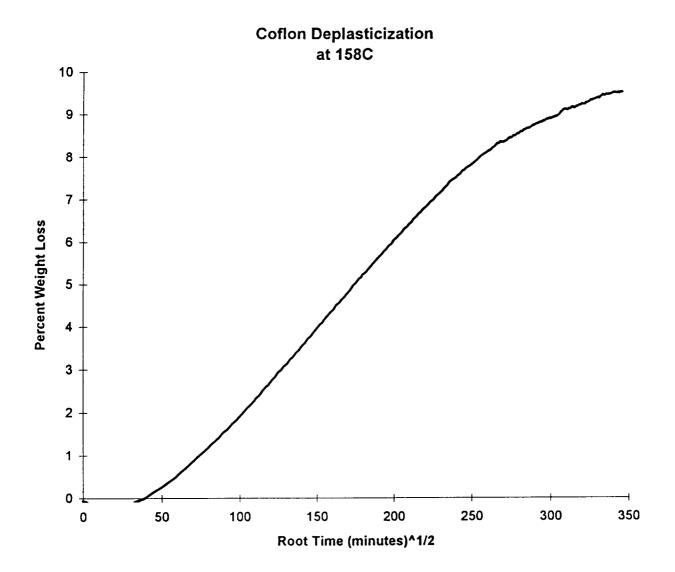
Coflon Deplasticization

We reanalyzed the thermogravimetric information and recalculated the times associated with deplastization for the Coflon pipe materials at specific temperatures. Below is the information that relates deplasticization of the Coflon to time and temperature.
