A COMPLIANT CASING FOR TRANSONIC AXIAL COMPRESSORS

Gregory S. Bloch  
Air Force Research Laboratory  
Wright-Patterson Air Force Base  
Dayton, Ohio

Chunill Hah  
National Aeronautics and Space Administration  
Glenn Research Center  
Cleveland, Ohio

23 OCT 02

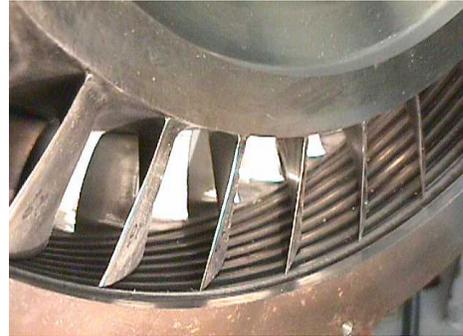
## Compliant Casing Installation

- **Installed in SMI rig**
- **7 rows of brushes**
  - **5 mil clearance between rotor tip & brush ID**
  - **25 mil clearance between rotor tip & backing plate**
  - **(Smooth casing had 13 mil clearance)**
- **Measurement uncertainties**
  - **Mass flow  $\pm 0.08$  lbm/s**
  - **Pressure ratio  $\pm 0.004$**
  - **Efficiency  $\pm 0.20$  percent**

### Discuss SMI rig

single stage machine typical of 1st stage of modern core compressor

19"OD, 1120 ft/s tip speed

5 mil minimum clearance

25 mil clearance to brush backing plates

No abradable coating installed here, so gap increased for safety

13 mil clearance to smooth casing (for comparison)

The SMI rig was tested in the CARL facility, and aerodynamic performance was determined by mass-averaging an array of 80 PT probes and 80 TT probes located 2.1 stator axial chords downstream of stator TE.
