APPENDIX A: SPRINGDALE STREETScape, PARKING, AND SHUTTLE STOP INVENTORY

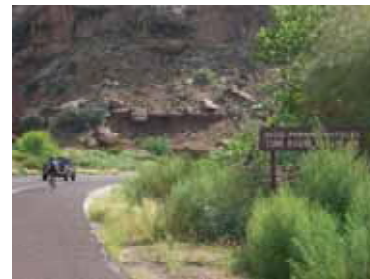
Looking East - A

- Ⓐ "Avoid Parking Hassles Tune Radio to 1610 AM" sign is small in scale and beginning to be obscured by vegetation. Recommend vegetation maintenance.
- Ⓑ "Parking in Zion Full" sign is small in scale.
- Ⓒ Gravel pull out here

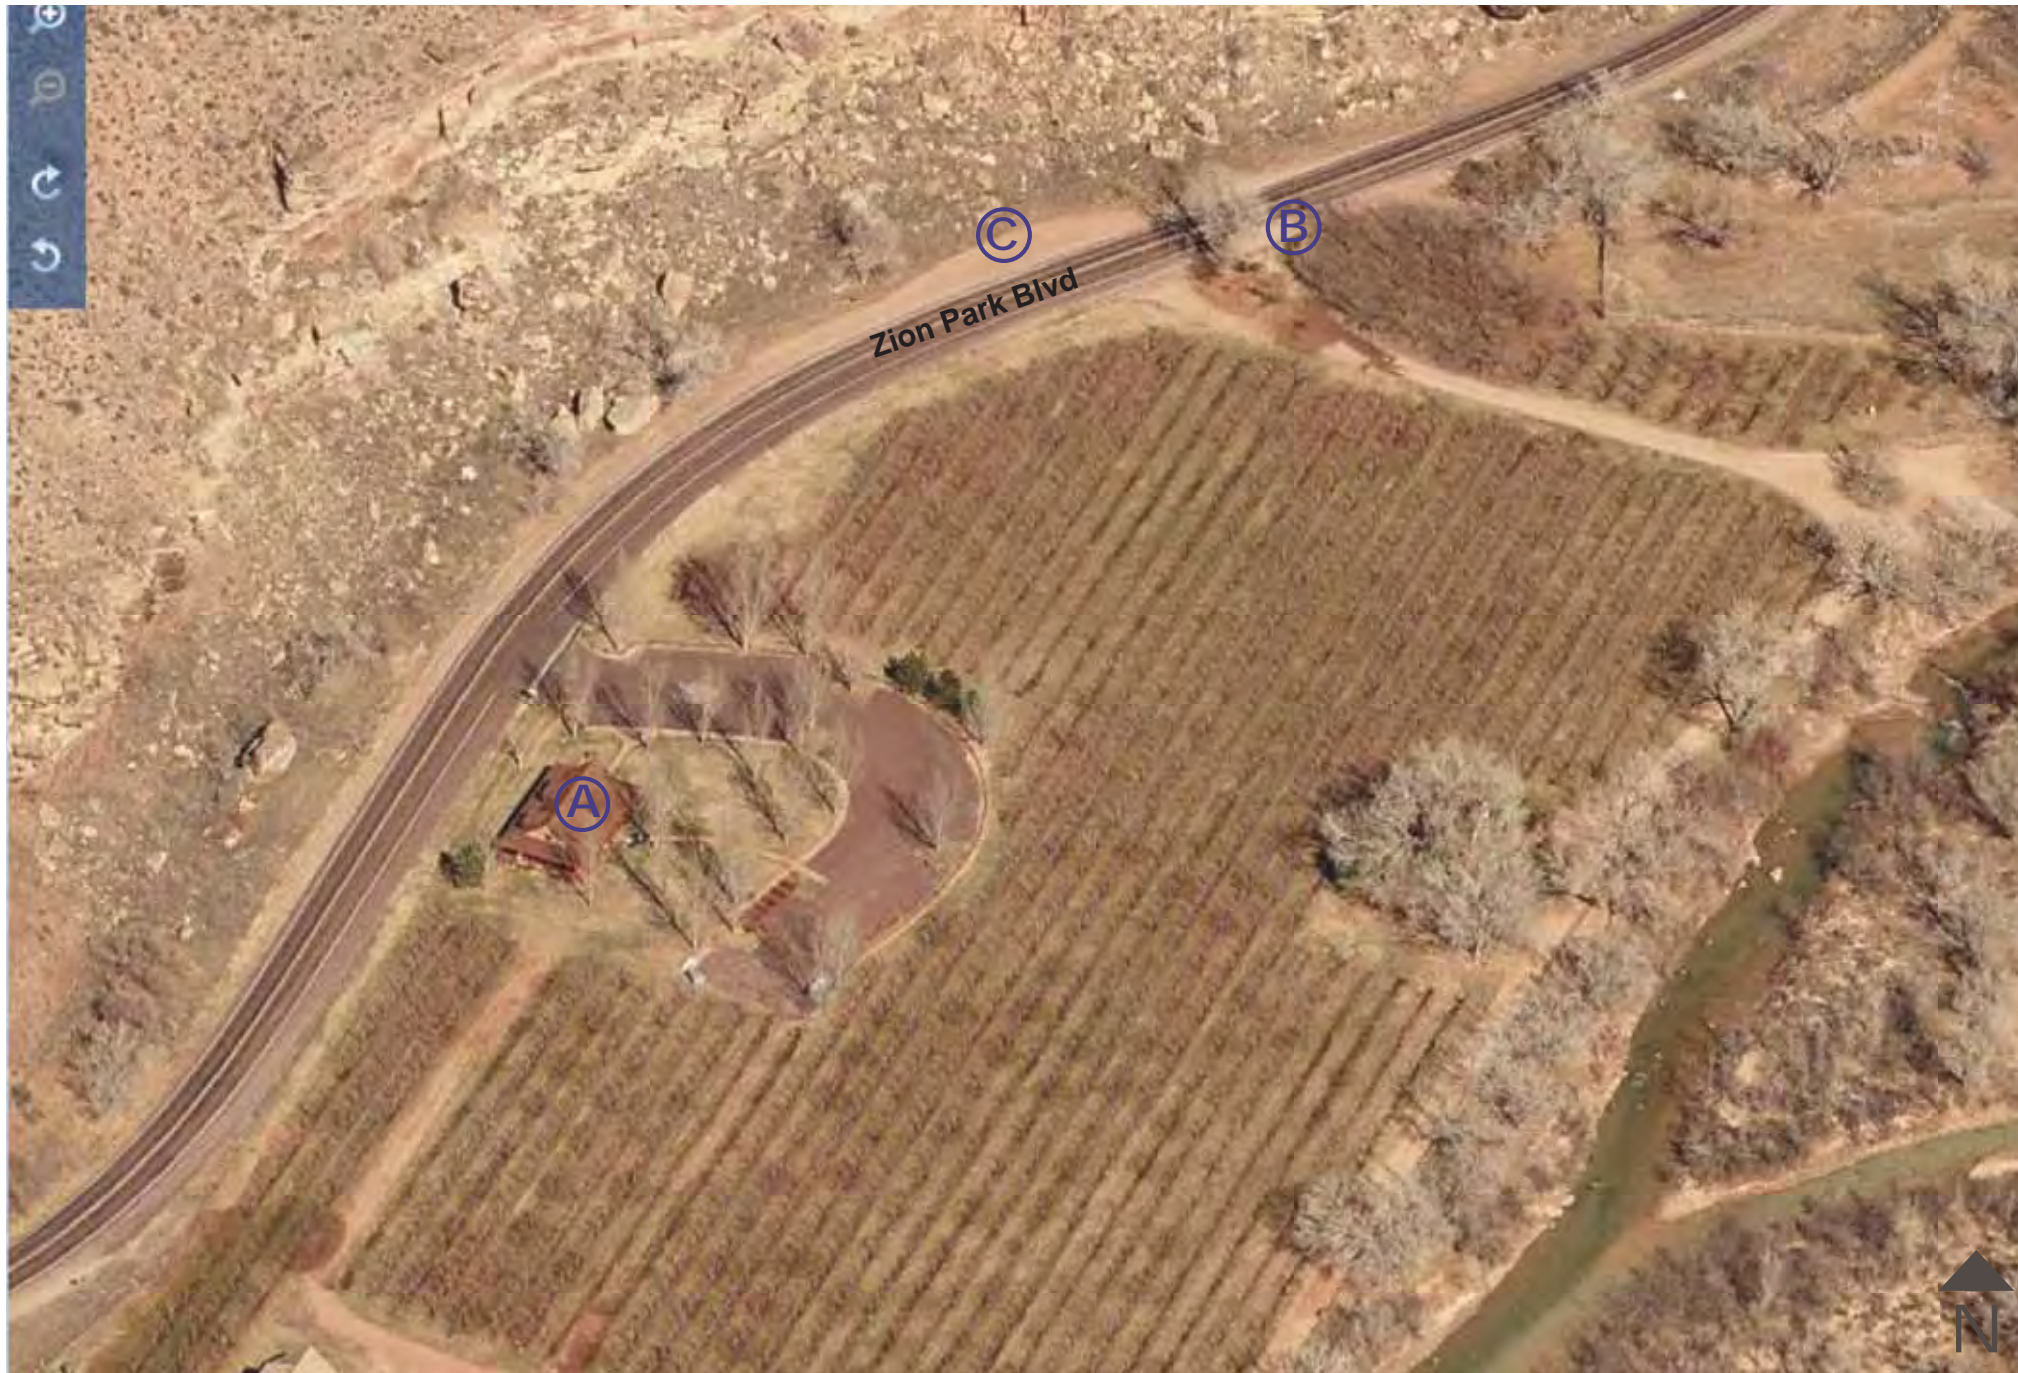
Zion Park Boulevard

- Ⓐ Springdale Fruit Company is a destination location which has restrooms and a large parking lot. There is potential for this area to become a Shuttle Stop. It is a comfortable setting which would provide a place for people to gather their bearings before beginning the journey on the shuttle through town and then transitioning into the park. Education materials and maps could be provided here for the shuttle, parking, and the park itself.

- Ⓑ "Park In Springdale Sign" is small in scale.
- Ⓒ Large gravel pull out here

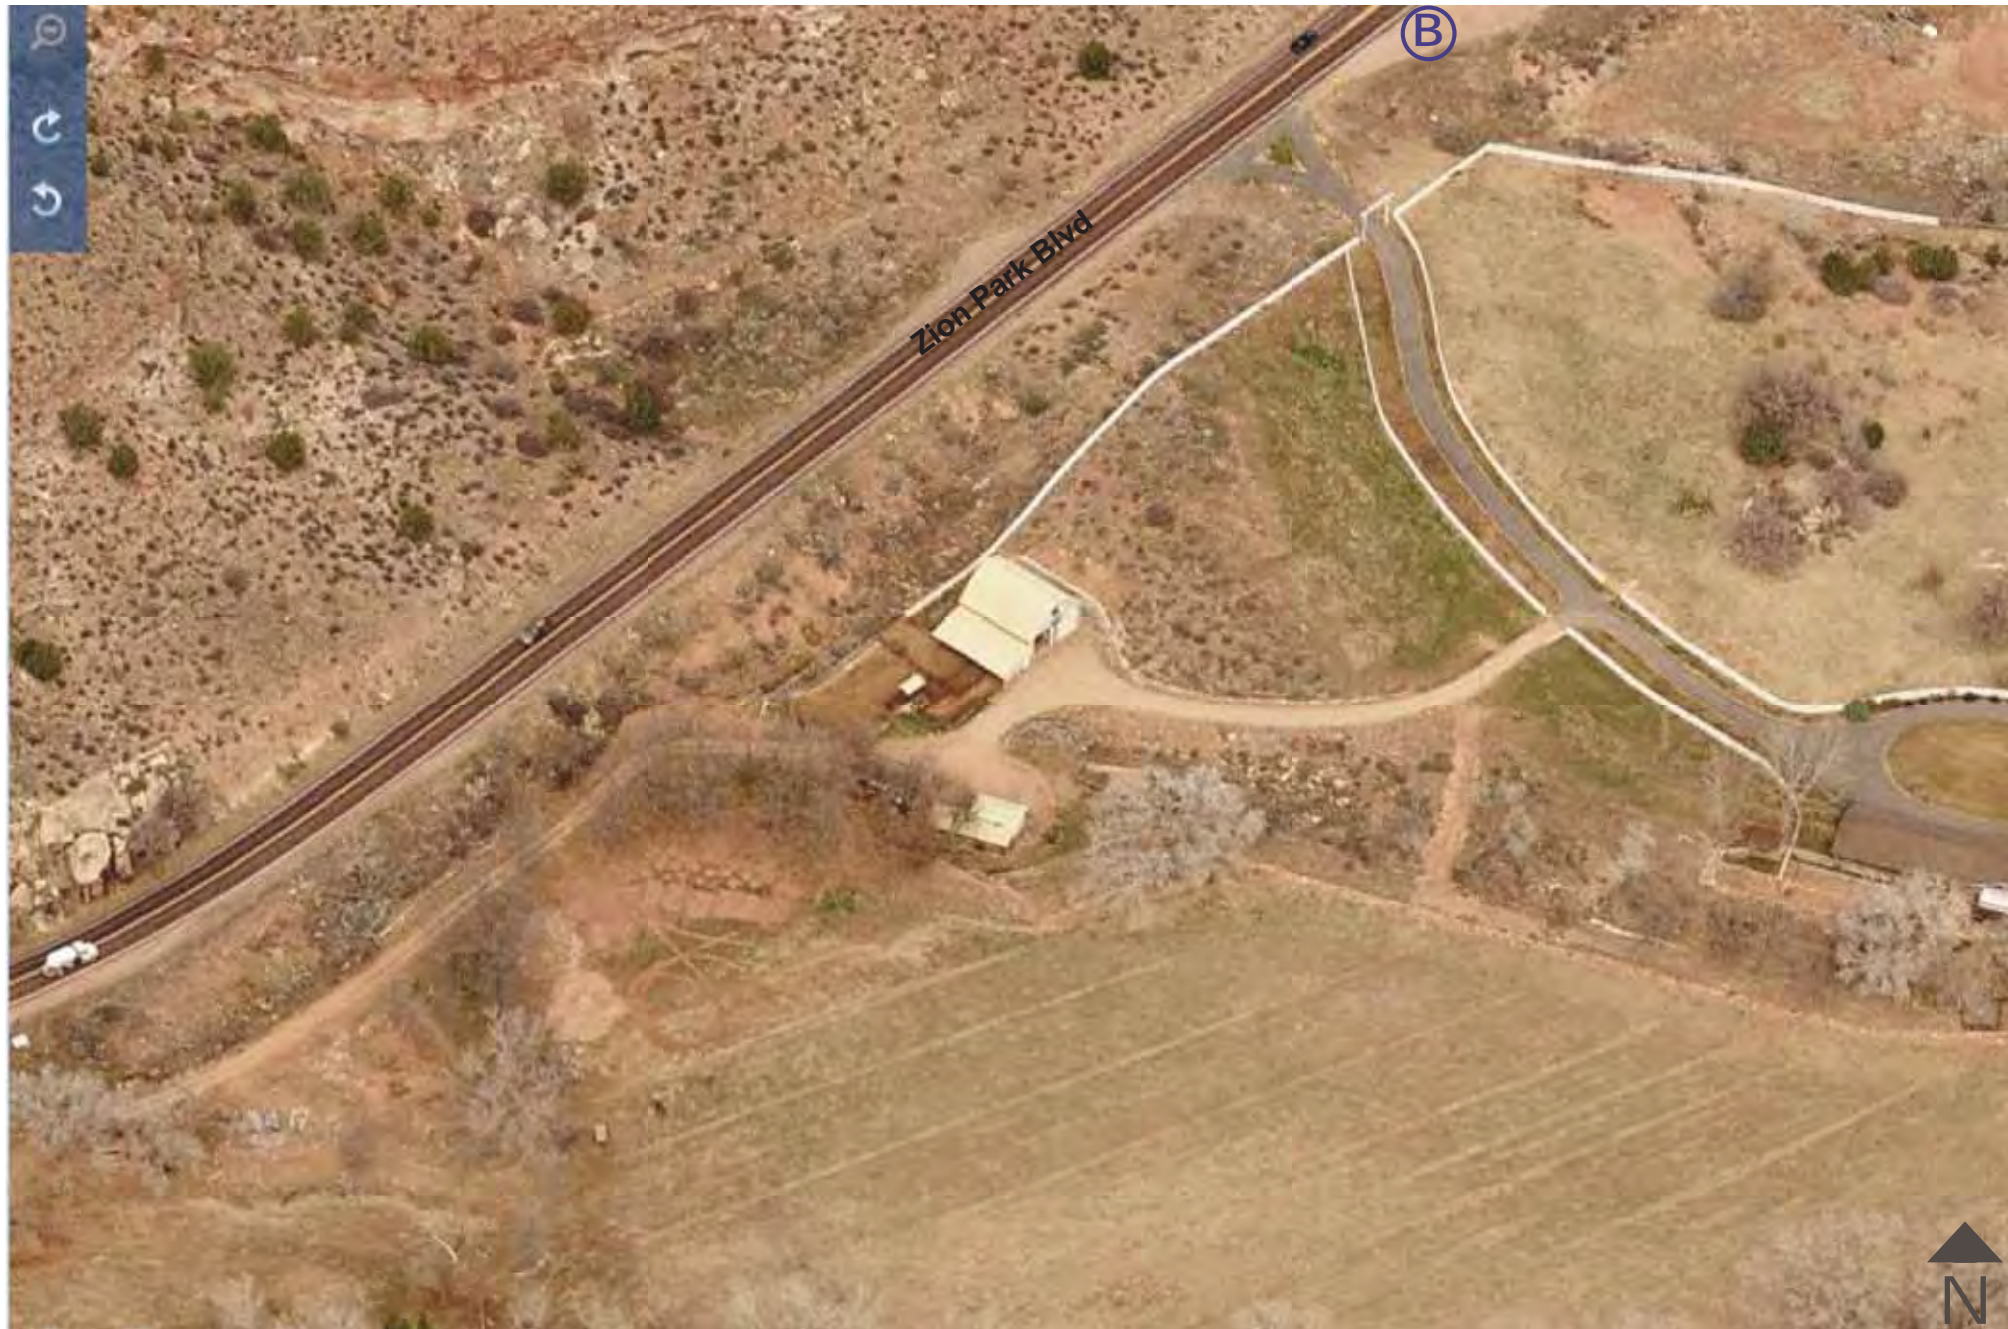
Zion Park Boulevard

- Ⓐ Springdale Zion Canyon Gateway sign
- Ⓑ Traffic is slowing, many cars pulling off into gravel lot to take photos.

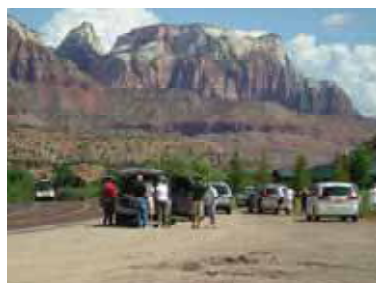
Undeveloped Pull Off - Looking North - F

- Ⓔ The pavement is buckling and potholing due to the shuttle layovers and general use. Restriping should be performed following pavement repairs.
- Ⓕ This informal pull off is an attraction to visitors entering Springdale who want to coordinate their day as they enter the corridor. Several groups of people and cars stop to take pictures of the surrounding canyon in addition to planning their trip.

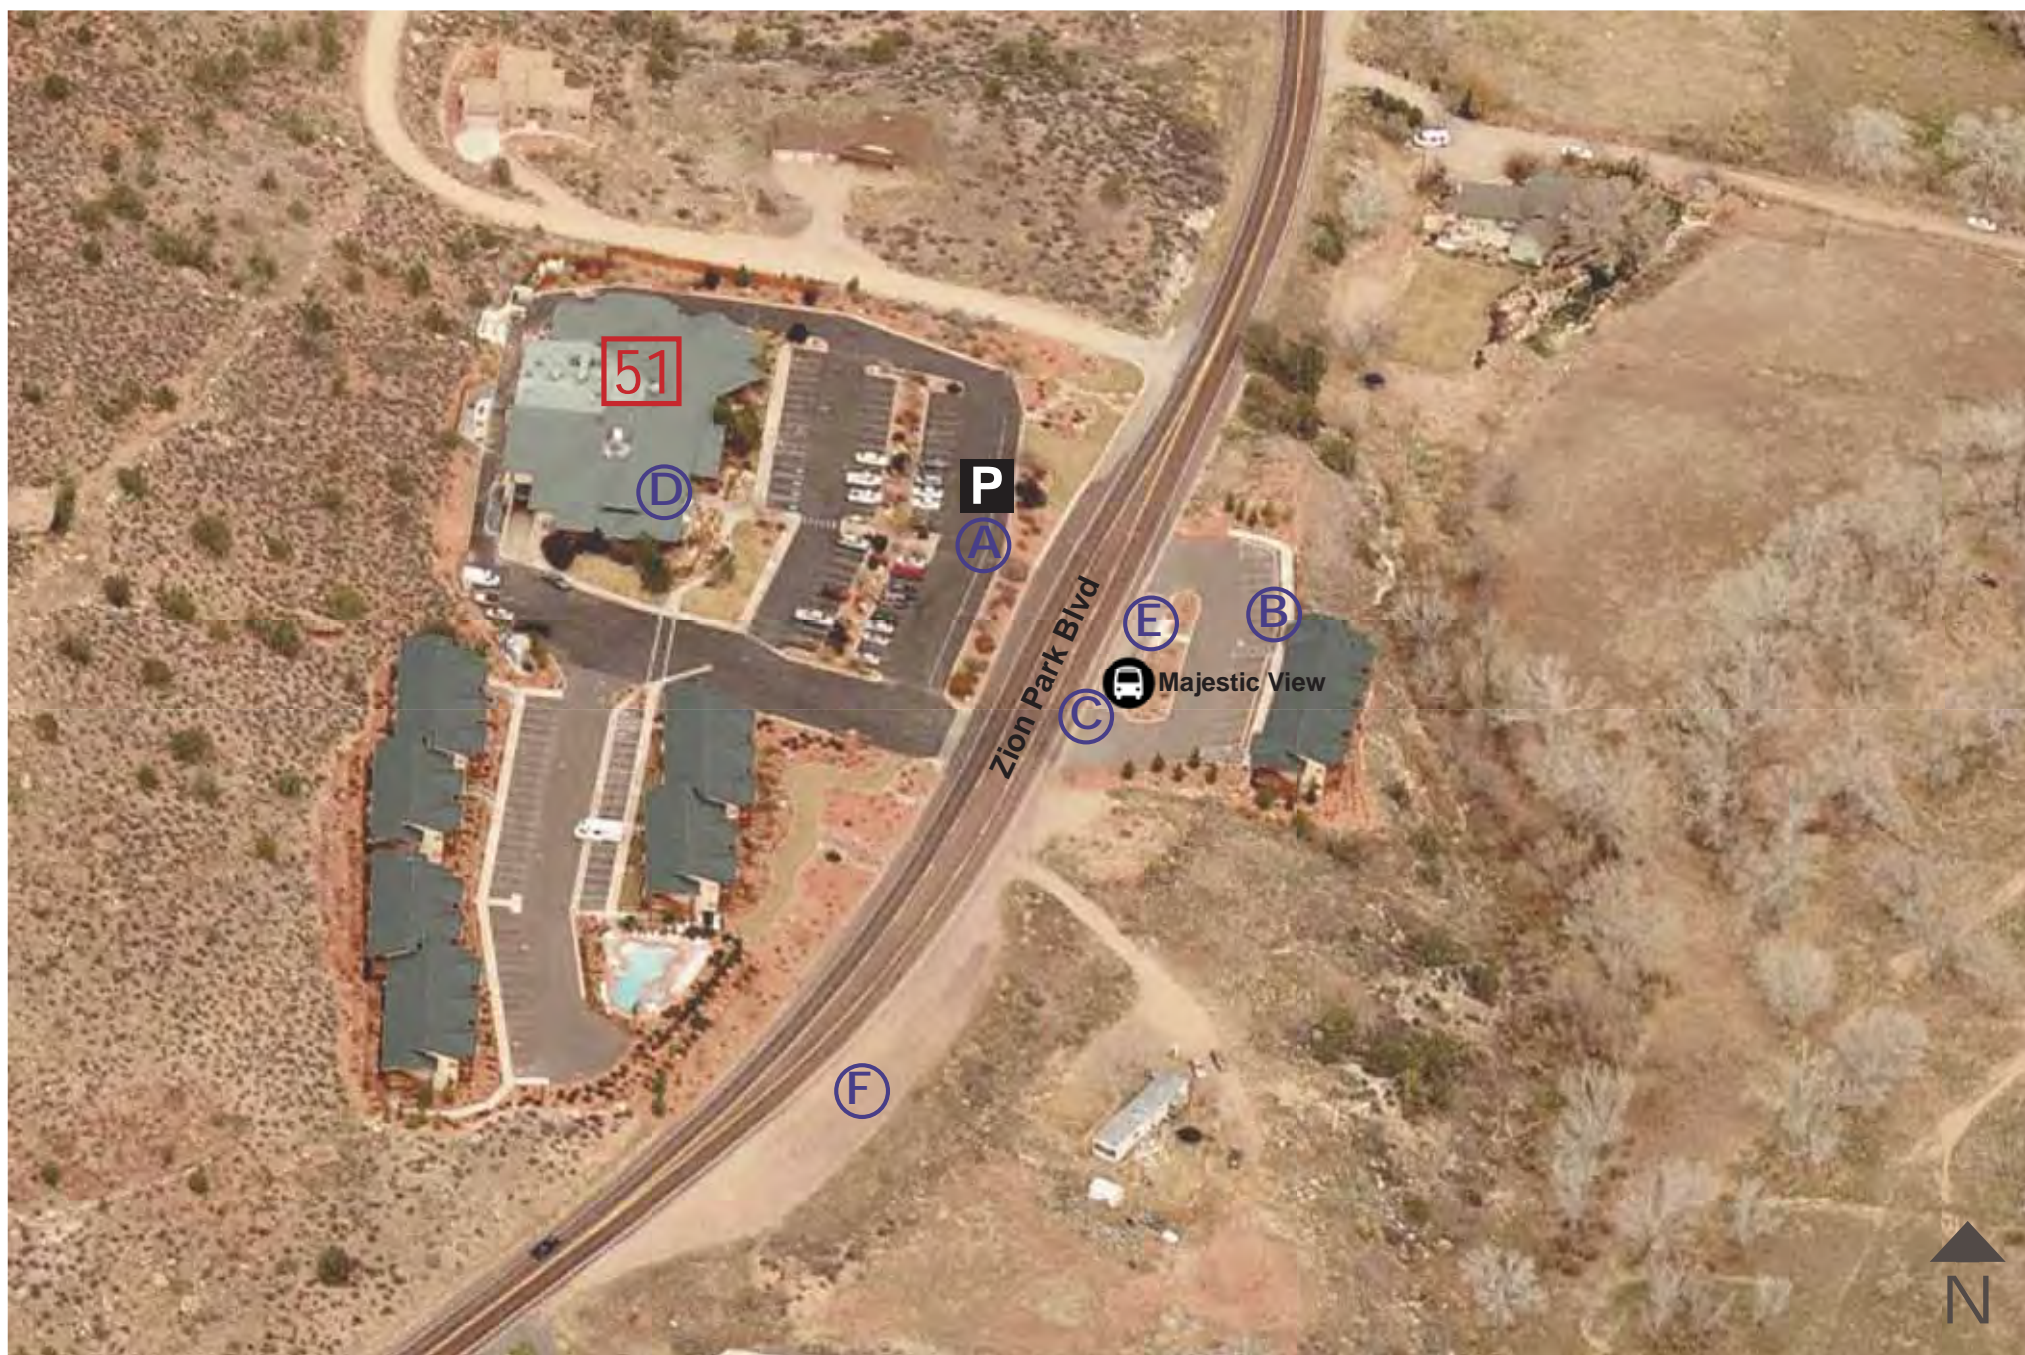
Zion Park Boulevard - 51 Majestic View Hotel

- Ⓐ Springdale Loop park and ride spaces are adjacent to the road but on the opposite side of the road from the Shuttle Stop. No sidewalk connection or crosswalk exist from the park parking spaces to the stop across Zion Park Blvd. These parking spaces are not clearly identified for visitors driving into town.
- Ⓑ 8-1/2 x 11 laminated paper signs identify these parking spaces as reserved for hotel guests only. There are 15 spaces with 13 rooms in this building. Overall, adjacent parking to the Shuttle Stop is lacking.

- Ⓒ The most southern stop on the Springdale Loop. Some visitors driving into town believe this may be the start of the Park shuttle, thus creating confusion that the hotel room building adjacent to the parking lot is the park visitor center.

- Ⓓ Once or twice a year, sandwich board signs are placed in the parking lots to deter out-of-town visitors from parking in the hotel guest spaces. Other than these one or two times a year, drive-in park visitors typically don't use up more spaces than what the Majestic View has available. Hotel guests most often use the shuttle to get to town and the park.

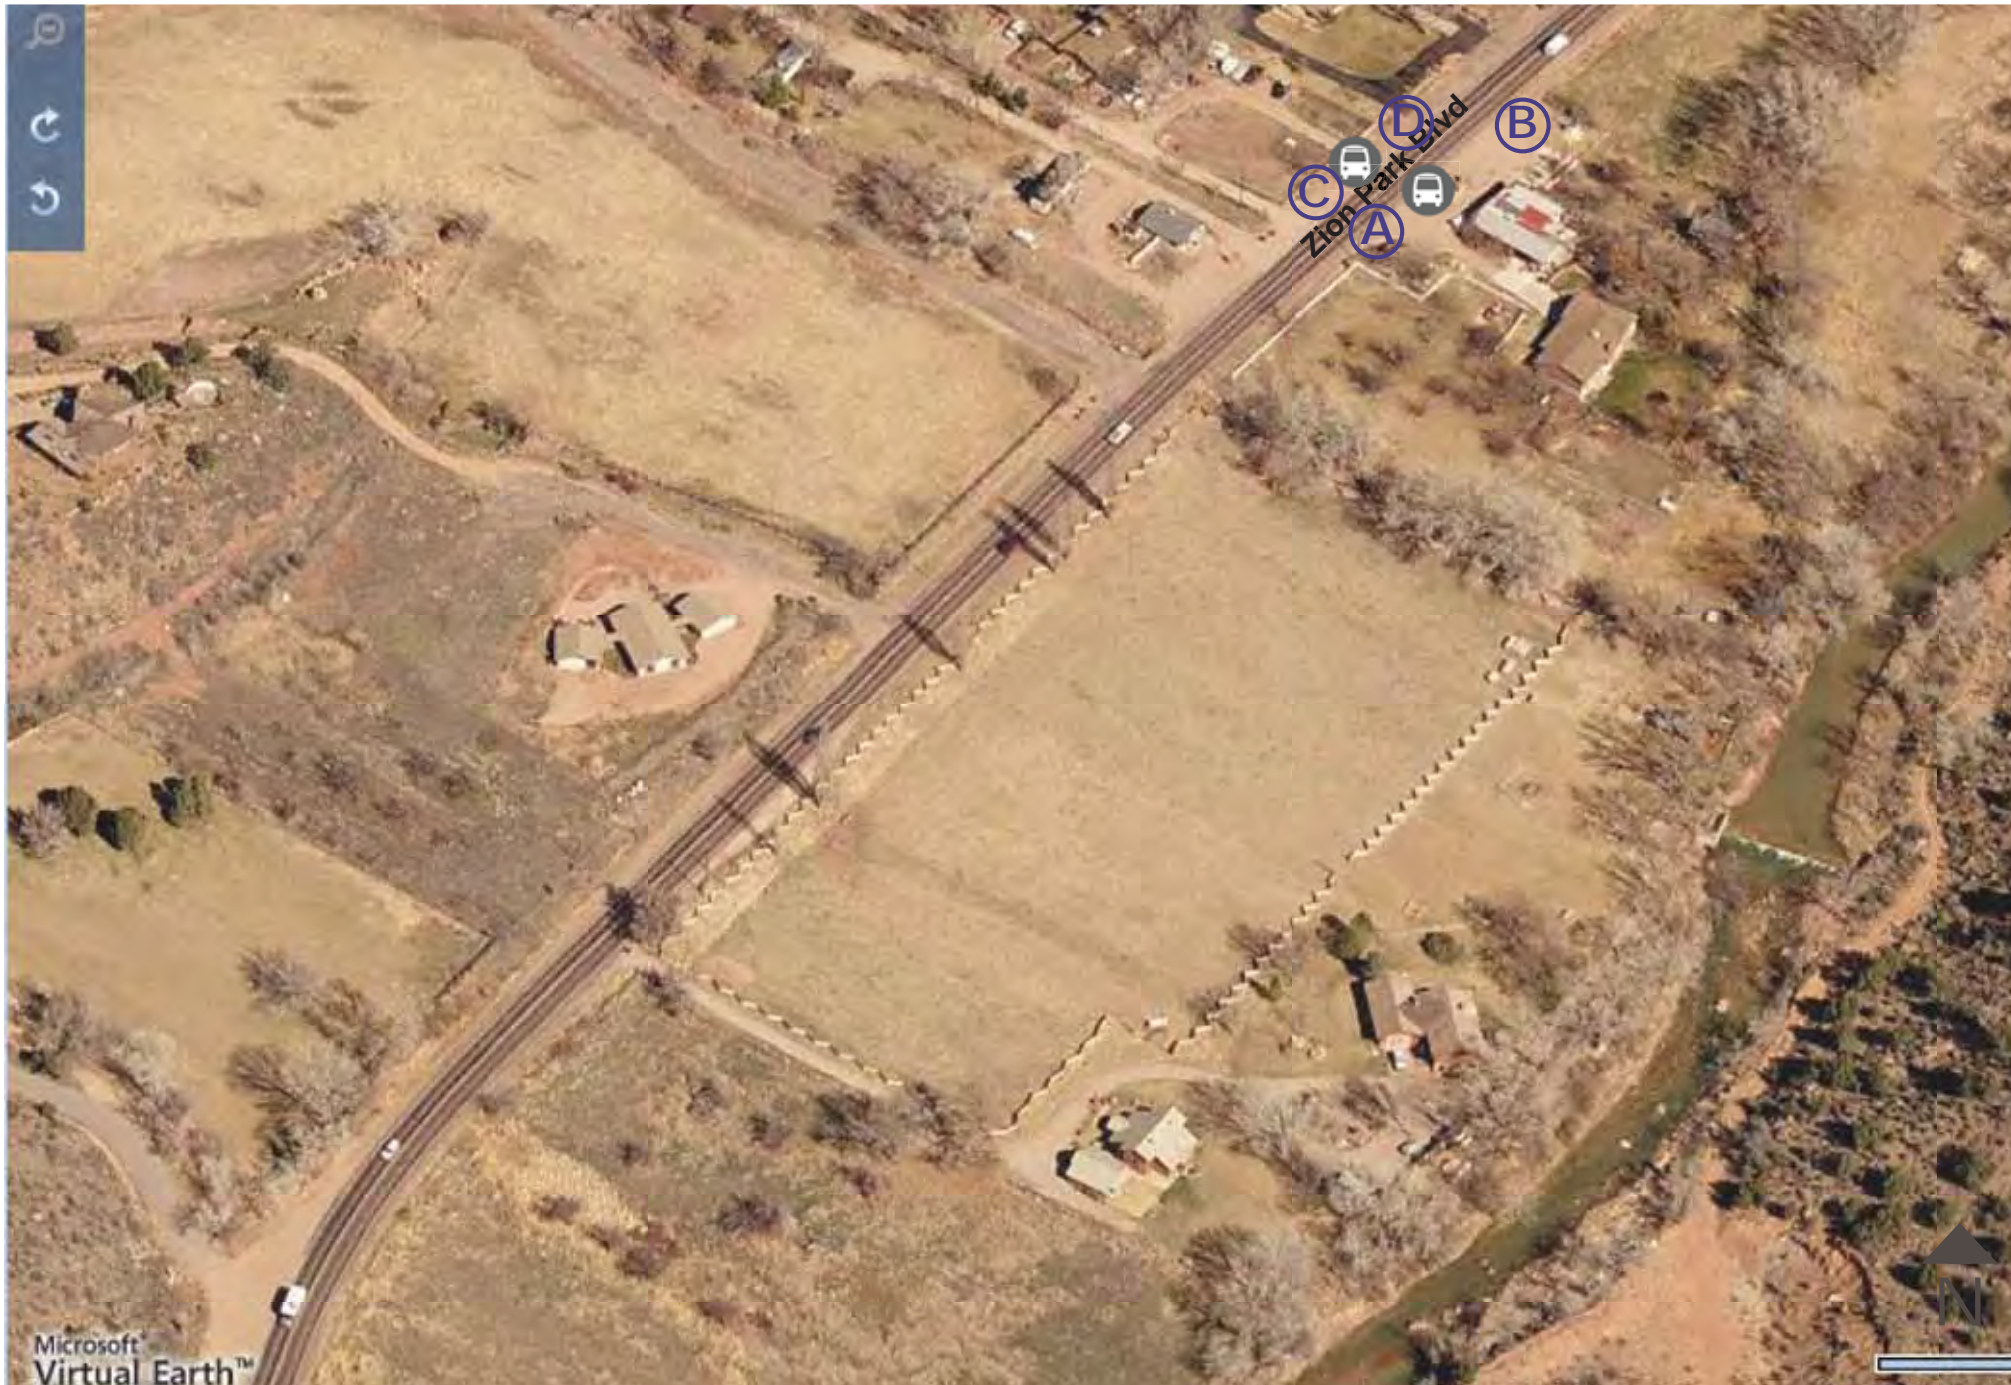
Silver Bear Flag Stop

- Ⓐ No parking spaces exist for Park visitor use in association with this flag stop.
- Ⓑ Infrequently people park at the Silver Bear unknowing that there are designated parking locations in other areas of Springdale.

- Ⓒ Undeveloped Shuttle Stop. No sidewalks, crosswalks, curb/gutter, or sidewalk/roadway separation exists.
- Ⓓ This Shuttle Stop is used by mostly local residents.

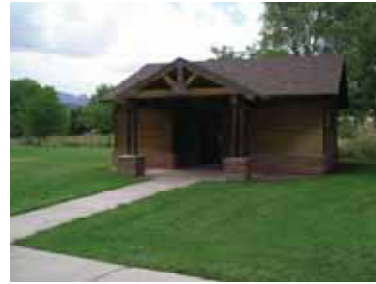
Park Restrooms - C

- Ⓐ Pleasant City park off Zion Park Blvd. Great stop for incoming visitors to stop, have a picnic, and stretch their legs before moving further into town.
- Ⓑ Parking space layout is unmarked and confusing. Some visitors parallel parked, some parked on an angle, and some parked straight in.
- Ⓒ Restroom makes this a good stop for visitors driving from great distances.
- Ⓓ Zion Adventures uses the roadside dirt area north of the park entrance for river raft pick up.
- Ⓔ No sidewalk connection exists between River Park and the Driftwood/Quality Inn Shuttle Stop.

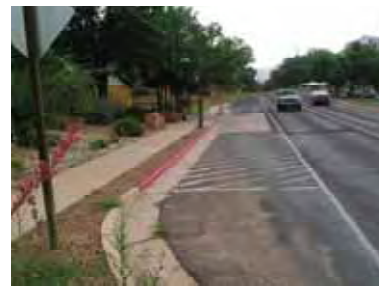
Shuttle Stop - Looking North - F

- Ⓔ All four of the identified locations on this map provide safe pedestrian travel ways to the Shuttle Stops.
- Ⓕ The Shuttle Stop shelters, sidewalks, and Shuttle Stop features (both northbound and southbound) are in good condition. Cleaning and minor maintenance upkeep is necessary.

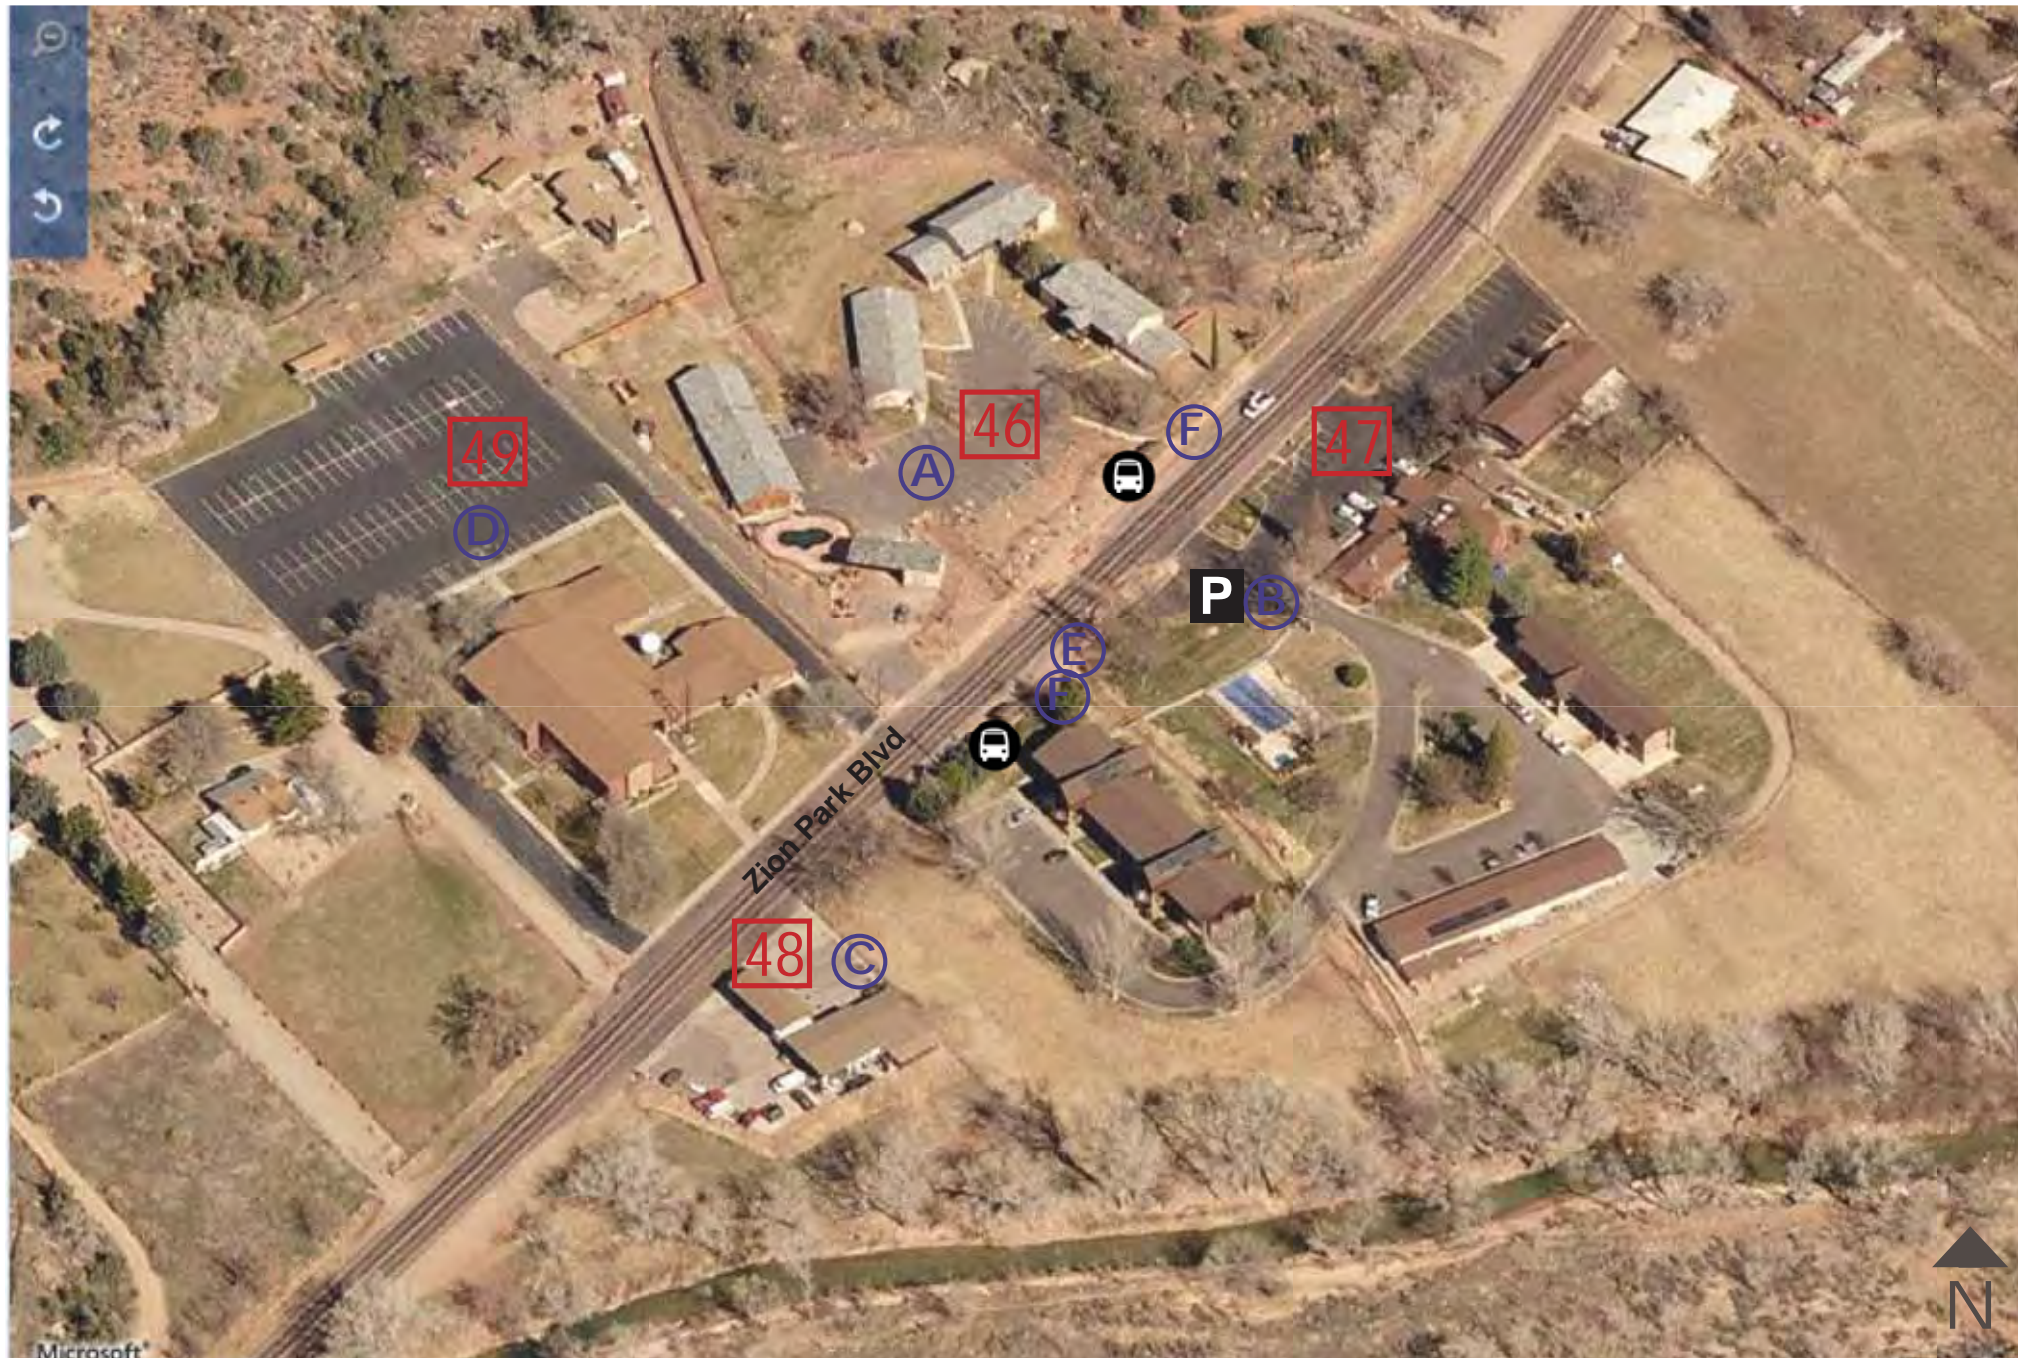
Zion Park Boulevard - 46 Quality Inn - Montclair, 47 Driftwood, 48 Chevron, 49 LDS Church

- Ⓐ 46 - Shuttle parking is not provided or was not clearly identified at Quality Inn & Suites Montclair. A good sidewalk connection exists from the southbound Shuttle Stop to the hotel parking lot.
- Ⓑ 47 - Driftwood Inn provides shuttle parking spaces. These spaces are identified with colored concrete and blue signage. Seven of the spaces are located adjacent to the northbound Shuttle Stop. The other shuttle parking spaces are located at the north end of the hotel parking lot.
- Ⓒ 48 - Chevron does not allow parking for shuttle users. Sometimes the attendant must notify parking visitors to move their car to the Driftwood Inn.
- Ⓓ 49 - The LDS Church has a large lot but has not identified spaces for shuttle parking. Signs are posted stating "No Overnight Parking."

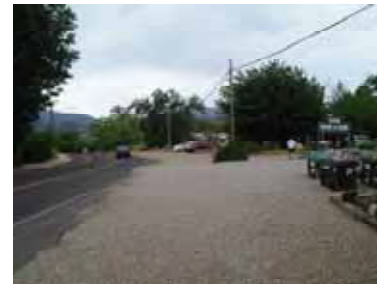
Zion Rock and Gem - Looking South - C

- Ⓐ Shuttle parking is not identified at either Zion Rock and Gem or Bike Zion.
- Ⓑ A wide roadway shoulder on the west side of the road provides ample parking for the businesses.
- Ⓒ The pedestrian environment is a rural, unimproved condition and is not conducive for safe pedestrian movement.

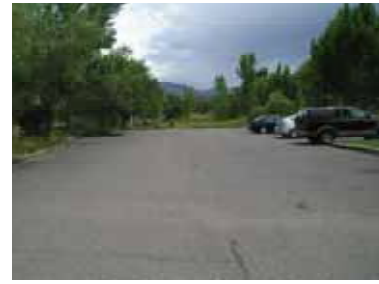
Bit & Spur Parking Lot - Looking South - B

- Ⓐ Shuttle parking are identified at the Zion Park Inn.
- Ⓑ The Bit & Spur provides a large quantity of daily spaces for visitor shuttle parking.
- Ⓒ The Zion Park Inn has constructed a great walkway offset from the road extending from the southern property edge to the northern property edge, but falling short of the Shuttle Stop.

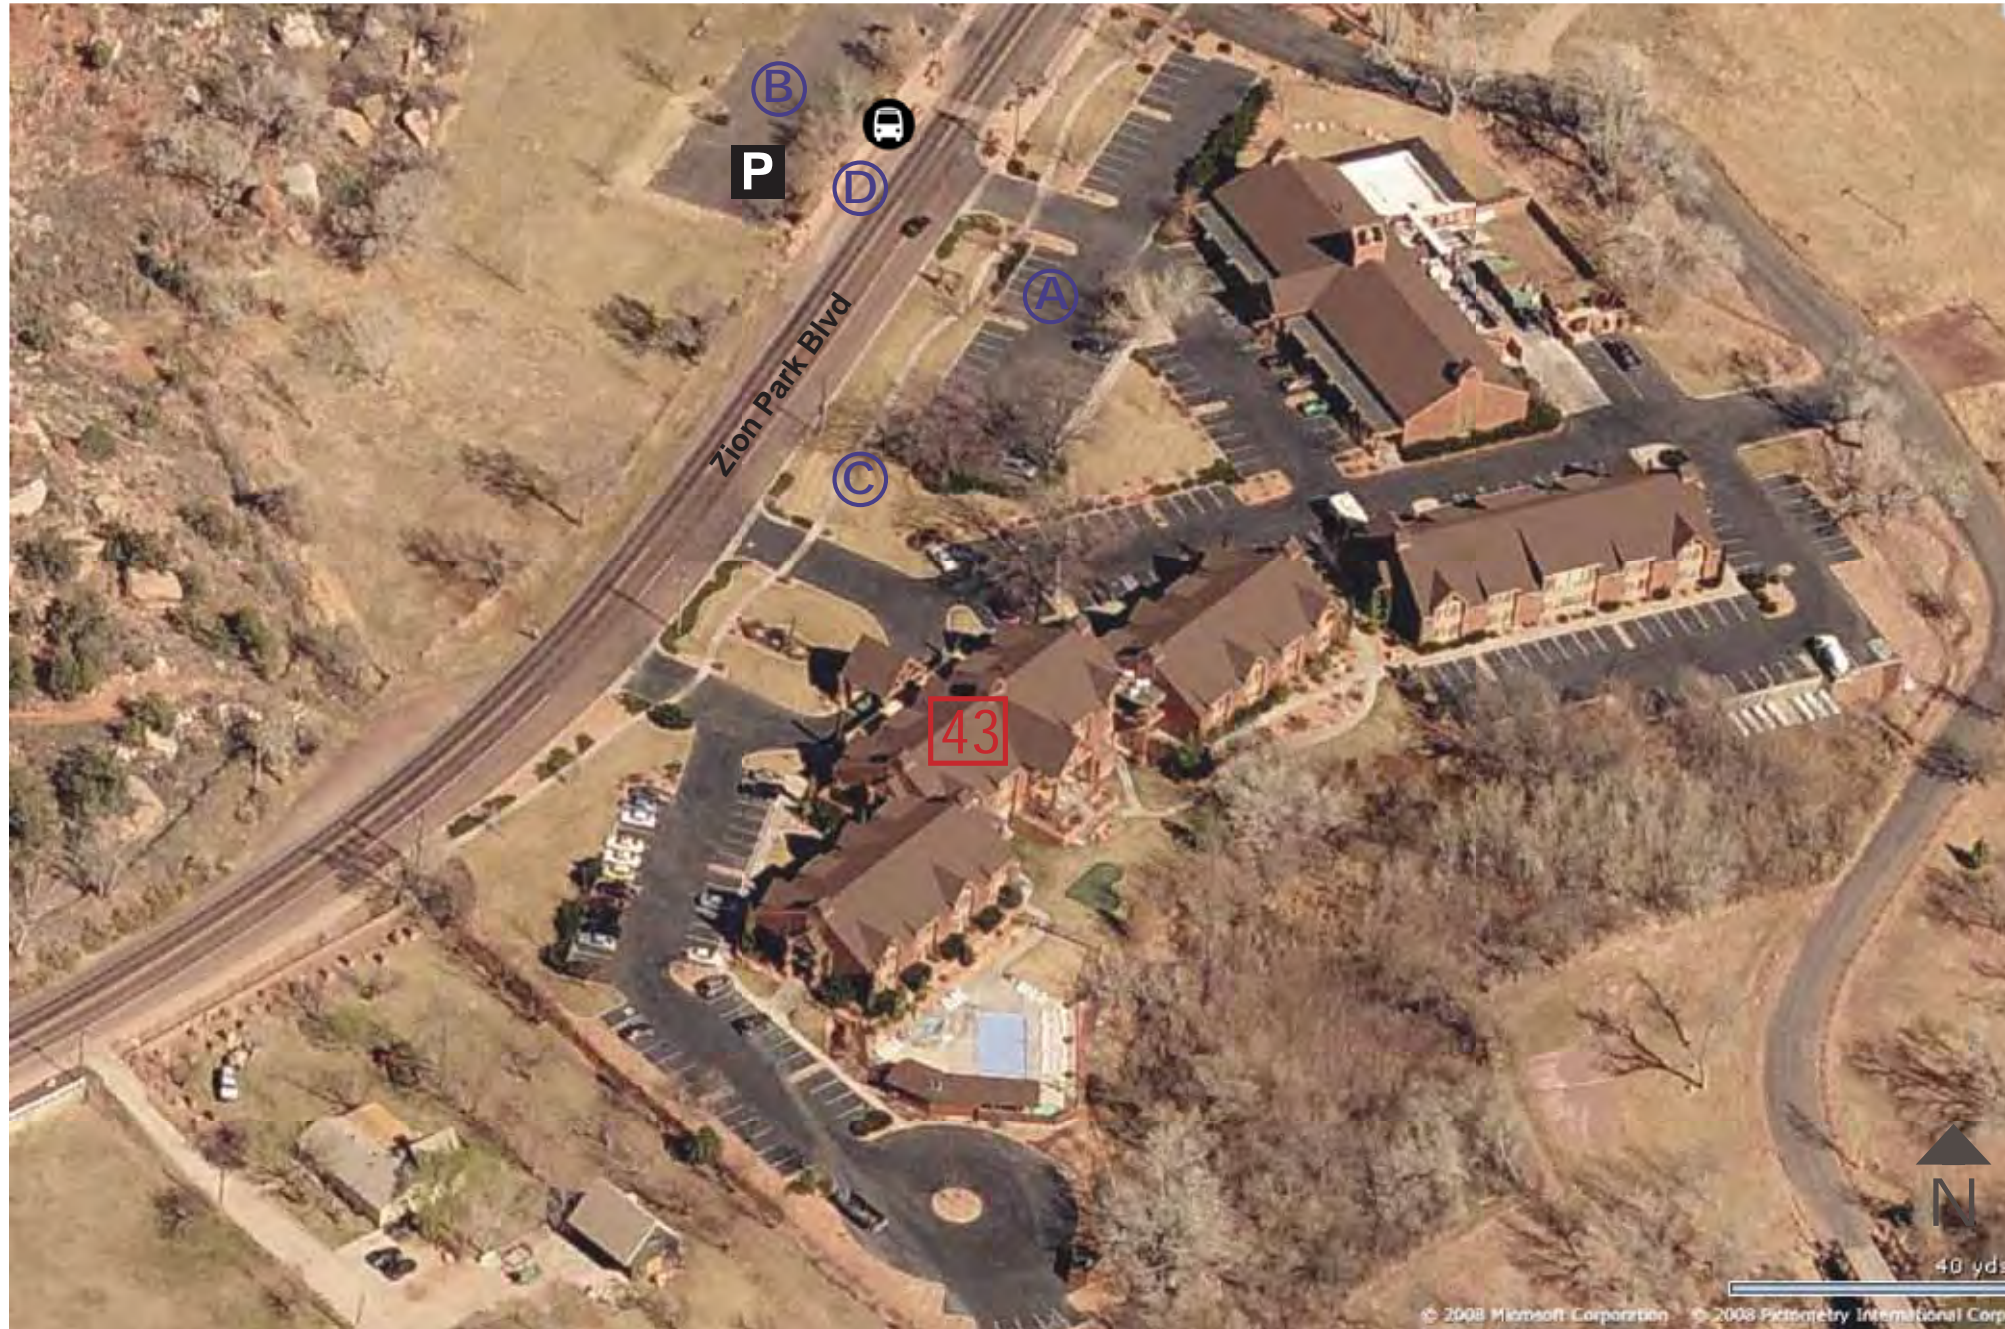
Zion Park Boulevard - 43 Zion Park Inn

- Ⓓ Adequate street improvements exist at the southbound Shuttle Stop. One missing pedestrian connection is the Bit & Spur parking lot to the roadside sidewalk at the southbound Shuttle Stop location.

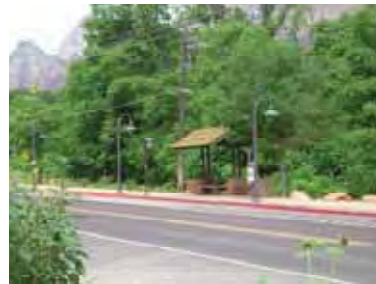
Zion Park Inn Shuttle Stop - E

- Ⓓ Adequate street improvements exist at the southbound Shuttle Stop. One missing connection is the Bit & Spur parking lot to the roadside sidewalk at the southbound Shuttle Stop location.
- Ⓔ The northbound Shuttle Stop is separated from the southbound Shuttle Stop location. The northbound stop is isolated and has no direct connection with adjacent business or residential areas.
- Ⓕ The Shuttle Stop shelters, sidewalks, and Shuttle Stop features (both northbound and southbound) are in good condition. Cleaning and minor maintenance upkeep is necessary.

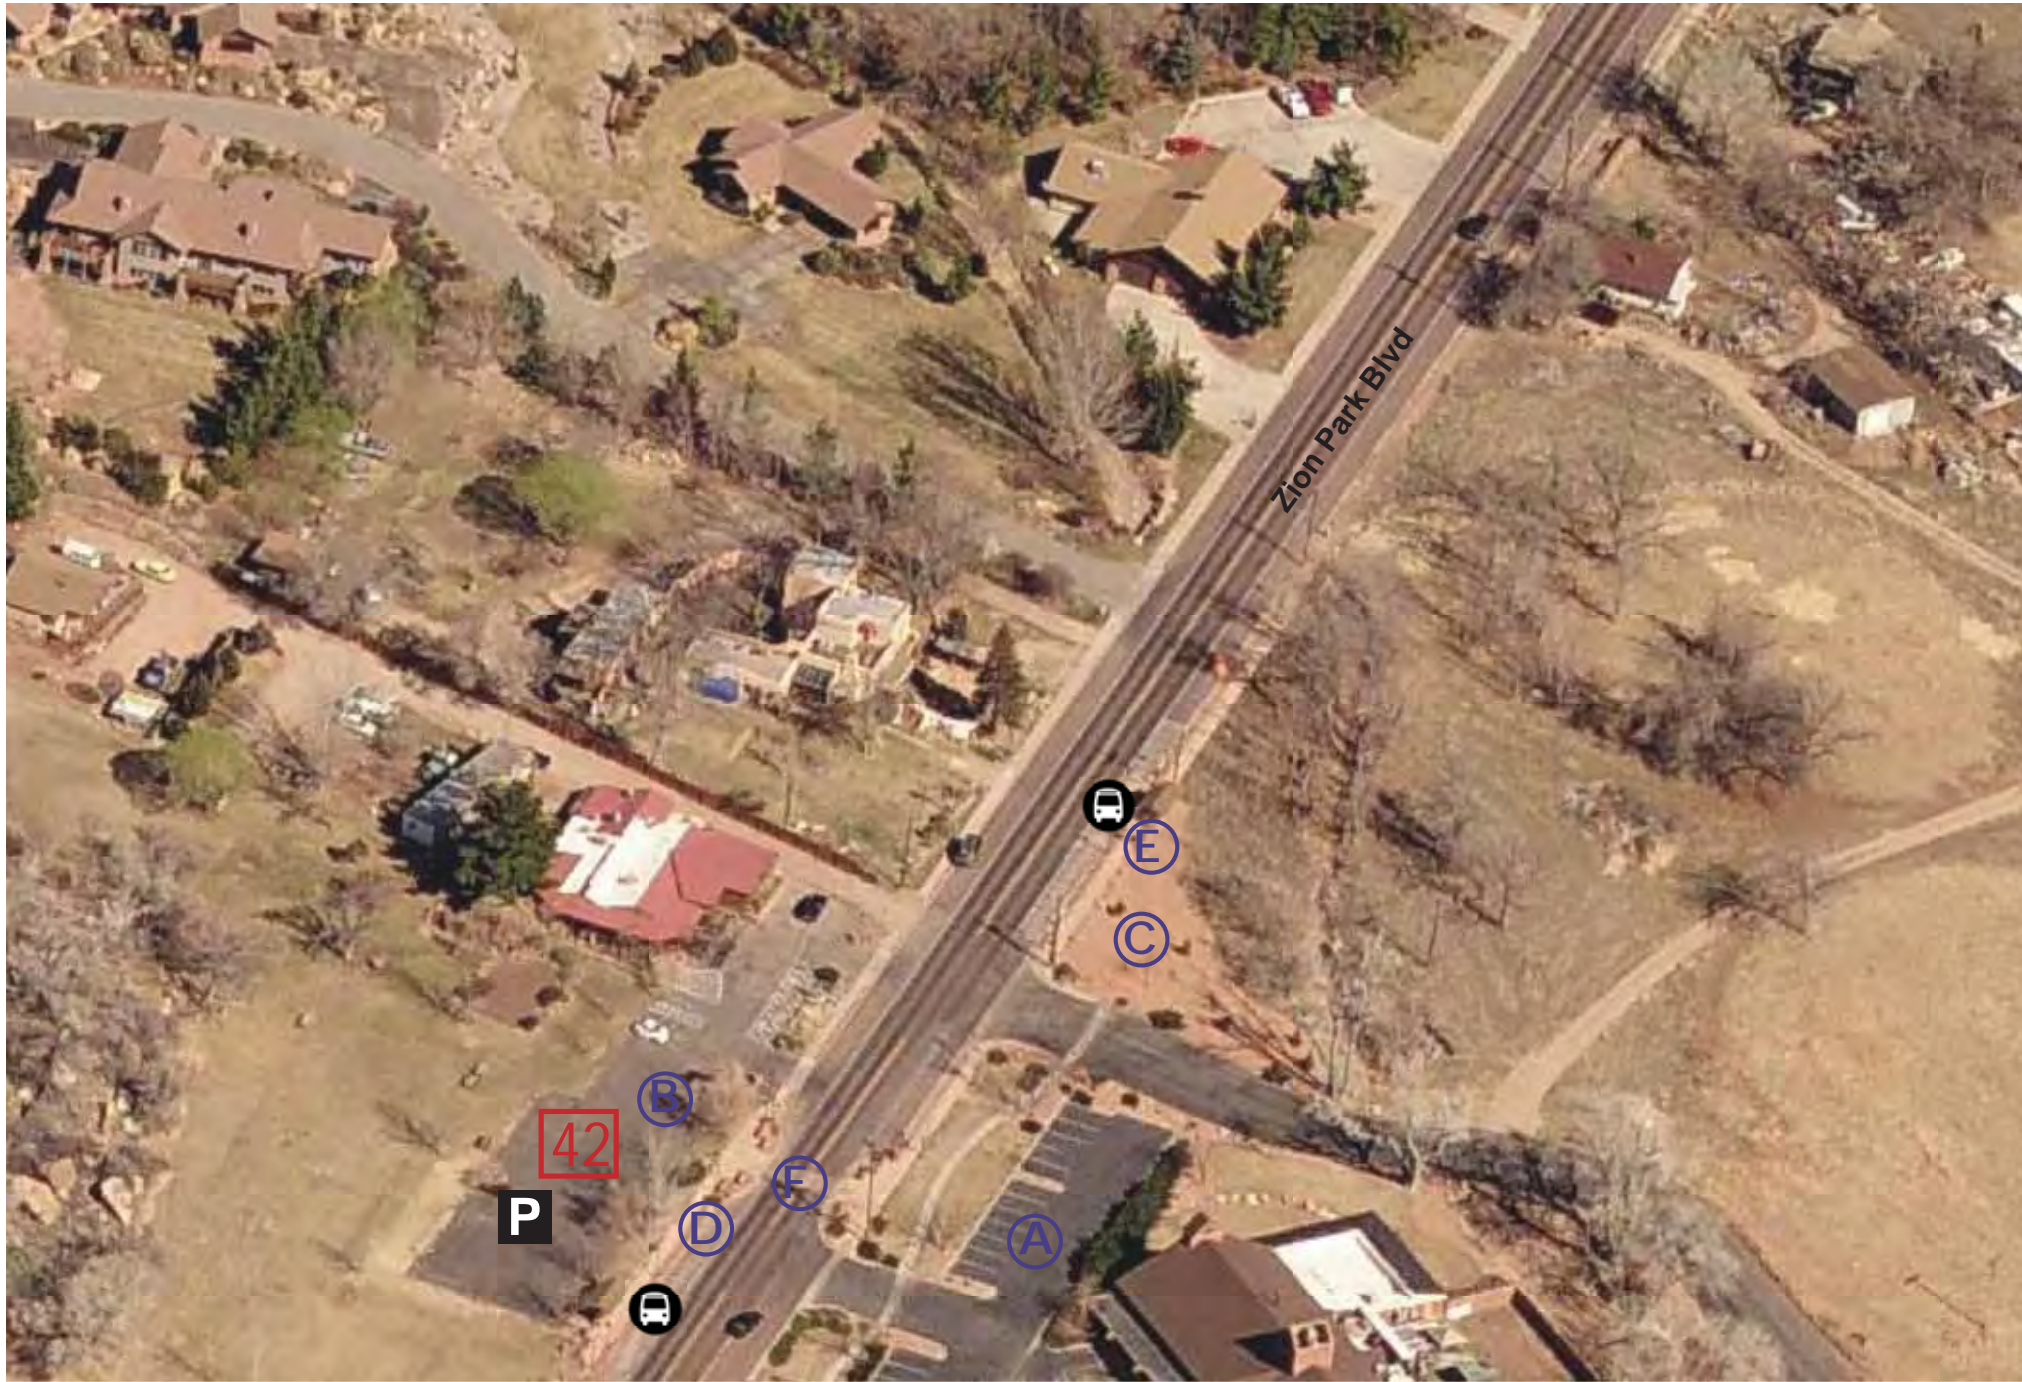
Zion Park Boulevard - 42 Bit & Spur

- Ⓐ Shuttle parking for drive in visitors is not designated at the Zion Park Inn.
- Ⓑ The Bit & Spur provides a large quantity of daily spaces for visitor shuttle parking.
- Ⓒ The Zion Park Inn offset walkway does not connect with the northbound Shuttle Stop. A sidewalk adjacent to the roadway connects the Zion Park Inn walkway with the Shuttle Stop.

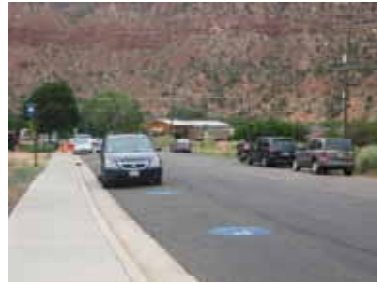
Lion Blvd - Looking West - A

- (A) Lion Blvd. provides plenty of parallel parking spaces along both sides of the road. Zion Adventures may sometimes cone off a few spaces to park vans and trailers for loading and unloading.

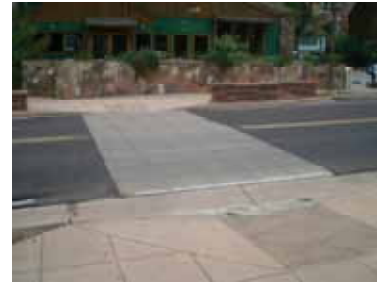
Crosswalk - Looking West - K

- (H) Sidewalk ends just north of Flanigans (Spotted Dog Restaurant). No sidewalk between Flanigans and Cliffrose flag stop.
- (I) Curb on south edge of driveway is broken and cracking, in need of repair.
- (J) Bulbout at crosswalk is in very good condition. Sidewalk nice and wide here.
- (K) Crosswalk concrete is cracking, could be made more visible.
- (L) Bent culvert located here. Recommend removing culvert.
- (M) Concrete curb/gutter begins here and continues north.
- (N) Access across Koritas/Quality Inn driveway is not ADA compliant.
- (O) Unattractive assortment of remnant posts/poles and lack of vegetation just north of Koritas/Quality Inn driveway. Recommend improving this area
