APPENDIX A: SPRINGDALE STREETScape, PARKING, AND SHUTTLE STOP INVENTORY

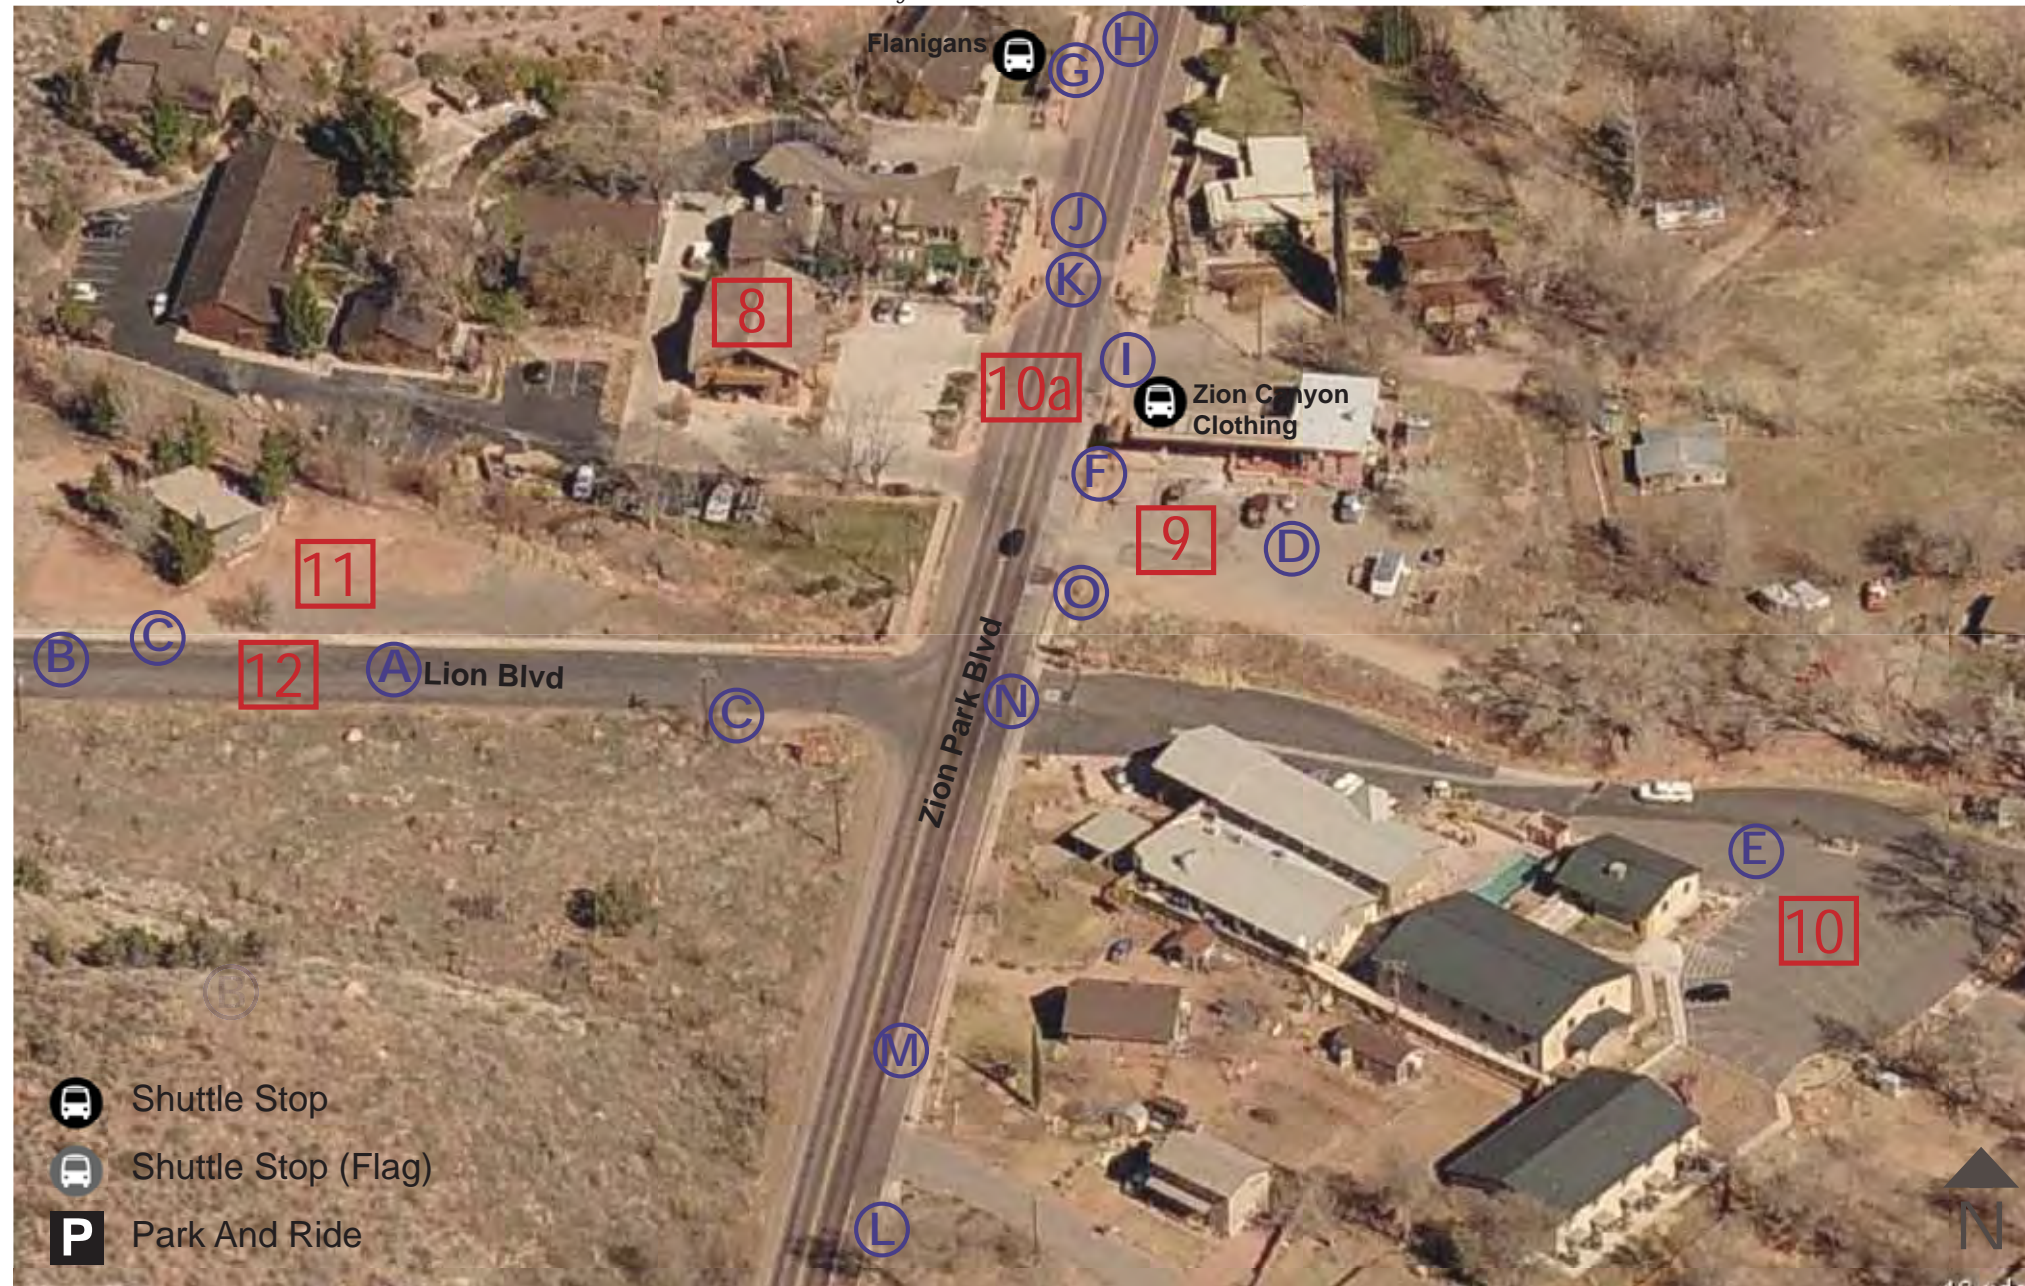
Zion Park Boulevard - **12** Lion Boulevard On-Street Parking, **11** Zion Adventures, **10a** On-Street Parking, **10** Koritas/Quality Inn, **9** Zion Canyon Clothing and Gift, **8** Flanigans

- (A) Lion Blvd. provides plenty of parallel parking spaces along both sides of the road. Zion Adventures may sometimes cone off a few spaces to park vans and trailers for loading and unloading.

- (B) The Lion Blvd. parallel parking spaces extend along the north side of the road from Zion Park Blvd. to the library and community center. A sidewalk provides a good pedestrian walkway along the north parking spaces, but it is a long walk from the spaces near the library to the nearest Shuttle Stops.

- (C) The sidewalk along Lion Blvd. needs vegetation maintenance and the south edge parking area at Zion Blvd. is without a sidewalk.
- (D) "No Parking" signs everywhere. Parking for customers only, but lots of space. Could easily reconfigure parking lot to get more spaces than current configuration.

- (E) No signs for shuttle parking. People would have to park behind motel. No "No Parking" signs either but one directing people to office before back of building. Best serves customers.

- (F) Shuttle route maps on sign are old and hard to read.
- (G) Driver remarked that this stop is difficult to get out of when people are turning in and out of Flanigan's parking lot. Many drivers wish the stop was just forward from the driveway.

- (H) Sidewalk ends just north of Flanigans (Spotted Dog Restaurant). No sidewalk between Flanigans and Cliffrose flag stop.
- (I) Curb on south edge of driveway is broken and cracking, in need of repair.
- (J) Bulbout at crosswalk is in very good condition. Sidewalk nice and wide here.
- (K) Crosswalk concrete is cracking, could be made more visible.
- (L) Bent culvert located here. Recommend removing culvert.
- (M) Concrete curb/gutter begins here and continues north.
- (N) Access across Koritas/Quality Inn driveway is not ADA compliant.
- (O) Unattractive assortment of remnant posts/poles and lack of vegetation just north of Koritas/Quality Inn driveway. Recommend improving this area

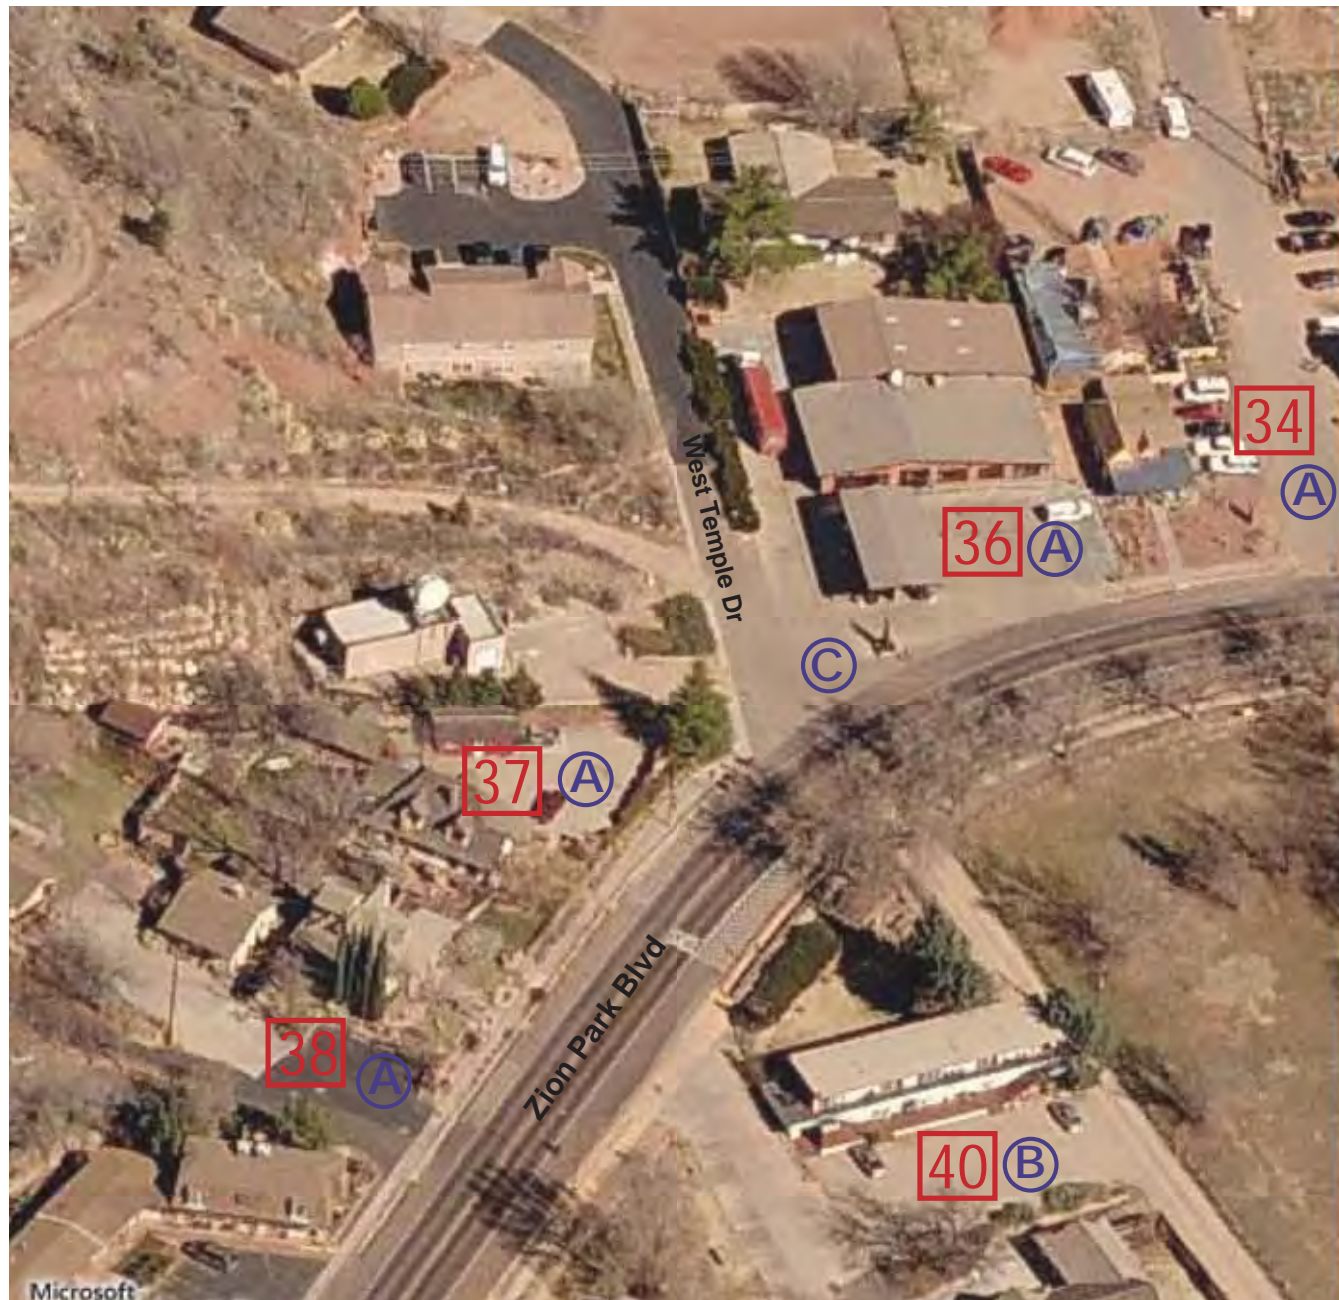
Zion Park Boulevard - 40 El Rio, 38 Red Rock Jewelry and B&B, 37 Under the Eaves, 36 Shell Station, 34 Lazy Lizards/Oscars

- Ⓐ Parking for customers at businesses. Not enough parking stalls available for shuttle use.
- Ⓑ Del Rio lacks signage indicating who can use the parking lot. This is a small lot with poor visibility from the street.

- Ⓒ Sidewalk gap between West Temple Drive and Lazy Lizards. It is currently a concrete surfaced drive entrance for the Shell Station. Concrete is spalling in many areas presumably due to heavy amount of vehicular traffic circulating in and out of business.

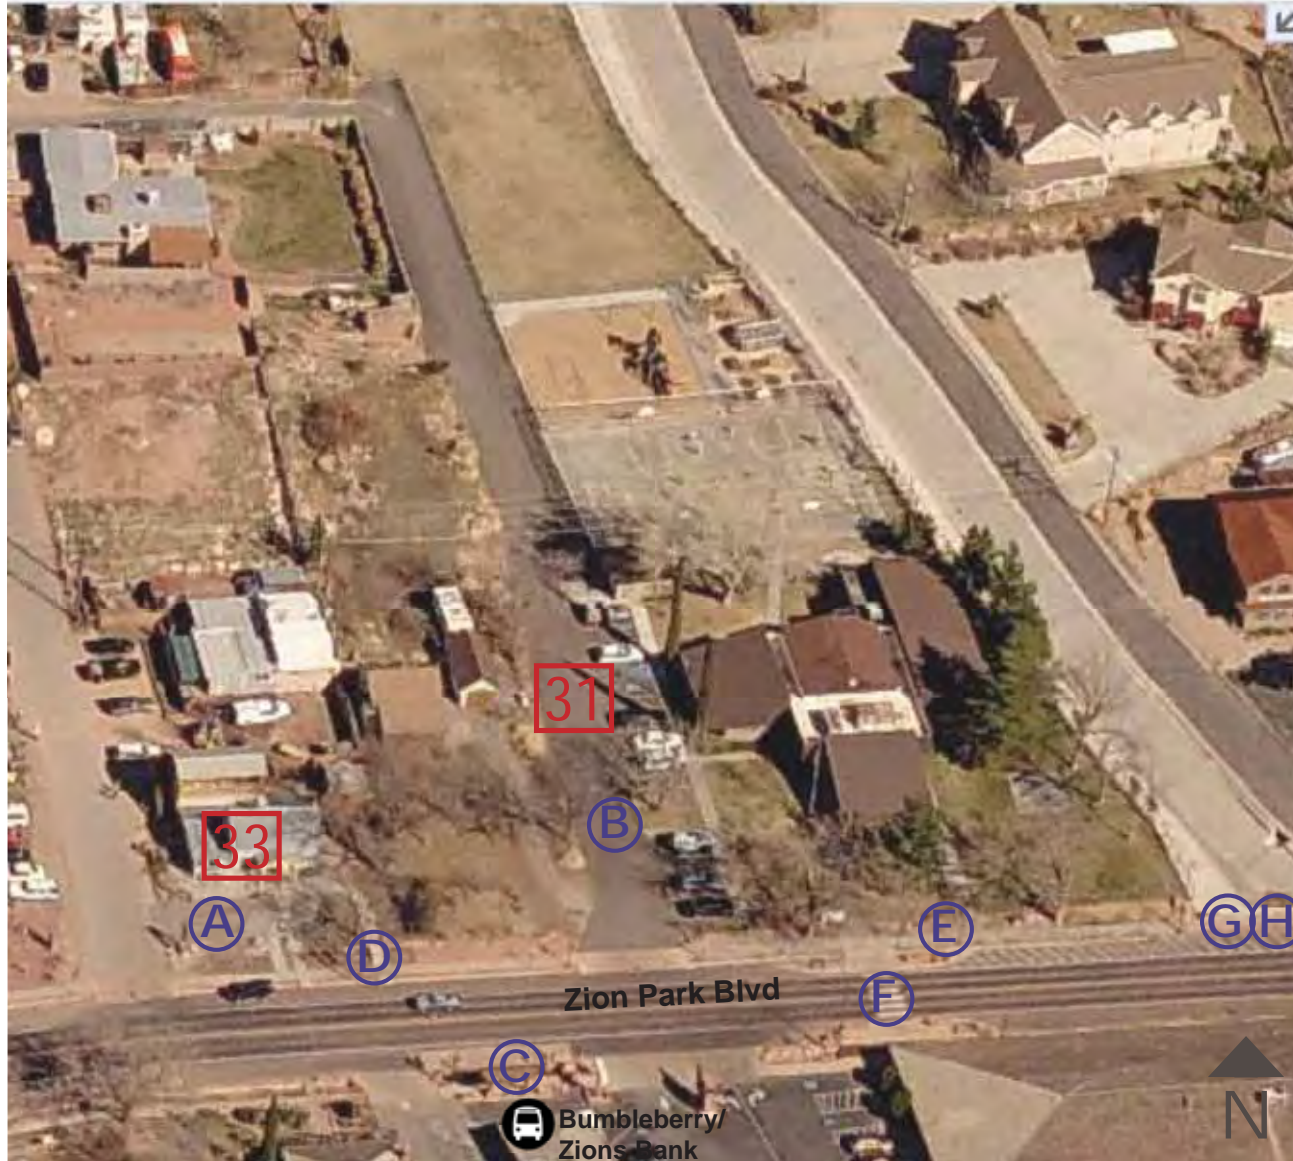
Zion Park Boulevard - **33** Mean Bean, **31** Springdale Elementary School

- Ⓐ Parking at Mean Bean is limited, used by customers.
- Ⓑ Parking availability at school fluctuates between seasons. Best kept for school use.

- Ⓓ Sidewalk from Shell Station to Springdale Elementary Drive is narrow, approximately four feet wide with narrow gravel band, sandstone curb and gutter, and an asphalt parking lane. All are in fair/good condition, exhibiting some wear and tear. Asphalt edge along gutter is not eroding as much at this location as compared to others.
- Ⓔ Sidewalk from Springdale Elementary Driveway to ditch is approximately five to six feet wide with narrow gravel band, sandstone curb and gutter, and an asphalt parking lane. All are in good condition. Street parking is restricted along school frontage.
- Ⓕ Crosswalk is beginning to fade. Concrete bulbout is in good condition. Gravel beginning to wear away in planting beds.
- Ⓖ Sidewalk at ditch is approximately four feet wide with concrete curb, in good condition. Street parking is not permitted here.
- Ⓗ Flashing school speed limit sign here - 20 mph

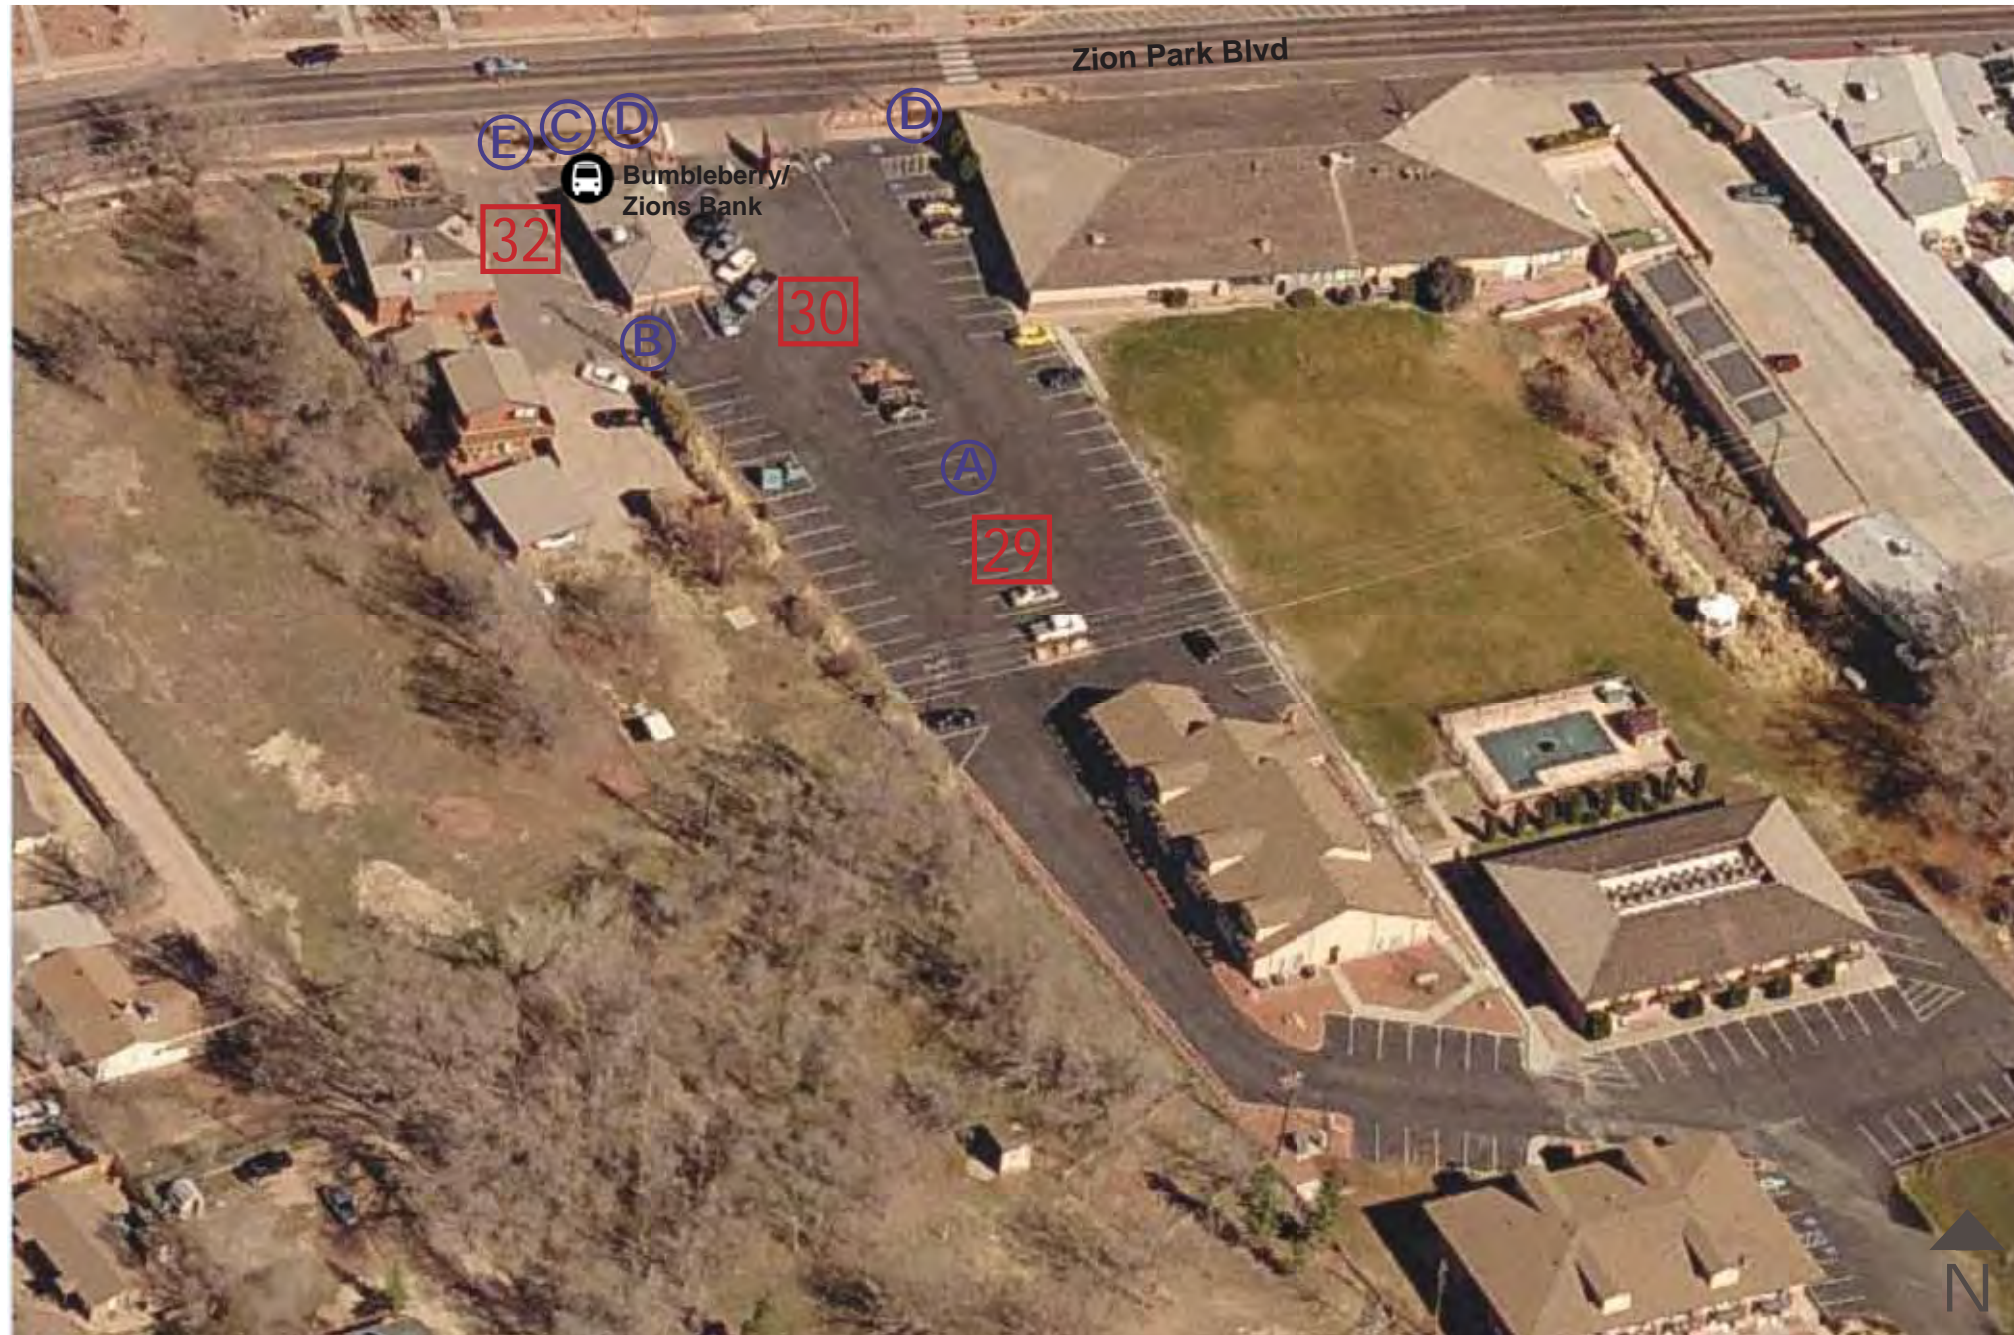
Zion Park Boulevard - **32** Canyon Offerings, **30** Zions Bank, **29** Bumbleberry

- Ⓐ There are a number of signs in the Bumbleberry parking lot that indicate it is for customer parking only. It is clearly defined who can park here. If shuttle users are allowed to park here it should be clearly indicated.
- Ⓑ The Zions Bank and Canyon Offerings parking lots are fairly small and best serve customers.

- Ⓒ The Bumbleberry/Zions Bank shuttle stop is located at a blind curve and drivers have commented that it is a dangerous spot to pull out of. The ground plane at this location also tilts drastically toward sidewalk, making it challenging for passengers to embark and disembark. This Shuttle Stop has shelter in excellent condition. Many drivers and others have commented that relocating this Shuttle Stop to the front of the Zion Park Motel (28) would place it directly across the road from Pizza & Noodle. This could potentially increase safety and legibility.

- Ⓓ The boardwalk covering the sandstone ditch at this location has unstable boards and the slats are wide which creates difficulty for strollers, wheelchairs, etc.
- Ⓔ Flashing school speed limit sign here - 20 mph

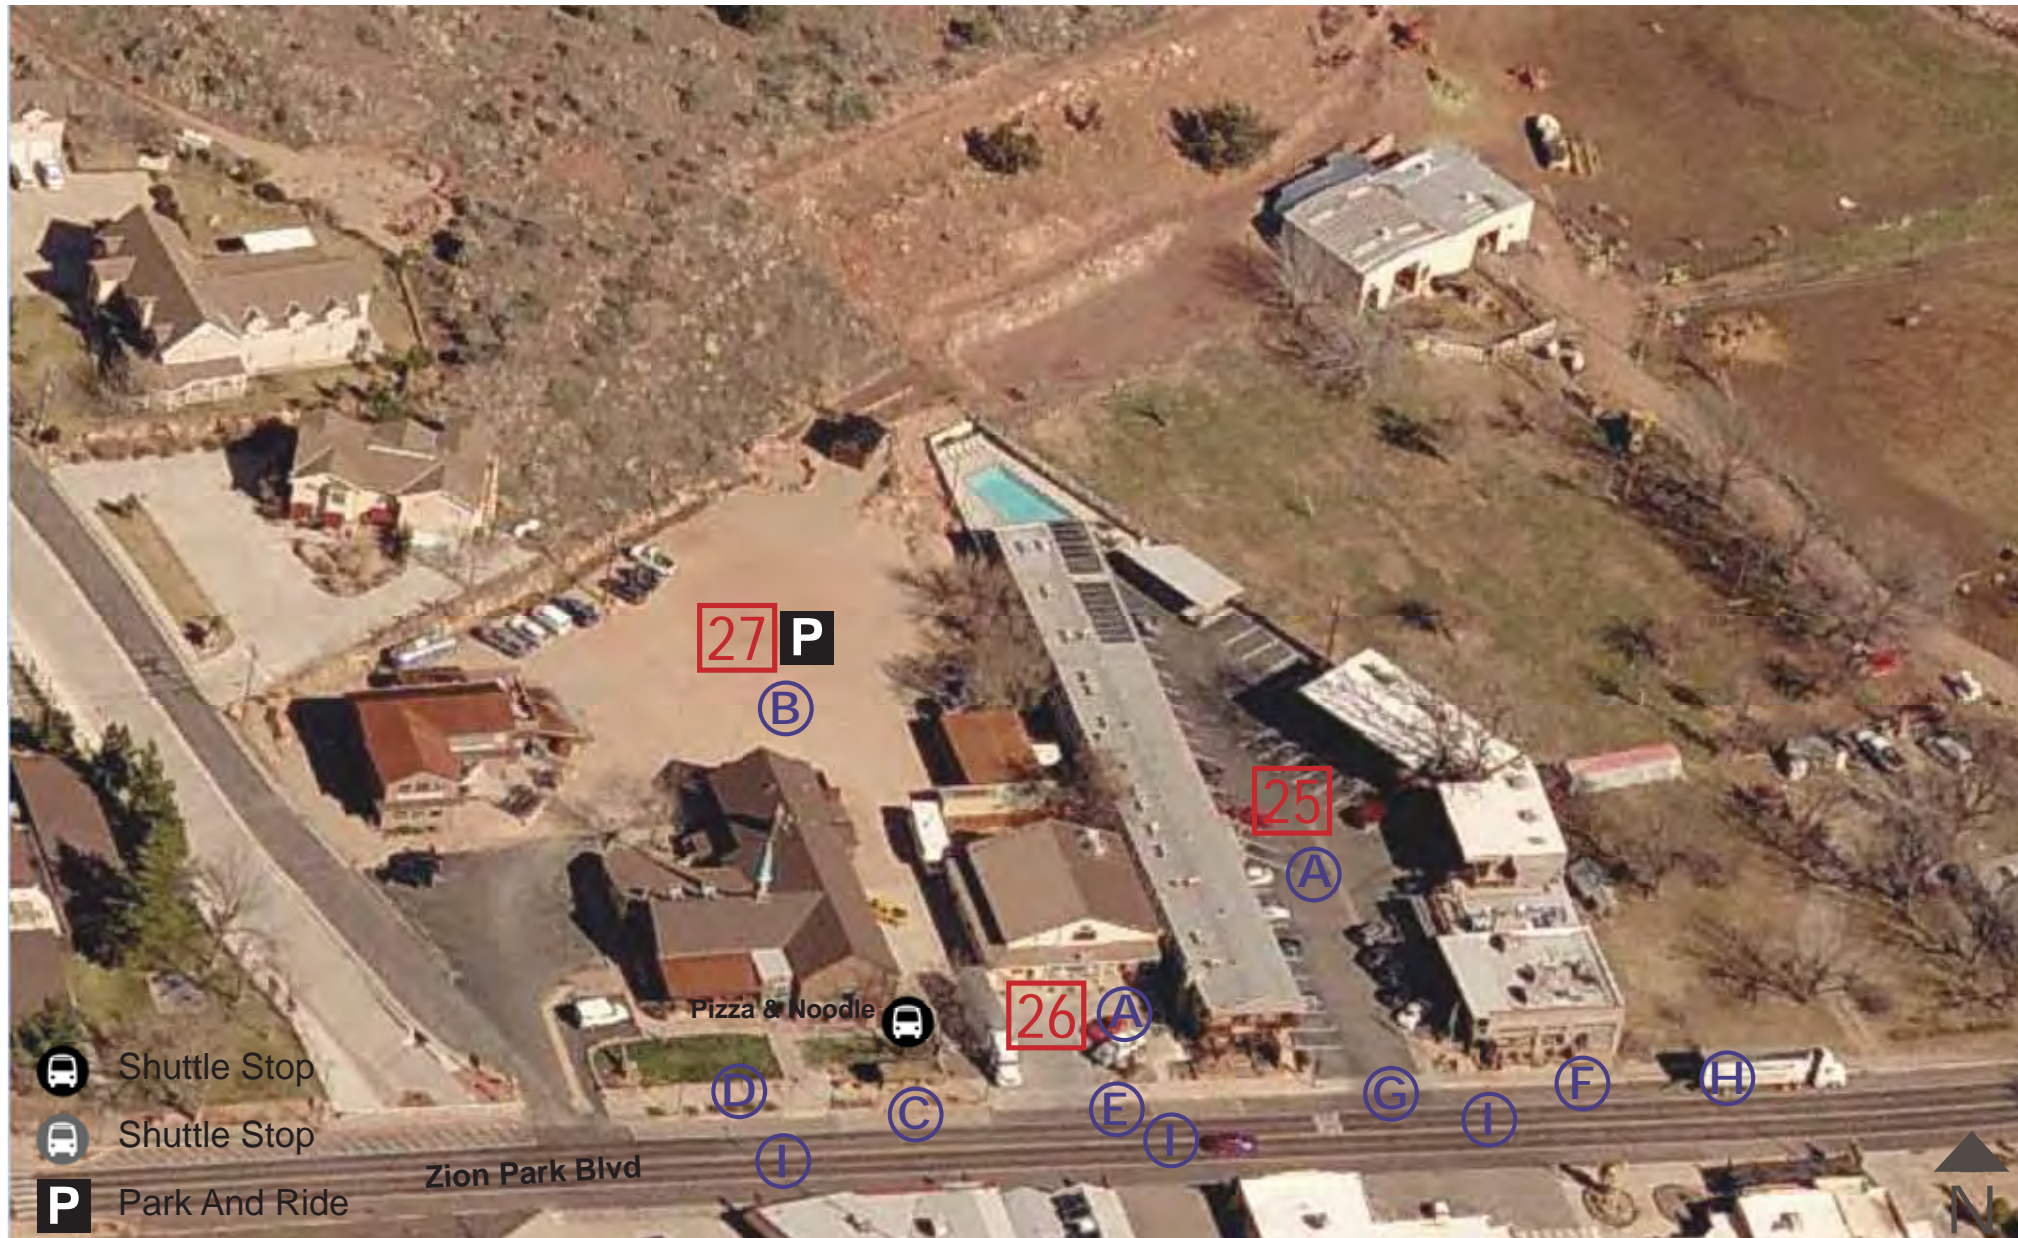
Zion Park Boulevard - **27** Pizza Noodle Complex, **26** Zion Park Deli, **25** Pioneer Lodge

- (A)** Parking at Pioneer Lodge and Zion Park Deli best serves customers due to size and because lodge guests can keep car parked and use shuttle.
- (B)** Park and Ride sign for Zion Pizza & Noodle is small, difficult to spot from vehicle unless driver knows what they are looking for. Parking lot is dirt with a few no parking signs placed at entrance, which may deter some visitors. It is not clear where people can park to use shuttle. No arrow on sign indicating where park and ride is located specifically.

- (C)** Concrete shuttle pad is eroding and cracking. "Zion Pack Day Trips" sign on pole is faded and cracked. Shuttle route map on shelter is faded and ripped. Information kiosk is hard to spot, blocked by vegetation. Shelter is in excellent condition, with ample seating.

- (D)** Sidewalk is approximately ten feet wide at Shuttle Stop and narrows at driveway apron to Zion Park Deli. In good condition.
- (E)** Cones on the sidewalk here to prevent cars from driving into sandstone curb and gutter. Sidewalk is eroding where it hangs over sandstone curb and gutter. There is no gravel strip between sidewalk and curb here. Curb and gutter are old, in fair condition.
- (F)** Sidewalk is in good condition here, approximately 5.5 feet at Pioneer Lodge and approximately four feet east of Pioneer Lodge.
- (G)** Concrete curb here, in excellent condition.
- (H)** Asphalt edge is eroding where it meets sandstone curb and gutter.
- (I)** A lot of pedestrian activity in this location. People cross at various locations. No crosswalk located here.

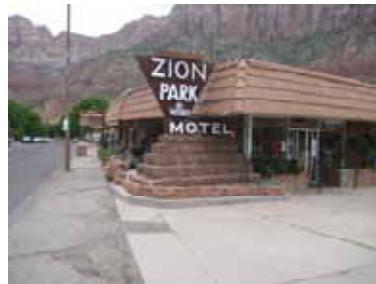
Looking East - C

- Ⓒ Sidewalk in fair/poor condition in driveway for Zion Park Motel parking.
- Ⓓ Sidewalk in fair/poor condition this area.
- Ⓔ Identified location for moving Zions Bank Shuttle Stop, see page A-15 for Zions Bank Shuttle Stop observations.

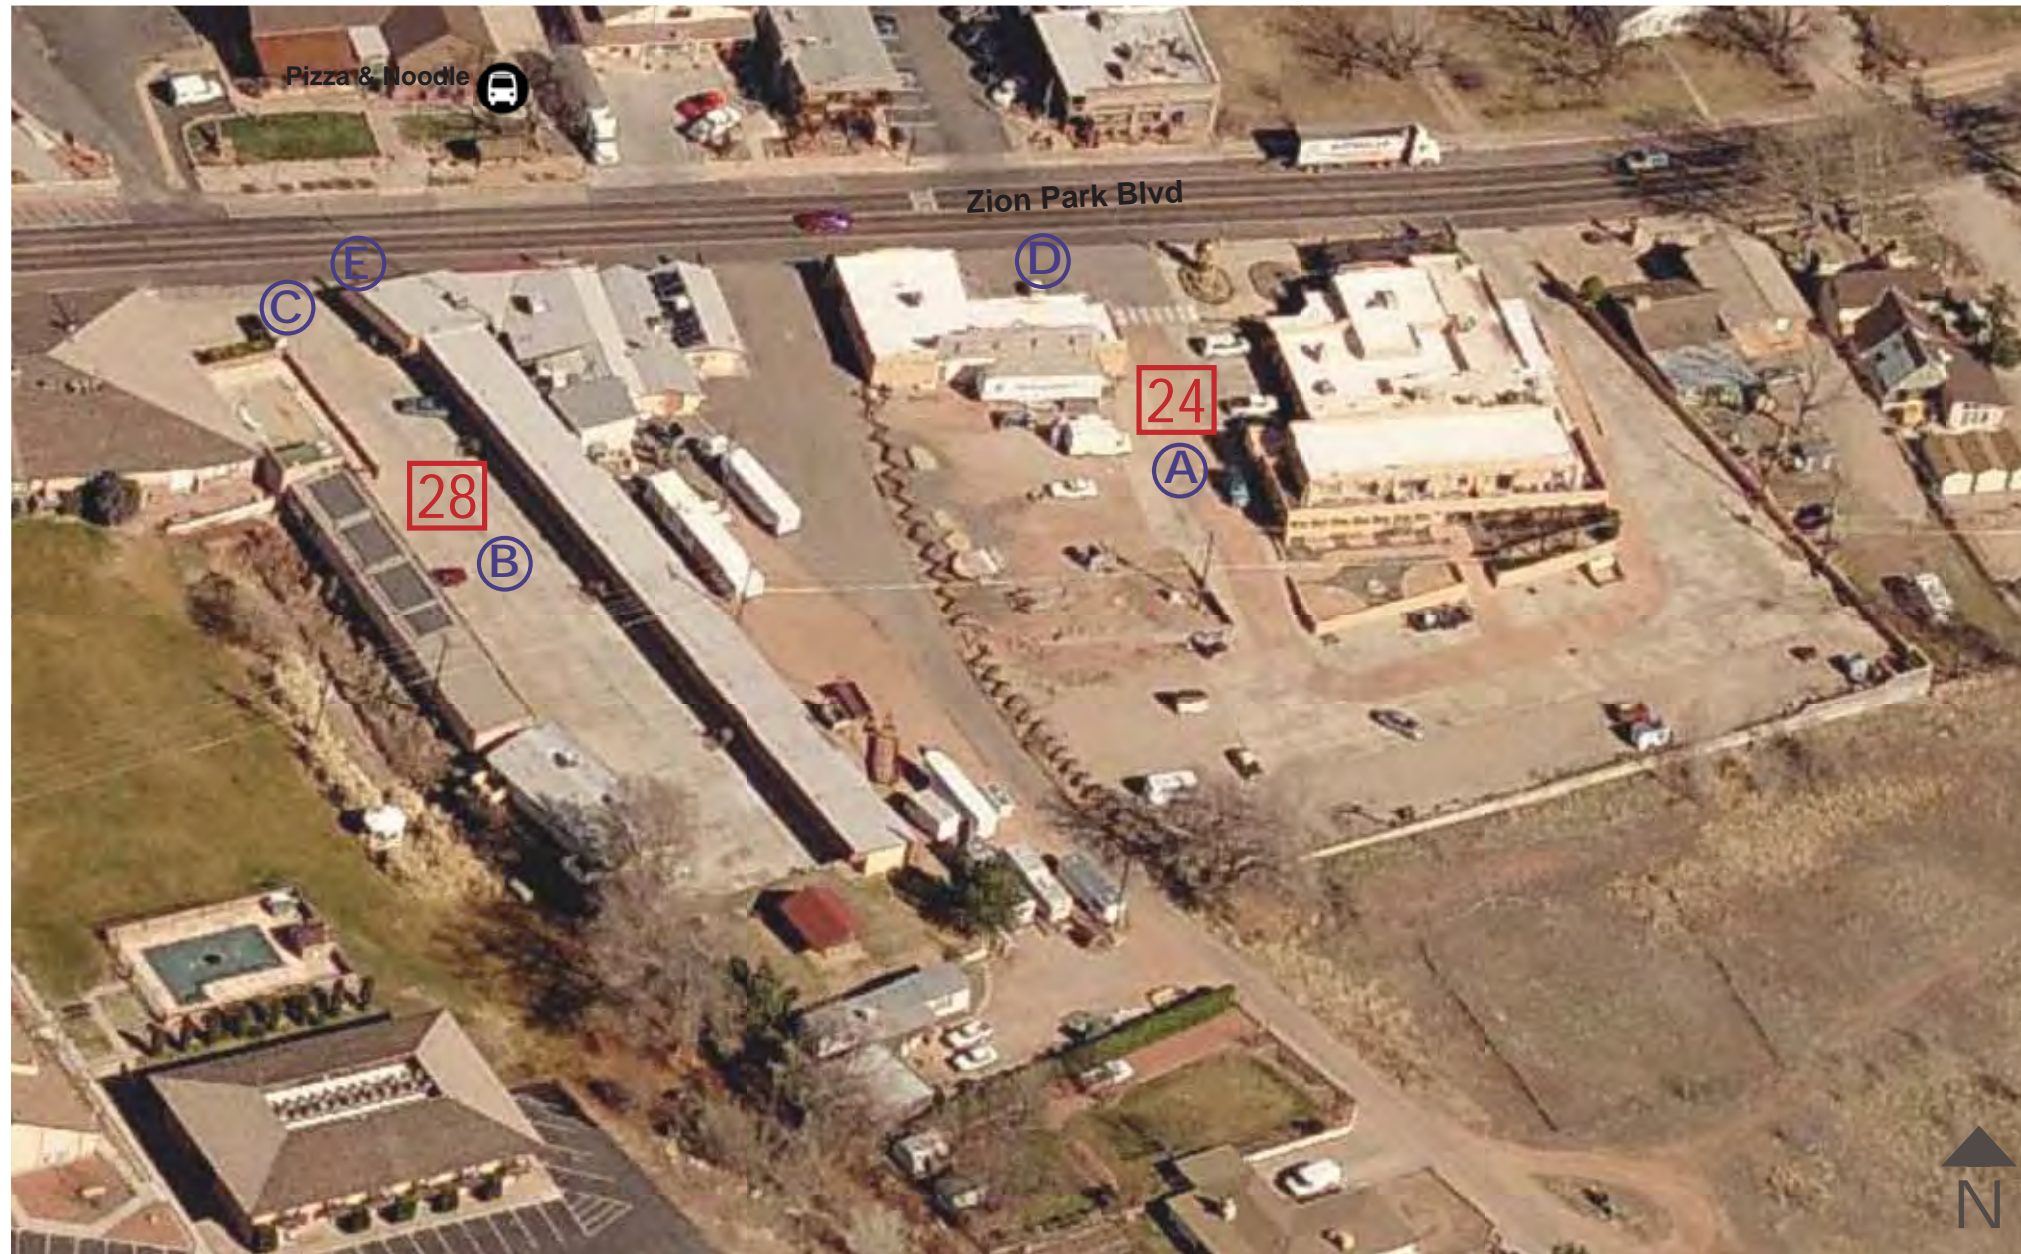
- Ⓐ There seem to be four suitable areas to park providing many spaces. However, these areas are not clearly defined as to who can park here. Some of these areas are unpaved and would require some work to be a more suitable parking environment. There is one parking area that is adjacent to the laundromat. This is a small lot and seems to be heavily used by people using this facility.
- Ⓑ There is a lack of signage in this parking lot indicating who can park there and for what uses. Parking appears to mainly be used by customers.

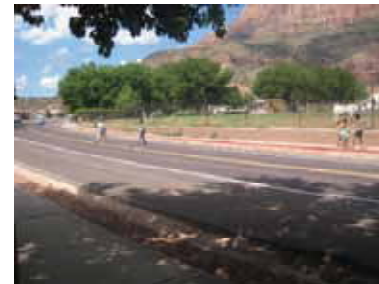
People Crossing Road - Looking Southwest - I

- (E)** Sidewalk in fair condition, displaying spalling and wearing at edges, joints, and corners.
- (F)** Extreme spalling at utility cover here.
- (G)** Asphalt parallel parking is tight, eroding at sandstone curb and gutter edge. Curb and gutter is old, eroding in places. Narrow gravel strip is in fair condition.
- (H)** Sidewalk is covered with gravel and is cracking profusely at driveway to Desert Pearl vacant lot.
- (I)** Many people cross street here to reach the ranch.
-

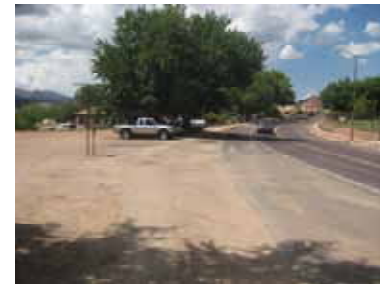
Desert Pearl Vacant Lot - Looking Southwest - B

- (A)** Not many spaces available for shuttle parking. Customer parking only.
- (B)** This area is a large unpaved, dirt parking lot that is not clearly defined for its allowable uses. There are a lot of people who park here and cross the street to get to the ranch. There is signage along the perimeter of the parking lot. The northeast portion of the lot is reserved for "Desert Pearl Employee Parking Only." There is a sign when you first enter announcing "No Overnight Camping or Parking." There is also a "Private Property No Trespassing" sign near the entrance of the lot.
- (C)** There is an area in the back of the Worthington Gallery that doesn't appear to be used.
- (D)** This lot is very small and set back from the street. Best serves customers.

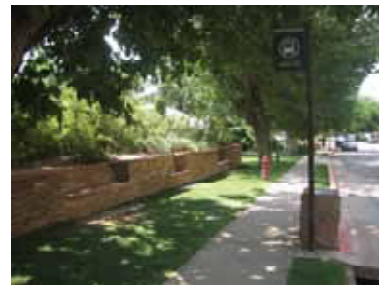
Looking South - D

- Ⓓ Shuttle Stop hard to see from a distance. Sign is small and shaded/covered by trees. No shelter. This flag stop feels integrated with the Desert Pearl. The benches that are a part of the seat wall and the proximity make it feel this way. The flag stop also has a dense canopy cover which makes it feel more comfortable in the heavy heat. Either make sign more visible or prune surrounding trees.
- Ⓔ Very exposed to elements. No furniture, people observed using low rail fence to lean on.

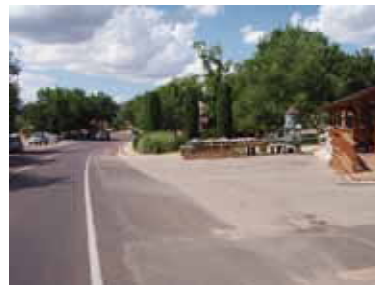
Looking Southwest - G

- Ⓕ "Isolated" concrete sidewalk segment at Shuttle Stop only. It sits between asphalt waiting area and asphalt paint striped shuttle pad.
- Ⓖ Sidewalk gap between Elm Street and Canyon Ranch segment. This is an asphalt drive for Big Chief business parking.
- Ⓗ Sidewalks ends on southbound side of road. Does not continue north of here.

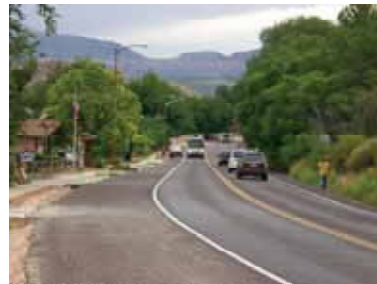
Looking Southwest - C

- Ⓑ Sidewalk in vicinity of post office is in variable condition, narrow and spalling in some locations. Asphalt edge is wearing away at sandstone curb/gutter.
- Ⓒ No sidewalk on southbound side of road but there is wide shoulder that people use to walk on.

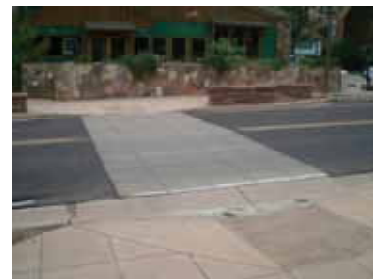
Crosswalk - Looking West - K

- (H)** Sidewalk ends just north of Flanigans (Spotted Dog Restaurant). No sidewalk between Flanigans and Cliffrose flag stop.
- (I)** Curb on south edge of driveway is broken and cracking, in need of repair.
- (J)** Bulbout at crosswalk is in very good condition. Sidewalk nice and wide here.
- (K)** Crosswalk concrete is cracking, could be made more visible.
- (L)** Bent culvert located here. Recommend removing culvert.
- (M)** Concrete curb/gutter begins here and continues north.
- (N)** Access across Koritas/Quality Inn driveway is not ADA compliant.
- (O)** Unattractive assortment of remnant posts/poles and lack of vegetation just north of Koritas/Quality Inn driveway. Recommend improving this area

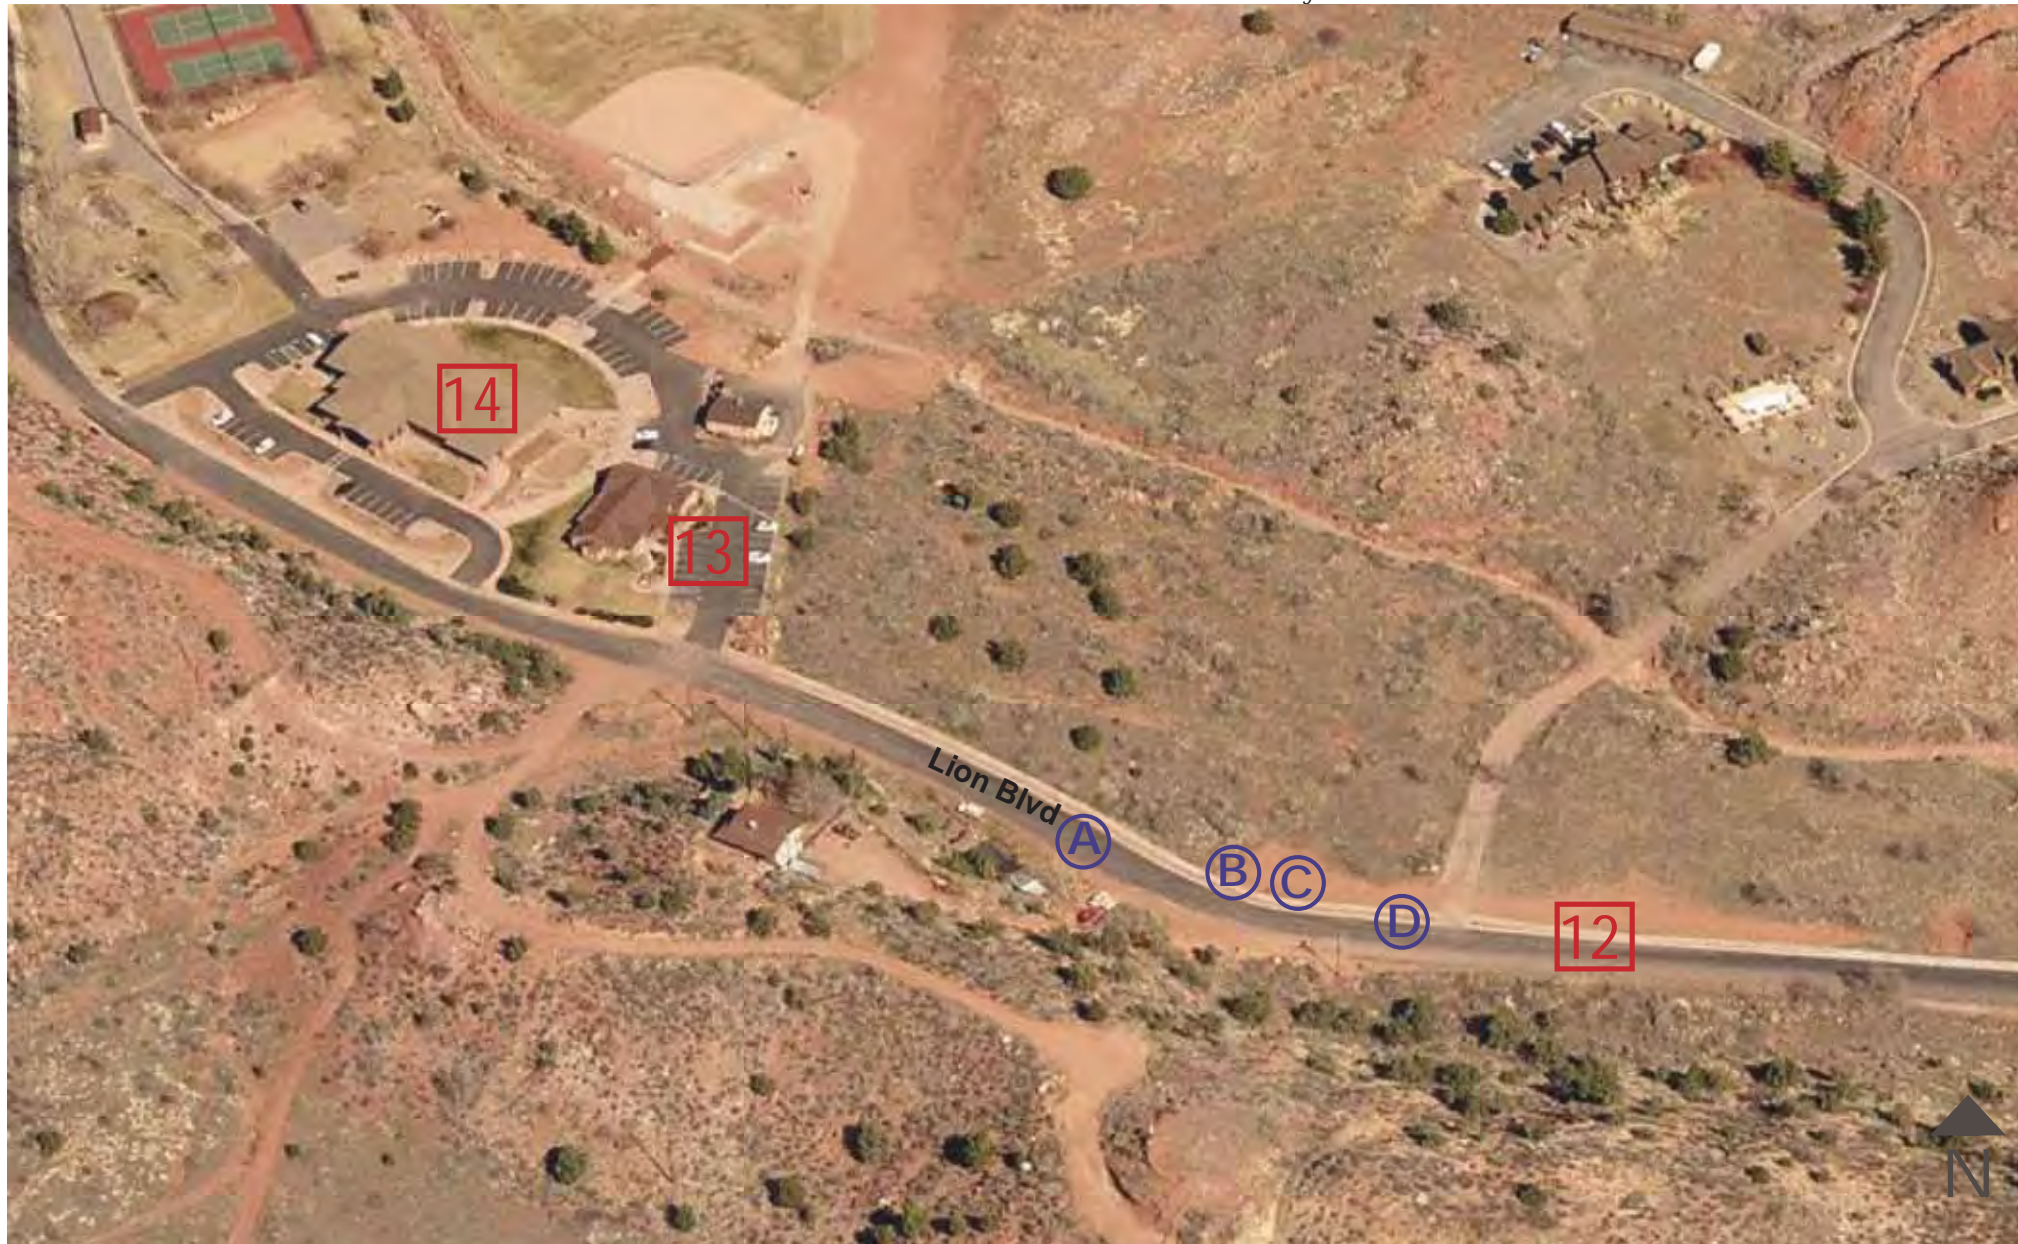
- Ⓐ Lion Blvd. provides plenty of parallel parking spaces along both sides of the road. Zion Adventures may sometimes come off a few spaces to park vans and trailers for loading and unloading.
- Ⓑ The Lion Blvd. parallel parking spaces extend along the north side of the road from Zion Park Blvd. to the library and community center. A sidewalk provides a good pedestrian walkway along the north parking spaces, but it is a long walk from the spaces near the library to the nearest Shuttle Stops.
- Ⓒ The sidewalk along Lion Blvd. needs vegetation maintenance and the south edge parking area at Zion Blvd is without a sidewalk.
- Ⓓ Blue markings on pavement designating Park And Ride are fading all the way to Zion Park Blvd.

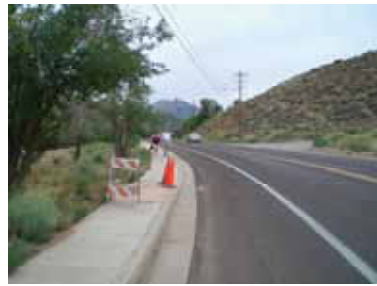
Looking South - D

- Ⓒ Sidewalk is constant width of approximately four feet wide with concrete curb and gutter.
- Ⓓ Amount of seating here does not make sense for this location. Could seating be relocated?
- Ⓔ Driveways are typically not ADA compliant.
- Ⓕ There are weeds that are encroaching upon sidewalk here. Weeds should be removed, perhaps some friendly native vegetation could be planted here (extending park out into the town).
- Ⓖ Beginning here and continuing north, sidewalk becomes approximately six feet wide, gravel band goes away, becomes concrete.
- Ⓗ No sidewalk, wide shoulder.
- Ⓘ Jersey barrier at slide area, constricts roadway.

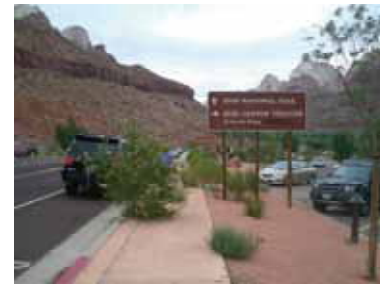
Looking Northeast - F

- Ⓔ Sidewalk in front of Takach Building has small area of landscape strip of red rocks and spiny plants. Plants are not very pedestrian friendly.
- Ⓕ Sidewalk is approximately six feet wide, in excellent condition, with concrete curb and gutter.
- Ⓖ Curb is broken and curb is exposed at southern edge of first driveway to lower parking for theater. The ramp at this corner does not meet ADA, very wide radius.
- Ⓗ No sidewalk on this side of driveway.
- Ⓘ Only area with sidewalk on this side of roadway.
- Ⓙ Jersey barrier at slide area, constricts roadway.
- Ⓚ Anthills encroaching sidewalk.
- Ⓛ No crosswalk here.
