APPENDIX A: SPRINGDALE STREETScape, PARKING, AND SHUTTLE STOP INVENTORY

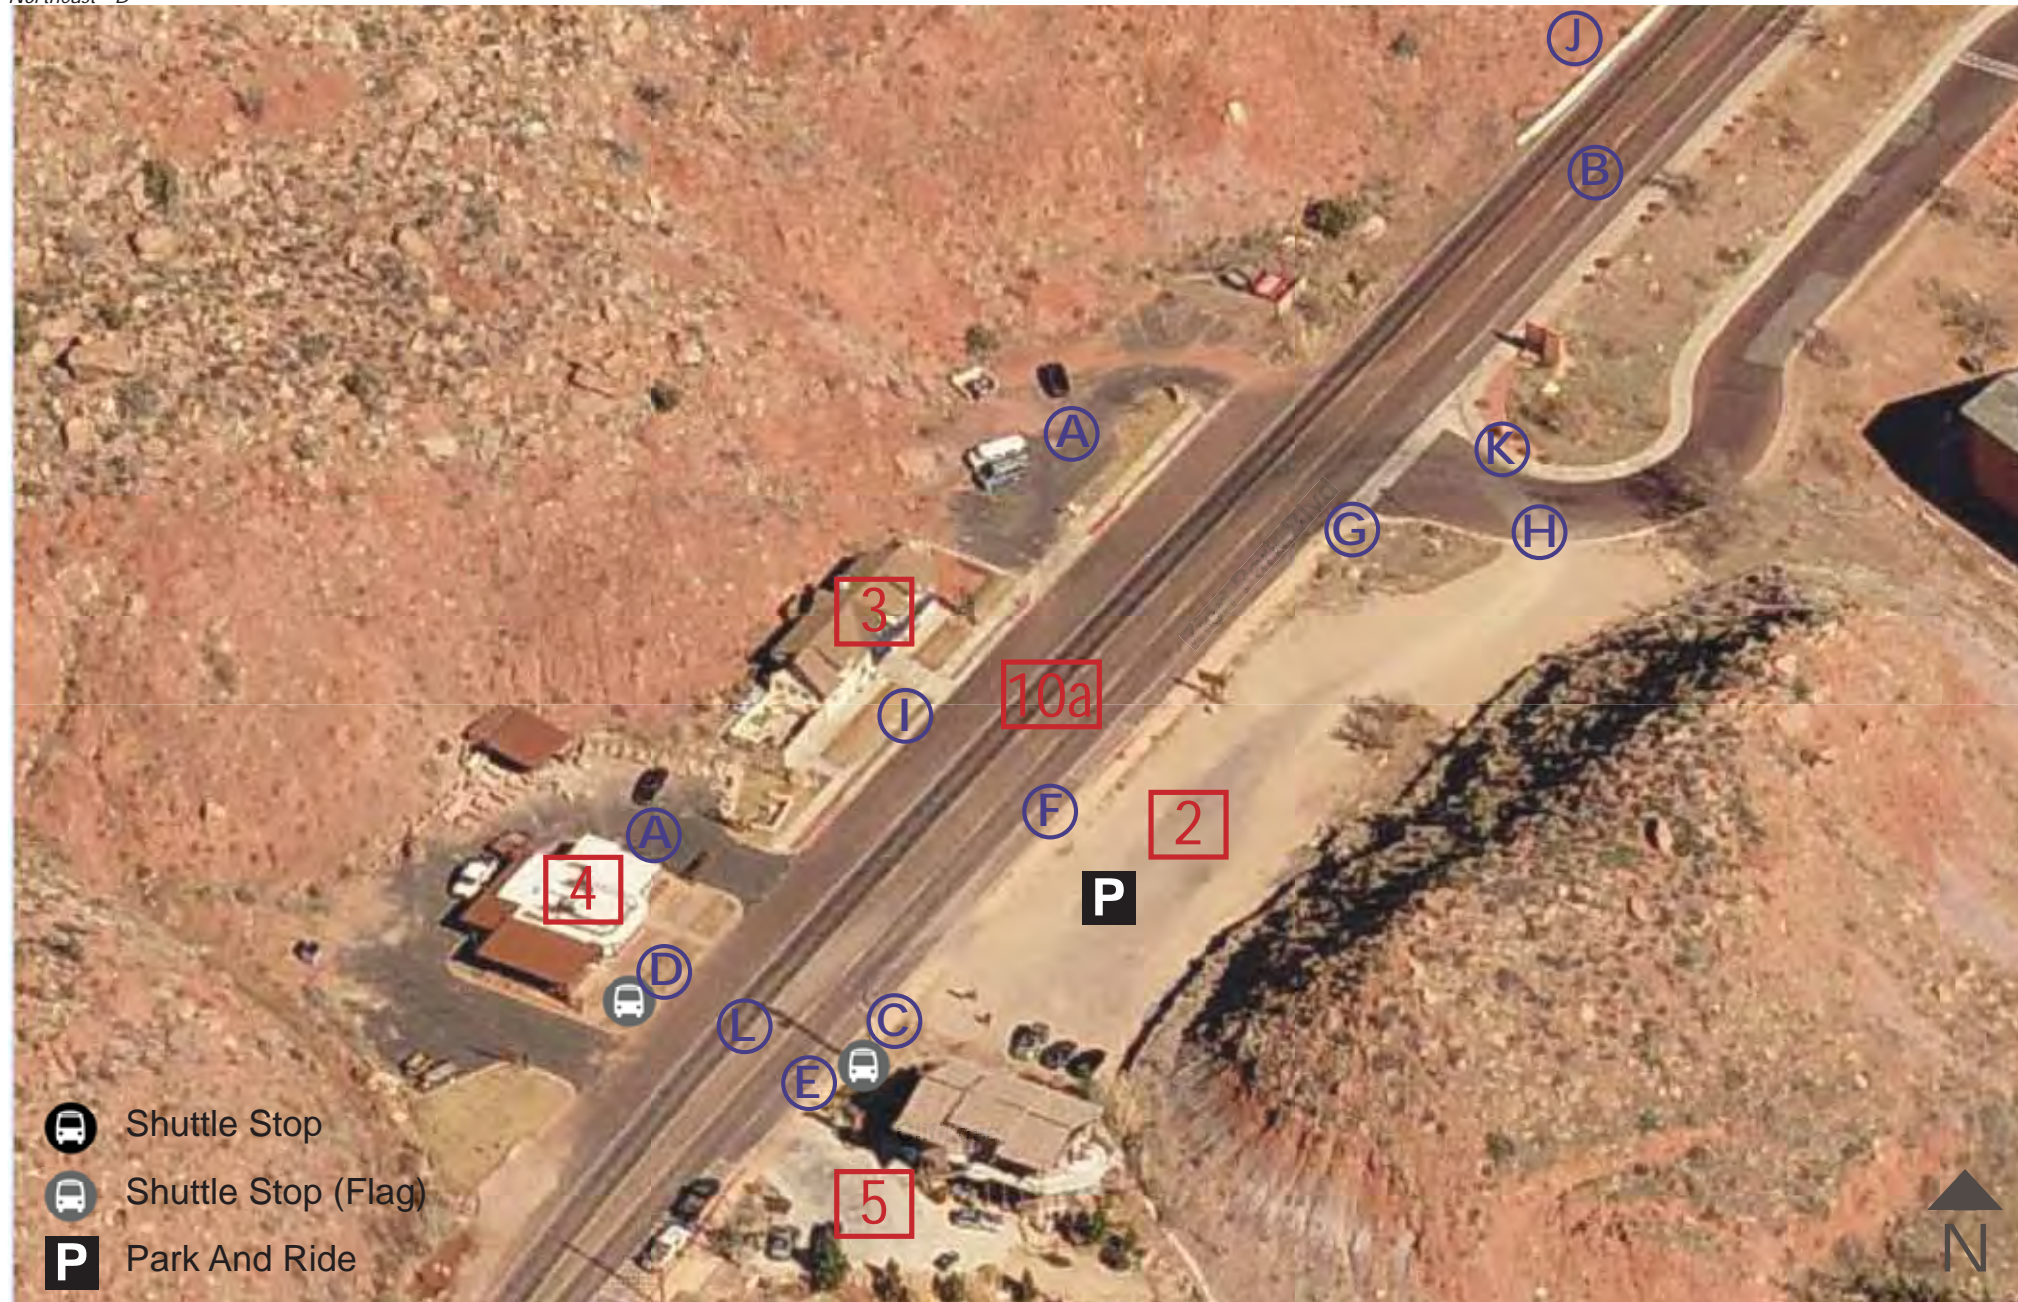
Zion Park Boulevard - **10a** On-Street Parking, **5** Takach Building, **4** Narrow Escapes, **3** Tsunami Juice, **2** Giant Screen Theater Complex Upper Lot

- Ⓐ Parking best saved for customers.
- Ⓑ On street parking well used here.

- Ⓔ Sidewalk in front of Takach Building has small area of landscape strip of red rocks and spiny plants. Plants are not very pedestrian friendly.
- Ⓕ Sidewalk is approximately six feet wide, in excellent condition, with concrete curb and gutter.
- Ⓖ Curb is broken and curb is exposed at southern edge of first driveway to lower parking for theater. The ramp at this corner does not meet ADA, very wide radius.
- Ⓗ No sidewalk on this side of driveway.
- Ⓘ Only area with sidewalk on this side of roadway.
- Ⓙ Jersey barrier at slide area, constricts roadway.
- Ⓚ Anthills encroaching sidewalk.
- Ⓛ No crosswalk here.

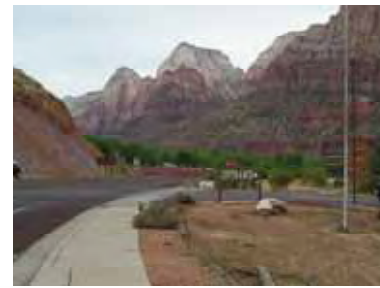
Northern Driveway (2nd) - Looking Northeast - A

(A) According to shuttle drivers and others, many visitors get confused by the “Entrance” sign at the second driveway to the theaters. Visitors think it is the entrance to the park, while it is actually the entrance to the theaters. Drivers recommend placing a Zion National Park entrance sign adjacent to this one with an arrow pointing straight ahead.

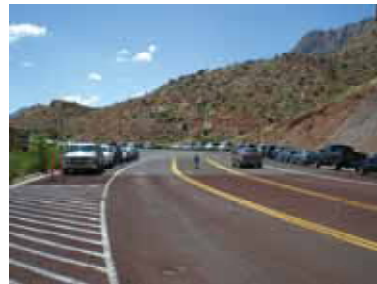
Looking South - C

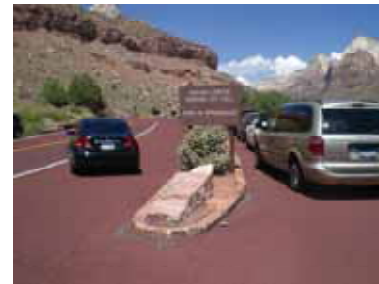
Car Turning Around - Looking North

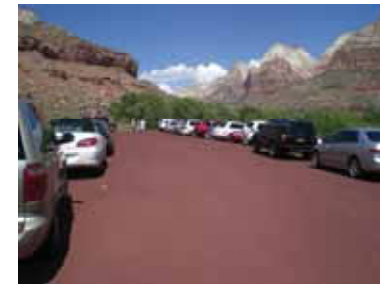
Parking Lot - Looking North

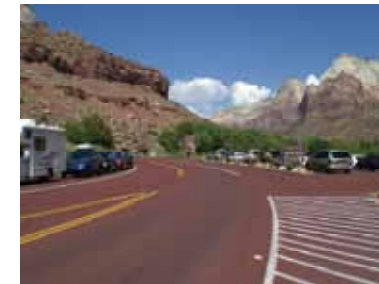
Looking North - A

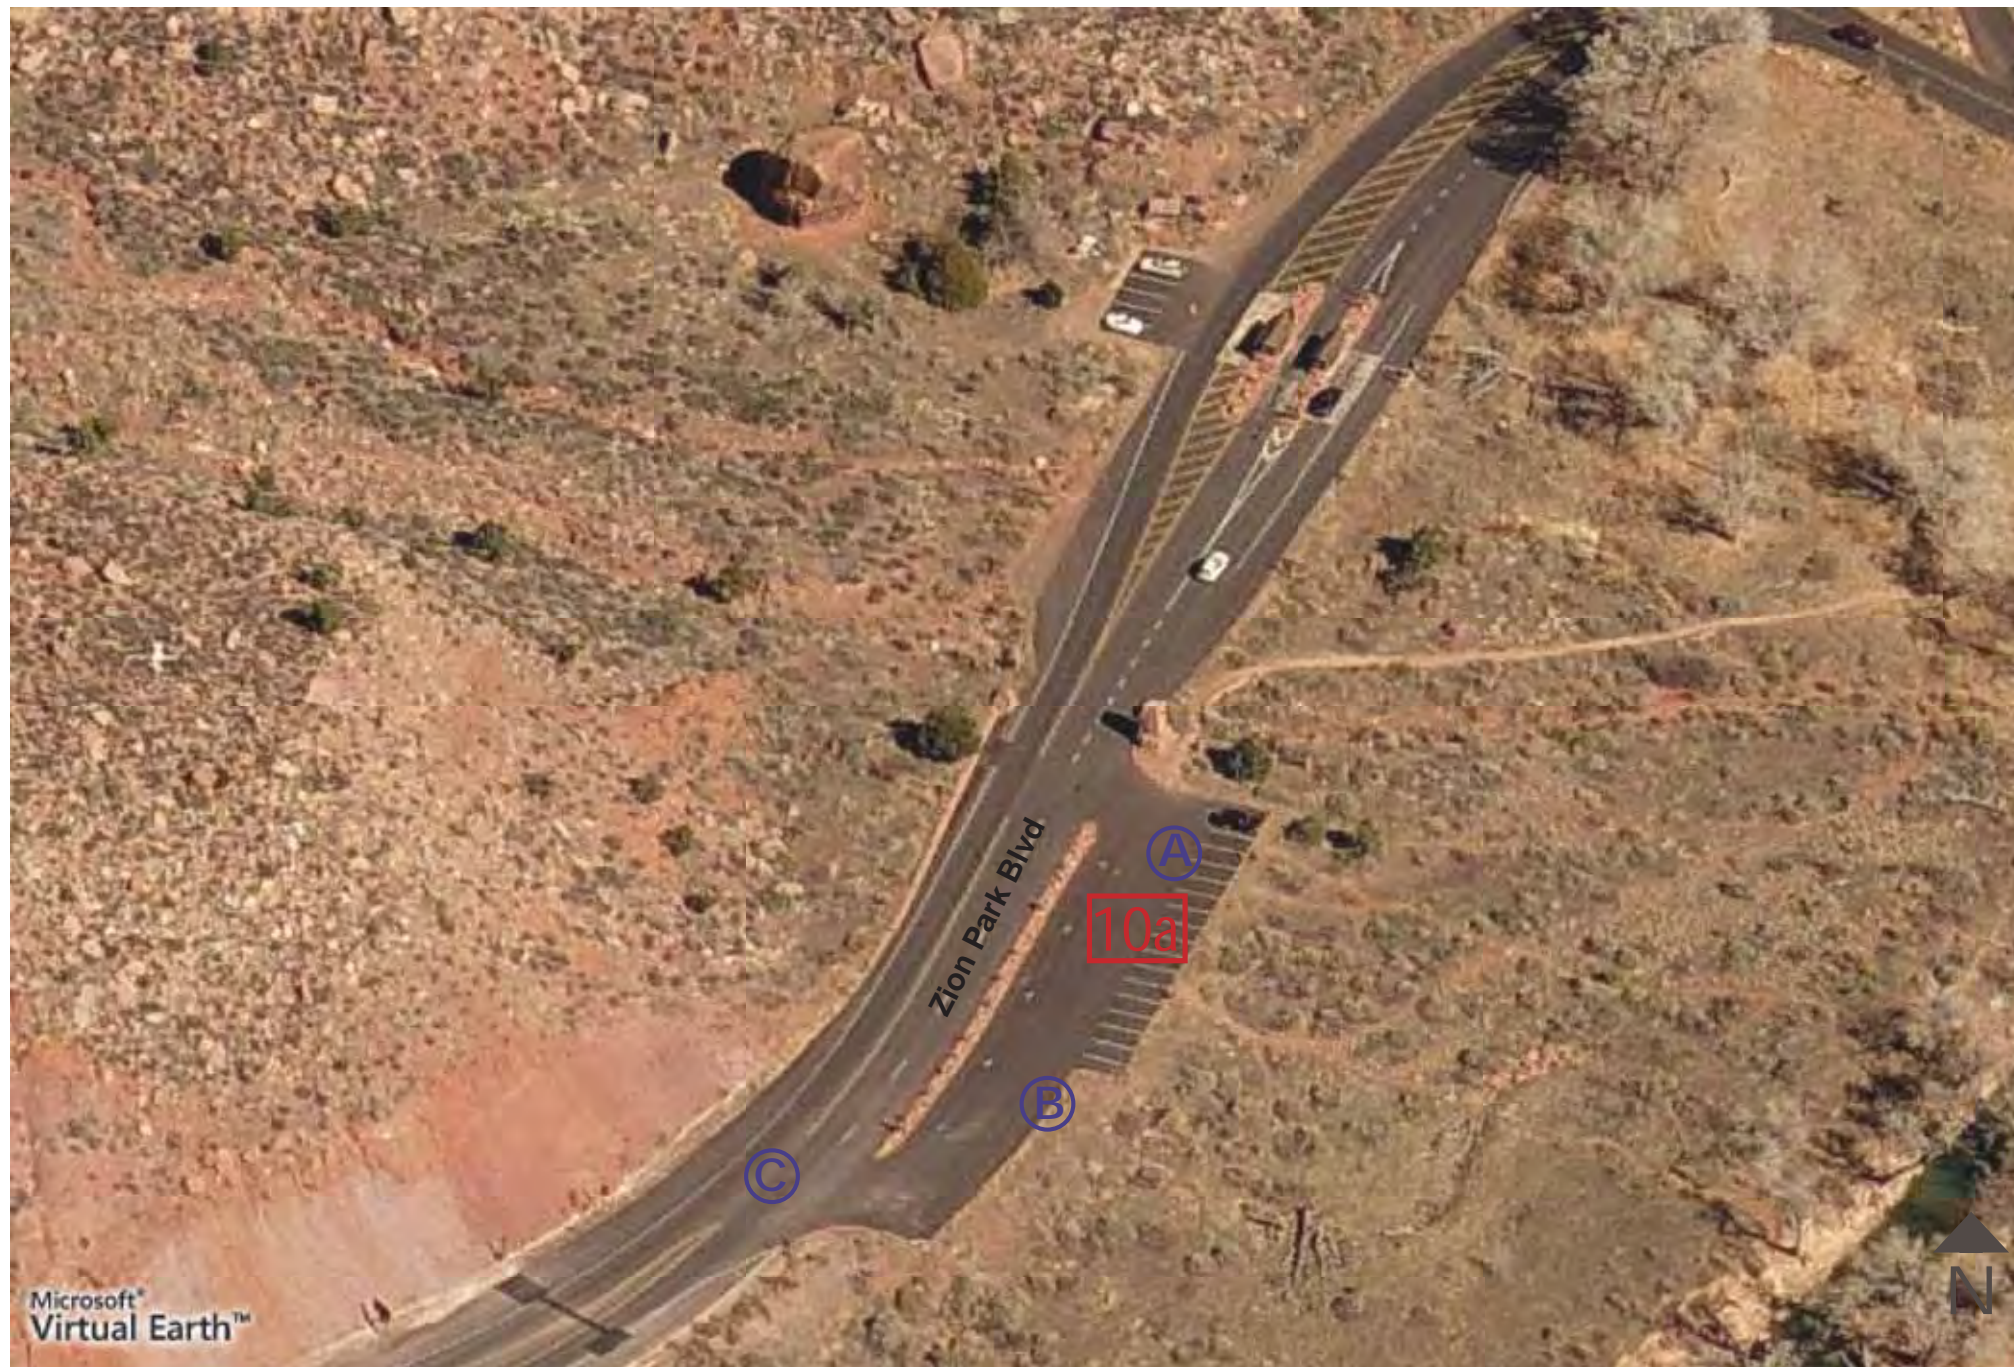
Zion Park Boulevard & Zion Park Entrance - 10a On-Street Parking

- Ⓒ No sidewalk on either side of road.

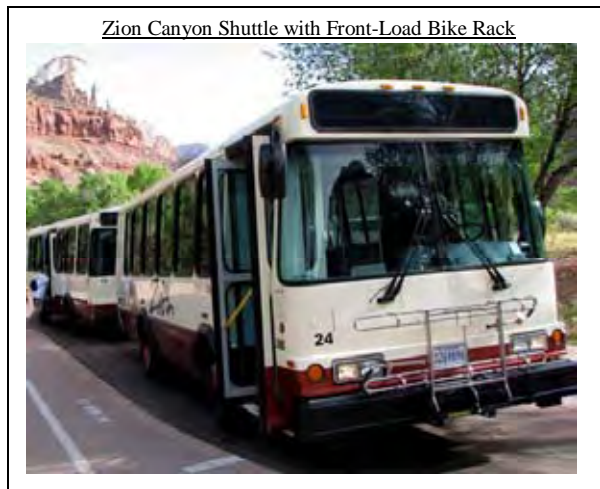
Many transit systems in the States, including the Zion Canyon Shuttle, use the front-mounted bicycle racks with two-bicycle capacity, as shown. However, once these racks are full, visitors with bicycles must wait for the next bus, which hopefully does not have a full rack. Some of the early concerns from both bicyclists and transport providers (and the bus drivers themselves) are primarily 'ease of use' concerns. Bus drivers do not want to become responsible for loading and unloading, and users often find there to be a great deal of pressure to load and unload the bicycle quickly, making it a stressful situation for all involved.

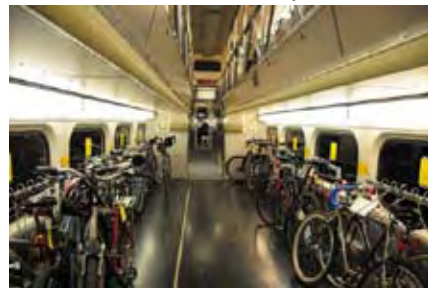
CalTrain Dedicated Bicycle Car

Hanging racks are popular as a space-saving measure, but require more maneuvering space to get them up and down, and take time to remove during alighting, a space versus time trade-off.
