Running and Enriching a Ceiling Medallion. The method of running and enriching a ceiling medallion remains the same today.

Residential Casement Windows

Salvaged Artifacts: The Lessons They Offer

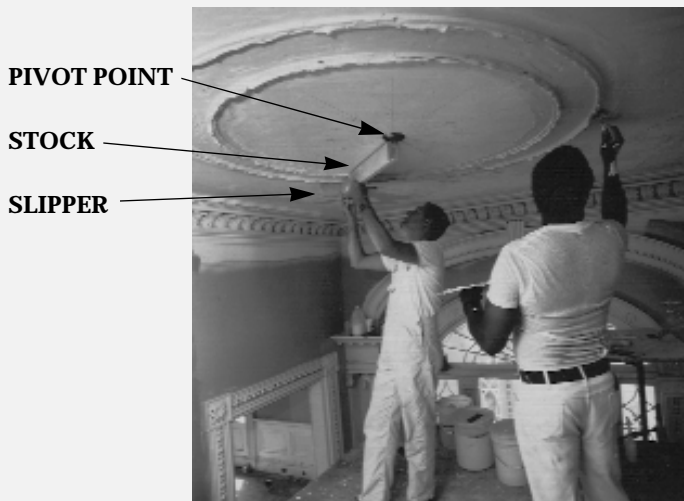
Fig. A. First, a plain-run surround is spun from a pivot point centered in the ceiling field. Photo by Peter Sanders.

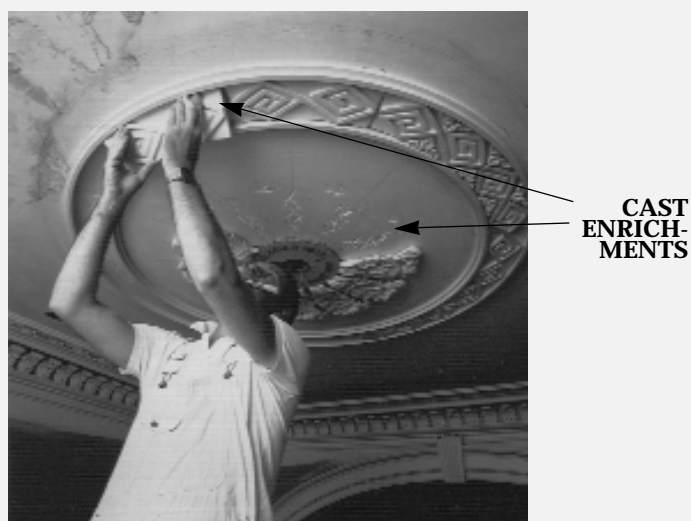
Fig. B. Ornament layout is determined using plane geometric principles; segmented locations are deeply scratched to provide a rough surface for adequate bonding using plaster as an adhesive. Photo by Peter Sanders.

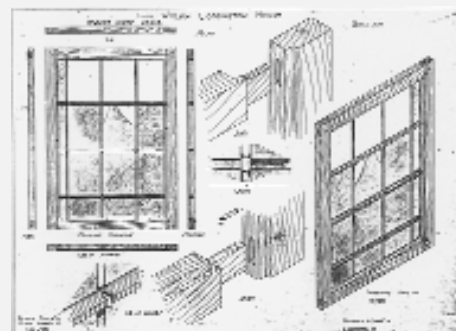
Fig. 1. Drawing made in 1929 of a c. 1641 wood casement window from the Governor William Coddington House, Newport, RI. The Rhode Island Historical Society's unsuccessful attempt to save the house from demolition in 1835 was one of the first concerted preservation efforts in the state. Both the sash and the drawing are now part of the study collection of the Rhode Island Historical Society, Providence, RI. Drawing courtesy Rhode Island Historical Society.

The wood casement sash depicted in the detailed drawing in figure 1 dates from c. 1641, and comes from the Newport, RI, home of Governor William Coddington. Now in the study collection of the Rhode Island Historical Society, Providence, the sash was the only feature salvaged when the Coddington house was demolished in 1835. Its survival, complete with glazing, affords a rare opportunity to examine the construction and design of a mid-17th-century architectural artifact.

The sash echoes the windows seen in the European towns and villages from which the colonists migrated. The simple mortise and tenon construction and the casement method of operation (side-hung sash that swing outward on hinges) are typical of the period, although stationary sash were also popular. The small size of the Coddington sash (27 1/2" H. x 20 1/2" W. x 1" D.) is characteristic of 17th-century American windows and reflects the scarcity and high cost of window glass, as well as the need for protection against harsh North American winters.

Glazing consists of small, hand-blown panes, set into the sash with lead strips termed "comes" or "calmes," reinforced with thin wooden bars. Although a rectangular pane is used here, diamond-shaped glazing was also common. Despite attempts at window glass manufacture at Jamestown, VA, most early glazing had to be imported from

The existence of architectural features like the Coddington sash in study collections can often provide the physical documentation needed to reproduce missing elements in historic house restorations. Such was the case in 1929 when architect R. Kinnicutt used the Coddington sash as a model in one of his Rhode Island projects. The study drawing shown here is one that he produced on this occasion.

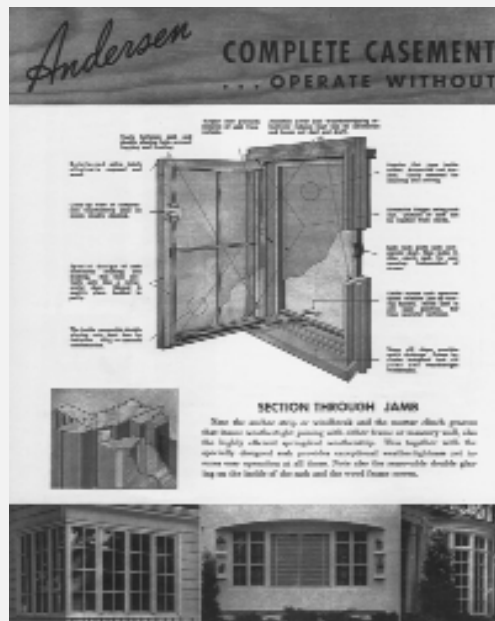
Fig. 2. Both a sample casement and the original product information are kept in the collection held by the Andersen Corporation. Courtesy, Andersen Corporation.

The wood casement window illustrated in the advertisement in figure 2 was manufactured in the 1930s by the Andersen Corporation. The company retains both the advertisement and the actual window in a collection at its head-

and produced wood casements, which, unlike the 17th-century ones, were shipped as complete units and came with modern conveniences like interior screens, weatherstripping, removable double glazing, and extension hinges to permit cleaning the outer side of the sash from inside the sash. In addition, under screen sash operators permitted opening and closing of the window just by turning the handle. Anyone viewing this window and accompanying advertising materials can appreciate the technology involved in “modernizing” a centuries-old design.

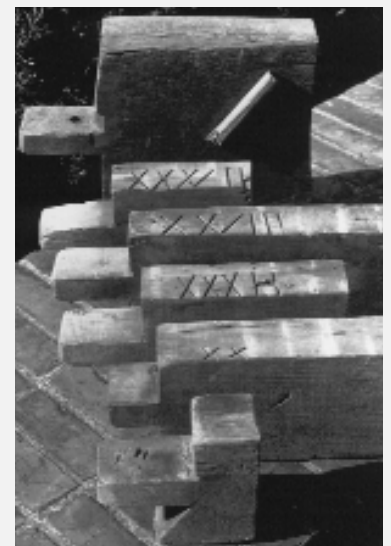
Fig. 1. Structural specimens from a 1755 Quaker Meeting House. Photo by the author.

These six cut-off joists (figure 1) are from the Greater Meeting House in Philadelphia, which was first built in 1755 on Second Street near the waterfront, then was moved to a new location on Twelfth Street in 1812, and then was dismantled and reconstructed at the George School in Bucks County, PA, in 1972. In the last move, the ceiling framing was discarded in favor of an “open” ceiling, and these joist fragments from the 1755 building were rescued and accessioned into the Independence National Historical Park Architectural Study Collection (INHP Acc. No. 2630-25).

It is useful to salvage structural parts of buildings into study collections especially when their context is recorded, as in this instance, with HABS drawings. With such specimens we can learn about the methods used by the carpenters for framing the mortise and tenon joints with different depth joists, some with wooden pins, some without pins, some with double tenons or with single tenons (as seen here), and some (seen here nearest to camera) have a haunch below the tenon. This latter aspect shows that the carpenter understood the possibility that this shallow joist might fail in vertical shear at the tenon, and the haunch provides extra bearing to compensate for the thin tenon.

Very evident in this photo are the Roman numerals used by the carpenters because the entire ceiling framing, together with the roof trusses, was

prefabricated on the ground by a group of carpenters, each using their own joint details, and thus the Roman numerals were necessary so that when the prefabricated system was taken apart for reassembly in the ceiling, every one of the pieces would go back into the correct location.
