# Effects of Fiber Coatings on Tensile Properties of Hi-Nicalon SiC/RBSN Tow Composites

Ramakrishna T. Bhatt

Prepared for the  
1997 Annual Meeting  
sponsored by the American Ceramic Society  
Cincinnati, Ohio, May 4, 1997

<b>1. AGENCY USE ONLY</b> ( <i>Leave blank</i> )	<b>2. REPORT DATE</b> December 1997	<b>3. REPORT TYPE AND DATES COVERED</b> Technical Memorandum	
<b>4. TITLE AND SUBTITLE</b> Effects of Fiber Coatings on Tensile Properties of Hi-Nicalon SiC/RBSN Tow Composites		<b>5. FUNDING NUMBERS</b>  WU-523-21-13-00 1L161102AH45	
<b>6. AUTHOR(S)</b>  Ramakrishna T. Bhatt and David R. Hull			
<b>7. PERFORMING ORGANIZATION NAME(S) AND ADDRESS(ES)</b> NASA Lewis Research Center Cleveland, Ohio 44135-3191 and U.S. Army Research Laboratory Cleveland, Ohio 44135-3191		<b>8. PERFORMING ORGANIZATION REPORT NUMBER</b>  E-10931	
<b>9. SPONSORING/MONITORING AGENCY NAME(S) AND ADDRESS(ES)</b> National Aeronautics and Space Administration Washington, DC 20546-0001 and U.S. Army Research Laboratory Adelphi, Maryland 20783-1145		<b>10. SPONSORING/MONITORING AGENCY REPORT NUMBER</b>  NASA TM-113170 ARL-TR-1552	
<b>11. SUPPLEMENTARY NOTES</b> Prepared for the 1997 Annual Meeting sponsore

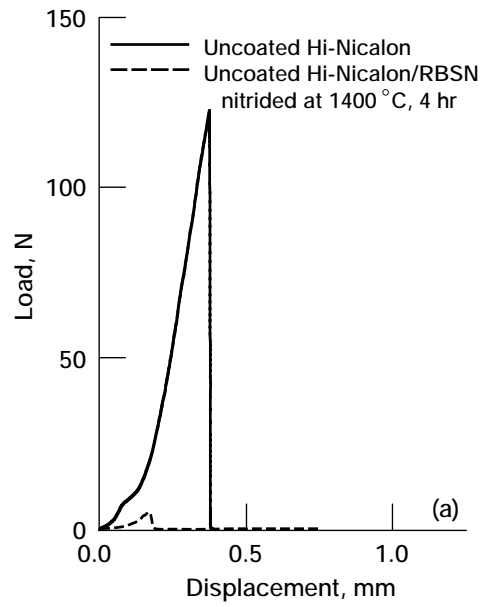
Figure 4.—Room temperature load-displacement curves for Hi-Nicalon SiC/RBSN tow composites. (a) Uncoated. (b) PBN coated.

to the testing direction. In general, in ceramic matrix composites it is known that the matrix fractures well before the fibers reach their ultimate fracture strength, and UTS of the composite is controlled to a large extent by the fiber bundles. Typical room temperature load-displacement curves of the uncoated and PBN/Si-rich PBN coated Hi-Nicalon SiC fiber dry tows, and the tows infiltrated with silicon and nitrided at 1200 °C and at 1400 °C for 4 hr in nitrogen are shown in figure 4. According to this figure, the room temperature fracture loads of the uncoated tow composites nitrided at 1200 °C and at 1400 °C are significantly lower than that of the dry bundles whereas the room temperature fracture loads of PBN/Si-rich PBN coated fiber tow composites decreased with increasing nitridation temperatures indicating progressive degradation of the fiber during the RBSN processing stage. The ultimate room temperature fracture loads of uncoated and all three types of coated tow composites before and after nitridation at 1200 °C and at 1400 °C for 4 hr are shown in figure 5. The error bars in the figure represent  $\pm 1$  standard deviation. In all cases, the ultimate fracture load decreased with increasing nitridation temperature. Both PBN/Si-rich PBN and BN/SiC coated Hi-Nicalon/RBSN tow composites nitrided at 1400 °C yielded nearly the same ultimate fracture loads within the experimental scatter.

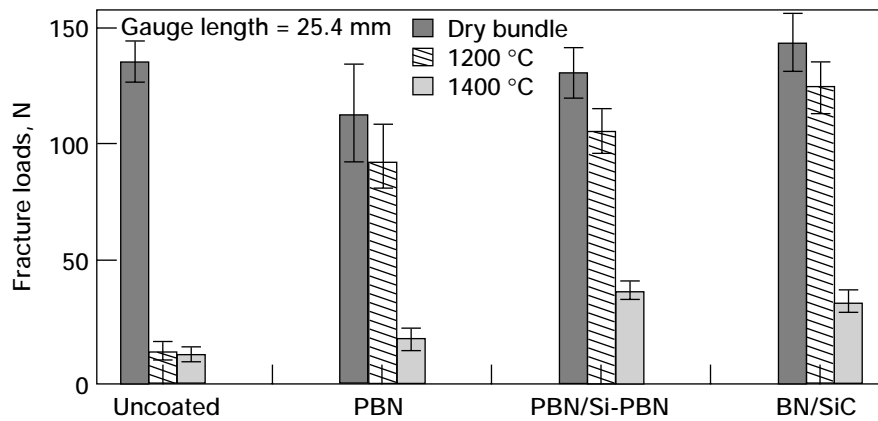
Figure 5.—Room temperature ultimate tensile fracture load of uncoated and CVD coated Hi-Nicalon SiC fiber tows and Hi-Nicalon/RBSN tow composites nitrided in N<sub>2</sub> for 4 hr.

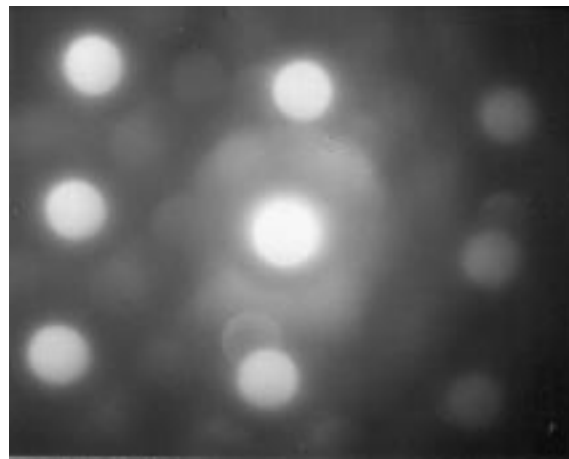
Figure 10.—TEM micrograph and CBED analysis of reaction product in BN/SiC coated Hi-Nicalon/RBSN tow composite nitrified in  $N_2$  at 1400 °C for 4 hr. (a) TEM micrograph of the BN/SiC interface. (b) CEBD patterns of the particles within the SiC coating.

Figure 10.—Concluded. (b) CEBD patterns of the particles within the SiC coating.

A bright field image of the transverse cross-section of the BN/SiC coated Hi-Nicalon/RBSN tow composite nitrided in  $N_2$  at 1200 °C is shown in figure 9(a). The crack in the BN/SiC coating, and the debonded region between the fiber and BN coating seen in figure 9(a) was probably caused during specimen preparation. Little reaction between the SiC coating and RBSN matrix was noticed. In contrast, the BN/SiC coated Hi-Nicalon/RBSN tow composites nitrided at 1400 °C showed almost complete reaction of the SiC coating with the RBSN matrix (fig. 9(b)). The reaction zone contained particles which are rich in iron and nickel impurities similar to that observed in specimens of the uncoated Hi-Nicalon/RBSN tow composites. Convergent beam electron diffraction (CBED) identified the reaction product as an iron silicide ( $Fe_2Si$ ) with the CsCl structure and a lattice parameter of 0.294 nm (fig. 10). Since XEDs of the reaction product also shows the presence of nickel, it appears that nickel is forming a solid solution with iron and substituting at the iron lattice sites. Again there is no evidence of the reaction between Hi-Nicalon SiC fiber and the BN coating. The reaction observed between the uncoated, and nonuniform PBN and PBN/Si-rich PBN coated Hi-Nicalon SiC fibers and the RBSN matrix can explain the loss of the room-temperature fracture load. What is not still understood is the loss of the room-temperature load at the 1400 °C processing temperature for the BN/SiC coated Hi-Nicalon SiC fibers where no obvious microstructural changes at the coating/fiber interface occurred. We suspect that the reaction between impurities present in silicon powder and uncoated regions of the Hi-Nicalon SiC fibers is also the probable cause for strength degradation of these fibers.
