## Coal Mine Fatal Accident 2004-03

Operator:	Blue Diamond Coal Company, Inc.
Contractors:	Chas Coal, Inc. Tyco Trucking Company, Inc. Calvary Coal Company, Inc.
Mine:	Calvary No. 80
Date:	February 3, 2004
Classification:	Machinery
Location:	District 7, Leslie Co., Kentucky
Mine Type:	Underground
Production	Non-producing status

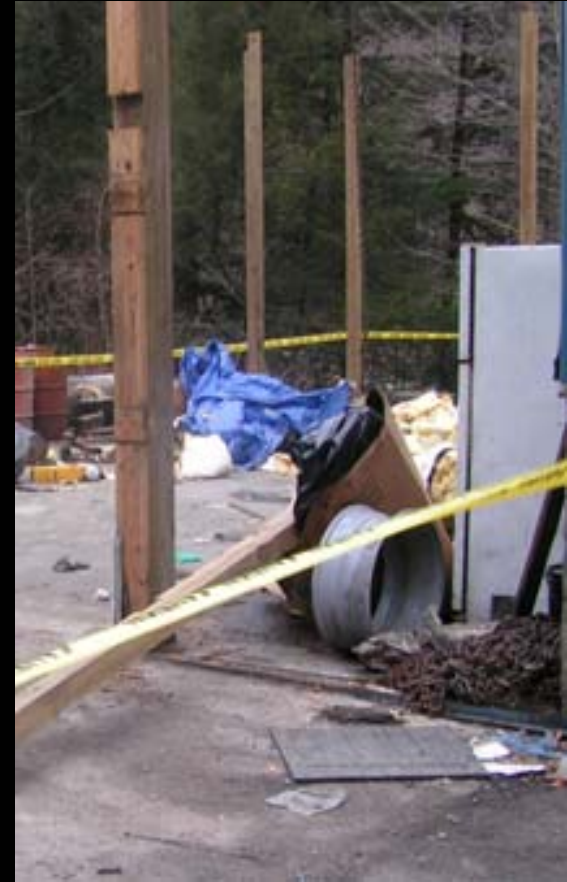
- On Saturday, January 24, 2004, the victim and his neighbor traveled to the mine to examine the structure.
- On Wednesday, January 28, 2004, the neighbor returned alone with his personal pickup truck and trailer and began dismantling the structure; and again on January 30, 2004
- On Tuesday, February 3, 2004, the neighbor returned to the site at around 10:00 a.m. and removed rafters and other materials until only the metal roll-up garage door and vertical wooden support posts remained. He was about to leave when he received a call from the victim who told him that he and his son were coming to help remove the wooden posts.
- The posts could not be moved by hand as the concrete floor had been poured around the posts.

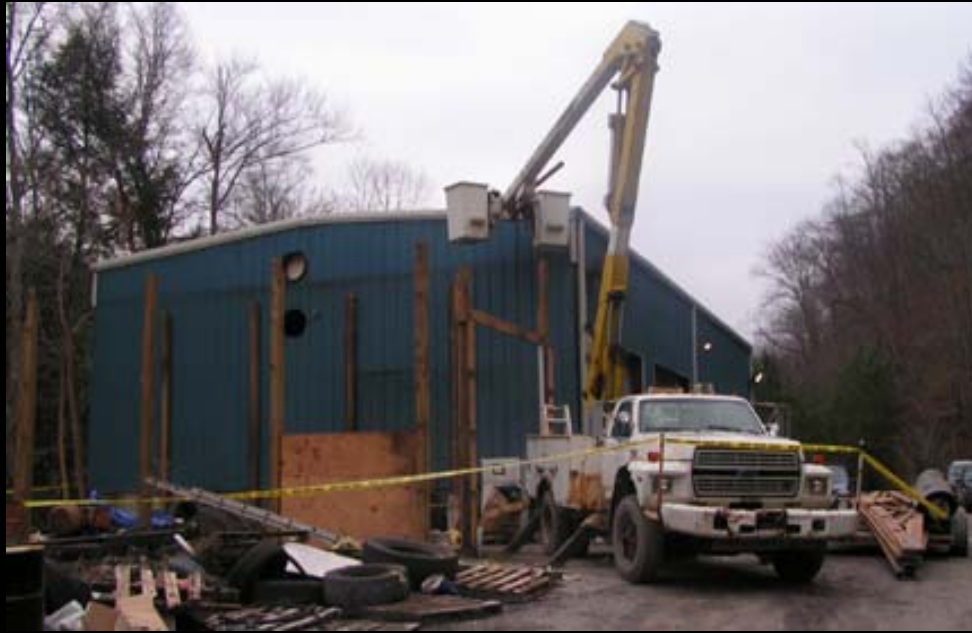
- After confirming that one of the posts was loose in the concrete, the victim successfully hoisted it out of the concrete floor and onto the trailer using the bucket truck.
- At approximately 4:30 p.m., they attempted to remove a second post. The victim pulled upward and wiggled the post back and forth with the aerial bucket trying to free it from the concrete.
- The post suddenly came loose from the concrete, causing the boom to catapult upward, throwing the victim from the bucket. He fell onto the concrete floor and received fatal injuries.

The fatal accident occurred because the aerial bucket truck was used improperly to lift a load. Failure to wear a safety belt or safety harness when working from a location where there was a danger of falling contributed to the severity of the accident.

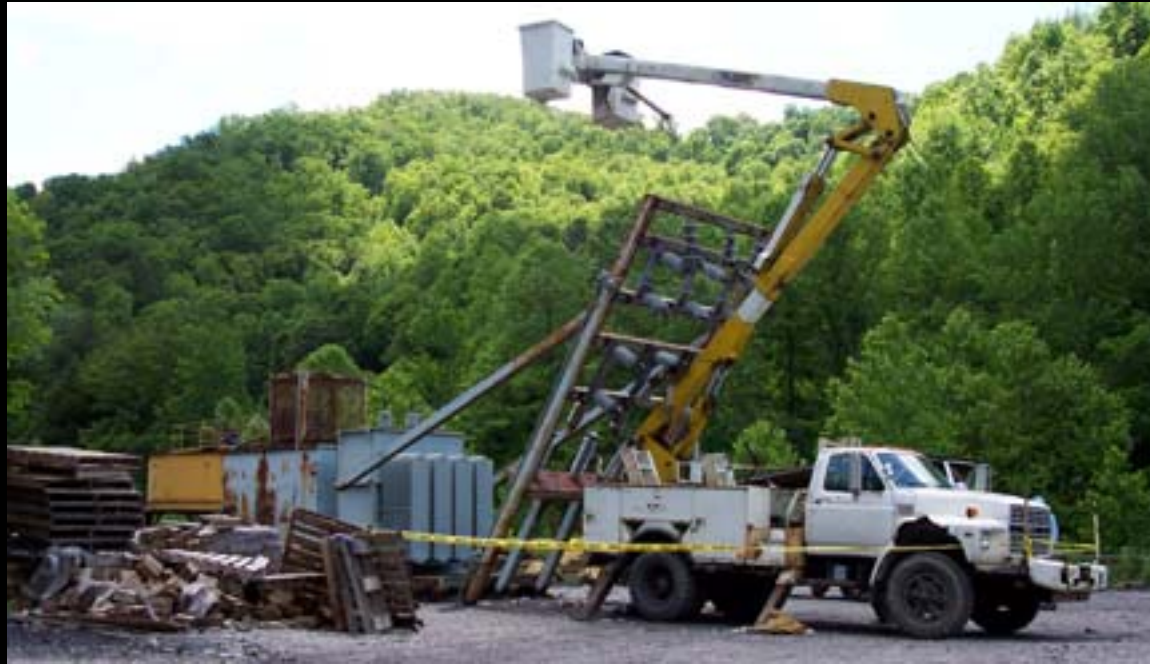
- The victim was aware of a similar fatal accident occurred at this mine on June 9, 2003, when the mine manager was thrown from this same aerial bucket truck (Report of Investigation, CAI-2003-14). The victim attempted to lift excessive weight with the boom of the truck when the nylon rope on the jib crane winch failed, causing him to be thrown from the bucket. He was also not wearing a safety belt or harness.
- Calvary, who operated the mine at that time, took steps to prevent a similar occurrence, including instructing miners never to lift anything with the aerial bucket truck and to use the safety harness.

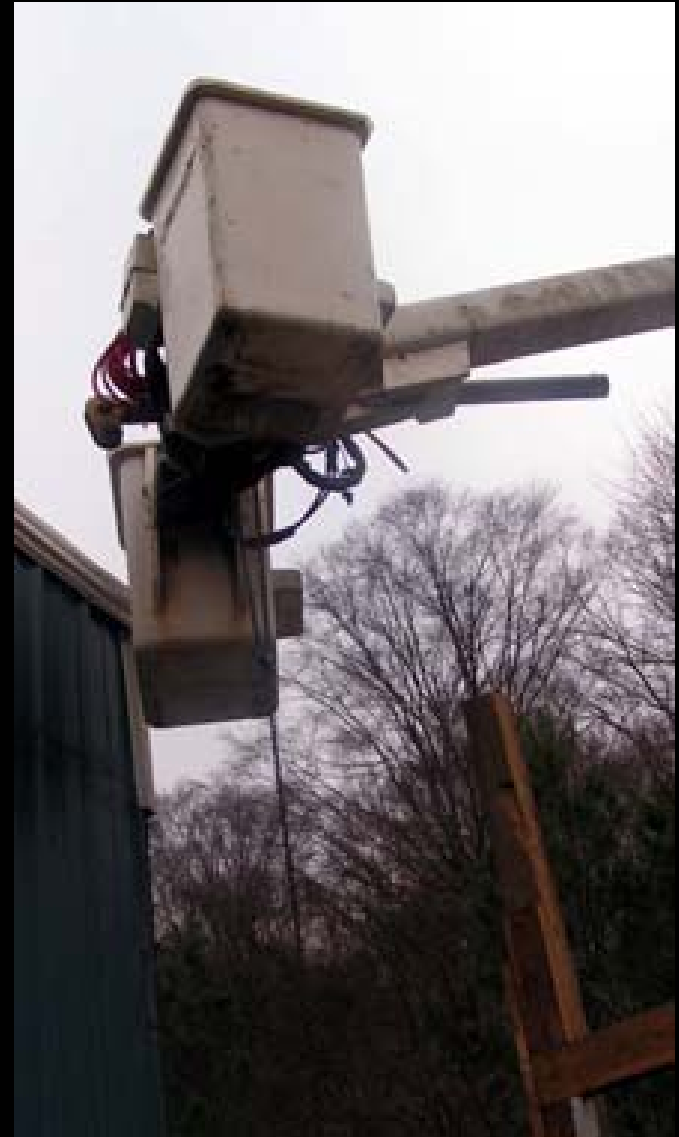
- Considering the angles of the boom arms, maximum load for the jib crane was 1,300 lbs.
- Since the chain was attached to a concrete embedded post, an undetermined amount of force was applied to the chain.
- The fiberglass boom was deflected approximately 27" down and to the right when the post came loose.
- No defects were found in the operation of the hydraulic functions.
- At the time of the accident, a safety harness was on the cab seat of the truck.

- Causal Factor: Written procedures for safe operation of boom truck were not being followed. The operator's manual stated: no one should be in the bucket when heavy loads are being lifted; and the lower controls, located in the bed of the truck, should be used to operate the boom when the lower boom arm lifting devices are being used.
- Corrective Action: Mine management should establish and enforce a policy that equipment be used only in a manner consistent with the manufacturer's suggested recommendations.

- *Causal Factor:* The available safety harness was not used while operating the aerial bucket.
- *Corrective Action:* Mine management should establish and enforce policies and procedures to ensure that employees use safety equipment.
