INEEL/CON-04-02568
PREPRINT

Waste Management '05

UNDERWATER COATINGS FOR CONTAMINATION CONTROL

Julia Tripp, Kip Archibald, Ann Marie Phillips, Joseph Campbell
Idaho National Laboratory

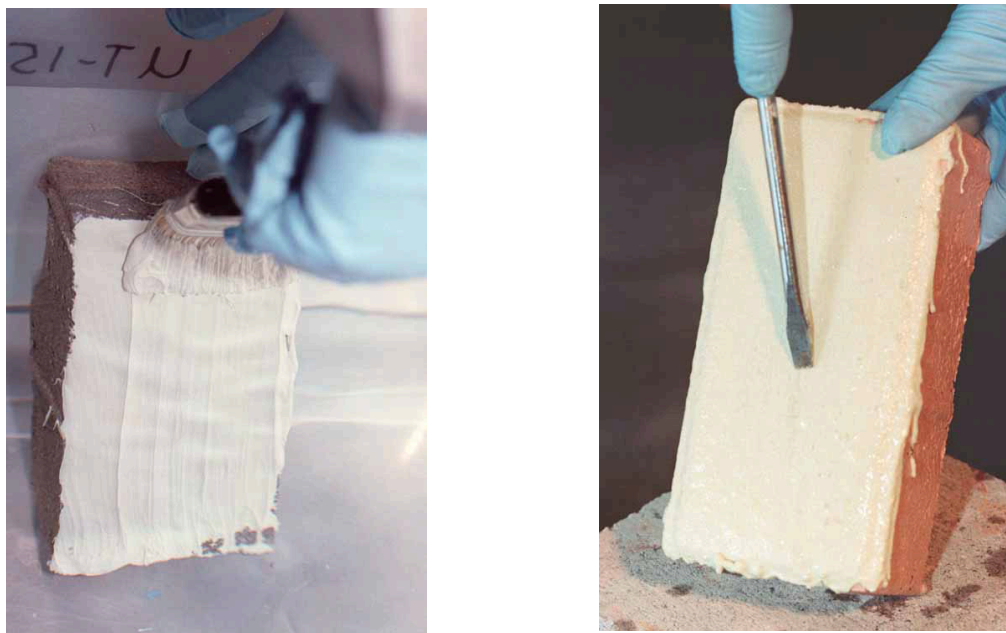
Figure 1. UT-15 adhered well to all surfaces when applying and after drying.

The three coatings that were the easiest to apply and adhered well were the NMP 1710, Corro-Coat FC 2100 Epoxy, and the UT-15 Underwater Epoxy. However, there is some concern on the Corro-Coat FC 2100 since after several weeks it broke off the stainless steel surface. Many of these coatings require a roughened surface to adhere well according to manufacturer's instructions and this may be why this coating came off. The surfaces were not roughened prior to application to more closely simulate field application conditions. In several cases, applied coatings bonded well to the epoxy painted surfaces but caused the bond of the epoxy paint to the surface of the coupon to weaken.

Based on these results, use of the UT-15 (Figure 1) and the NMP 1710 coatings were recommended for use in the actual fuel basins.

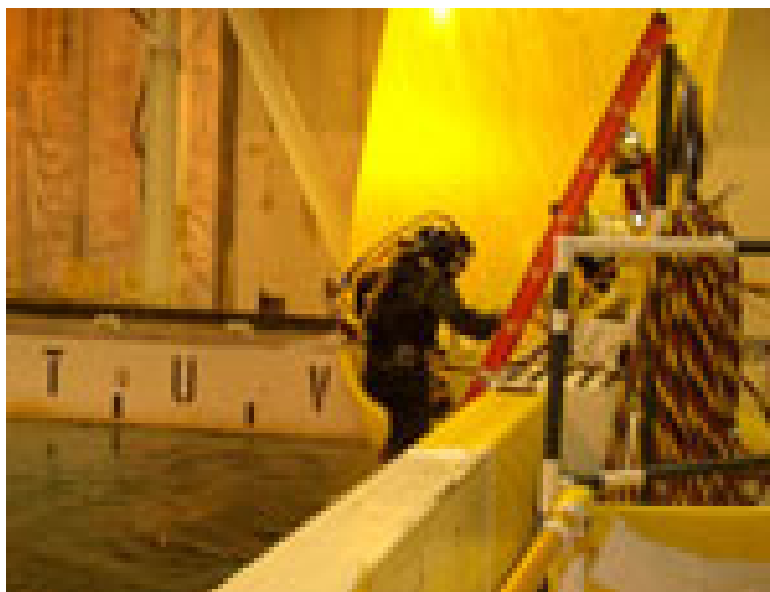
Figure 2. Diver enters basin at Test Area North.

S. G. Pinney commercial divers were chosen to complete this work. Before beginning dive activities, all areas to be worked on were surveyed by the divers themselves. The potential for finding unexpected debris items during cleanup of the basins was anticipated. The dive master was in constant voice and video contact with the divers during dive operations. Divers were instructed not to pick up anything before scanning it. There were no instances in which a diver entered an unsurveyed area or picked up objects that had not been surveyed. They first scrubbed the loose contamination off the basin walls and floors using a ship hull scrubber and vacuumed up the sludge. They then applied the UT-15 coating using a two-hose power roller system, which mixed the epoxy at the roller head, and eliminated the pot life concerns.

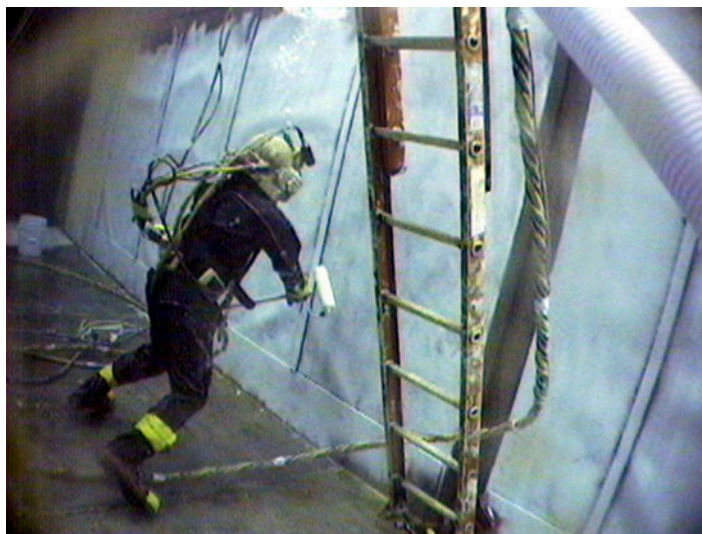
Figure 3. Applying fixative to the wall of the MTR canal.

The epoxy coating is much more difficult to apply under water than house paint in air. It took considerable effort to get a complete coating that passed the dive master's inspection. The divers also had to deal with the bubbled and loose paint layer on the TAN basin walls and the rough, bare concrete surface on the 603 Overflow Pit walls. The condition of the existing surfaces directly affected the time needed to apply the fixative.
