**Vancouver National Historic Reserve**

***Cultural  
Landscape  
Report***

**Vancouver, Washington**

Produced by Jones & Jones  
Architects and Landscape Architects, Ltd.  
Seattle, Washington

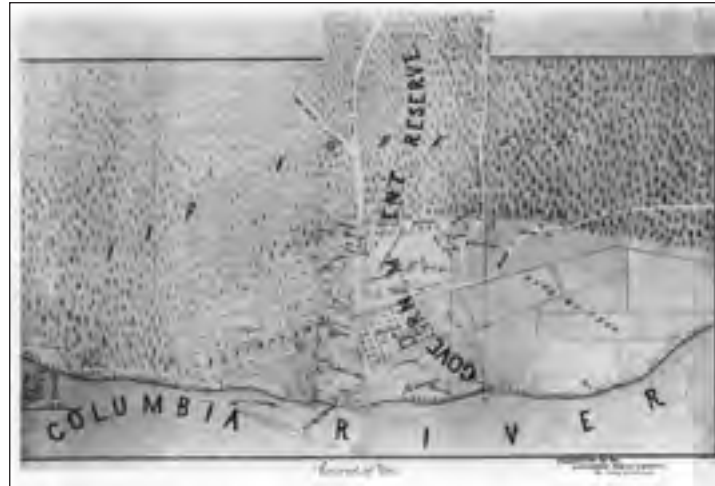
*1855 topographical sketch of the military reserve and the City of Vancouver. Layout of the post was aligned to the river while the city was laid out in a north-south orthogonal grid.*

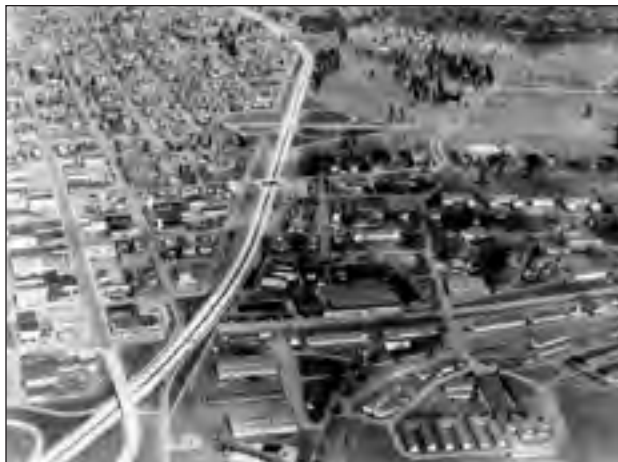
*Aerial view of Vancouver Barracks and the City of Vancouver shows CCC headquarters at lower right foreground. Construction of a new lift span bridge across the Columbia River and Highway 99 (now I-5) disconnected the military post from the city.*

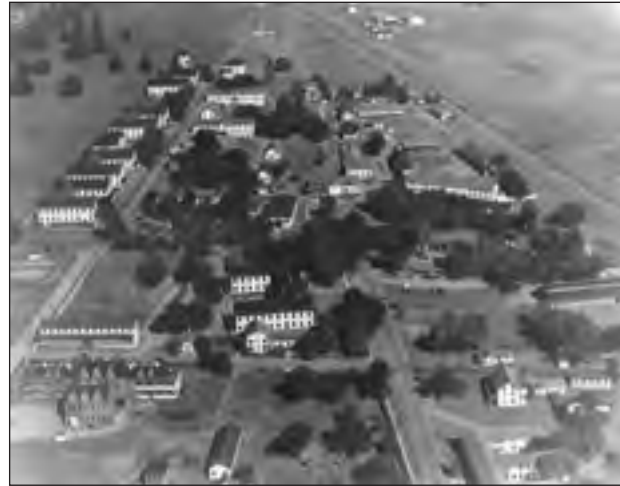
*Aerial view of barracks area clearly shows spatial organization of the site. Barnes Hospital is visible at left foreground while Pearson Field is located at right background. Photo by Jack Sholkoff, 1934.*

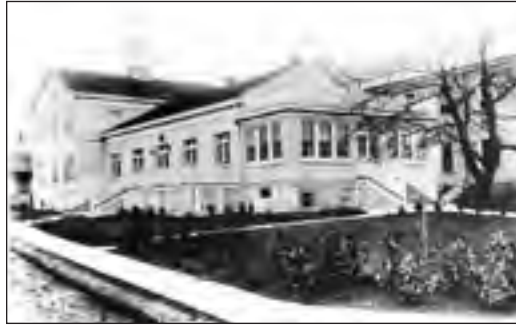
*The Red Cross building, a convalescence hospital for soldiers, was heavily landscaped with ornamental shrubs.*

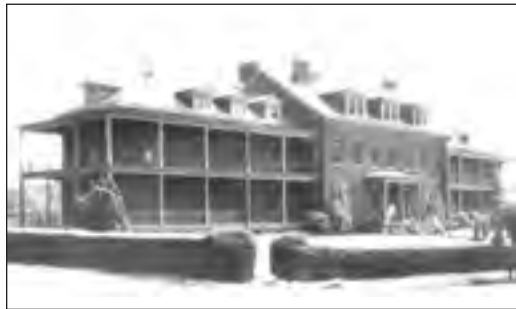
*Barnes Hospital's landscape consisted of a formal hedge enclosing the lawn, shrubs lining the sidewalk, and foundation plants densely planted at the entry.*

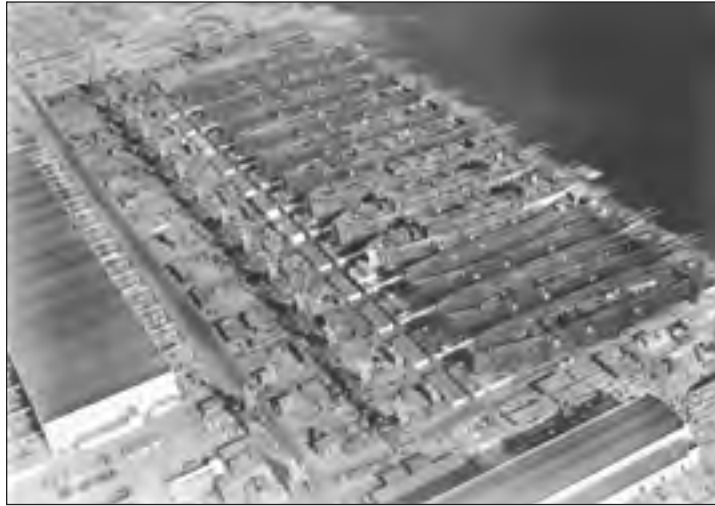
*Aerial view of Kaiser Shipyards and ships under construction in dry docks. Some remaining buildings and dry dock remnants still exist today in private ownership.*

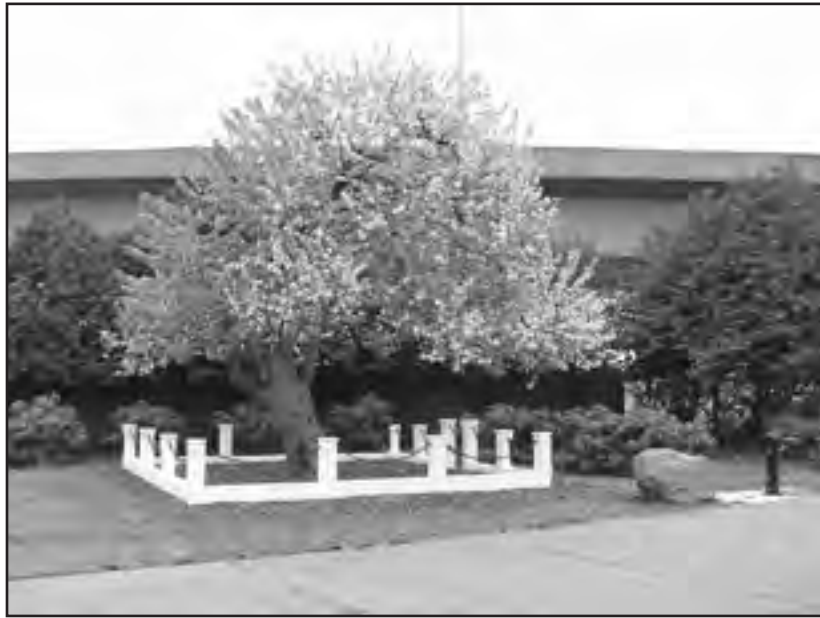
*Historic apple tree dating  
from Hudson's Bay Company  
era.*

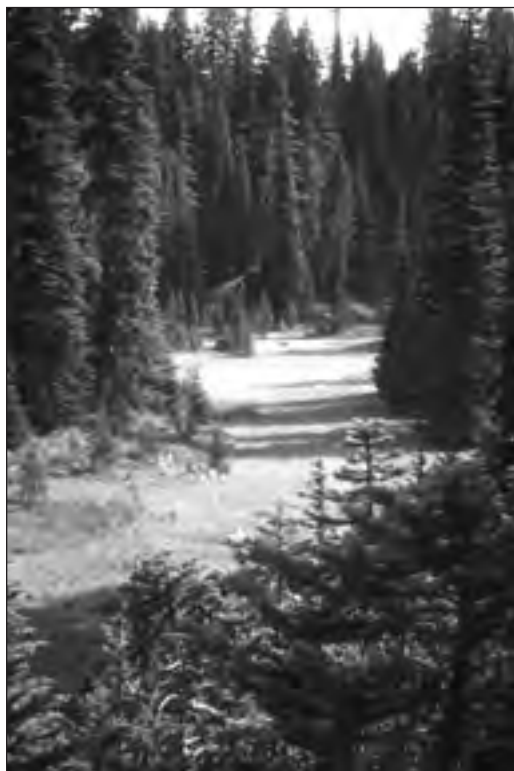
*South Cascades meadow along the Klickitat Trail that was likely created by Indian prescribed burning.*

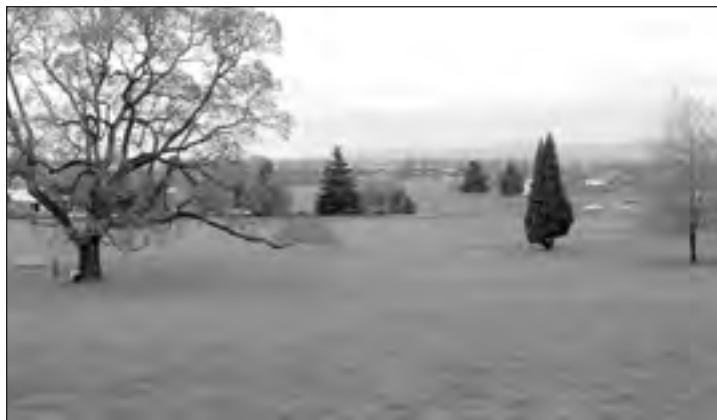
*The site's floodplain terraces and vegetative patterns defined the spatial organization of the HBC fort and all subsequent development.*

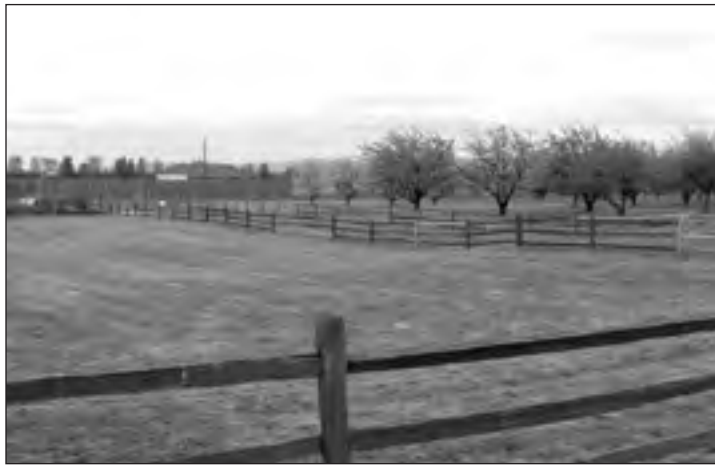
*The HBC-era orchard will be relocated slightly west to its historic location.*

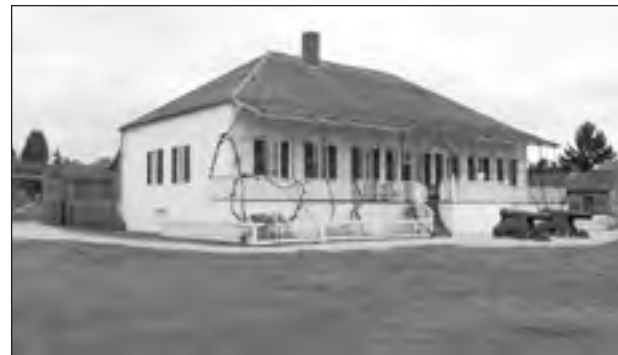
*The Chief Factor’s House was reconstructed within the HBC fort stockade.*

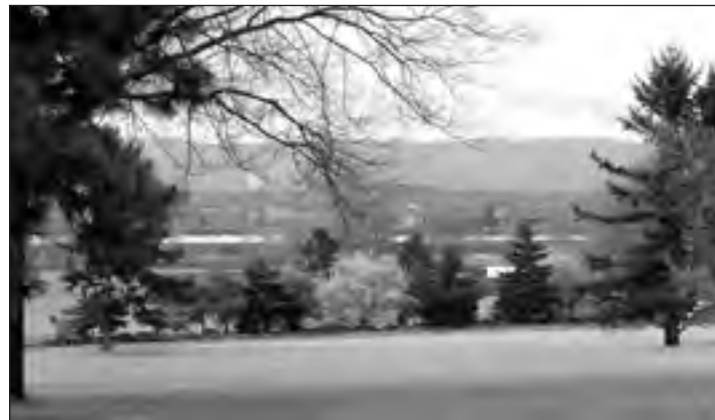
*The view from Officers' Row to the lower plain and the Columbia contributes to the Reserve's significance.*

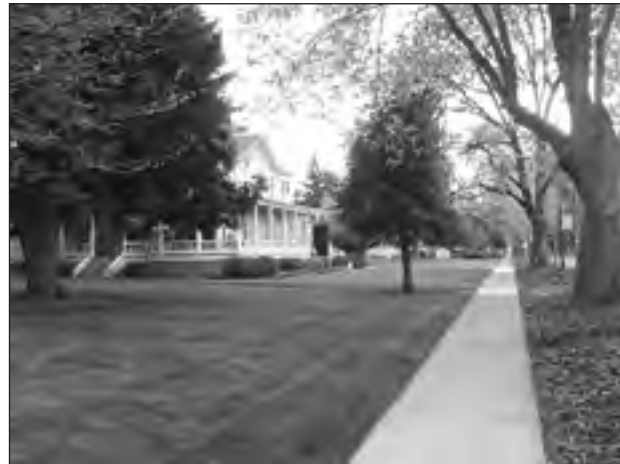
*The spatial organization of Officers’ Row residences, lawns, sidewalks and maple allee retain integrity.*

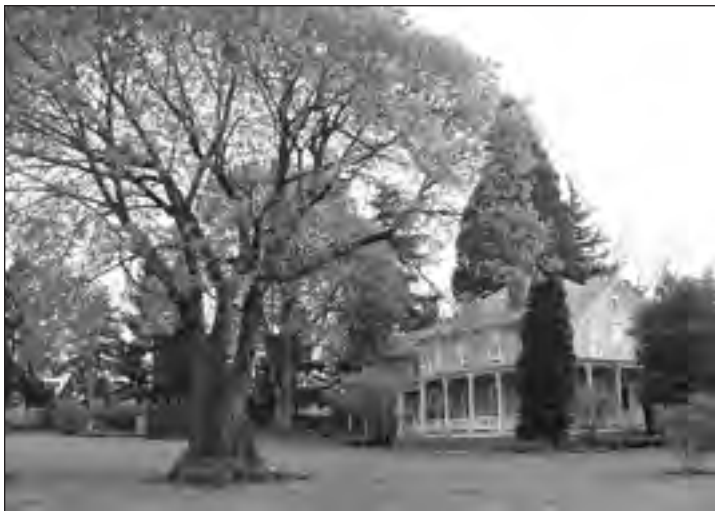
*Officers' Row landscape includes large specimen trees, ornamental foundation plantings and lawn.*

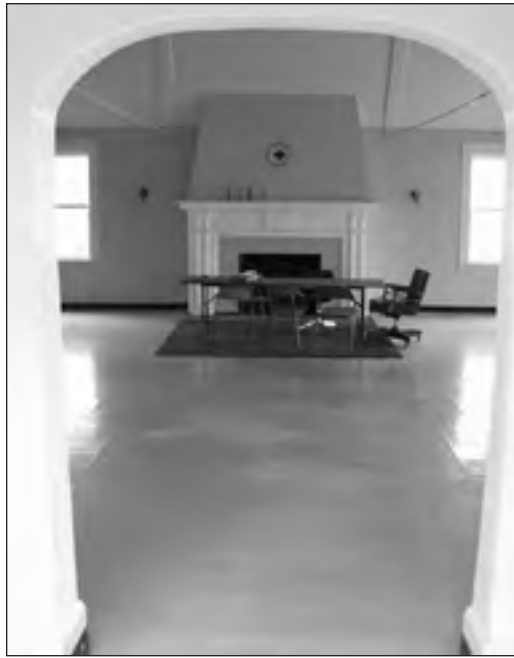
*Entry to Red Cross building, a Colonial Revival-style structure built in 1918.*

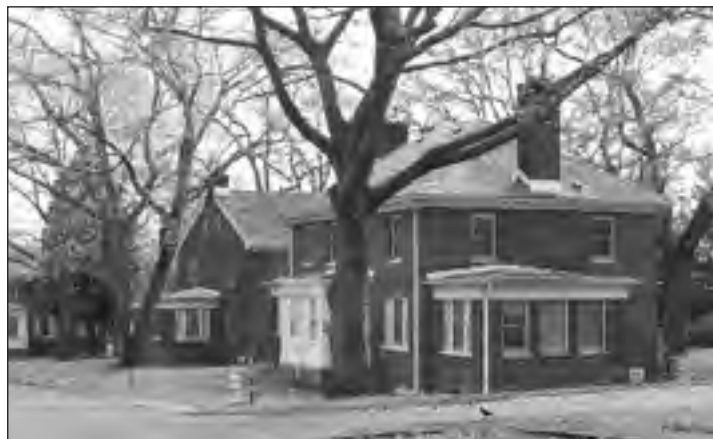
*These two-story brick duplexes built in the 1930s served as NCO Family Quarters.*

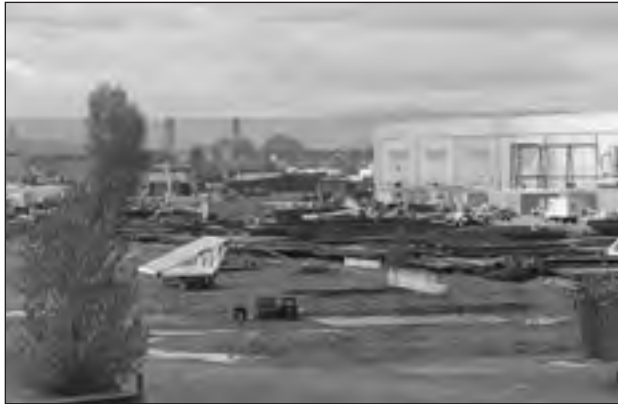
*Former Kaiser Shipyards site, in light-industry use today. Large structure on right is an original Kaiser ship-building facility.*

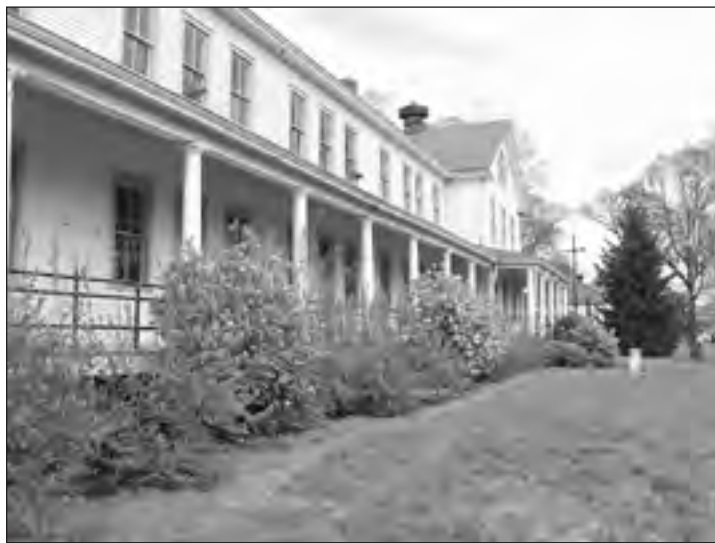
*Fewer than half of the original Barracks buildings still exist since the World War II period. These buildings contribute to the integrity of the Reserve.*

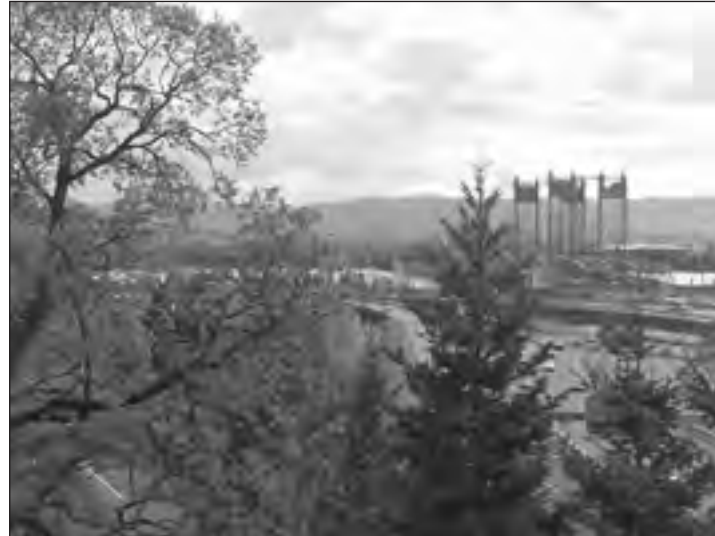
*Construction of Interstate 5 and its bridge over the Columbia River severed the direct connection between the West Barracks and the City of Vancouver.*

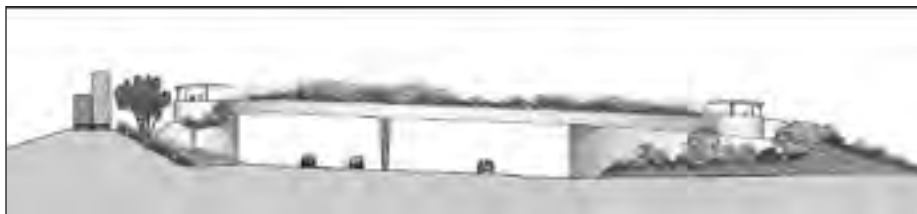
*The Vancouver Land Bridge will reinstate the physical landscape and social connection between the Historic Reserve and the Columbia River.*

walkways leading to Barnes Hospital and other buildings within the Barracks area. The most dramatic change to circulation resulted from the construction of Highway 99 and Interstate 5, which cut off connections between the site and the City of Vancouver. Aviation and railway travel still exist today; however, the site's transportation link to the Columbia River is virtually severed. Physical and social connection between the historic site and the river will soon be reinstated with the 2006 construction of the Vancouver Land Bridge.

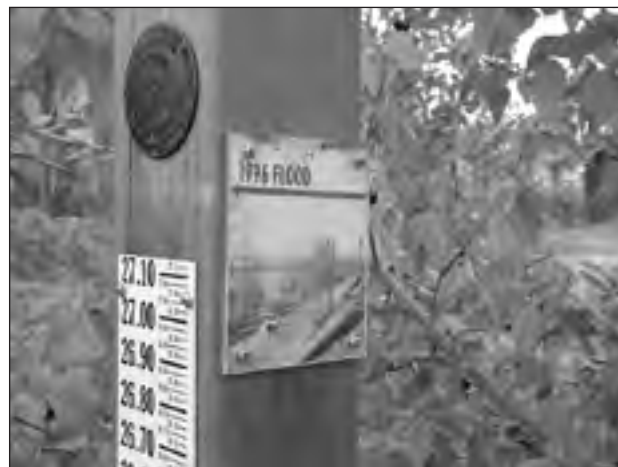
*Interpretive signage at Water Resources Education Center conveys Columbia River flood processes.*

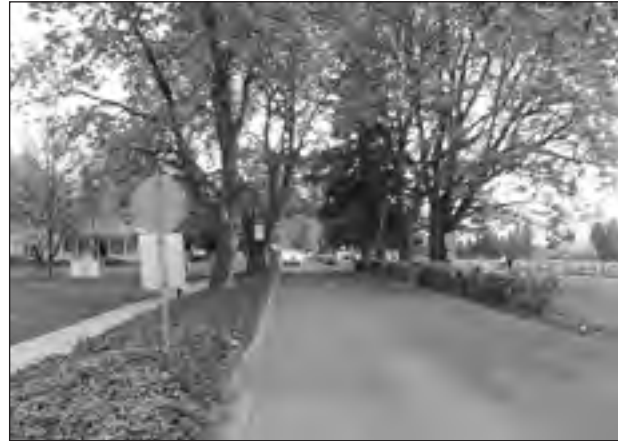
*Grant Avenue dates to the earliest U.S. military period.*

early military roads as distinct circulation routes associated with Vancouver Barracks. Early U.S. military roads include Grant Avenue, East Officers' Row, Fort Vancouver, NE Barnes, Hathaway, McLellan, Alvord, and the East Barracks interior roads.

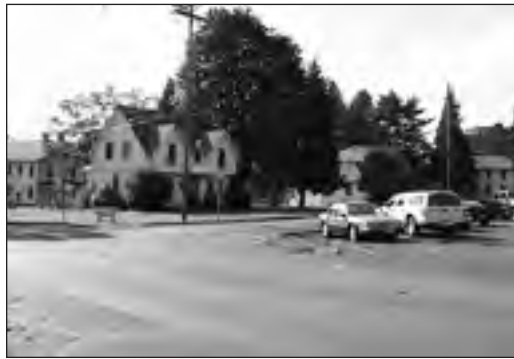
*Small parking areas are preferable to large lots that detract from the Reserve's character.*

associated with adaptive use of the Barracks area needs to respond to historic development patterns. Locate new parking areas in historic locations of circulation and parking systems. Parking design recommendations include: reducing total number of spaces and lot sizes; locating lots in specific areas to avoid negative impacts to cultural resources; breaking up parking areas with planting buffers; using permeable pavement; and designing surface stormwater treatment (e.g., bioswales).

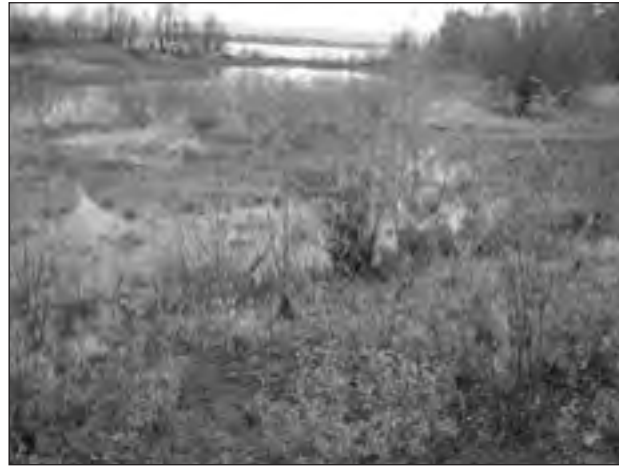
*Riparian vegetation at the Water Resources Education Center is the Reserve's most intact shoreline area.*

7. Continue wetland and riparian restoration efforts at the Water Resource Education Center.

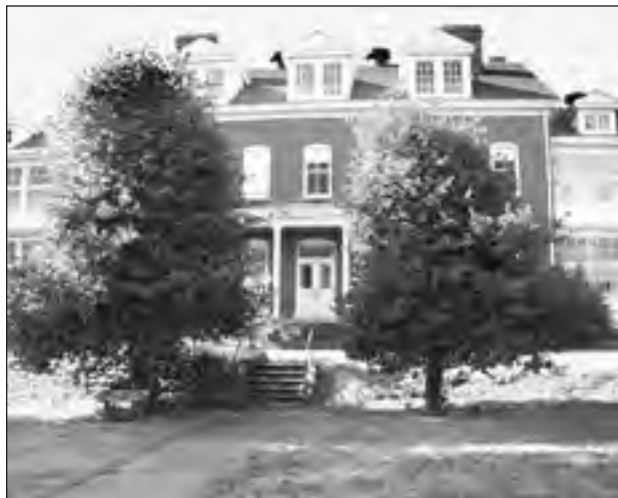
*Rehabilitation of overgrown ornamental plantings in the Barracks area is required to re-establish the landscape's historic character.*

Ornamental vegetation around Officers Row was reconstructed in the 1980s to emulate Victorian-era landscape gardening principles that were evident on site in the early 1900s. The landscape species representative of this period, as well as specific landscape forms such as hedges, vines, trellises, foundation plantings, lawns, flowering trees, and shade trees, should be maintained. More elaborate ornamental plantings were also historically established at Barnes Hospital and the Red Cross building, and may be re-established more in keeping with the early military landscape standards. In contrast, the residential barracks historically had very little ornamental landscape, and were

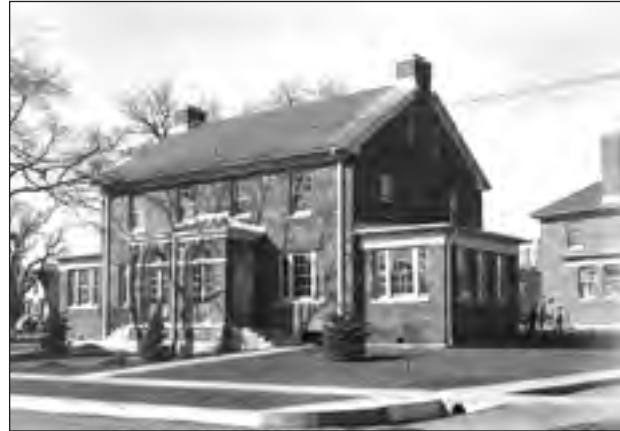
*Future developments should respond to the ordered dimensions and proportions of Barracks structures, sidewalks, lawns, and roads, as shown in this historic photograph.*

Preservation and adaptive re-use, currently underway in the West Barracks complex, are appropriate management strategies that fit with the Reserve's mission and diverse objectives. Various consultants, including Ward Tonsfeldt, David Leavengood, and Bill Hawkins, have undertaken historic architecture studies and design developments. Careful planning and design are essential to insure that new developments fit with the historic character of the site and that they do not diminish the integrity of the cultural landscape. It is critical to maintain the scale, dimension, and configuration of landscape elements such as structures, roads, pathways, and open spaces, and their relationship to each other. If the U.S. Army Reserve

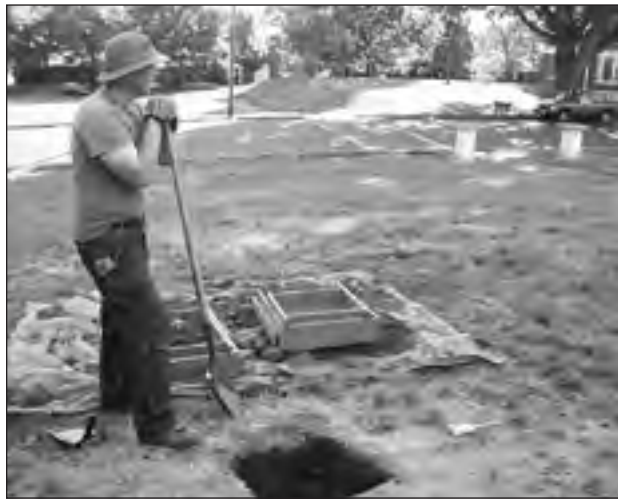
*An archeological dig was conducted in the West Barracks as part of adaptive use evaluation.*

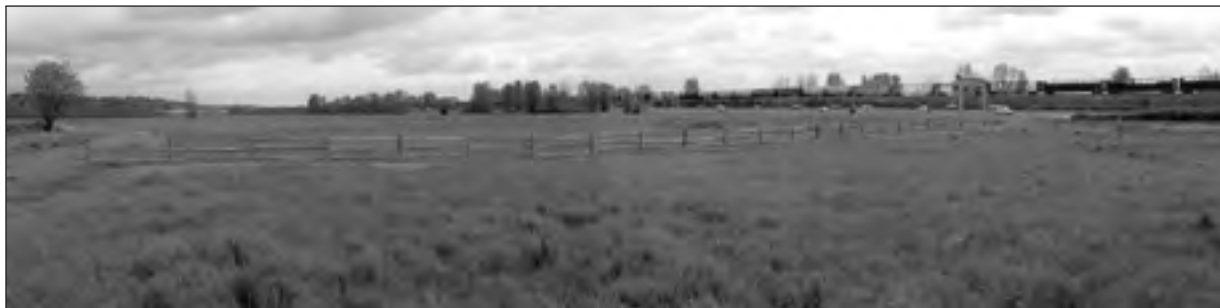
*View east of fort stockade, State Route 14 and the railroad. The Land Bridge will be built near the gate at the far right; the HBC village will be partially reconstructed in the foreground.*

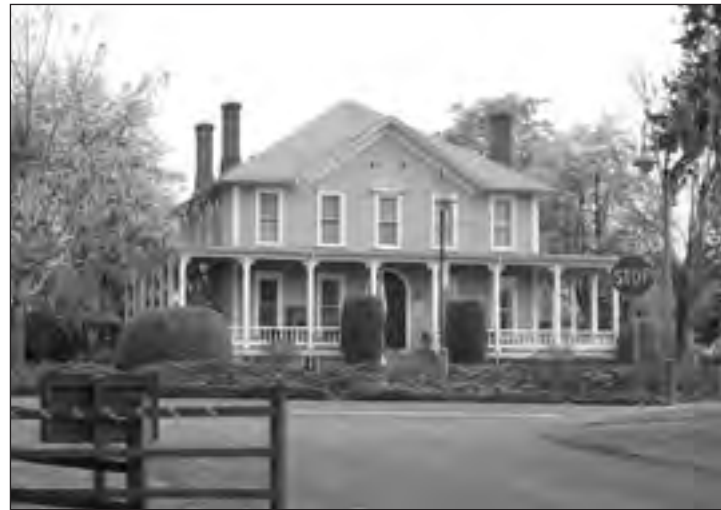
*Officers' Row residences and Barracks buildings dating from this historic period are predominantly the oldest structures in the Reserve.*

- Preserve all structures dating from this period, such as renovated O. O. Howard House, and several Barracks buildings (see appendix for full list of contributing structures). Rehabilitate West Barracks structures per recommendations in historic structures reports (Tonsfeldt 2002), as well recommendations by historic architect Bill Hawkins.

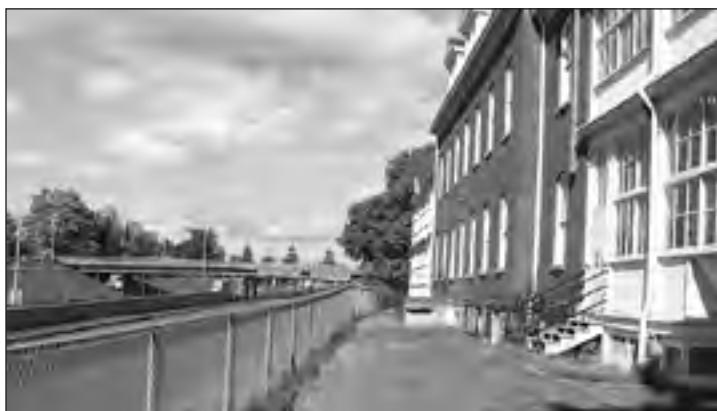
*Barnes Hospital sits just a few feet away from Interstate 5.*

- Highlight the Barnes Hospital's key role during this period in the structure's physical renovation and interpretation.
- Screen the interstate highway's visual and noise impacts on the West

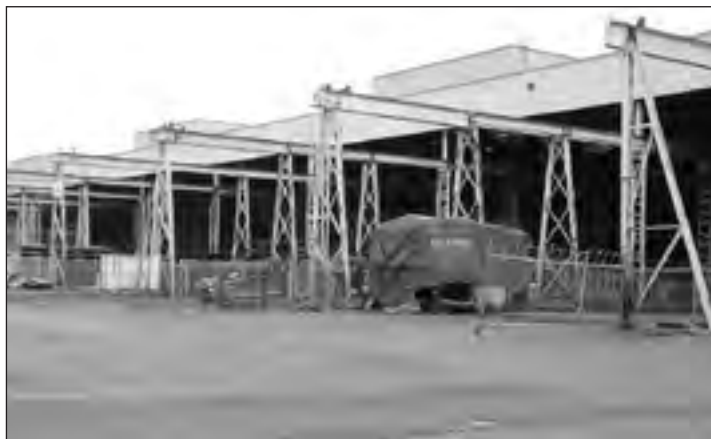
*Original Kaiser Shipyard structure is visible from Columbia Way.*

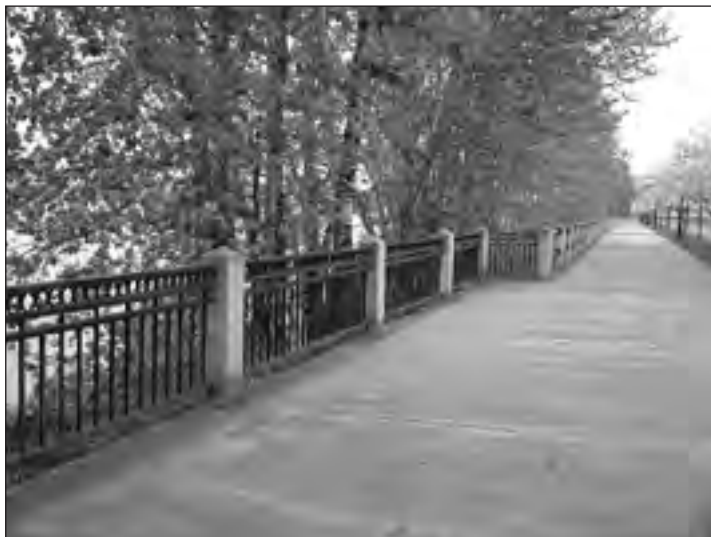
*The Discovery Trail can serve as a major connector between the core Reserve and the Water Resources Education Center.*

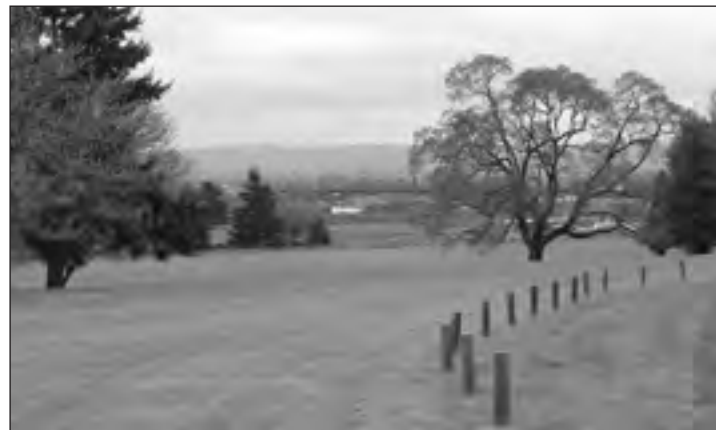
*"Plains Road" to fort may be realigned along historic route and resurfaced to match historic character.*
