## **Chapter Three: Existing Conditions Documentation**

This chapter includes written, graphic, and photographic documentation of 2002-2003 existing landscape conditions at Grant-Kohrs Ranch National Historic Site. This documentation is based primarily upon field investigations of the project area and is supplemented by existing conditions documentation contained in the Cultural Landscape Inventories (Amphion 1997 and Shapins 1999 and 2003). A site description and overview of landscape organization for the entire Ranch introduces this chapter and provides a context for the more detailed information that follows. Existing conditions documentation is presented for each of the nine major landscape zones comprising the project area and includes descriptions of existing landscape features, systems, and land-use patterns that are organized by the following landscape characteristics:

### **Overview of Grant-Kohrs Ranch National Historic Site Existing Conditions**

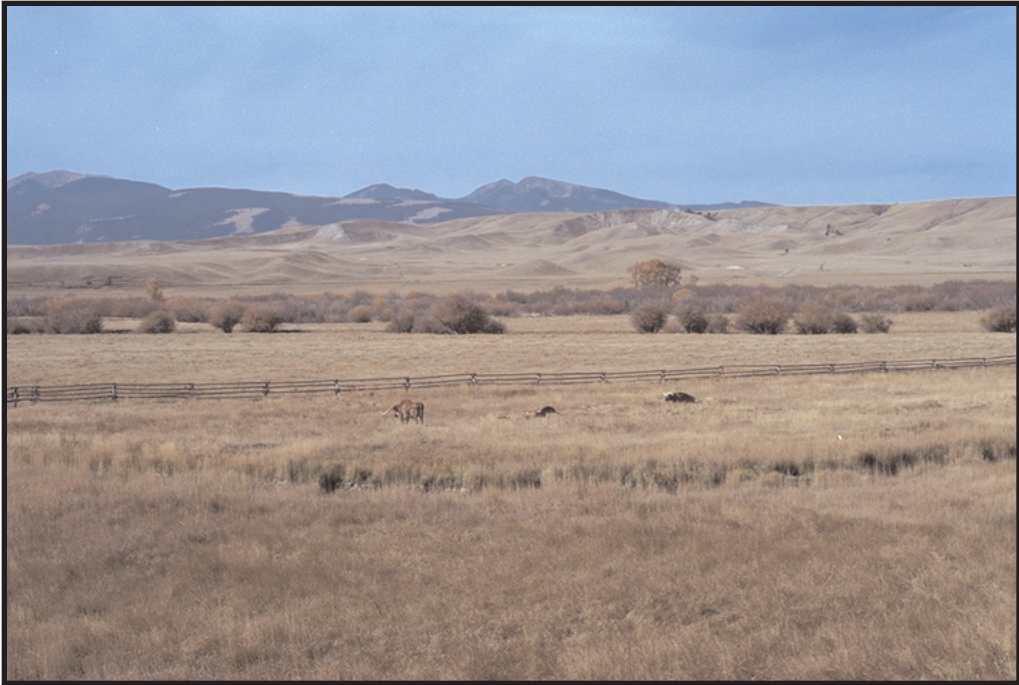
Photo 3-1 : (Z-23) Flint Creek Range and the distant peaks of Mt. Powell and Deerlodge Mountain provide a stunning backdrop to the rolling foothills below.

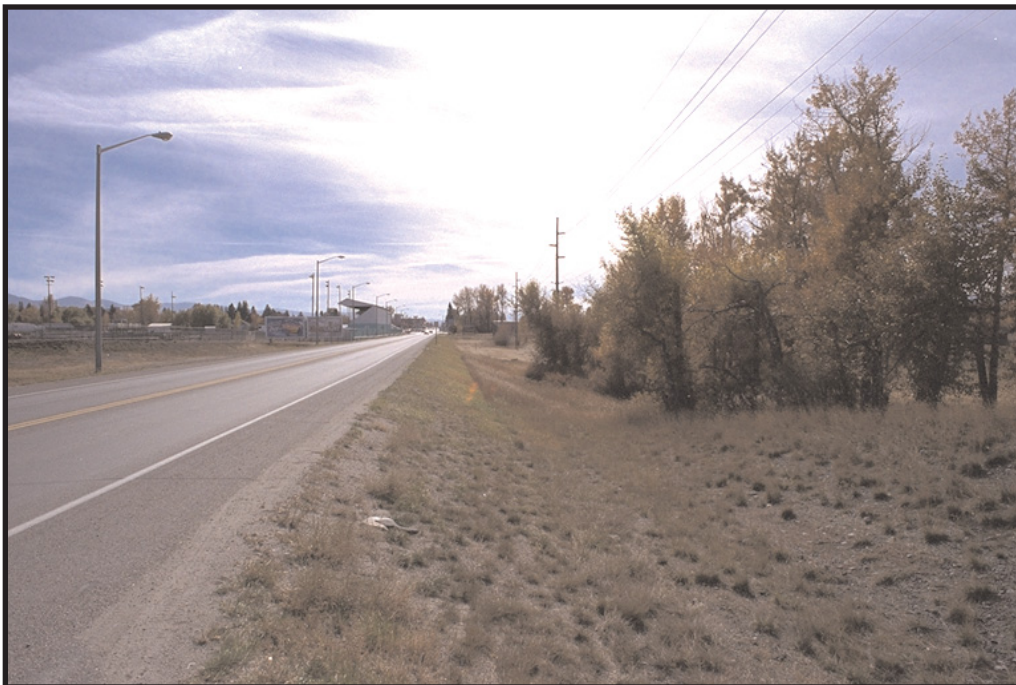
Photo 3-2 : (RA-01) Views to the east of the Ranch are defined by the City of Deer Lodge, Business Loop 90, and the modern residential and commercial development located along it.
