# **Hazard Ranking System Documentation Record**

**East 67<sup>th</sup> Street Ground Water Plume  
Ector County, Texas  
TXN 000606614**

**September 2006**

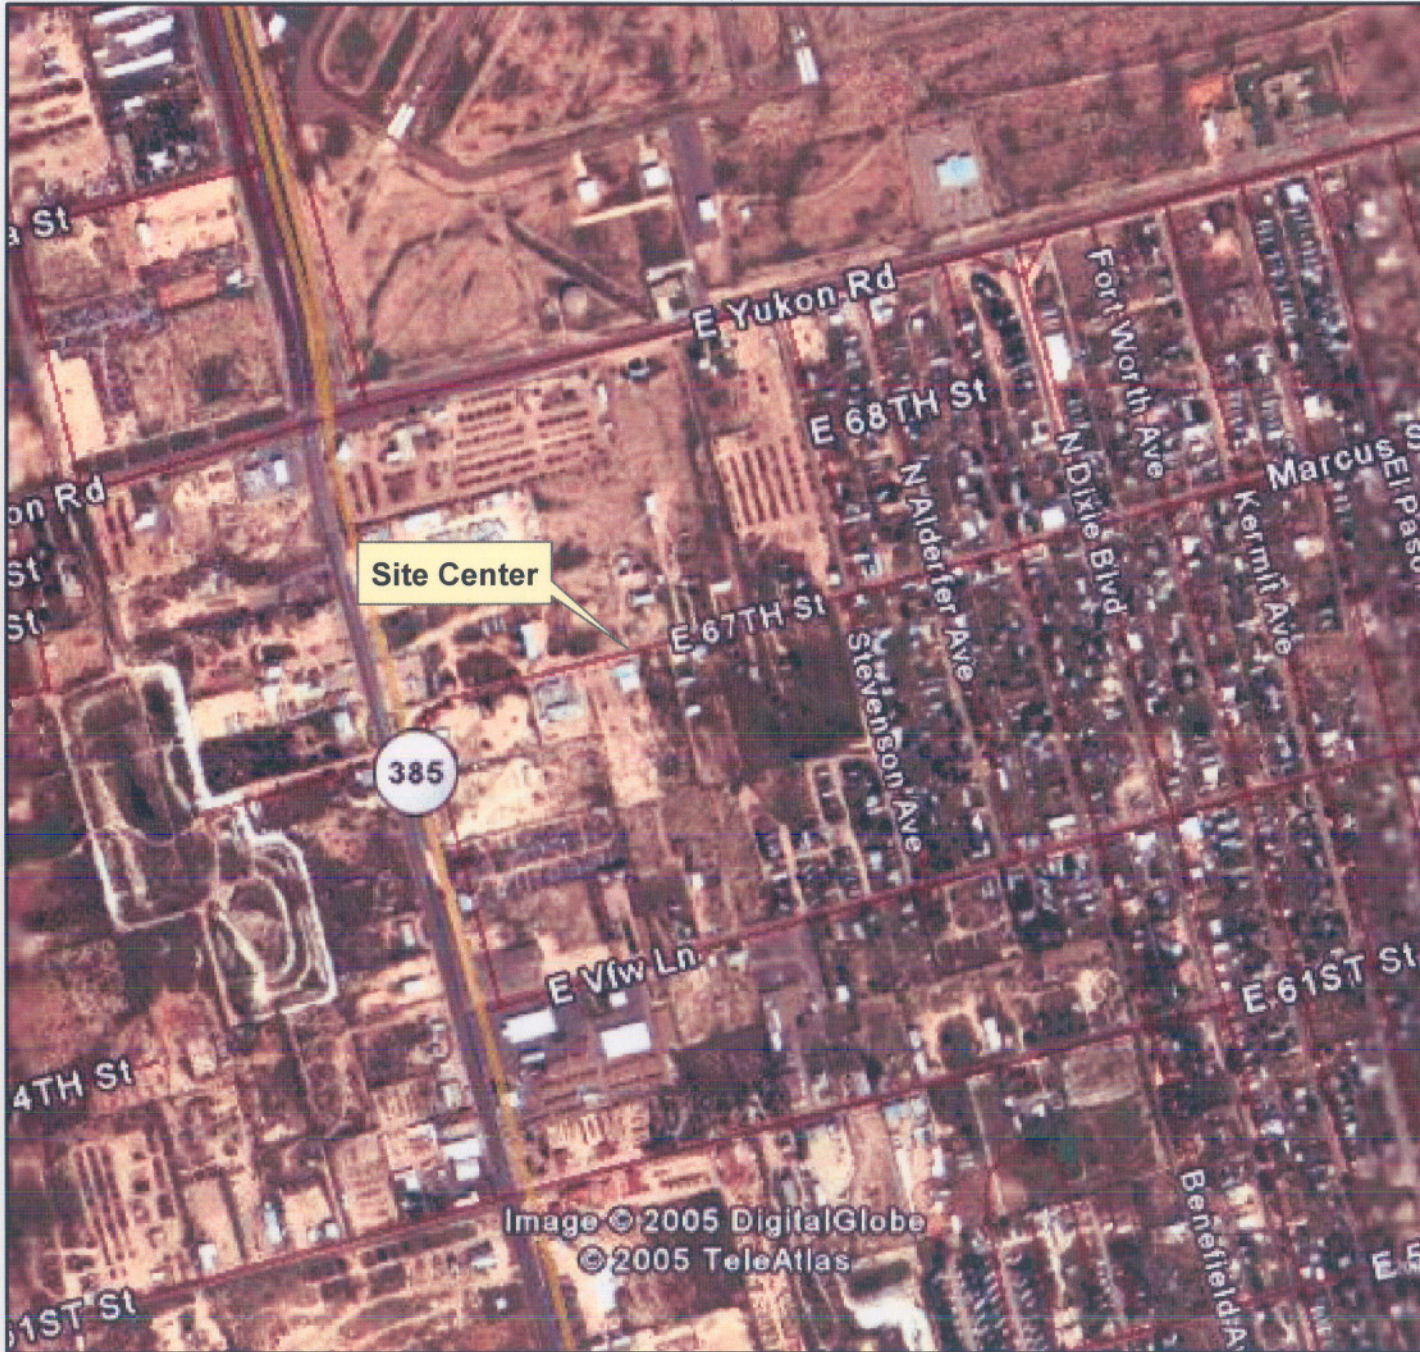
# Figure 2. Site Location Map

Figure 2  
Site Location Map

East 67th Street  
Ground Water Plume Site  
Odessa, Ector County, Texas  
TXN000606614

**Street Address of Site\*:** The center of the known ground water plume is located at the intersection of East 67<sup>th</sup> Street and Stevenson Street (see Figure 2, Site Location Map and the site coordinates below).

The East 67<sup>th</sup> Street Ground Water Plume site is situated in Ector County, adjacent to the City of Odessa. The ground water plume is centered along East 67<sup>th</sup> Street (see Figure 1, Regional Location Map and Figure 2, Site Location Map).

The outer boundaries of the contaminated ground water plume have tentatively been established along East 67<sup>th</sup> Street, from west to east and along Stevenson, from north to south, with the identification of ground water wells that were non-detect for VOCs along VFW Lane to the south and Alderfer Street to the east. Non-detect wells have also been established on the east side of Andrews Highway and Yukon Street to the north. The plume is centered at the intersection of East 67<sup>th</sup> Street and Stevenson Street (See Figure 2, Site Location Map).

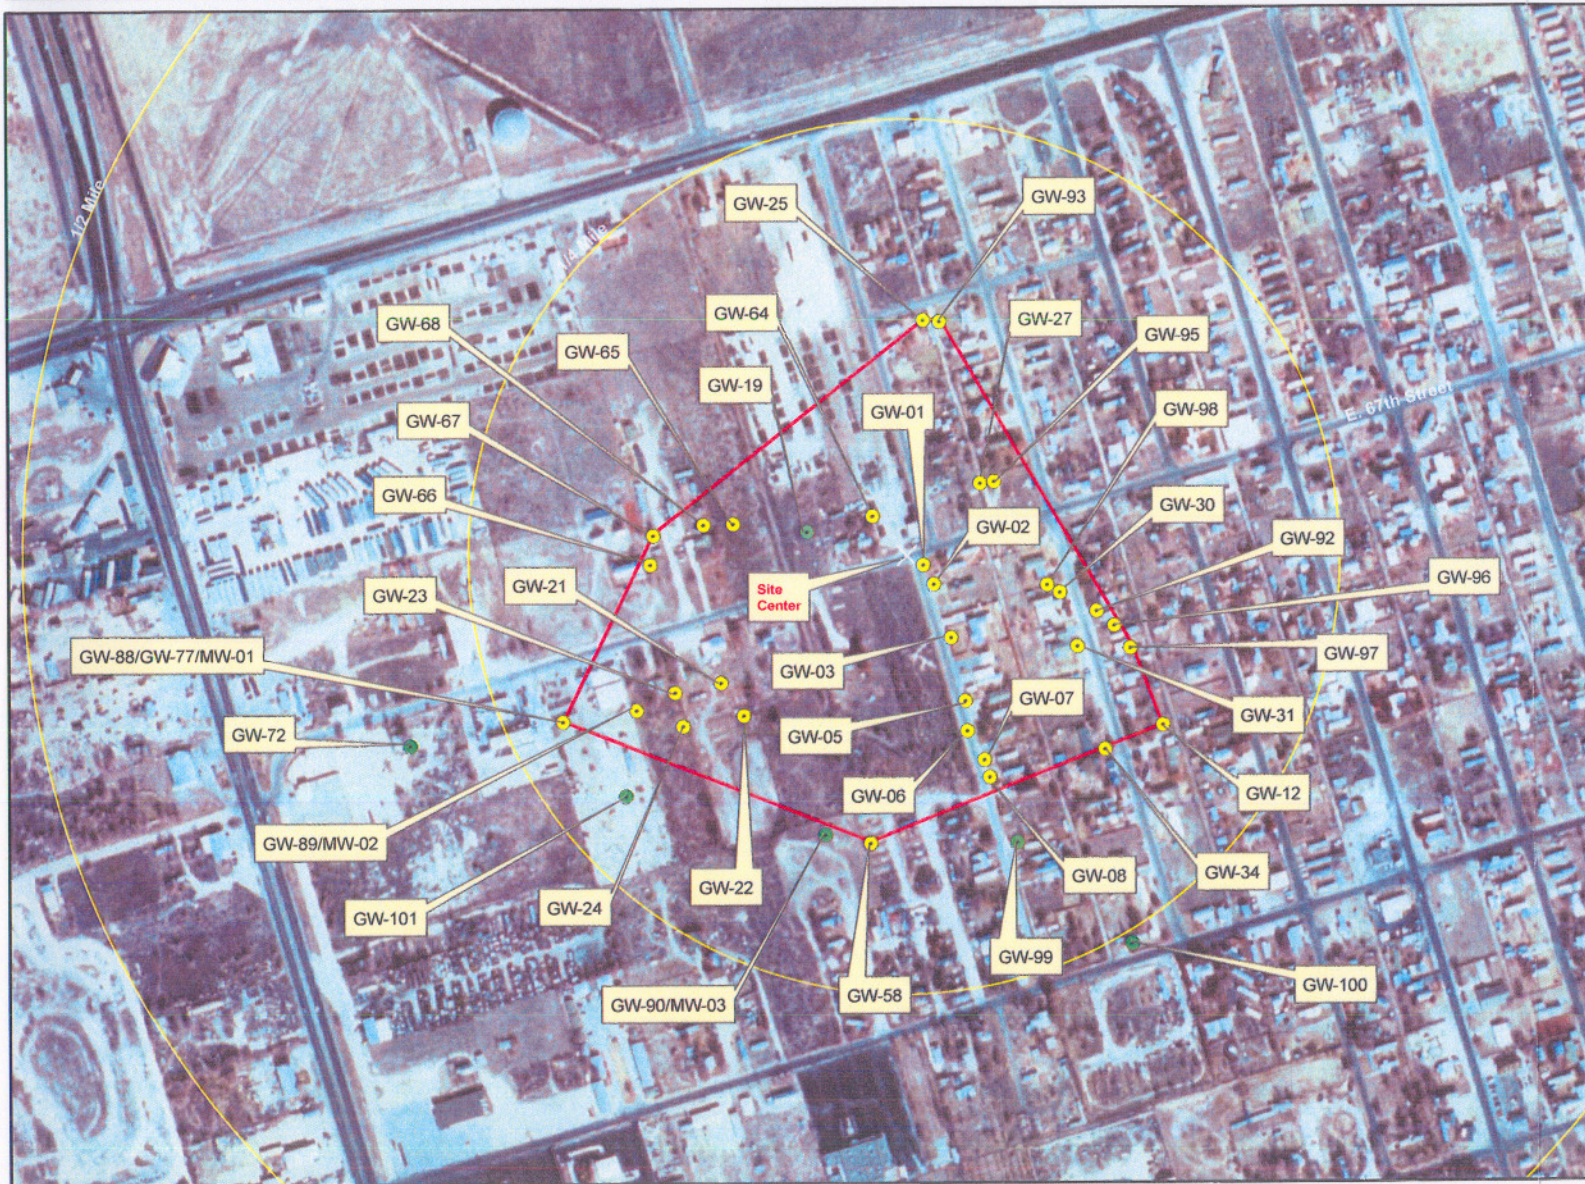
**Figure 3**  
 Ground Water Plume Map

- Ground Water Plume
- Wells with No Observed Release
- Wells with an Observed Release

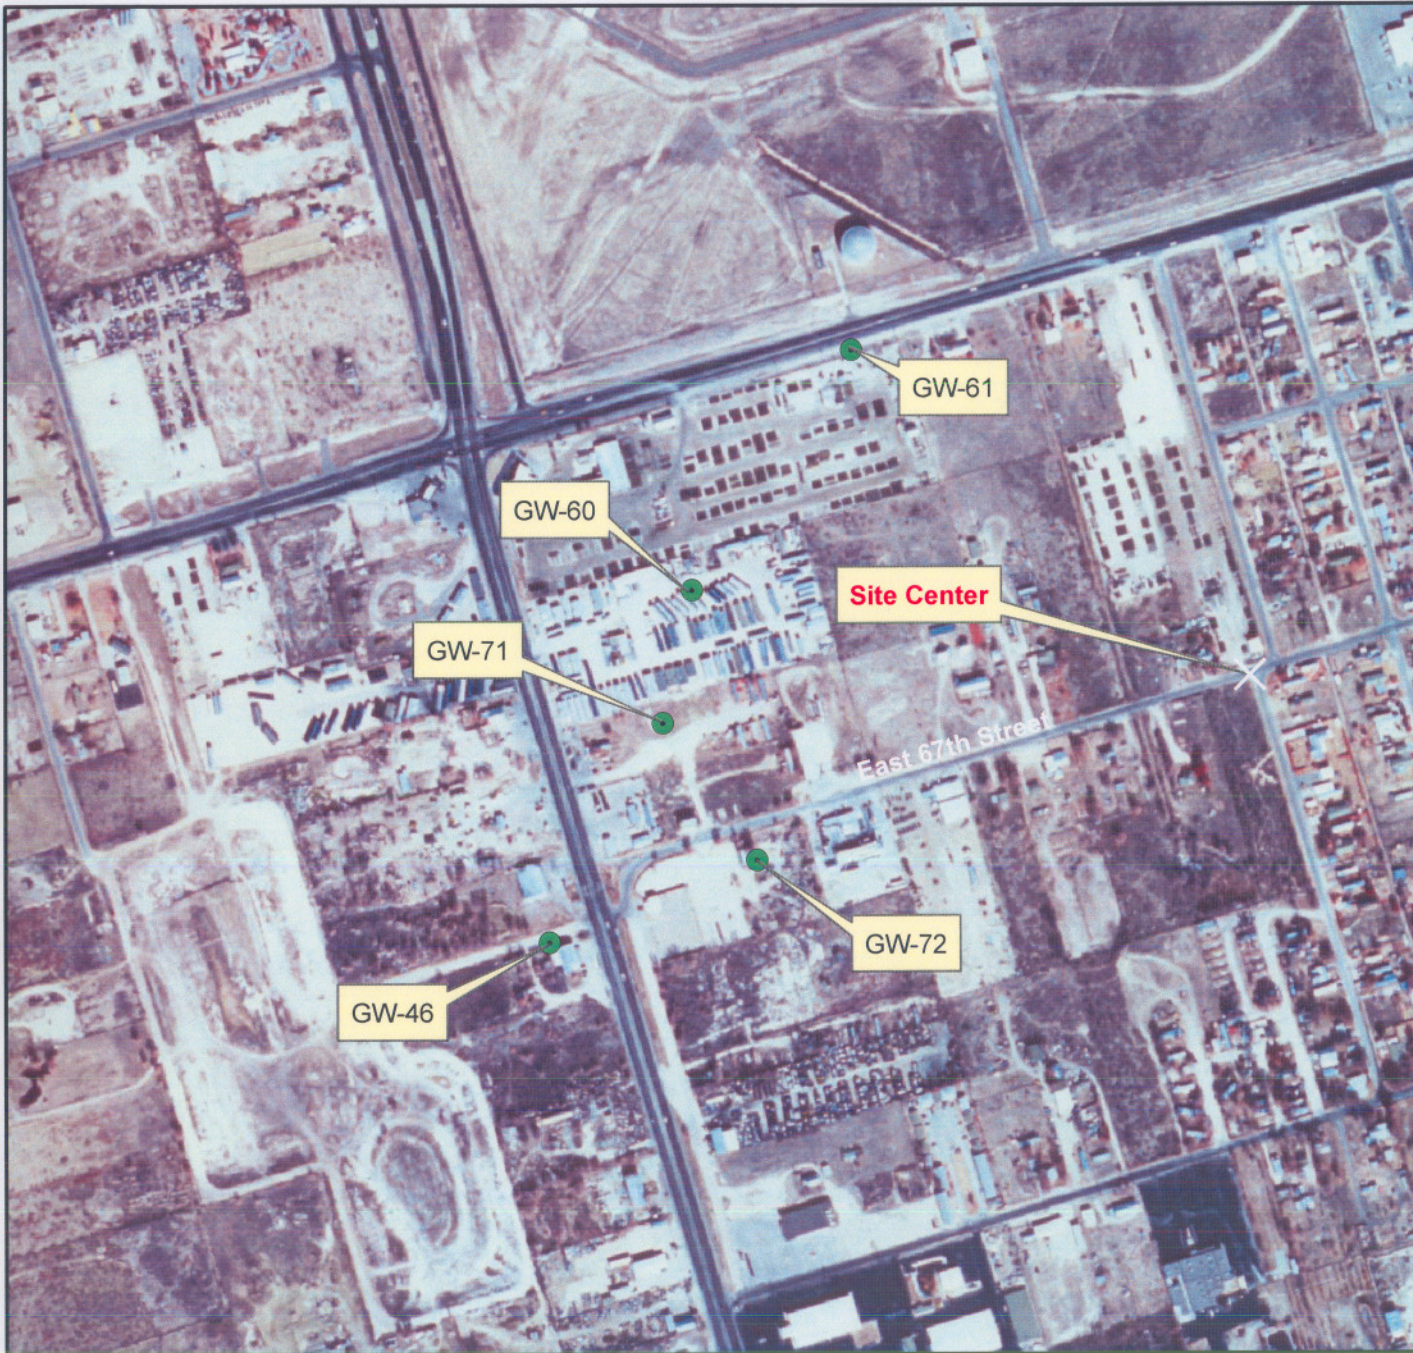
Figure 4  
Background  
Sample Location Map

● Background Wells
