INEEL/CON-02-01530
PREPRINT

**Contamination Control During In Situ Jet
Grouting For Application In A buried
Transuranic Waste Site**

**Guy G. Loomis
Jim J. Jessmore**

Waste Management 2003

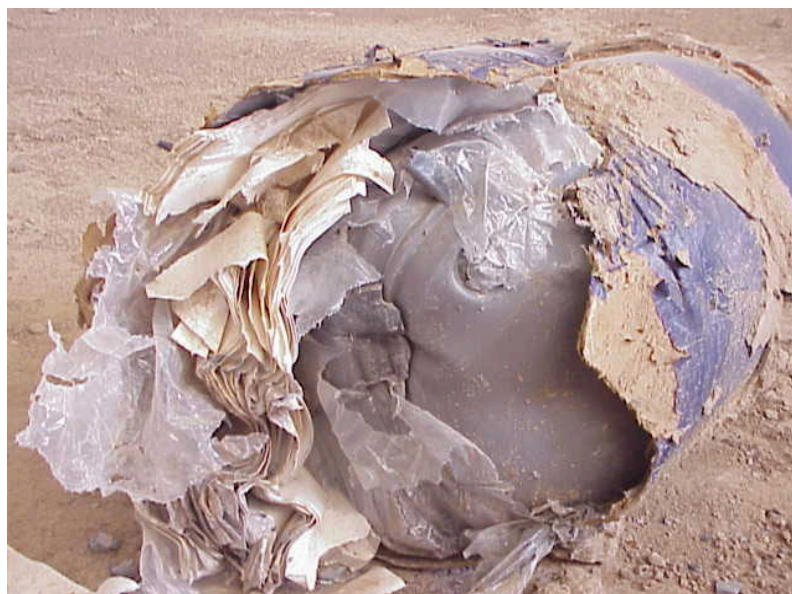
Fig. 4. Grouted drum containing combustibles.
