# INUNDATION AND SUBSTRATE STABILITY STUDY TO SUPPORT VERDE RIVER VEGETATION ANALYSIS

**Salt River Project  
P.O. Box 52025  
Phoenix, Arizona 85072-2025**

**Mussetter Engineering, Inc.**  
1730 S. College Avenue, Suite 100  
Fort Collins, Colorado 80525

May 20, 2004

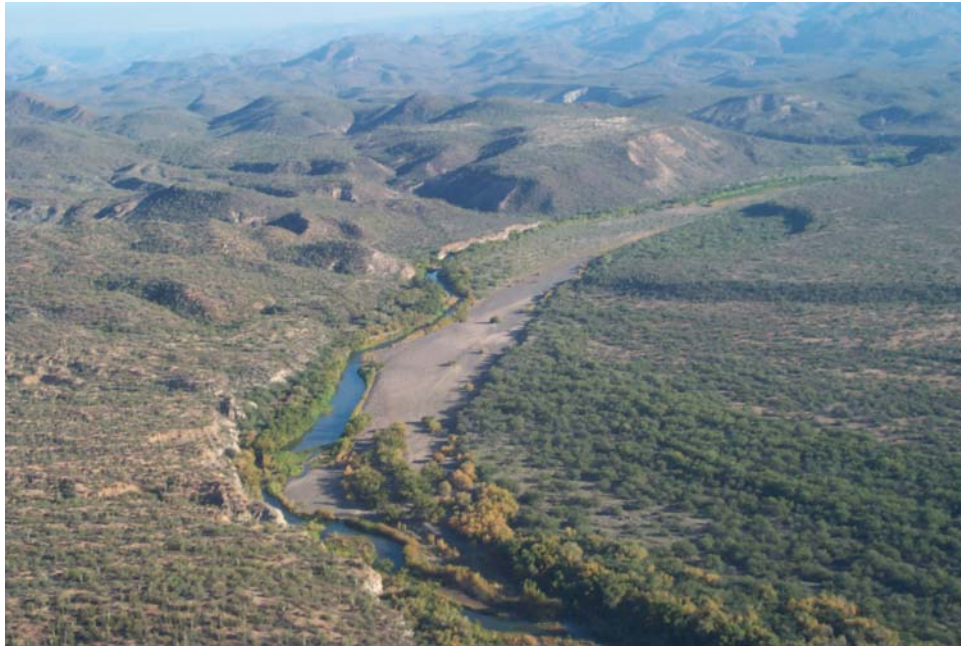
Plate 1. View upstream of Site 1 located upstream of Horseshoe Reservoir. The chute channel that extends the length of the site during flood flows is clearly visible, as is the downstream hydraulic control for the site that is formed by old alluvial fans on the right bank and a Holocene terrace on the left bank.

Although the quality and resolution of the aerial photographs is variable, it appears that the major change that has taken place episodically between 1934 and 2002 has been in the density of the vegetation in the upper portions of the chute channel that extends the length of the site (Figure 2.2 and Plate 1). Following the floods of 1906, 1920 and 1927 [recurrence intervals (RI) ranged from 10 to 18 years]; the 1934 photographs indicate there was very little vegetation growing in the active portion of the channel between the heavily vegetated bounding terraces. By 1953, following the 1952 flood (15-year RI), there appears to have been some vegetation establishment at the downstream end of the high bar surface that separates the main channel from the chute channel (Cross Sections 5 and 6, Appendix A). The 1968 photograph shows a significant increase in vegetation on the bar surfaces, which can probably be attributed to the

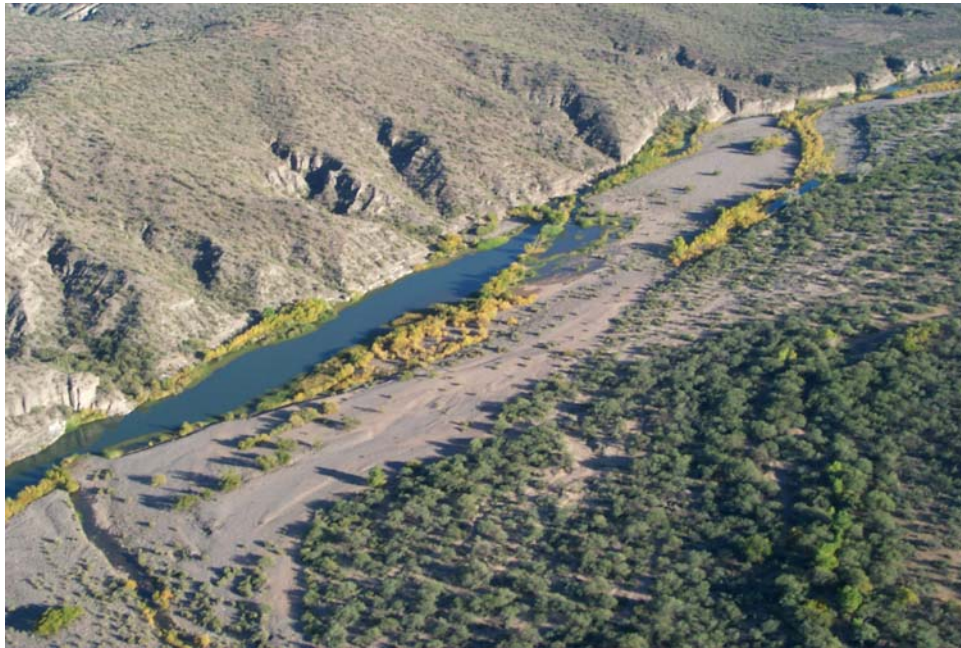
Plate 2. View downstream of Site 2 located downstream of Horseshoe Dam. The left valley wall is composed of basin-fill sediments and the right valley wall is composed of alluvial fan and terraces sediments. The new chute channel, formed in the 1993-1995 floods and that is now flanked by riparian vegetation, can be seen in the lower left portion of the photograph.

Site 2 is located within a section of the Verde River valley that is about 2,000 feet wide (Figure 2.2, **Plate 2**). Within the site, the active channel width is about 450 feet. The site is located in a depositional zone upstream from a valley constriction, located about one mile downstream, that is caused by the presence of more erosion-resistant basin-fill outcrop on the right bank and older alluvial terraces and tributary fan sediments on the left bank. As is common in arid zone rivers, the braided channel occupies the active valley floor between the terraces and the fan, and therefore, there is no floodplain in the classic sense (Graf, 1988). Further enhancing the depositional nature of the site is the presence of two large tributaries that episodically deliver significant quantities of sediment to the river. Davenport Wash is located on the left bank at the upstream end of the site, and an unnamed arroyo is located on the right bank at the site. Sediments delivered by the right bank arroyo have formed a large alluvial fan that has prograded out onto the valley floor. The left valley wall throughout the site is composed of basin-fill sediments that also crop out on the right valley wall immediately downstream of the site. The right valley wall along most of the site is composed of old alluvial and fan sediments into which the present arroyo is inset. Morphologically, the site is characterized by an approximately 200-foot-wide low-flow channel that is fringed by riparian vegetation. A large, sparsely vegetated cobble-gravel bar separates the main channel from a chute channel that is located on the margin of the valley floor and runs along the base of the bounding alluvial fan and terraces for much of the length of the site. The active and chute channels are flanked by thin strands of riparian vegetation. The downstream hydraulic control for the site is created by a constriction caused by the presence of erosion-resistant late- to mid-Pleistocene-age, coalesced fans on the right bank, and an early Holocene-age terrace on the left bank. Plots of the surveyed cross sections that were used in the hydraulic modeling, showing the geometry of the channel are included in Appendix A. (The locations of the cross sections are shown in Figure 2.2.)

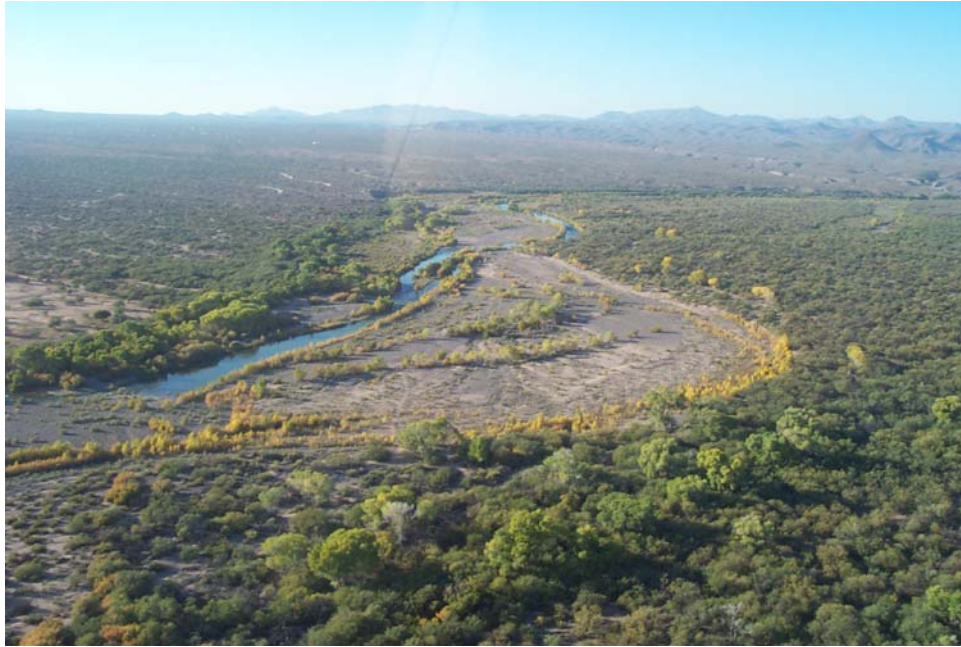
Plate 3. View upstream of Site 3 in the upper part of the picture. The right valley wall is composed of old alluvial and fan sediments, and the left valley wall is comprised of the older and younger Lehi terraces. The larger cottonwoods are growing on the Lehi terraces. Younger riparian vegetation is located on the margins of the active and chute channels.

Site 3 is located about 6.5 miles downstream from Bartlett Dam in a section of the Verde River valley that is about 4,000 feet wide (Figure 2.3, **Plate 3**). The active braided channel at the site is about 600 feet wide, and is flanked on the left side by the younger Lehi (Holocene) terrace that was overtopped by the large floods that occurred in the early part of the 20<sup>th</sup> century. The upper portion of the site is flanked by the older Lehi terrace, but the remainder of the site is flanked by both late- and early-Pleistocene age alluvial sediments that are dissected by a number of relatively small active arroyos. In common with most arid zone rivers, there is no floodplain in the classical sense (Graf, 1988). The older Lehi terrace was not overtopped by the large floods of the early part of the 20<sup>th</sup> century. The site is located in a depositional zone

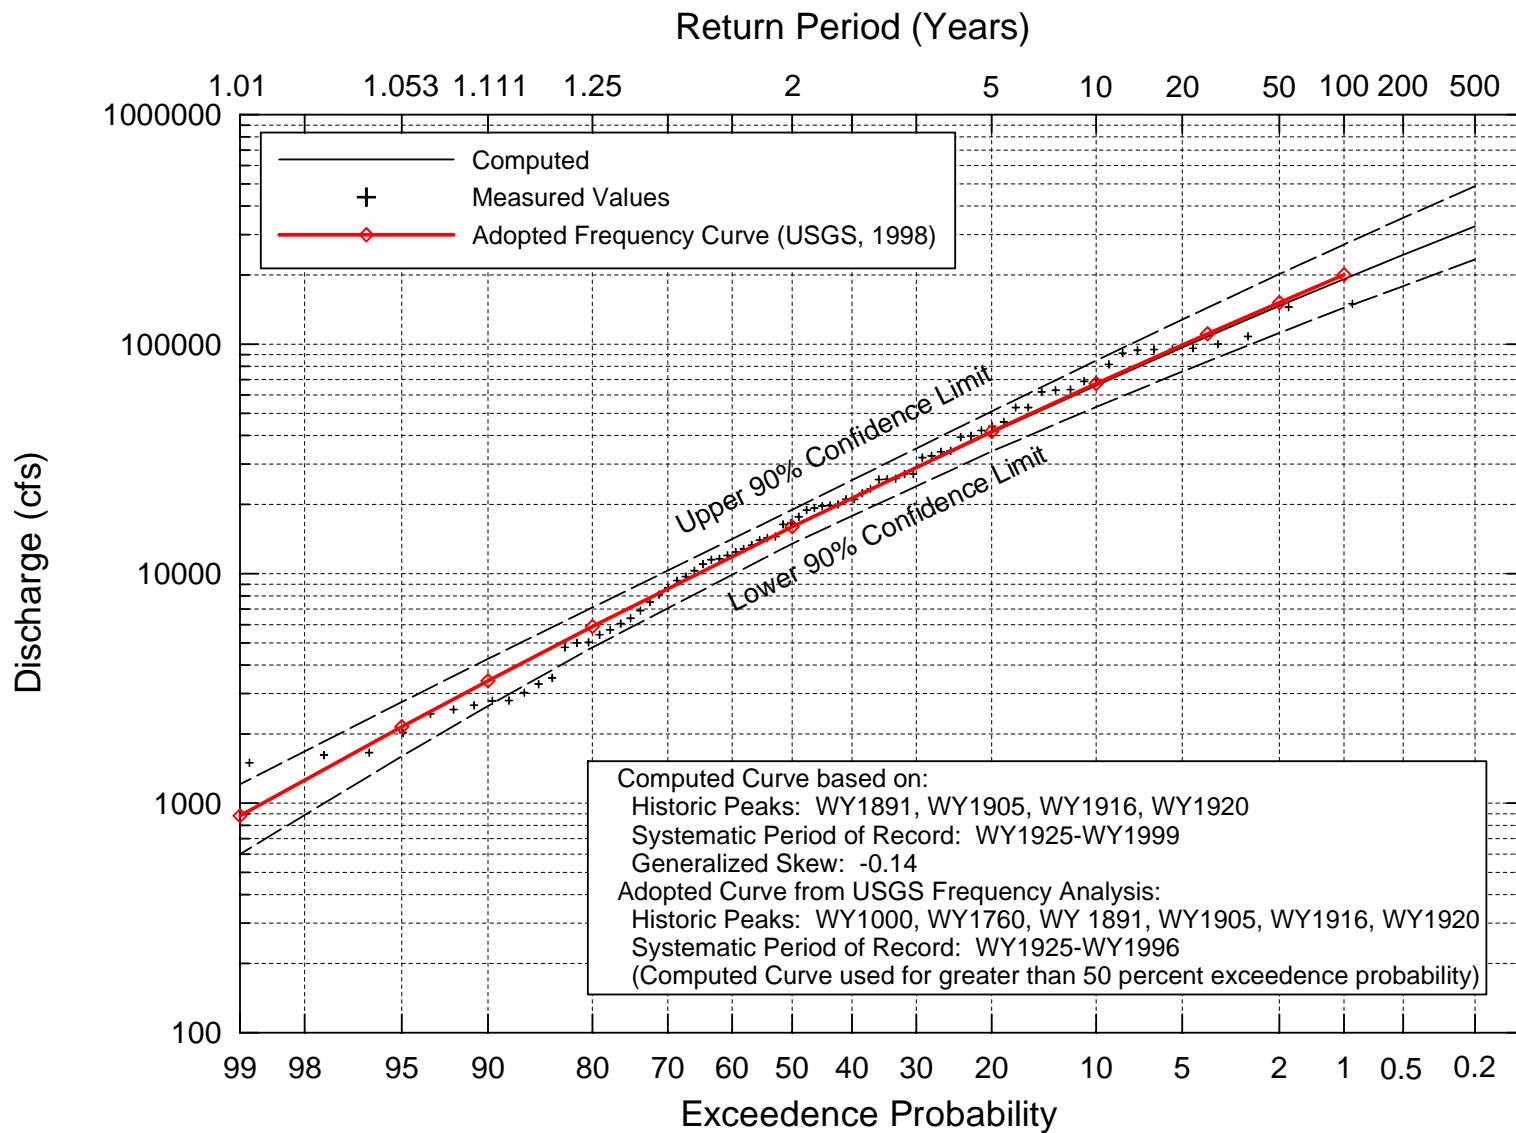
Figure 3.4. Recorded peak flows and estimated flood frequency curves for the period of record at the Verde River below Tangle Creek above Horseshoe Dam stream gage (USGS Gage 0908500).

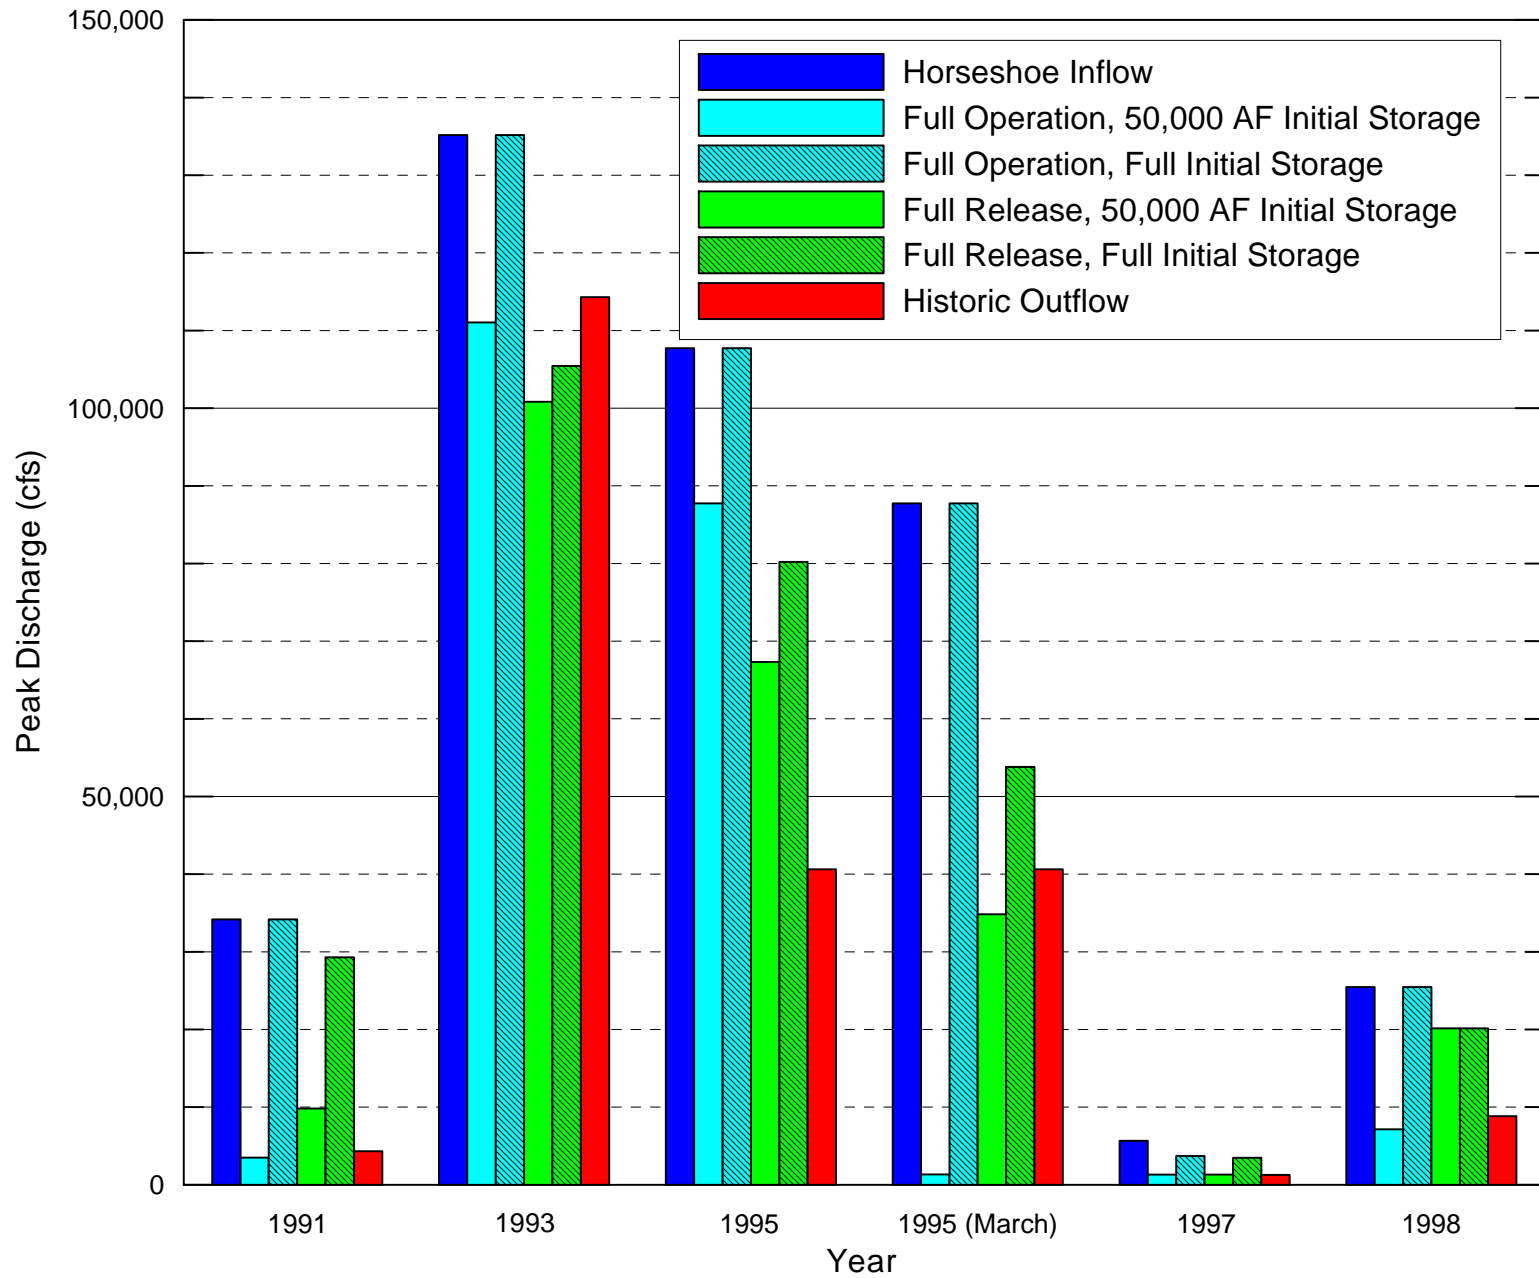
Figure 3.9. Bar graph summarizing computed flood peaks below Bartlett Dam for the various reservoir operational scenarios.

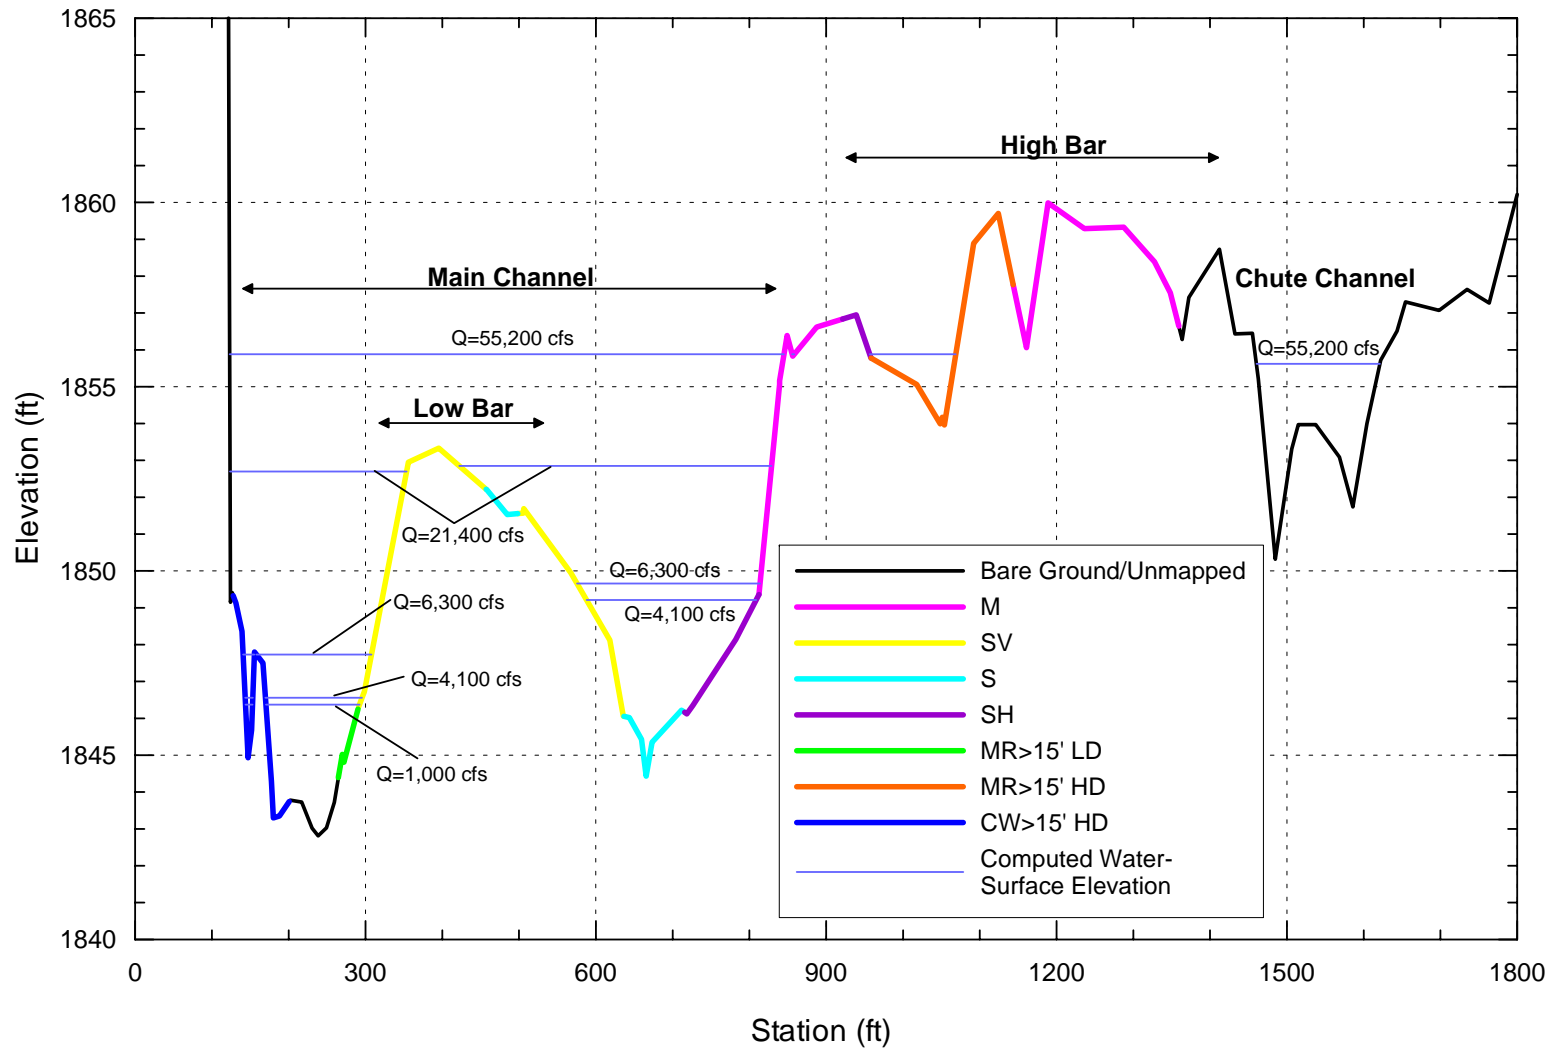
Figure 5.2. Typical cross section at Site 2 (XS2, KA Ranch) showing the geomorphic surfaces and associated inundation discharges.

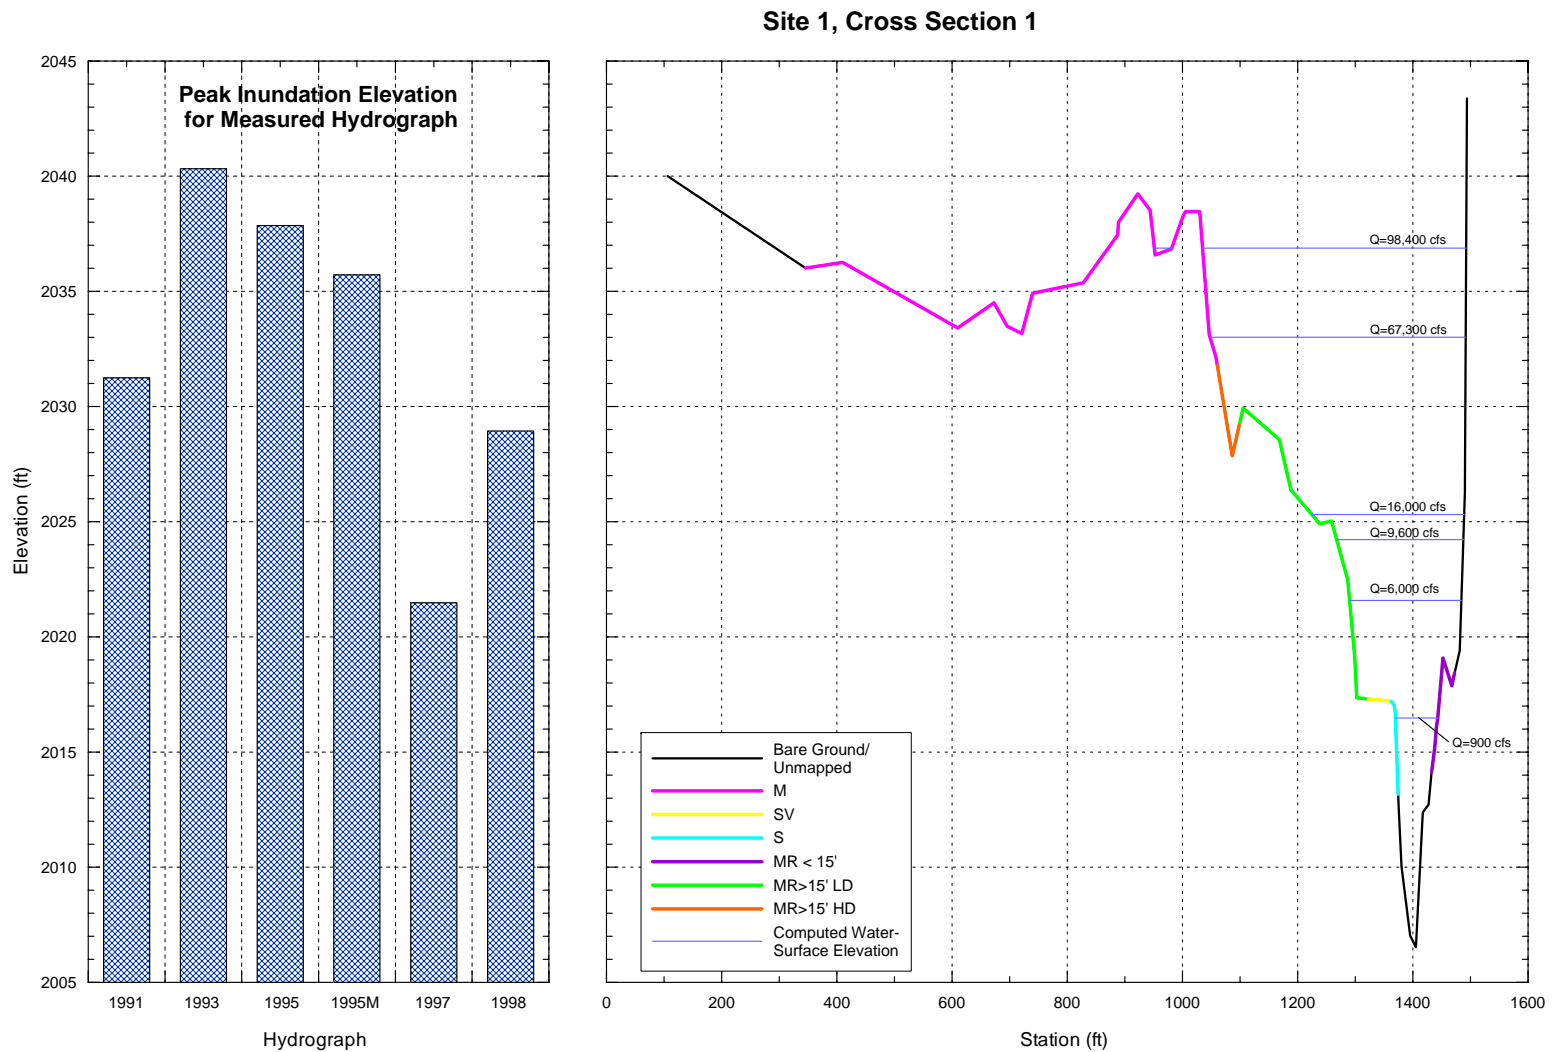
Figure 5.4. Peak discharge elevations for the 1991, 1993, 1995, 1995M, 1997 and 1998 floods plotted with the cross section profile for Cross Section 1 at Site 1. The cross section is color coded to show the distribution of the various types of vegetation at the site (refer to Table 5.1 for full descriptions of the vegetation codes).

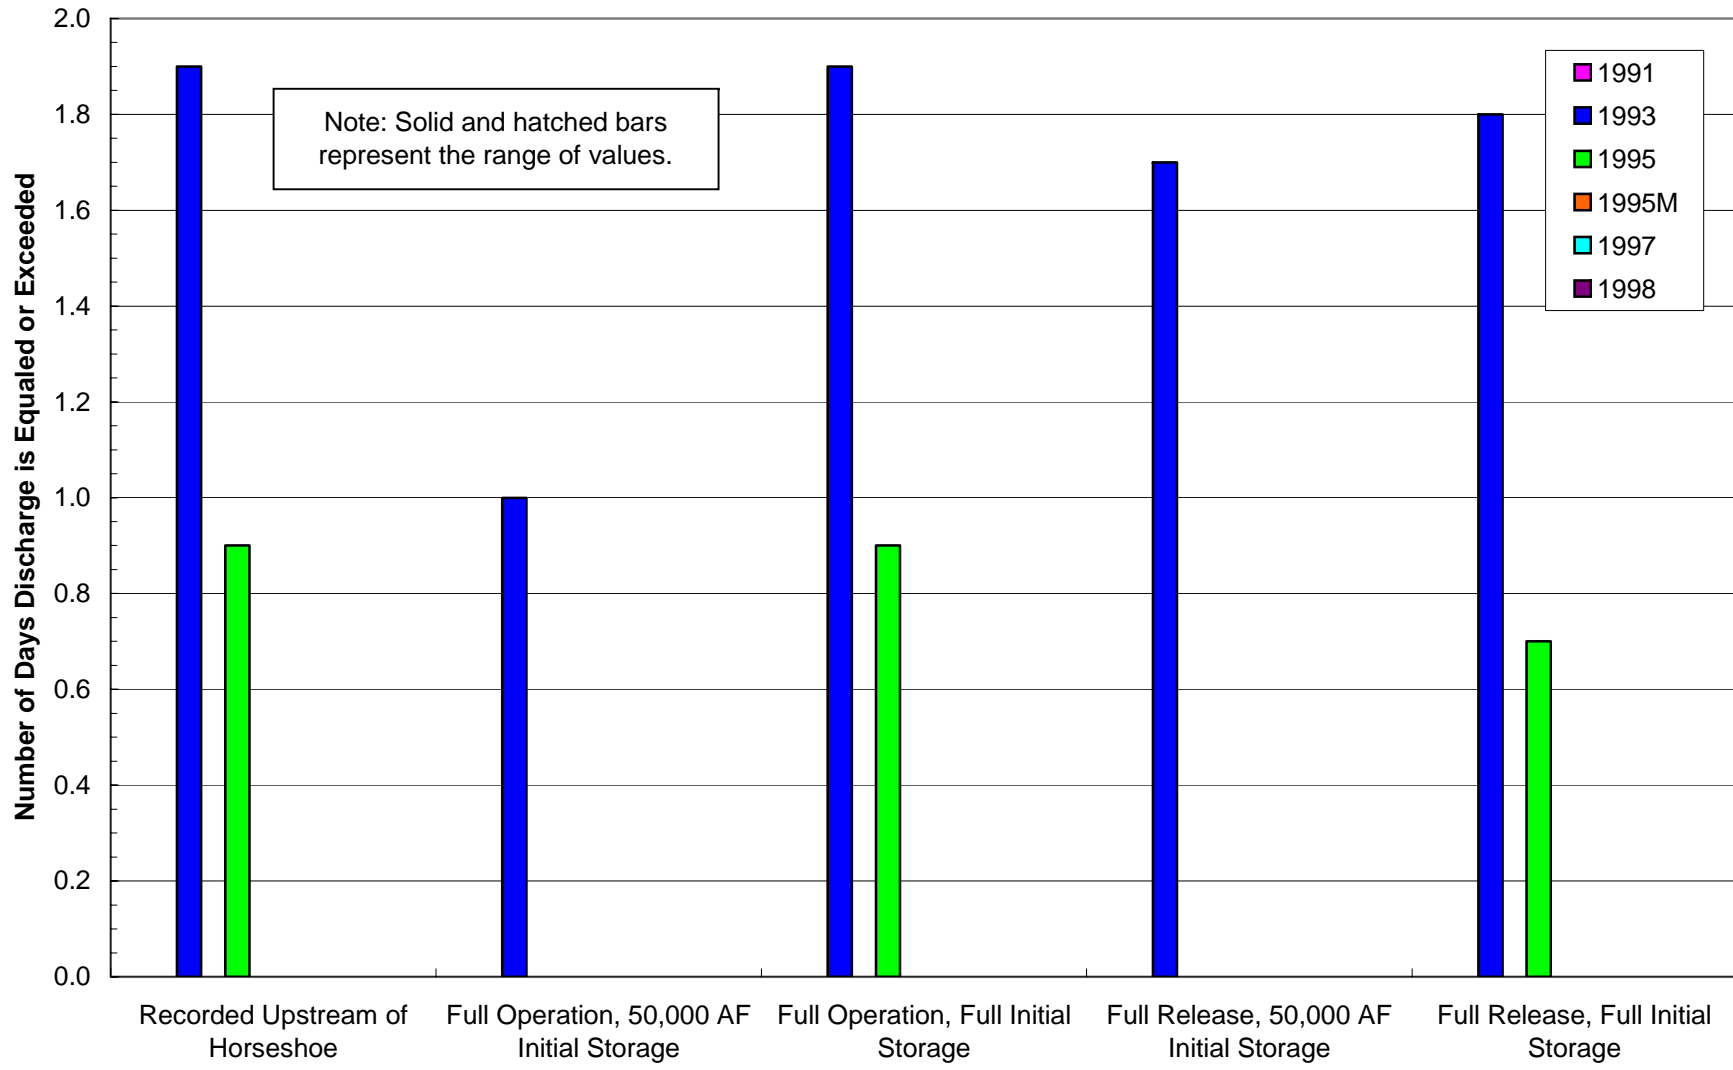
**Site 3 - Chute Channels - Measurable Transport  
55,000 to 150,000 cfs - 12 to >57yr RI**
