Erosion Control and Revegetation at DOE's Lowman Disposal Site, Lowman, Idaho

M. Kastens, R. Johnson, and D. Scheuerman,
S.M. Stoller Corporation, Grand Junction, Colorado

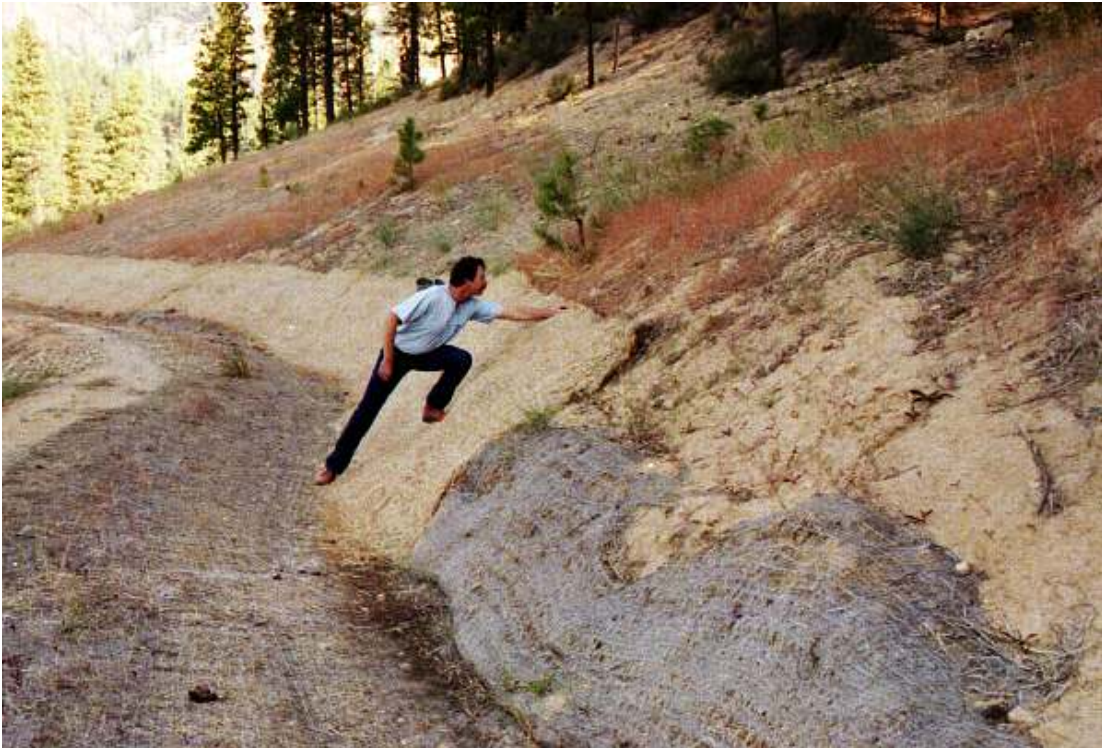
DOE visited the site in May 1999 to evaluate the success of the project following the first year's snowmelt and spring rains. Some portions of the upper interceptor terrace had washed out, and the erosion control fabric had slumped down to the invert of the bench. Approximately 300 feet of erosion control fabric required reanchoring in September 1999. Photo 1 shows the old, slumped fabric and the newly installed fabric.

Photo 1. Inspector checking erosion control fabric within the top interceptor bench.

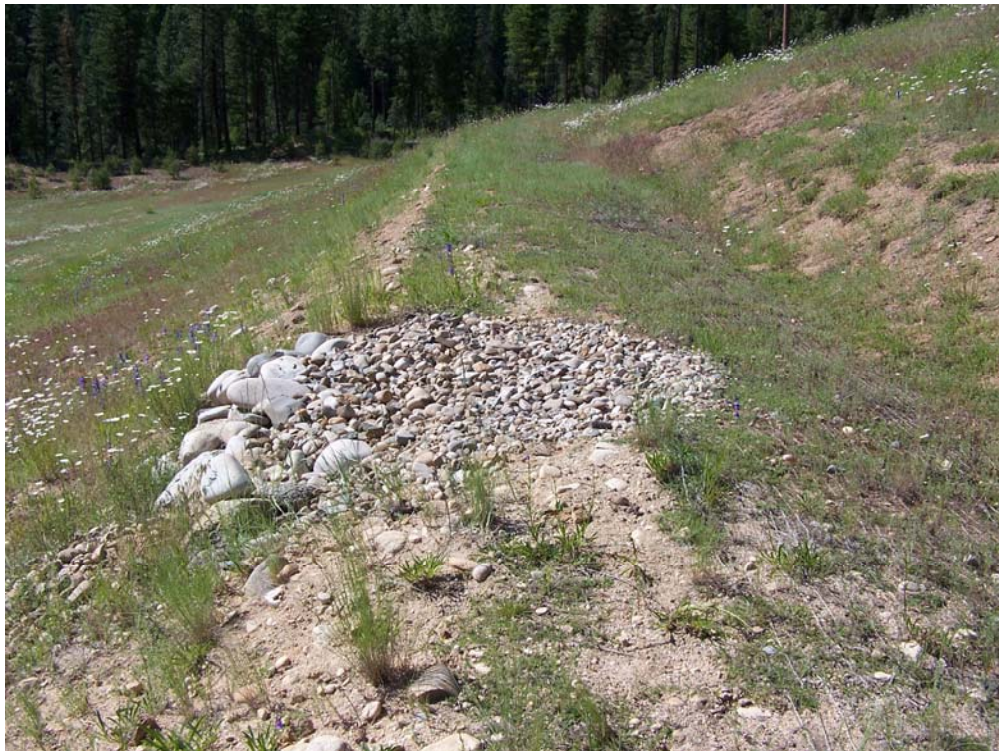
Photo 2. Riprap repair of the downslope portion of middle interceptor bench.

In May 1999, DOE also noted that some areas of the downslope portion of the interceptor benches had washed away, mainly due to the noncohesive nature of the granodiorite soils. In September, these washed-out areas were armored with riprap. Photo 2 shows a repair of the middle interceptor bench.

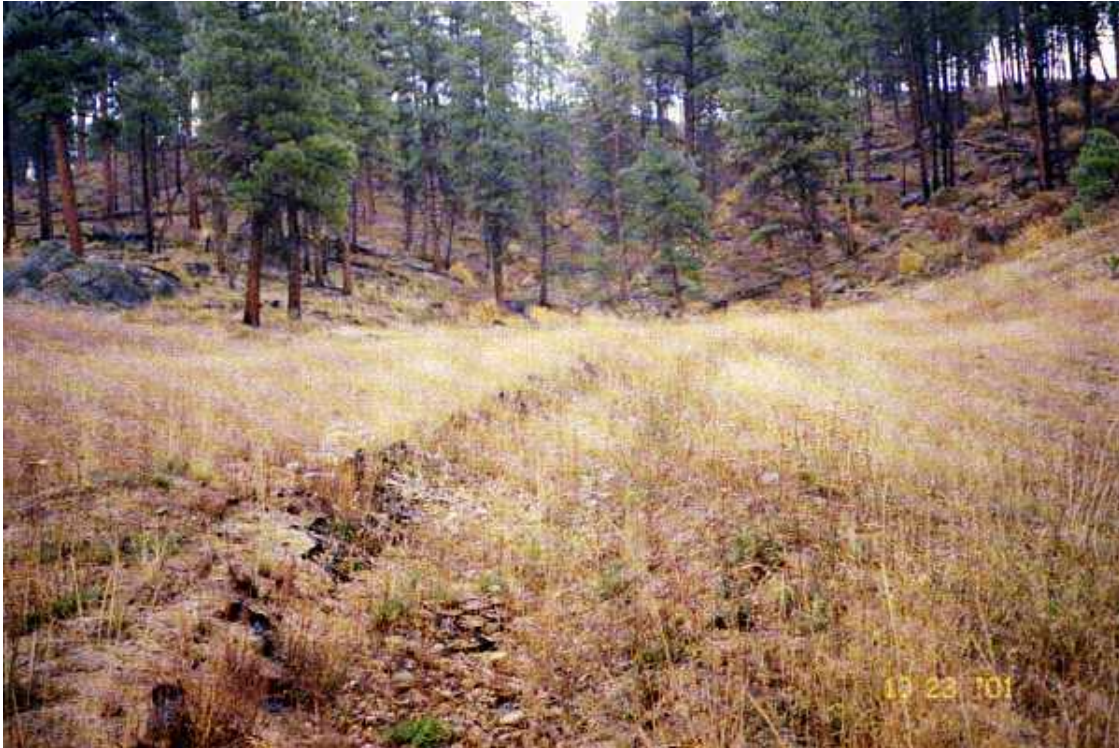
Photo 3. View upslope of GEOWEB cellular confinement system, filled with rock, in the collection ditch

The soil-sand-rock matrix that was used to fill the GEOWEB fabric installed in the collection ditch had also washed away shortly after installation. This matrix was too fine to withstand the erosive forces of the site's runoff water. DOE repaired this area by backfilling the GEOWEB fabric with angular rock measuring 1 to 3 inches in diameter. Photo 3 shows the collection ditch several years after the repair.

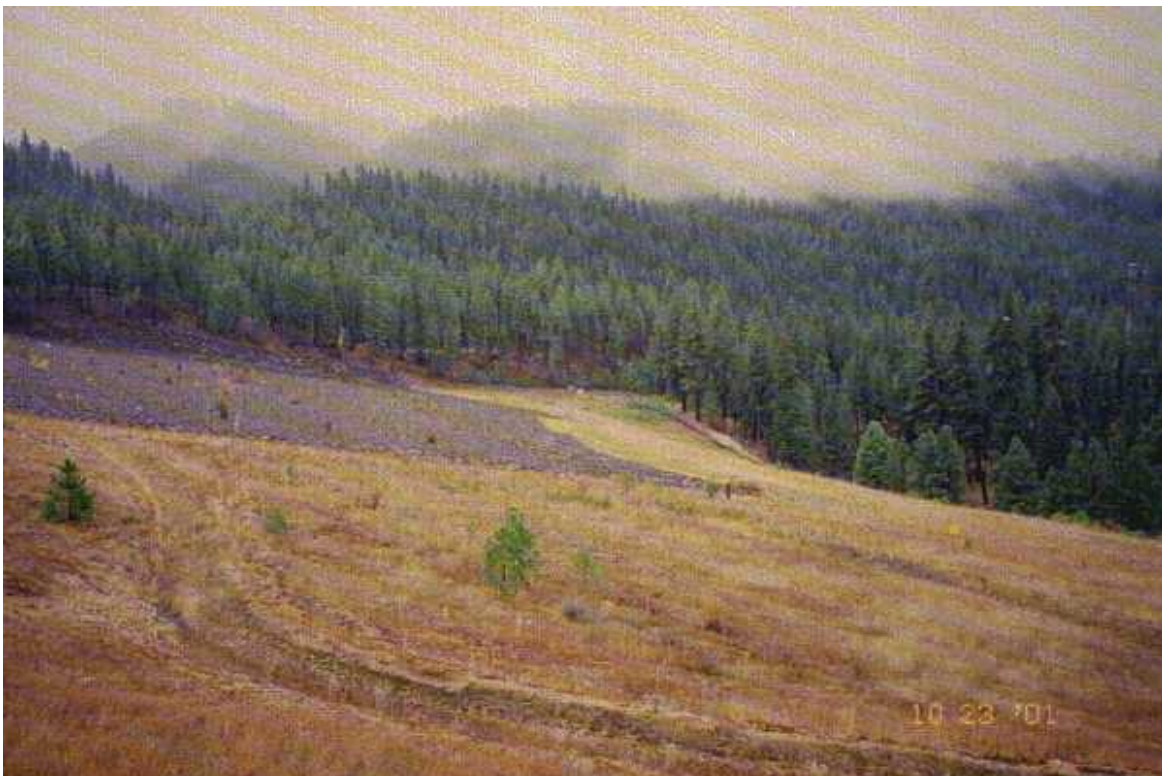
By the time of an October 2001 site visit, the interceptor benches, collection ditch, and vegetation were effectively controlling soil erosion in the 5-acre area. The revegetation effort was considered successful. Although some areas were dominated by cheatgrass (*Bromus tectorum*), an annual weedy species, most of the revegetated area supported healthy stands of desirable perennial species such as yarrow, penstemon, prairie coneflower, western wheatgrass,

bluebunch wheatgrass, and needle-and-thread grass. In addition, volunteer plants of ponderosa pine were establishing. Photo 4 shows an overview of the 5-acre area in October 2001.

Photo 4. View east of the middle and lower interceptor benches in October 2001 (rock-covered disposal cell is in background).
