# National Park Service and Army Join Forces for Historic Preservation

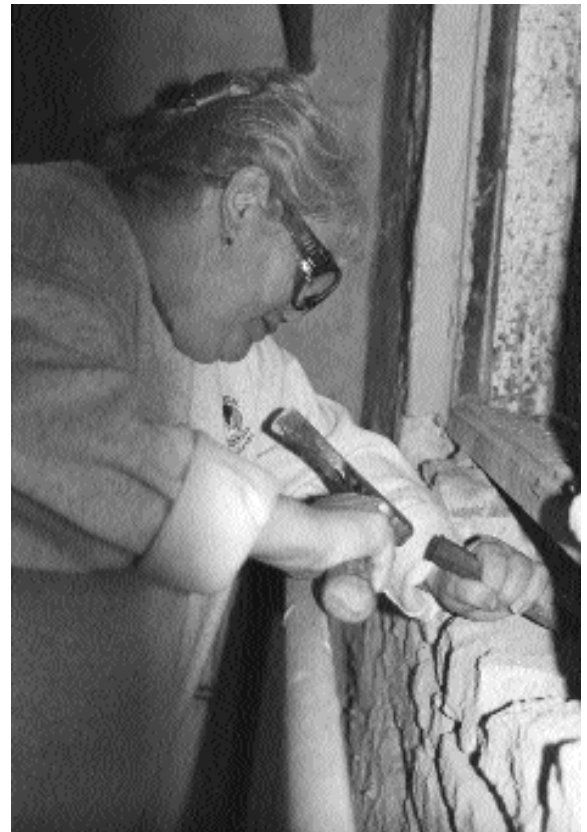
*Lucy Klass, an engineering technician from Fort Belvoir, Virginia, peers through dust-dimmed goggles to chisel away the crumbling cement from a former masonry repair. Use of the wrong material allowed water seepage and caused further damage to the brickwork. The new repair will be made with a sand and limestone compound as in the original construction.*

Praner, an environmental engineer, was getting his hands-on-training with a group repairing water-damaged masonry in the museum basement.

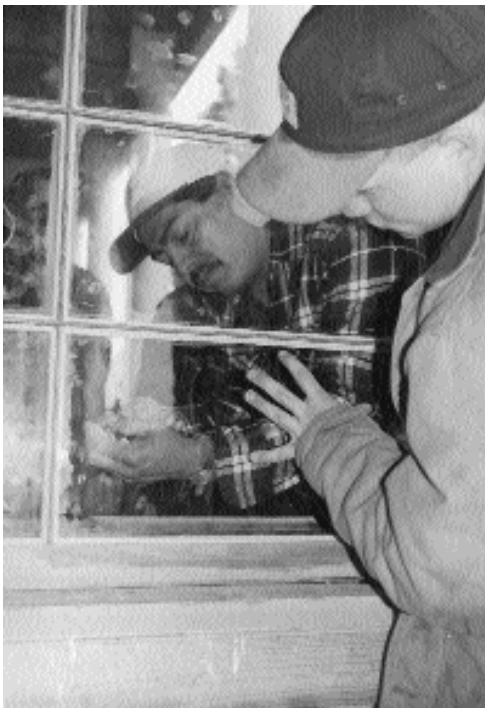
*John Mendez (left) of Public Works, Fort Sam Houston, refines his glazing technique as Harold Leggett, (right) of the Corps of Engineers in Buffalo, New York, provides assistance, with a little resistance on the window pane.*

The window repair process included proper removal of the window, the old glazing material and the original glass. After sanding the sash, the original glass is put back in, if possible, and old fashioned handmixed linseed oil glazing, is reapplied with a skilled technique.

The original glazing material, as well as being historically accurate, is superior mater-

ial to modern commercial putty. The linseed oil glazing holds its body, doesn't dry out, and is easier to remove and replace.
