# **Farmers Mutual Ditch Environmental Mitigation Project for the Army Corps of Engineers**

USDA NRCS Los Lunas Plant Materials Center

2005

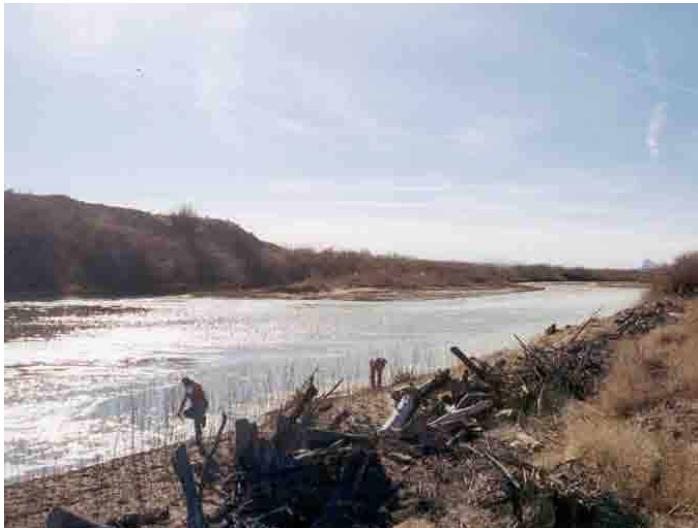
Figure 1: Russian olive debris piled on the river bank for erosion protection.

During the first phase of the project in the winter of 2003, site preparations began when the BLM cleared a 1,000-foot stand of Russian olive (*Elaeagnus angustifolia*) on the north bank of the San Juan River. The debris from the trees was piled on the bank of the river to protect the bank during high river flows (Figure 1).

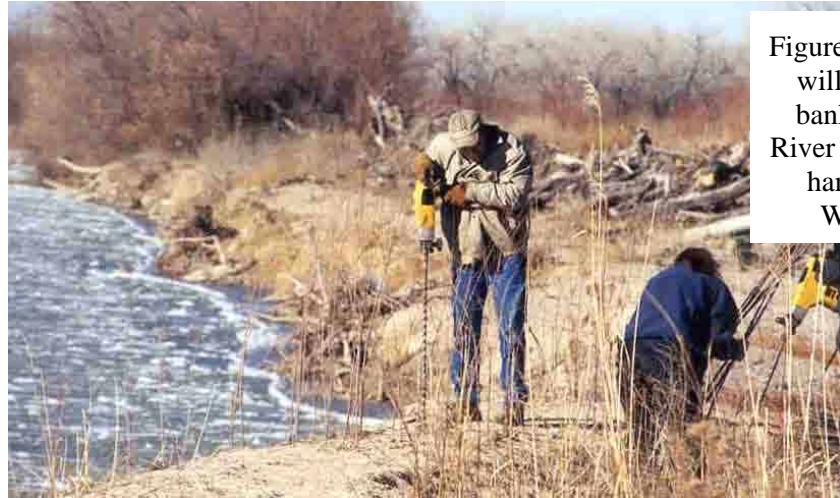
Figure 2: Planting coyote willows on the north bank of the San Juan River with electric rotary hammer drills near Waterflow, NM.

In December 2003, the second phase of the project involved harvesting 9,000 vigorous coyote willow whip cuttings from the Bureau of Reclamation's (BOR) low flow canal on the west side of the Rio Grande, about five miles south of Socorro, New Mexico. The willows were harvested daily for a two week period. At the end of each day, the willow cuttings were transported to the LLPMC and placed in water baths to keep them hydrated. The final phase of the project involved restoring this farm field back to a riparian plant community. Using a 10-amp electric rotary hammer drill, the willows were planted on the riverbank in sandy soil to a 30-inch

depth and placed on 1–2-foot centers. This planting intends to stabilize the bank and provide wildlife habitat (Figures 2 and 3).

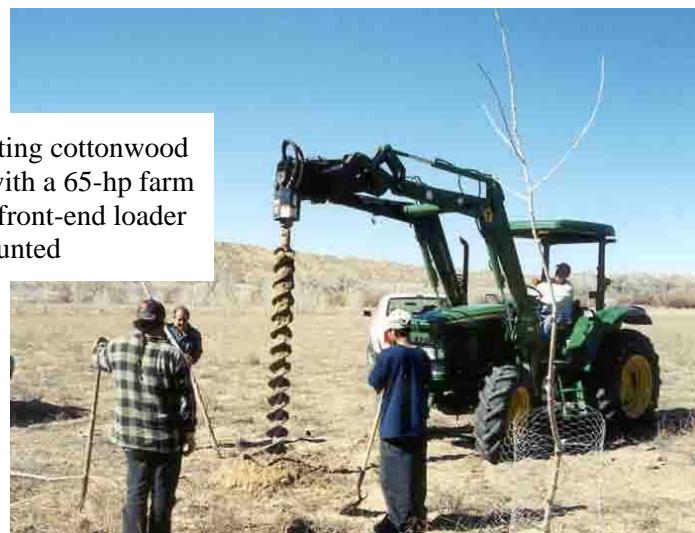
Figure 3: Planting cottonwood pole cuttings with a 65-hp farm tractor with a front-end loader mounted

The Rio Grande cottonwood pole cuttings were originally collected from the Bosque del Apache Wildlife Refuge and were established in a pole production plantation at the LLPMC. The cottonwood pole cuttings (12–15-ft. in length) were planted on 15–20 foot centers using an 8-foot auger, 10 inches in diameter and mounted on a front-end loader of a 65-hp farm tractor (Figure 4).

The cottonwood pole cuttings were planted at locations where the auger could drill 8-ft. deep; easily reaching the 4–6-ft .water table that existed during the planting period (February 2004). Each cottonwood pole cutting was protected from beaver predation with a 5' high by 30" in diameter poultry wire tree-guard. There were large open areas of the planting site located near the river where the auger could not penetrate a gravel layer below the surface (approximately 3 ft. down). Because the intended planting holes were dry at this shallow depth, the pole cuttings were not placed in these holes.

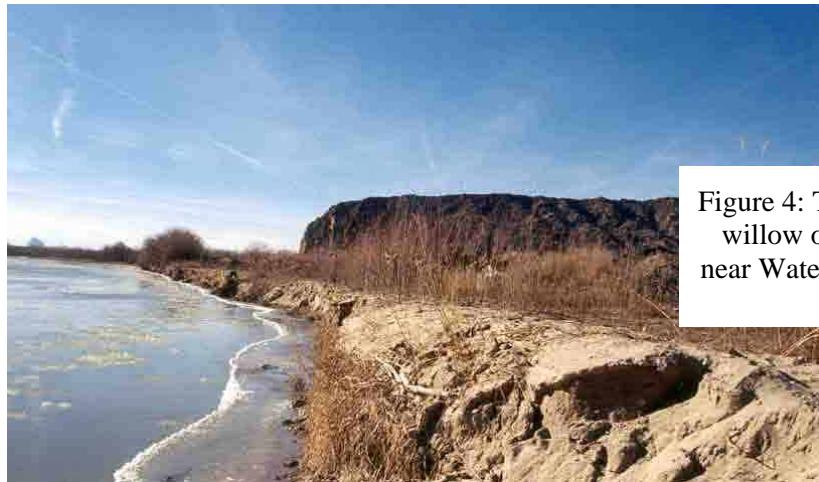
Figure 4: The site before planting willow on the San Juan River near Waterflow, NM in February 2004.

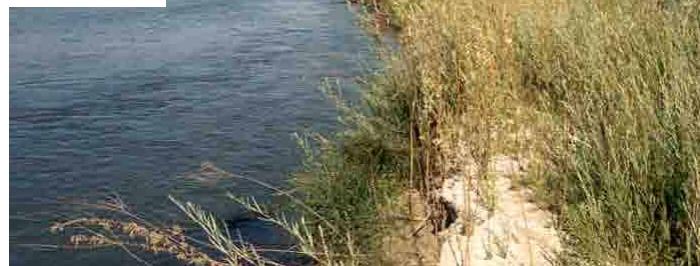
Figure 5: Same site after planting coyote willow in June of 2004

The planting was evaluated for rate of survival in June of 2004 by Ernie Janke (ACE), Patty Phillips (ACE) and Greg Fenchel (LLPMC). We estimated an 80 percent (or greater) survival rate for the coyote willow whip cuttings (Figure 5). There were areas of the planting where patches of willows had dead tops, but they were readily re-sprouting at the base of the whips. These areas were located on sites higher than 5 feet above the river (Figure 6).

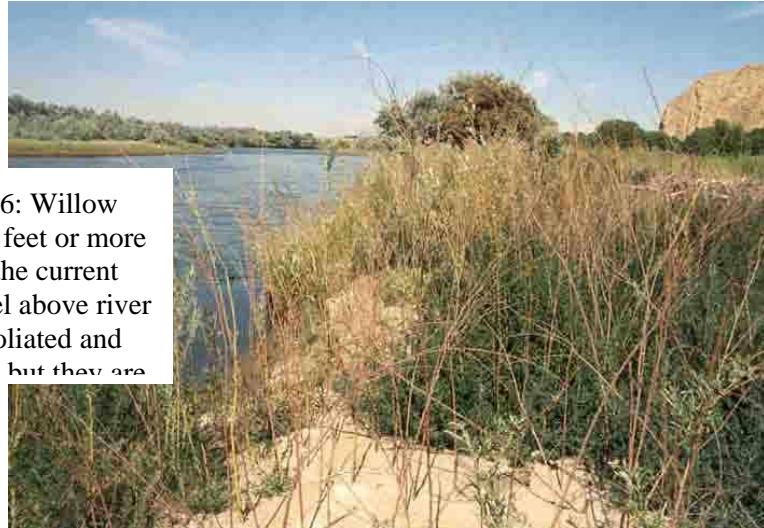
Figure 6: Willow planted 5 feet or more above the current water level above river are defoliated and dried out but they are

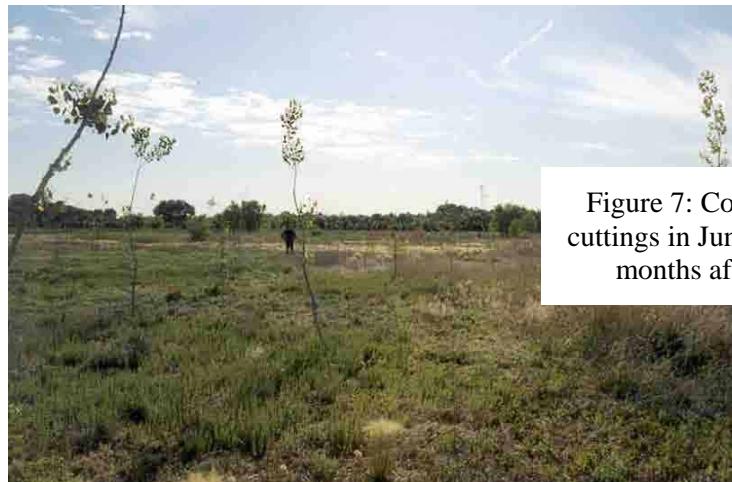
Figure 7: Cottonwood pole cuttings in June of 2004, three months after planting.

The Rio Grande cottonwood pole cuttings displayed a 95 percent survival rate (Figure 7). There were 43 dead pole cuttings, appearing randomly throughout the planting.
