Soda Lake, WY - Capping Case Study

Vickie Meredith, Project Supervisor
Wyoming Department of
Environmental Quality, Lander WY

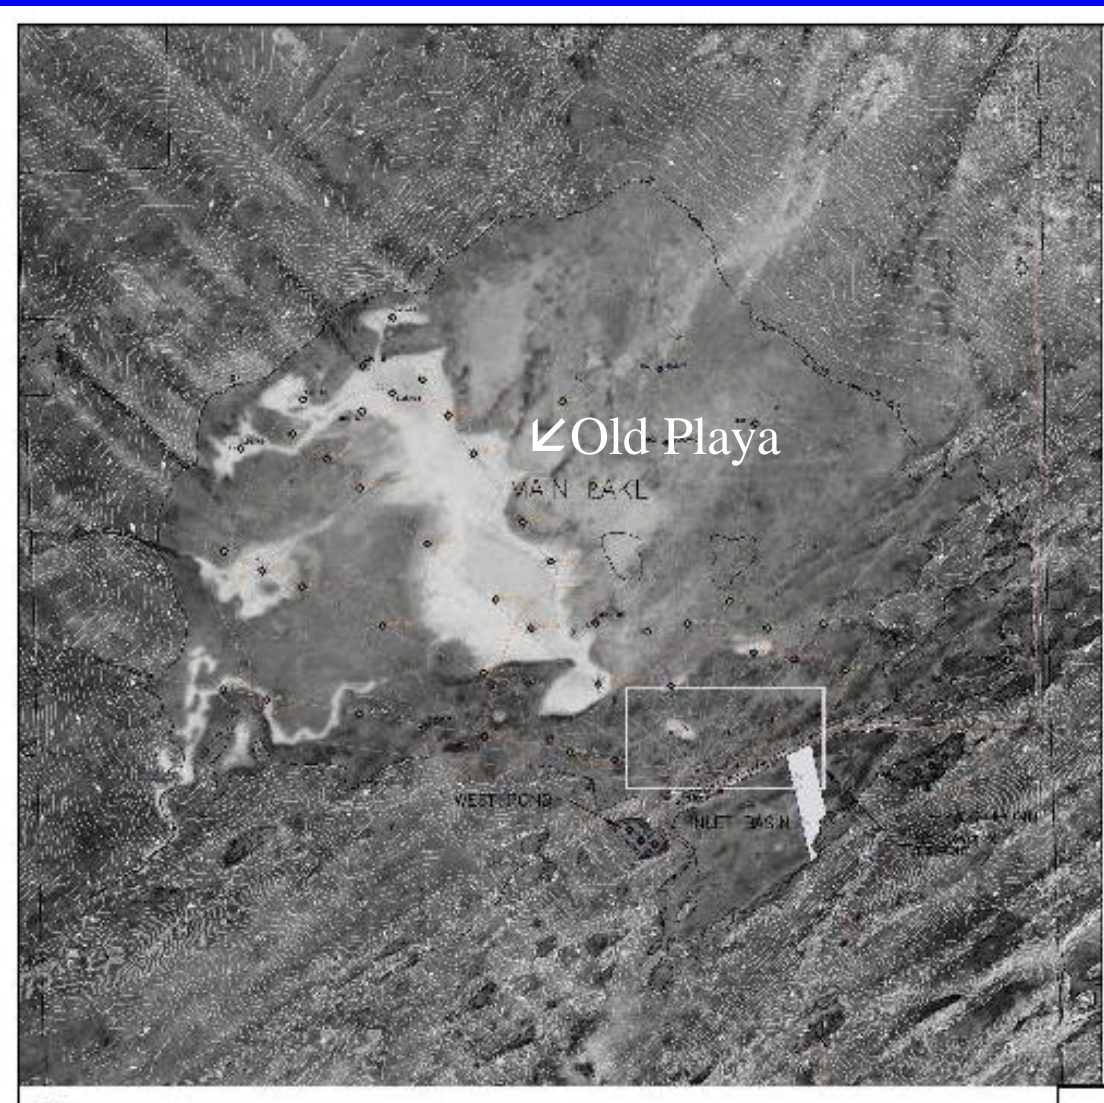
Pre-1957 playa basin

- Soda Lake is a natural playa basin historically about 100 acres in size.
- Formed in a shale/sandstone depression.
 - Prehistoric sand dunes on about 1/3 of the uplands
- Natural salinity over 50,000 ppm.
 - Some low amounts of natural high TDS groundwater inflow and surface runoff.
 - Historically the lake formed in the winter and mostly evaporated in the summer.
 - WY has 11 inches of rain/snowfall, 40 inches of evaporation

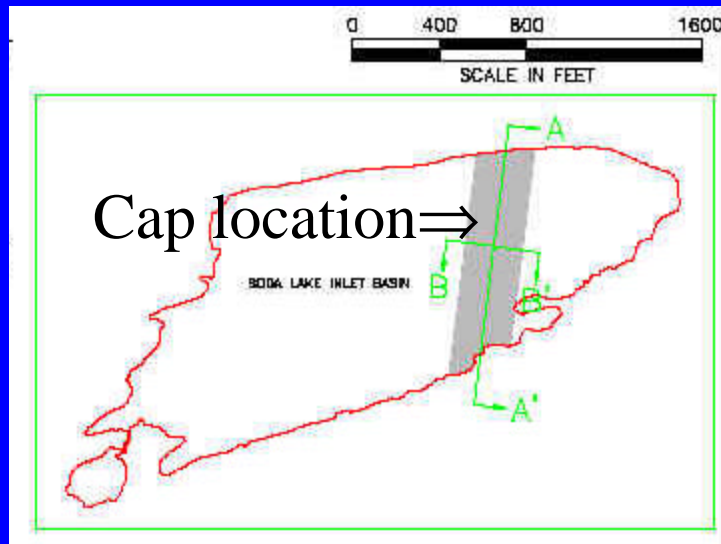
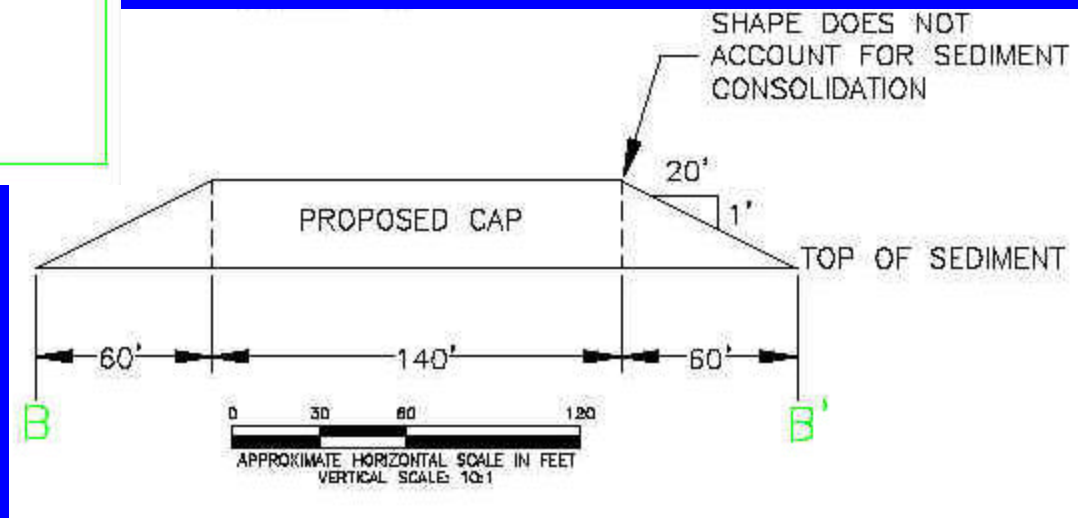
Location and Schematic of Demonstration Cap

- Final cap design thickness of 1.5 feet
 - Primary Consolidation Model predicted
 - 0.6' to 1.6' of cap consolidation
 - rapid initial consolidation
 - Cap was designed to embed itself into the soft sediments and the lower sand layers of cap serve as the foundation for upper clean zones to rest upon
 - cap instability if high loads were placed upon the in-situ sediments
 - Cap constructed in 1.5" lifts
 - under conservative advective flux modeling, sediment and water quality criteria would not be exceeded at the cap surface

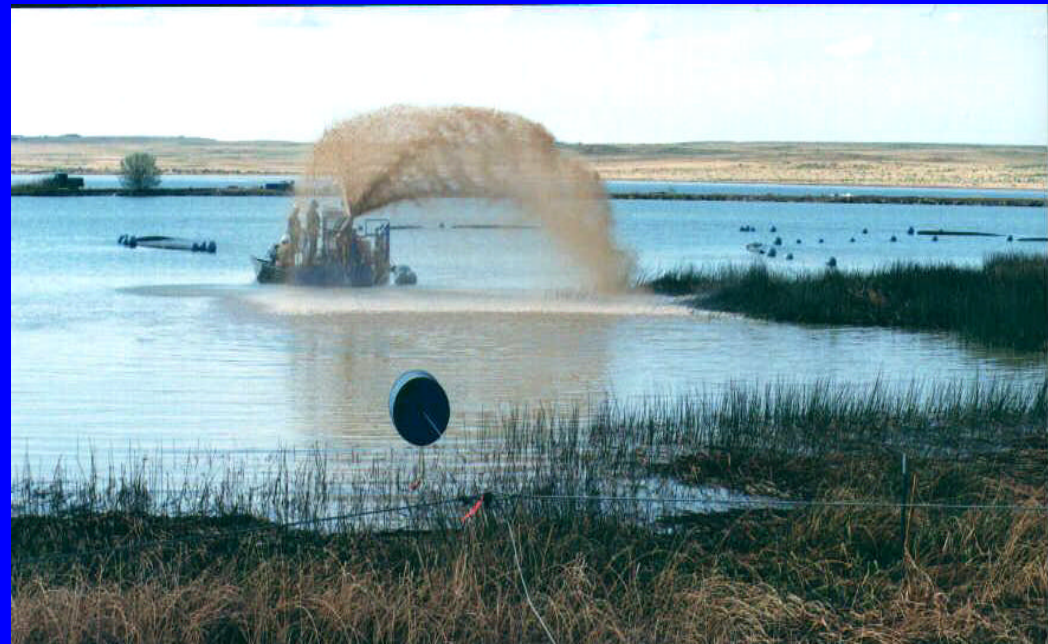
Pumped onto spreader barge for deep water areas or sprayed onto shallower areas with a nozzle

Spraying sand slurry into shallows

- Cap sand was provided on-site
 - Sand dunes
- Sand was slurried with 70% water from the lake

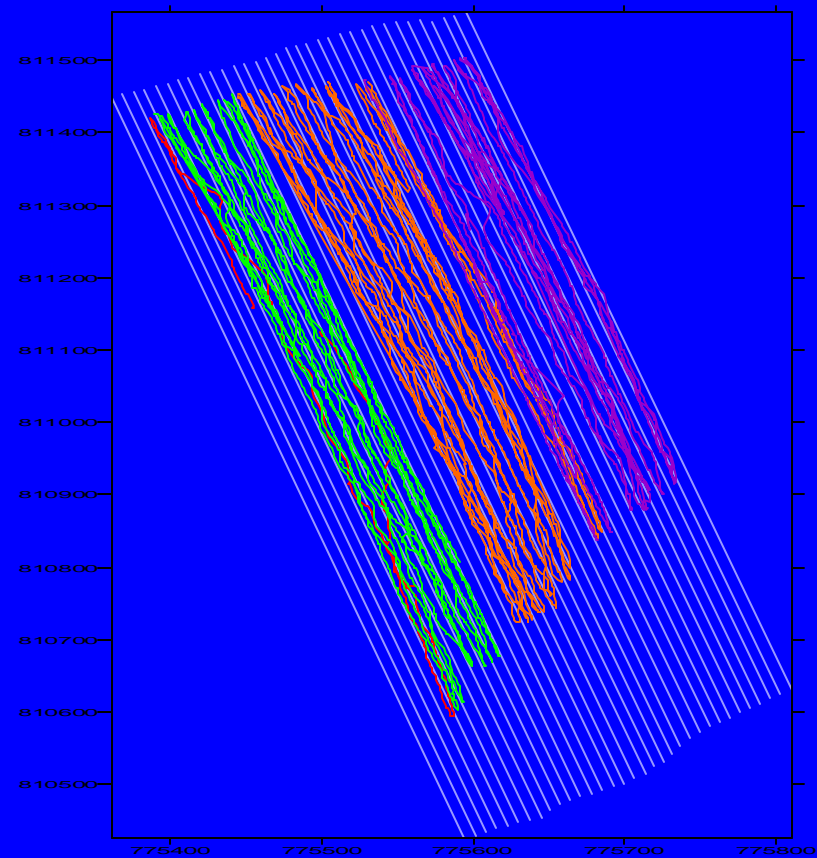
- Spreader barge tracked with GPS - output daily
- Plotted nightly to ensure adequate coverage
- Revisited missed areas over time

Days shown in different colors

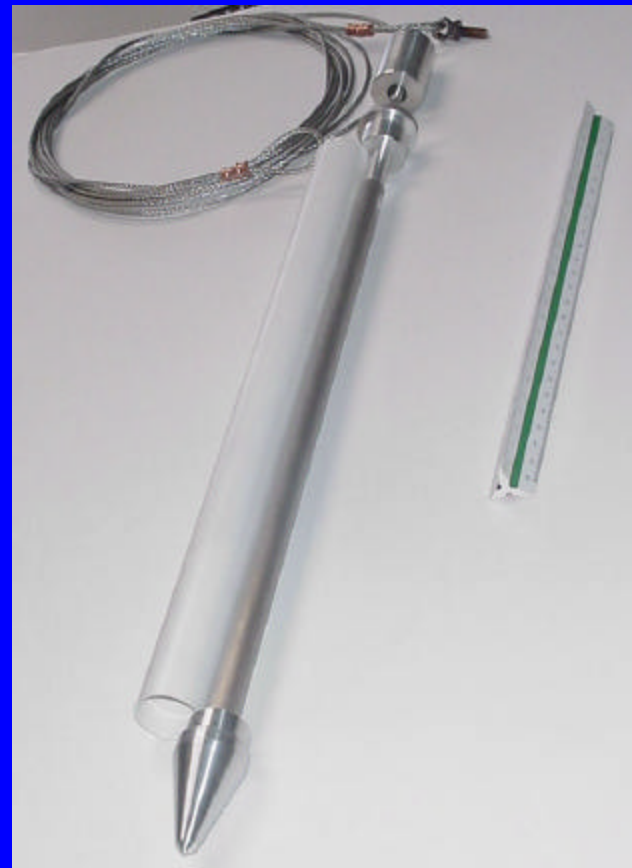
Rod with slotted PVC for driving dialysis bag samplers into upper cap.

- Cap Isolation
 - analysis of bulk sediment for contaminants using cores
 - Coring was unsuccessful in gathering pore water
 - » Water drained quickly from sand before sampling
 - Switching to dialysis bag peepers instead
 - No Contaminants detected in bulk sediments from upper 2 feet of cap
 - Lower mixing zones had some detected PAHs

- Pore water techniques required modifications
 - Sampling not done yet
