**Final Report**

**CHARACTERIZING POLYESTER  
ROPE MOORING INSTALLATION  
DAMAGE**

**PN 7141-RRR**

**By:  
Ray R. Ayers, Ph.D., P.E.**

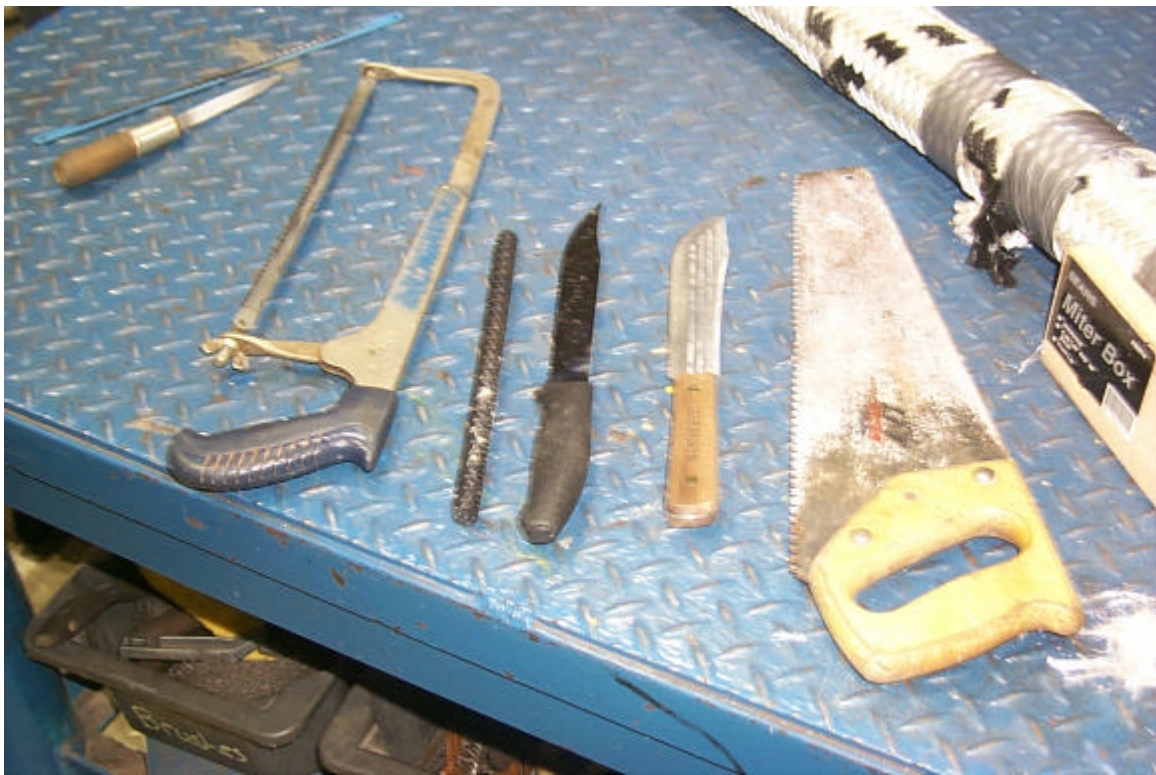
**Figure 1.** Cutting devices used.

To better understand how susceptible polyester rope is to damage, we performed some simple external damage experiments on a short specimen of 450,000 lb rope. For ease of cutting we placed the rope in a wooden miter box to constrain rotation. The cutting devices we experimented with included a crosscut handsaw, butcher knife, fish filleting knife with serrated edge, a piece of steel reinforcing bar and a hacksaw, all shown in Figure 1. But our technician used his machete for cutting a test length from the reel of 4-inch diameter rope, as shown in Figure 2.

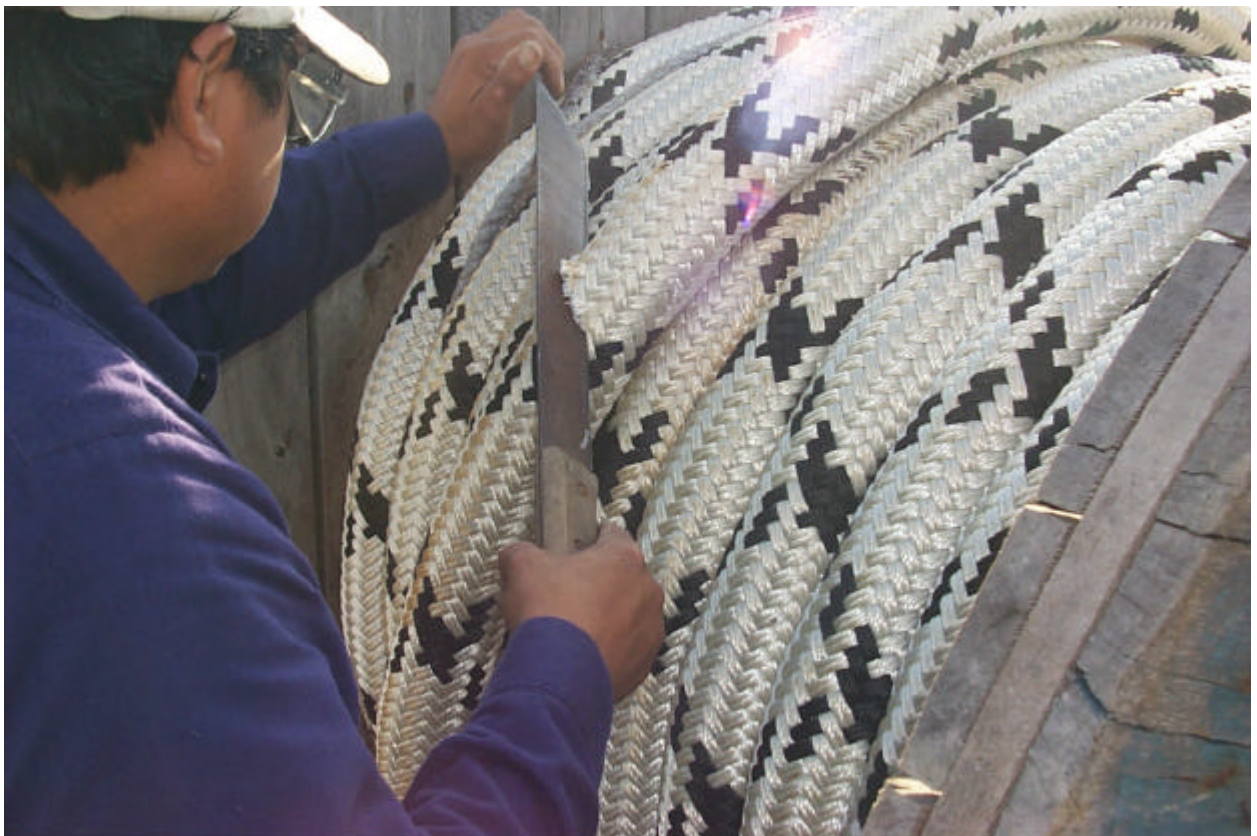
**Figure 2.** Machete was used for major cuts.

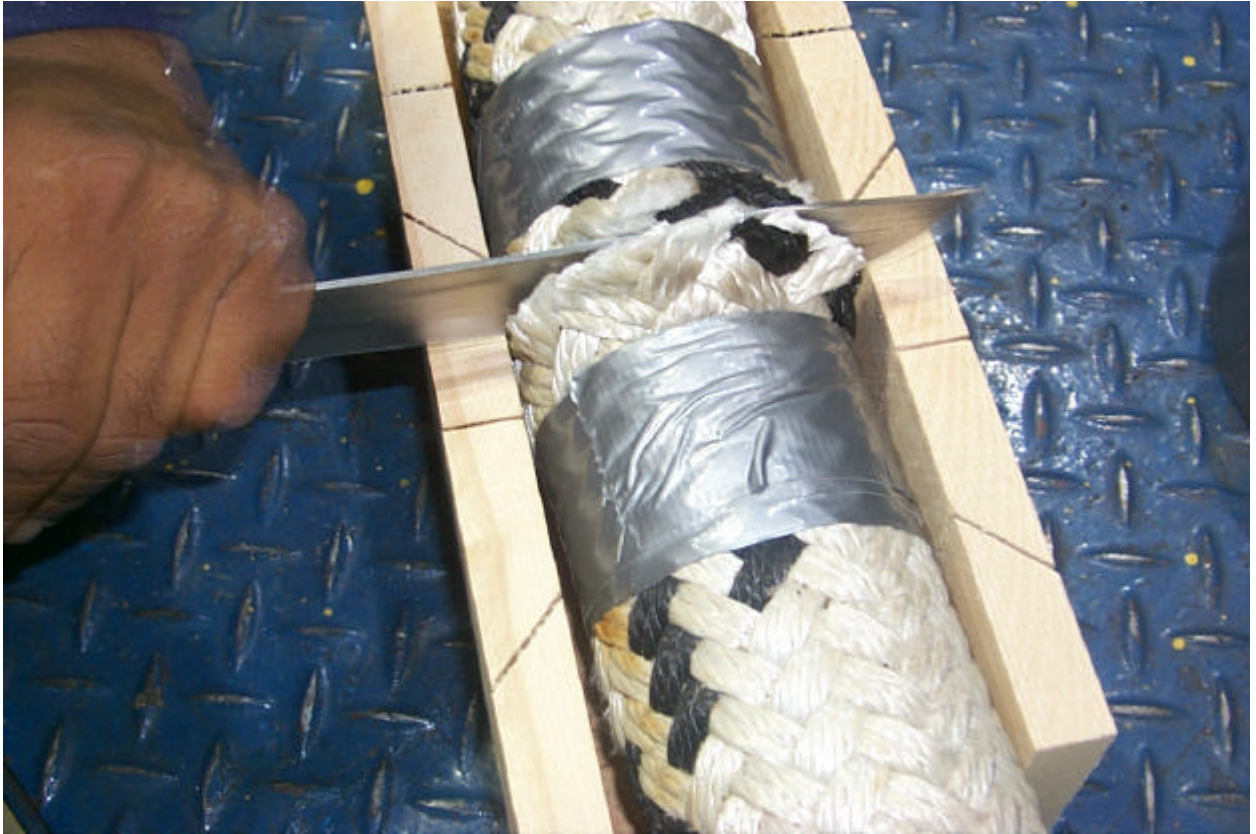
**Figure 3.** Cutting with butcher knife.

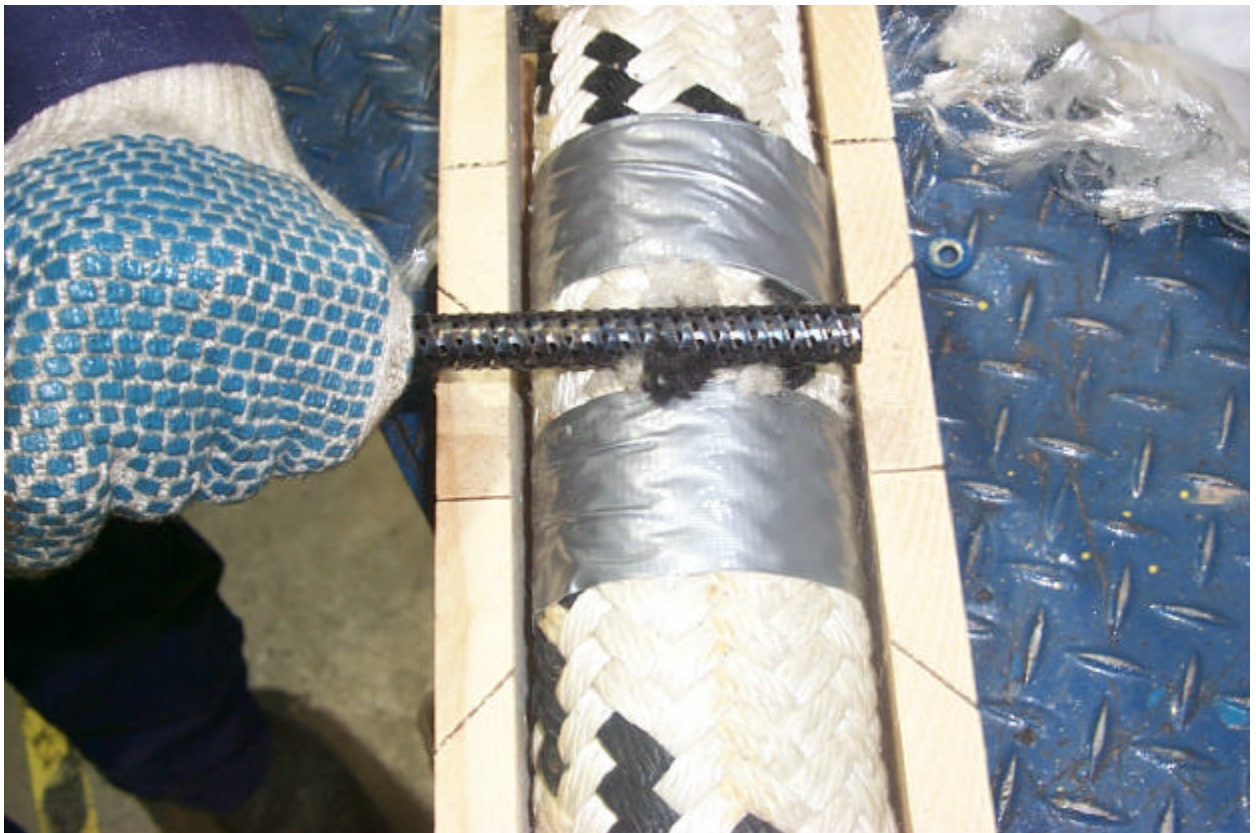
**Figure 4.** Cutting with piece of reinforcement bar.

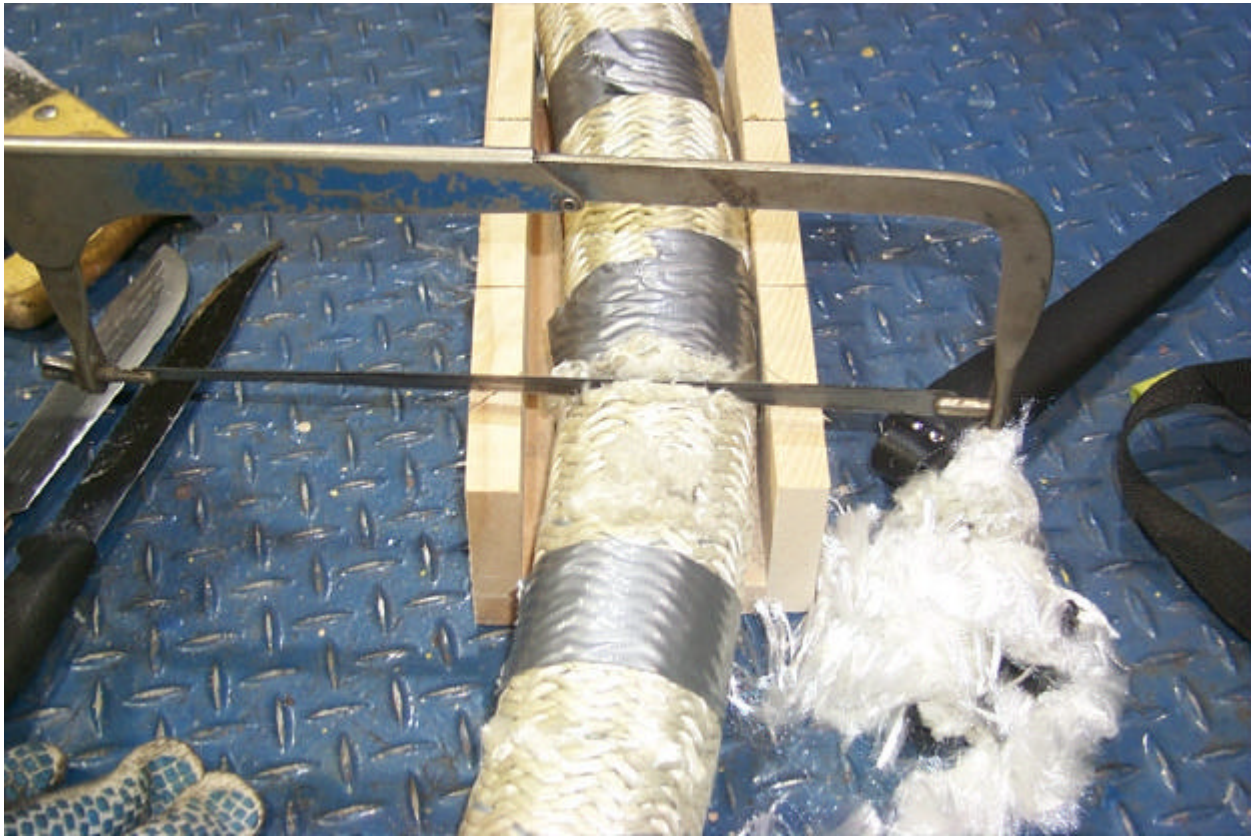
**Figure 5.** Cutting with hacksaw.

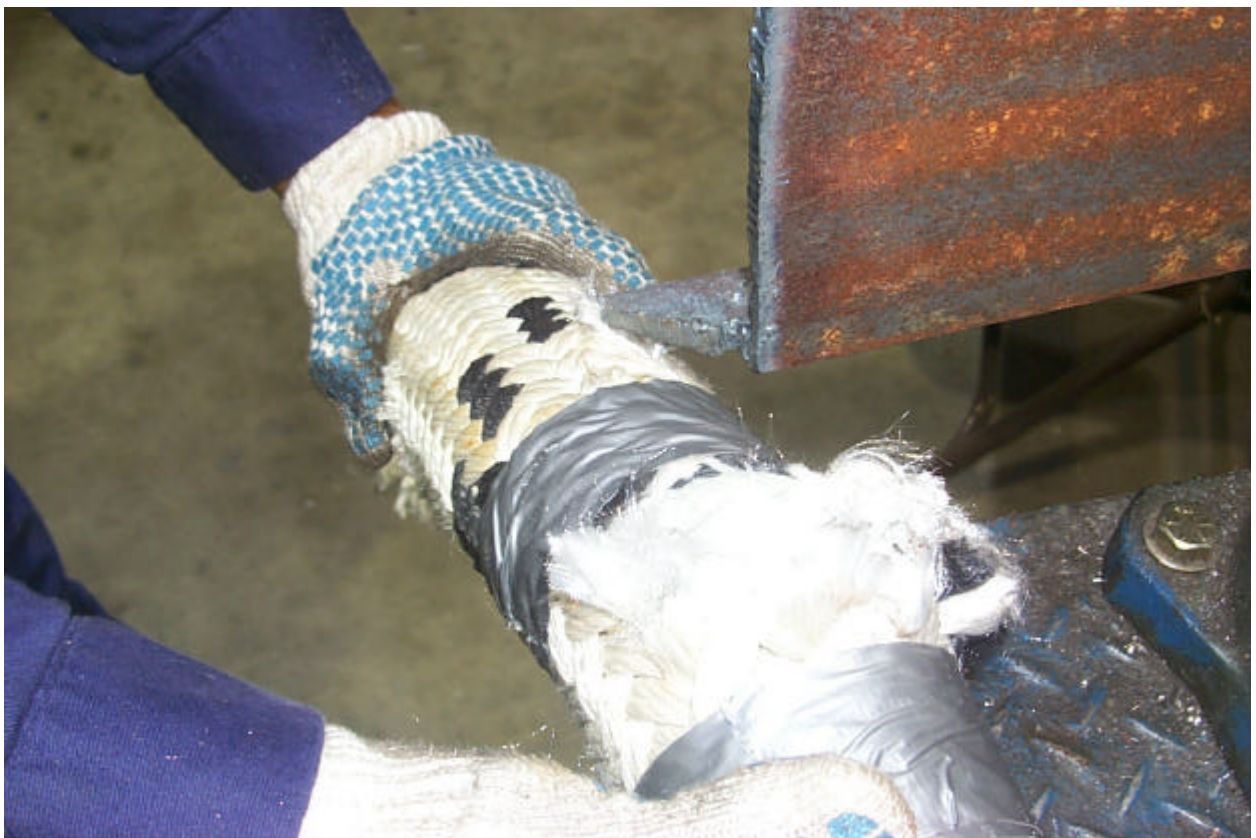
**Figure 6.** Puncture test with raw edge of steel angle.

Figure 6 shows us trying to puncture the jacket of the rope with the rough edge of a piece of steel channel section. It was difficult to inflict much damage in this case. Cutting the jacket was relatively easy.

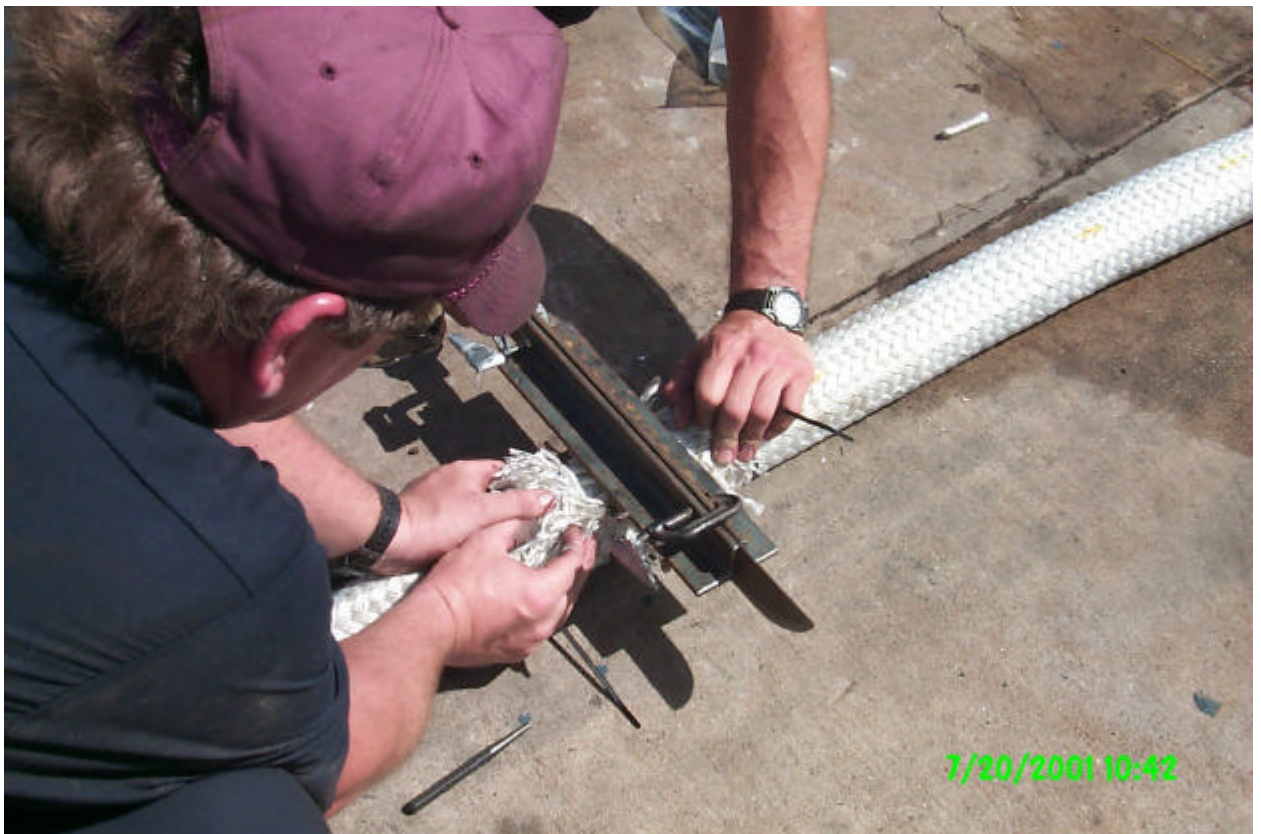
**Figure 8.** Photograph of using a knife to cut rope assembly.
