Trail Terminology
Trace	General term for any original trail remnant.
Depression	Shallow dip in the surface, often very faint and difficult to see.
Swale	A depression, but of deeper dimensions and with sloping sides.
Rut	Deep depression, without a center mound and having steep sides.
MET Guide pag	e 16.

Class 1: Unaltered Trail Symbol: (1)

Summary - Mapping

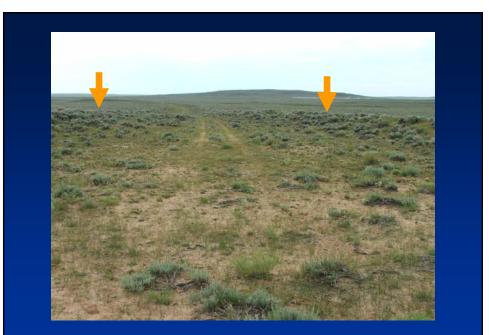
Big Sandy Swales Class 1 (Class 2 within trail corridor)

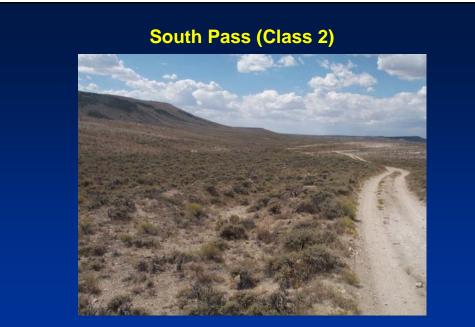
Note: Parallel trails in the area, some of which are Class 1.

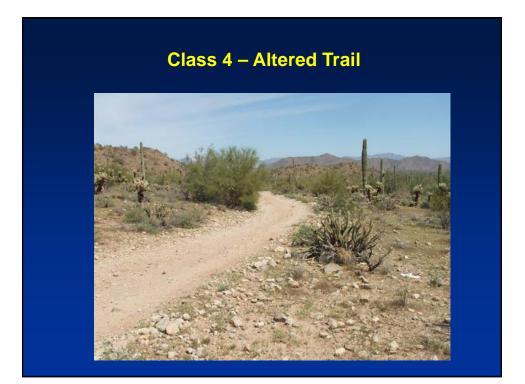
Class 2 and Class 4 (Beyond Fence)
